# **AN INDEPENDENT INVESTIGATION AND ADVISORY ON THE ROLE OF WATER, SANITATION AND HYGIENE IN THE 2023 CHOLERA OUTBREAK IN HAMMANSKRAAL, SOUTH AFRICA**

### ***Part 2: Assessment of the Functionality and Compliance Status of the Temba Water Treatment Works***

Final Report to the  
**Water Research Commission**

**WRC Report No. 3167/2/24**

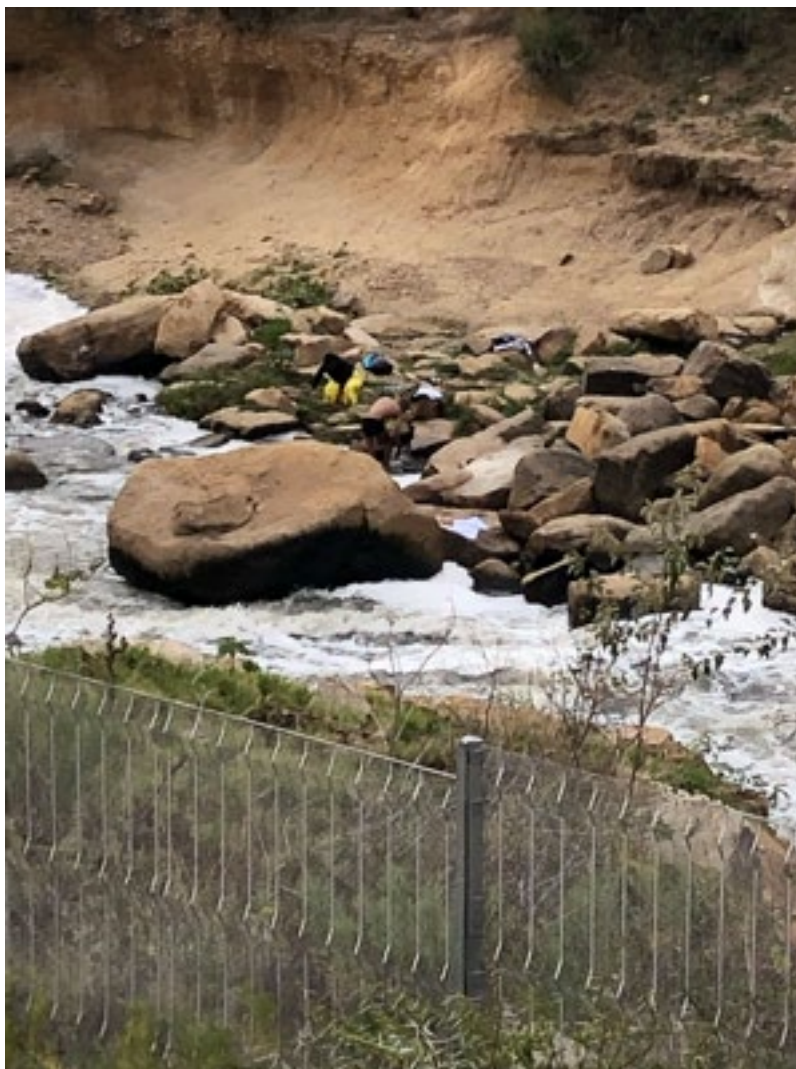
The overflow of the dam was foaming and was not what would be expected from surface water. The foam was similar to what is seen at the Rooiwal Wastewater Treatment Works (WWTW) discharge point. People were washing their clothes in the water while others bathed in the same water. See Figure 2 below.

**Figure 2: Community washing downstream of the dam**

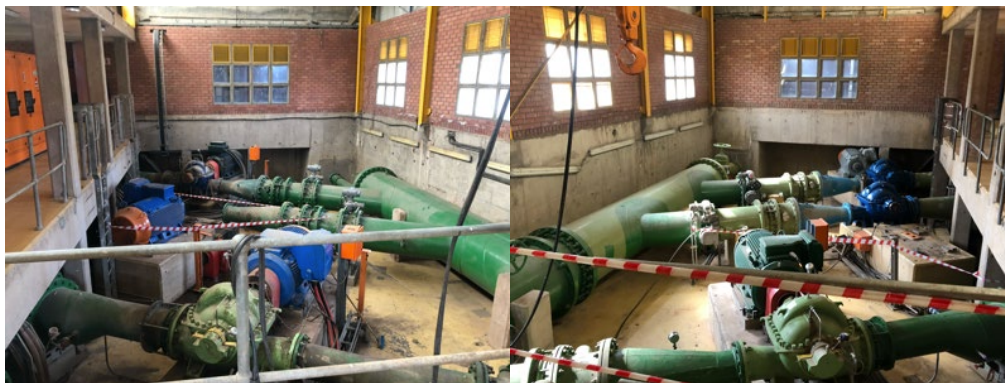
The pump station has two lines, each with three raw water pumps. Only two (2) pumps were operating, while a third pump was available as a standby pump. Only one of the flow meters was functional, but the pumps are rated at 1 249 m<sup>3</sup>/h. The inflows from the two lines are measured at the water treatment works and was 402 l/s for the old line and 408 l/s for the new line. The combined inflow into the works is, therefore, 810 l/s, which equates to  $\pm 70$  Ml/d. The flow is only 58% of the design capacity of the water treatment works.

Figure 3: Raw water pump station

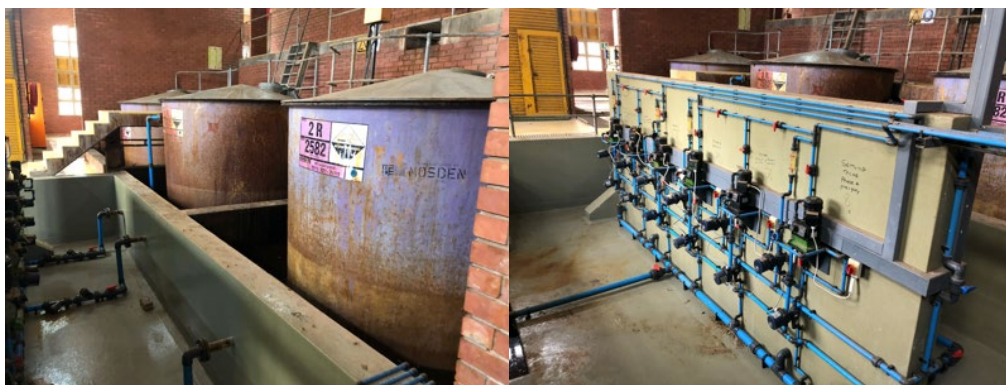
The polymer is transferred to three (3) day tanks, each with 2 500 ℓ capacity. Various sizes of dosing pumps are used to dose the polymer to the various pre- and post-dosing points within the process. The sizes ranged between 14 and 18 ℓ/h. The required dosing rate for the current water quality was unknown to the operational staff on shift. Records are not kept of actual stock, stock used, back-calculation of dosage and the comparison against the required-dosage.

Figure 4: Polymer Day Tanks and Dosing Pumps

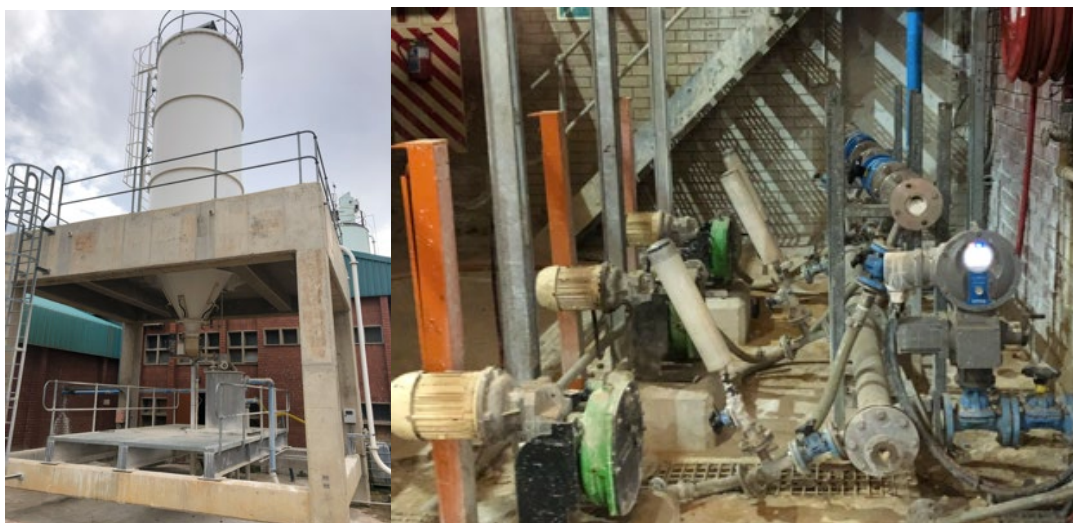
Provision is made for lime dosing. Lime is delivered in a lime silo while mixing equipment and various peristaltic pumps are available to dose lime. The system is, however, not functional due to moisture problems, and no lime dosing was taking place on the day of the assessment.

Figure 5: Lime dosing system (not operational)

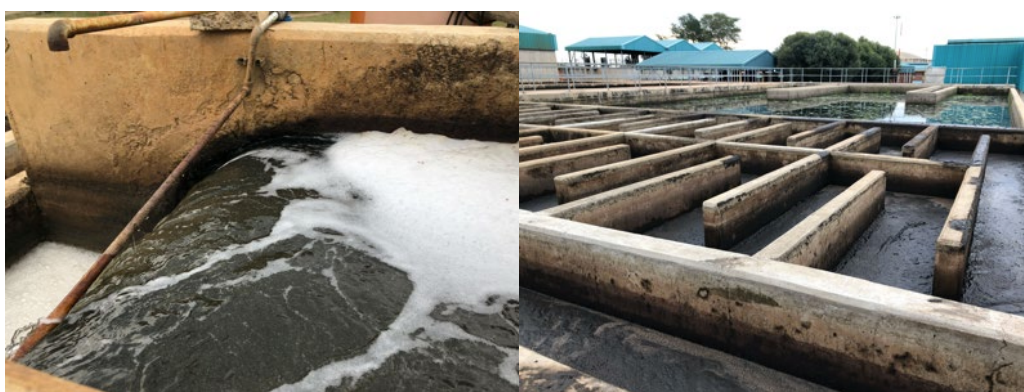
**Figure 6: Module 4 flocculation and clarification**

The black foam could be seen looking like anaerobic sludge, while the intake water was not similar in nature. The filtered water from Module 3 is transferred to the Ozone contact tank and the GAC filtration plant.

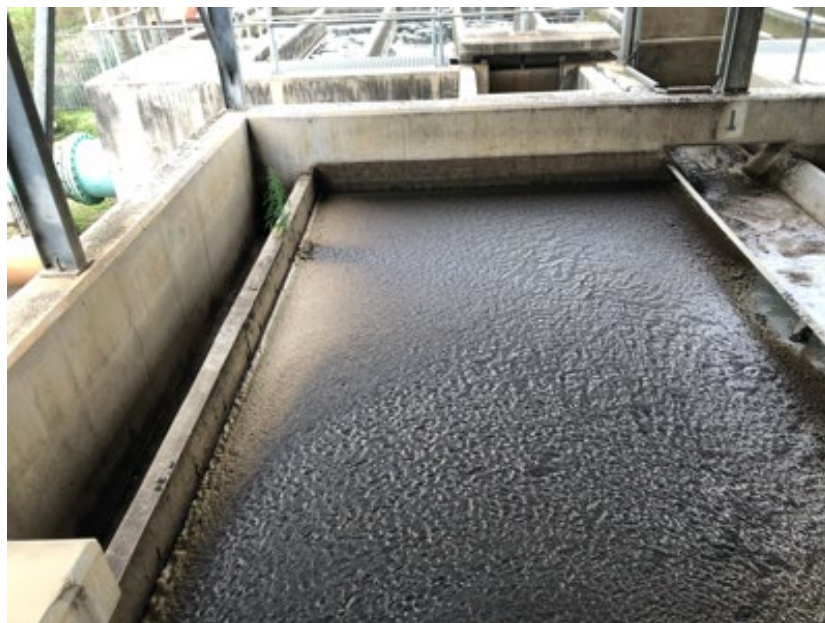
**Figure 7: DAF unit for Module 5**

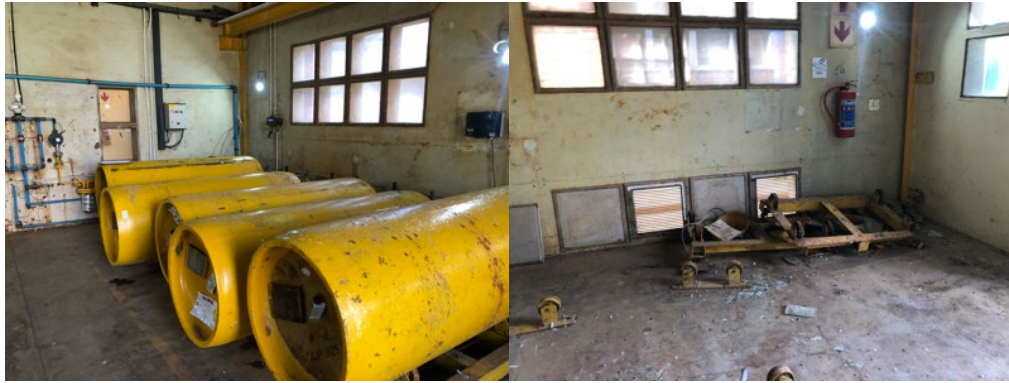
The chlorination room is unsafe and not meeting the requirements of SANS 10298. There were 15 full chlorine drums in the storage area. The empty drums were not properly prepared for transport. The protective hoods were not replaced on all the cylinders.

The chlorine room (pressure and vacuum side) is not locked, and access is freely available. Four (4) drums are connected to one of the chlorine banks, while no drums were connected to the second chlorine bank. The scales were dysfunctional; therefore, the mass of chlorine used, and the remaining mass are unknown. The transfer pump was operational at a flow rate of (1 300 l/s) 4 680 m<sup>3</sup>/h. The chlorine dosing took place at 26 kg/h, resulting in a chlorine dosing of about 6 mg/l. The staff would not know when the chlorine bank is running empty. This could result in an extended period of no disinfection, as chlorine residuals are not taken every two hours, and the frequency of inspections of the chlorine dosing facility is unknown.

**Figure 8: Chlorine Bank 1 and Bank 2**

1. Repair the chlorine leak, which is further damaging the remaining equipment. Implement the requirements of SANS 10298. Check the chlorine room for leaks using an ammonia solution.
2. Move the abstraction point to the highest point from the Leeukraal Dam.

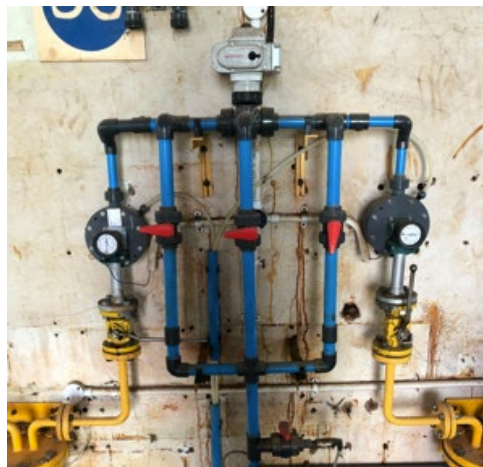
**Figure 9: Change-over system but no second chlorine bank**

3	Automatic change-over facility available and operational		0	1	Available, but not sure of working, but no standby chlorine bank available.
4	Chlorine alarm operational		0	1	Major leak on line after chlorine injection but no warning light or siren indicating of leak. State of equipment confirm this as a regular event.
5	Windsock available		1	1	
6	Chlorine room inspected and recorded as per SANS 10298 requirements		0	1	No inspections for leaks are recorded once per shift.
7	Sample taken after on-site storage (30 min retention time)		1	1	
8	Level of on-site reservoir/s recorded		0	1	
9	Actual usage (kg) determined		0	1	No working scale.
10	Actual dosing (mg/l) determined		0	1	No working scale.
11	More than 30 days stock available		1	1	15 Full Cylinders available.
		27%	3	11	
<b>Stabilization</b>					
1	Is stabilization required (CaCO <sub>3</sub> ppt available)		†	0	
2	Stabilization applied		0	1	
3	Guideline pH available		0	1

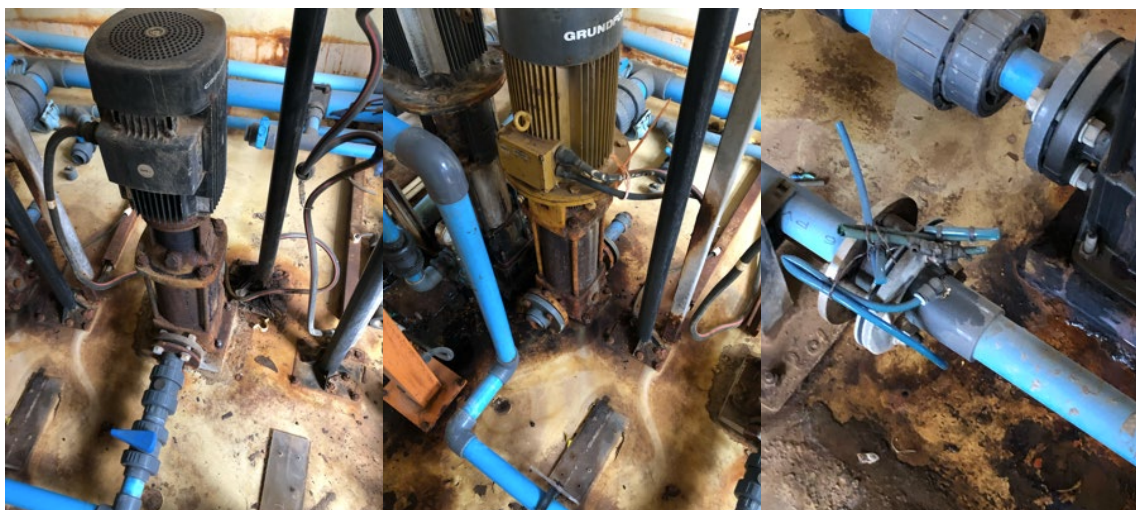
The vacuum room of the chlorine facility has several badly damaged carriage water pumps, and the remaining infrastructure is prone to serious damage due to a chlorine leak in the vacuum side. The Process Controller suggested that the discussions be held outside the vacuum side of the chlorine room due to the very strong chlorine smell. The staff does not understand the risk of these types of events.

**Figure 10: Poor condition of carriage water pumps**

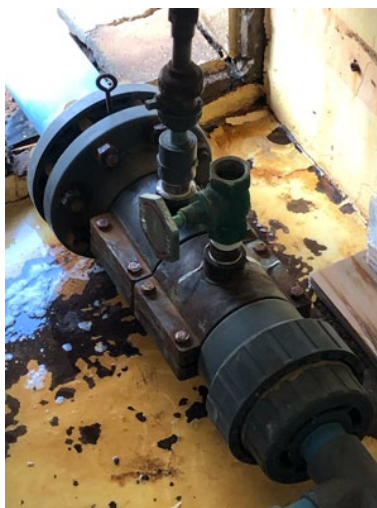
The mass of chlorine escaping with the carriage water inside the room is unknown, but it was clear that not all the chlorine reached the on-site storage reservoirs. The chlorine residuals vary between 0.6 and 1.23 mg/l, confirming the treatment level of the Rooiwal effluent. Records of actual stock, stock used, and back-calculation of dosing are not performed.

Based on the condition, the operating practices, and the frequency of measuring the free chlorine, water is highly likely to be distributed without being disinfected. This would pose a risk to the consumers supplied by Themba WTW.

**Figure 11: Leaking component (after chlorine injection)**

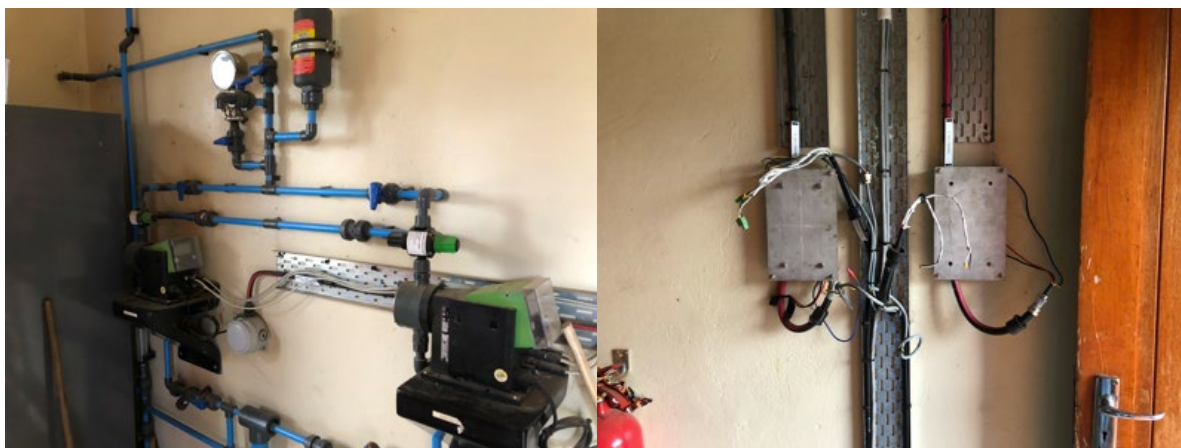
Four bulk tanks for ammonium solution and dosing pumps are available. The system is not operational, and the condition of the equipment has not been assessed. Limited information on the capacity is known. Ammonia is stored in 4 x 10 000 l storage tanks.

**Figure 12: Ammonia dosing system**

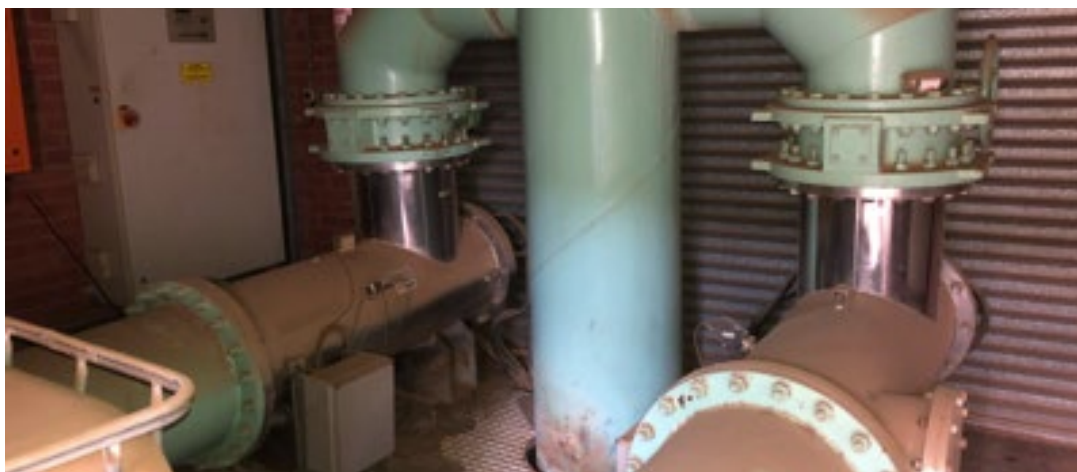
The system is not operational, and the condition of the equipment has not been assessed. Limited information on the capacity of the two units is known.

Figure 13: Ultraviolet System

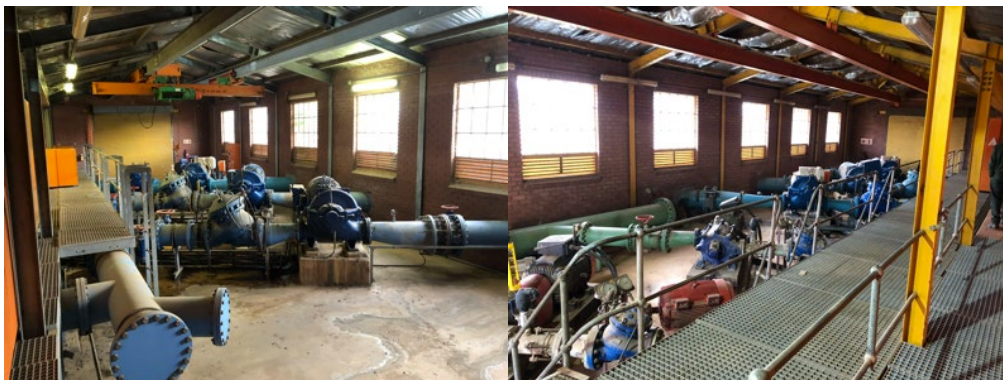
operation during the site inspection. The total delivery was recorded as 800  $\ell$ /s. Several pumps were out of commission for maintenance.

**Figure 15: High Lift Pumps**

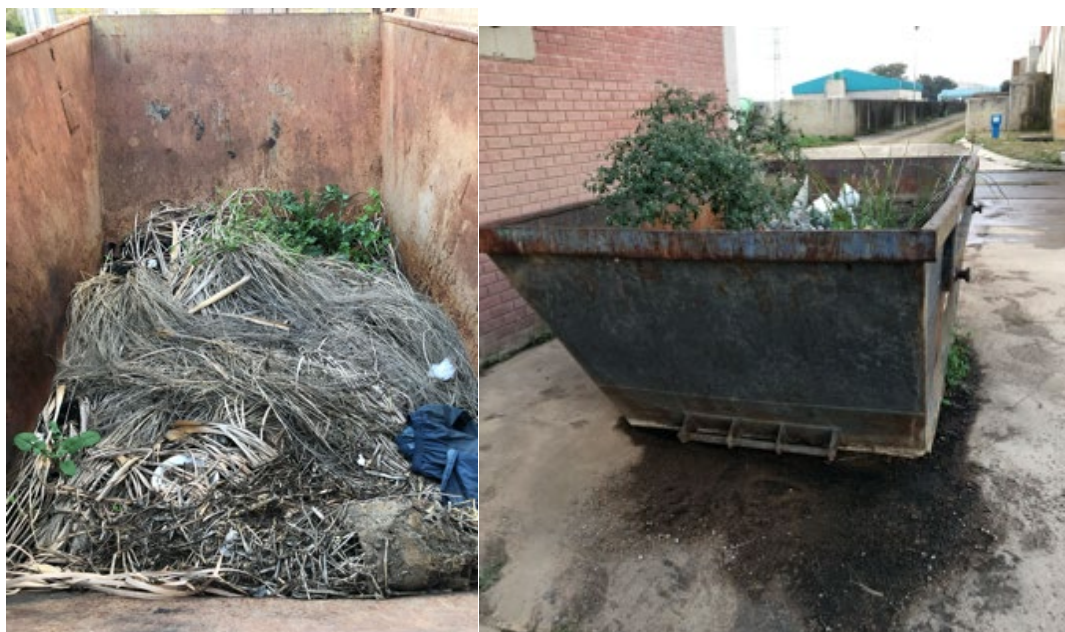
Provision is made for the sludge and backwash water to be treated by recovering the supernatant, while the sludge should be treated using a set of belt presses. The sludge handling system could not be inspected due to the unavailability of staff and access to the building not being obtained. From an inspection of the building from the outside, it was evident that the sludge is not thickened on-site, as seen below in Figure 16.

**Figure 16: Skips for the disposal of thickened sludge**

The Process Controller reported that the sludge is discharged back into the river just below the dam, negatively impacting downstream river water users. The filter wash water and sludge will also contain elevated levels of bacteria, and it is recommended that the sludge handling be re-instated.

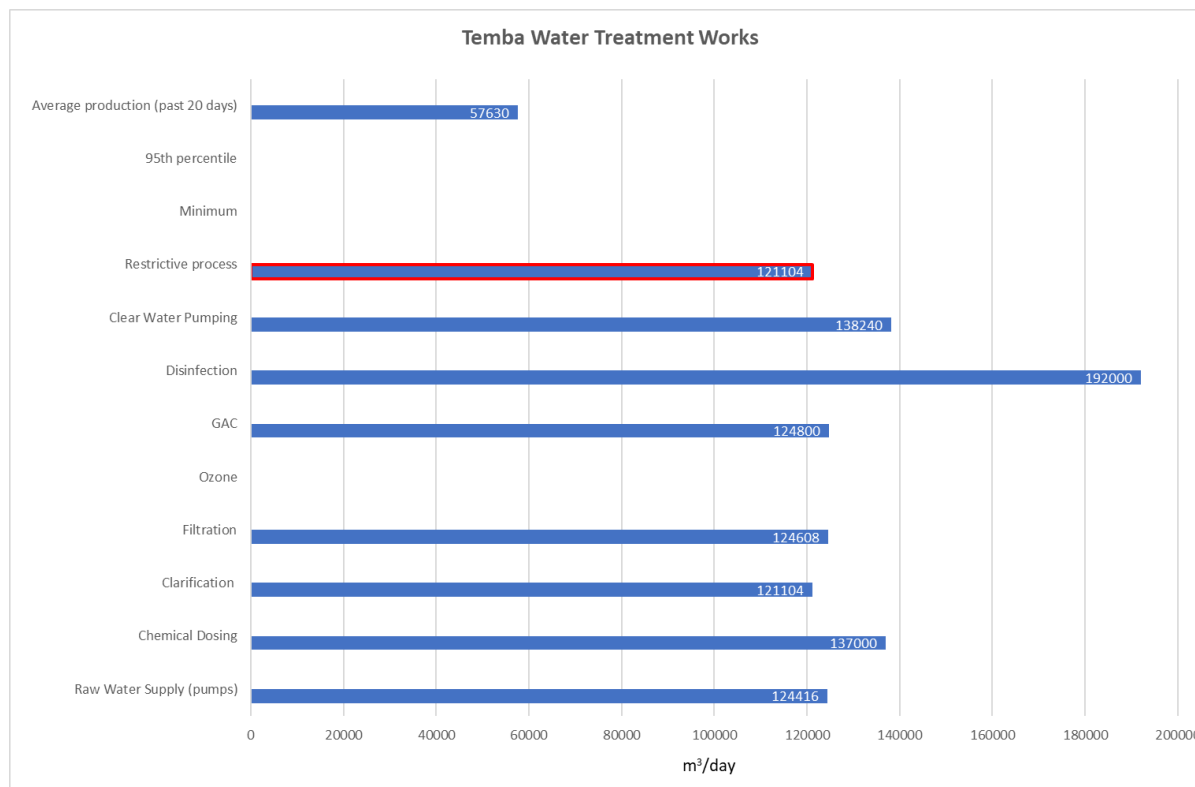
**Figure 17: Performance Graph**

The performance graph shows that the Temba Water Treatment works operate within the plant's capabilities. The poor water quality can, therefore, only be attributed to the chemical dosing, which is not optimised.

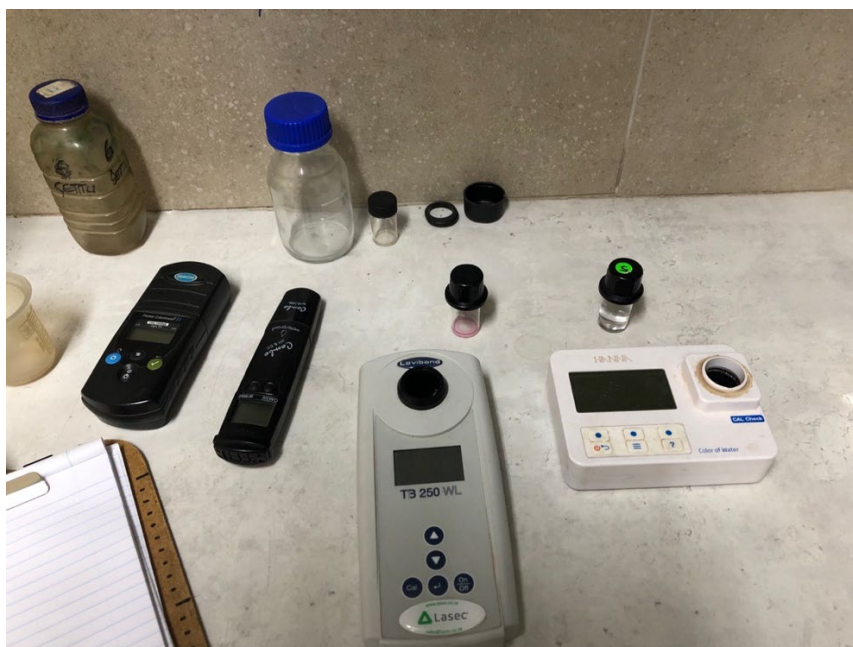
There were no pH buffers and secondary standards for the turbidity meter. Instruments are, therefore, not checked for accuracy. A system should be implemented to confirm the accuracy of the on-site process control instruments.

**Figure 18: Process Control Instrumentation**

A jar tester should form part of the process control equipment available to the Process Controllers. Raw water has to be tested with various chemical dosages and combinations to achieve a final water quality which complies with the turbidity requirement of 1 NTU.
