# **AN INDEPENDENT INVESTIGATION AND ADVISORY ON THE ROLE OF WATER, SANITATION AND HYGIENE IN THE 2023 CHOLERA OUTBREAK IN HAMMANSKRAAL, SOUTH AFRICA**

## **WORK PACKAGE 4: WATER AND SANITATION SAFETY ASSESSMENT AND ENVIRONMENTAL MONITORING**

### ***Part 1: Assessment of the Functionality and Compliance Status of Two Wastewater Treatment Works (Rooiwal and Temba) in the Outbreak Area***

**WRC Report No. 3167/1/24  
ISBN 978-0-6392-0652-3**

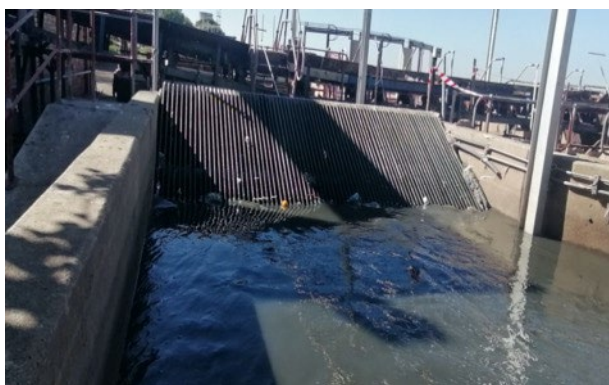
Provision is made for installation of three mechanical fine screens. However, the three fine screens have been removed for long periods resulting in raw wastewater only passing through manual coarse screens. Cleaning frequency of the manual coarse screen is also inadequate. Unavailability of fine screens results in carrying-over of debris to downstream processes. The screen conveyor is available and working but evidently, it requires serious maintenance, also, poor screenings disposal practices were observed as screenings are left lying around the plant without indication of when they would be removed.

**Figure 3: Manual screens currently in use**

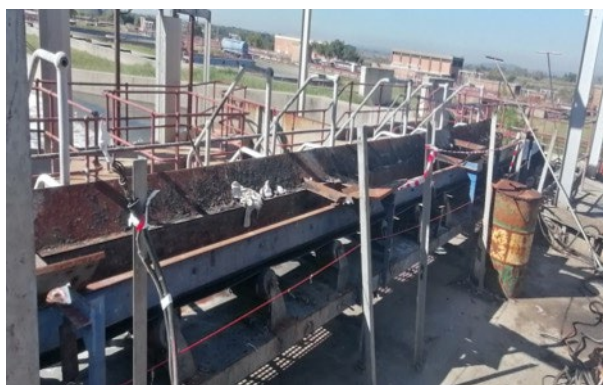
**Figure 4: Poor condition of the conveyor belt**

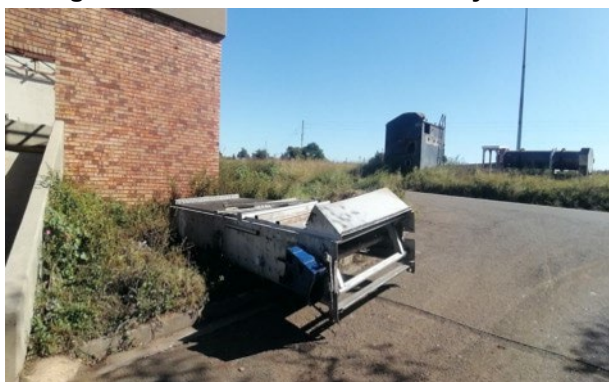
**Figure 5: One of the mechanical screens left unattended**

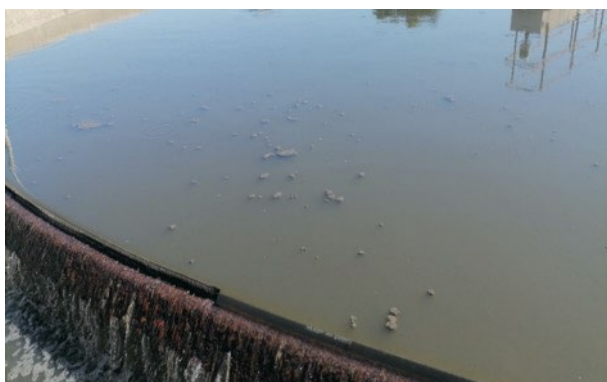
After the grit traps flow is split between the three modules, through three different channels. Each channel feeds to one of the three clarifiers installed. The flow distribution does not take place with positive overflow weirs, but occurs imperfectly on channel, floor level. This seems to be a design flaw, resulting from poor hydraulic profile. Furthermore, due to high inflows at the plant, it was observed that there is overflow in the channels and this results in raw sewerage being fed directly into the biological reactors. The PST bridge for one of the three PSTs is not working. Two of the three PSTs have excessive scum and fat layers. Excessive sludge bulking and rising were also evident. All PSTs equipment is in poor condition and requires urgent maintenance. Desludging equipment is working, and it was indicated that it discharges to the digesters once a day. However, the sludge conditions in the tanks still suggest inadequate desludging.

**Figure 7: Sludge conditions in the PSTs**

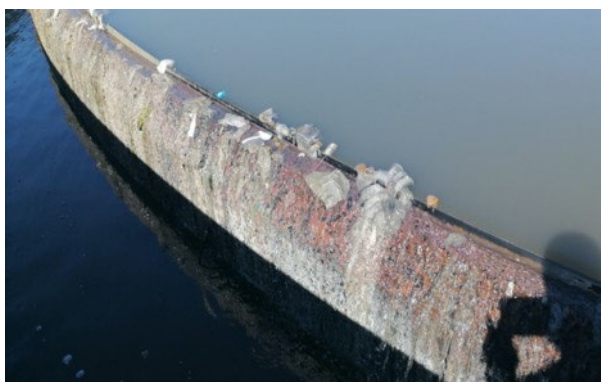
**Figure 8: Debris carryover from PST**

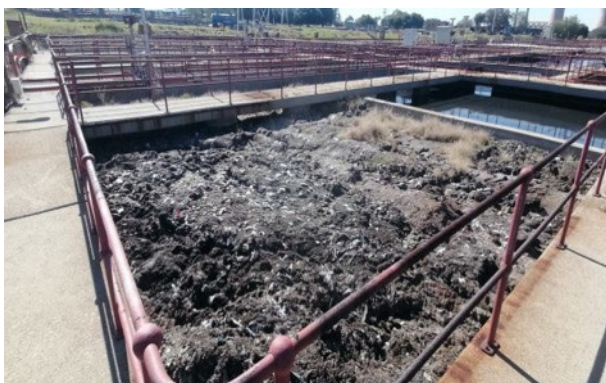
**Figure 9: Typical conditions at the anaerobic zones**

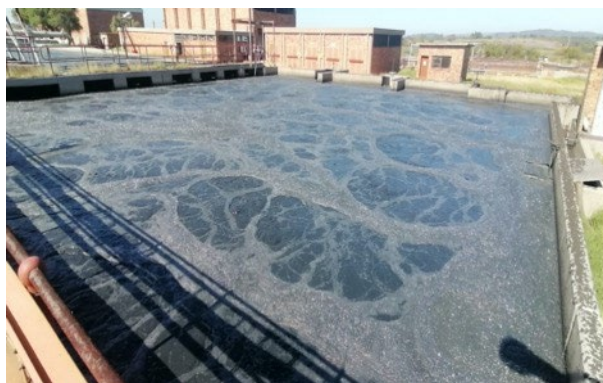
**Figure 10: Foaming in the aeration basin**

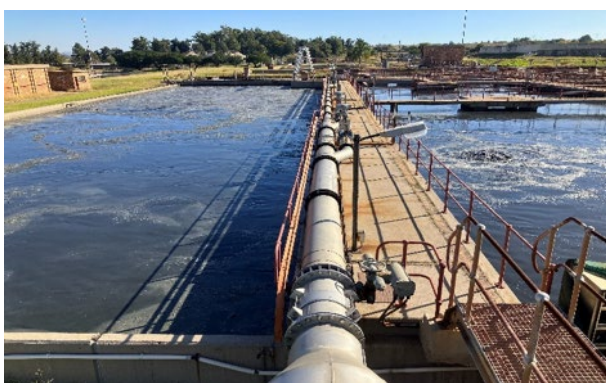
normal maximum air velocities of 20 m/s, but never more than 25 m/s, under peak performance conditions. The pipework design is a contributing factor to the low blower utilization. In addition, the bubble diffusers and diffuser pipework leaks so much air that the fear exists that whole diffusers or sections of pipe may be dislodged. This is according to operators, the reason for running only one blower per module at turned down capacity.

**Figure 11: Leaking pipework in the diffusers**

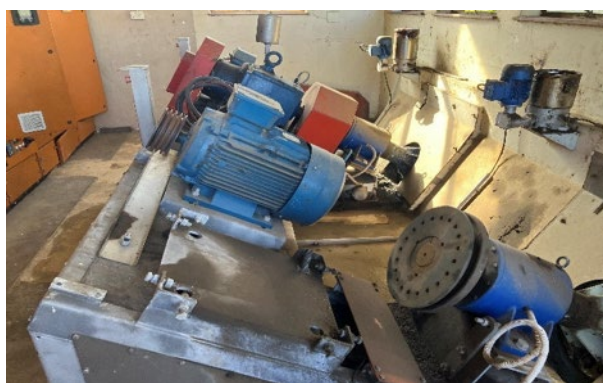
**Figure 12: Typical condition of the RAS pumps, only one pump working**

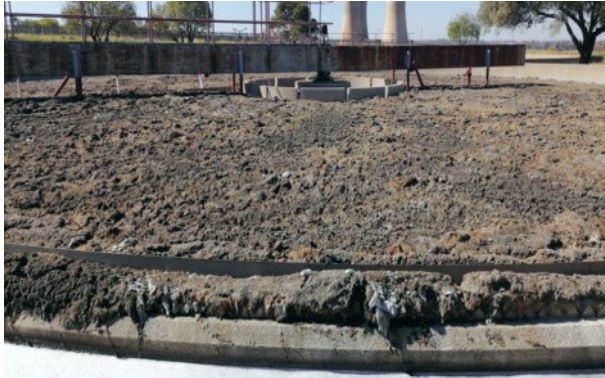
There are six clarifiers installed for each of the three modules. The condition of the clarifiers is generally poor, also exposing that maintenance is seriously lacking. It appears that scum removal equipment appears to have not been used in a long time, though it is working condition, indicating the lack of process controlling. The scum withdrawal pipes are overburdened with debris and plastic material which have been carried over due to inadequate screening at the inlet works.

**Figure 13: Typical condition of the clarifiers (module 2)**

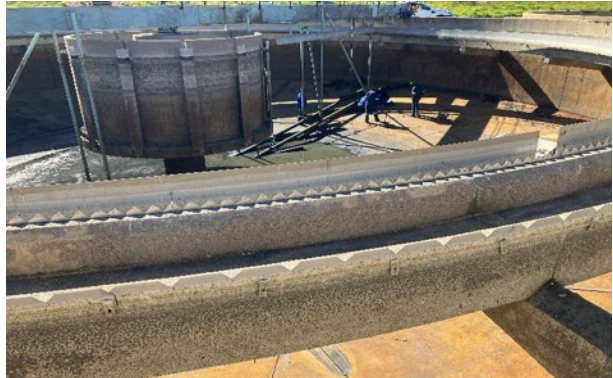
**Figure 14: some clarifiers isolated for repairs (module 1)**

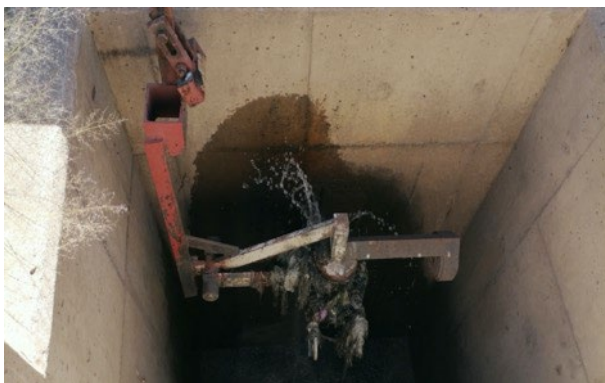
**Figure 15: Scum removal valves overburdened with debris**

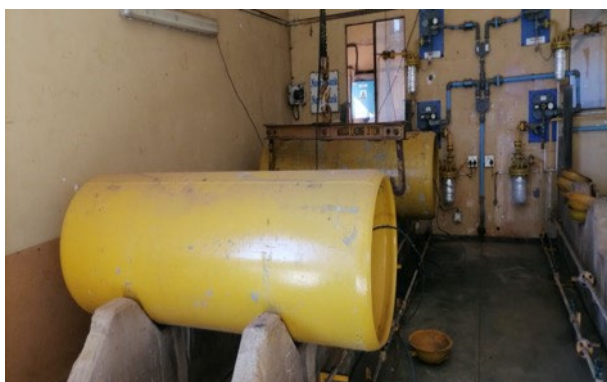
Disinfection is normally achieved using chlorine gas. There are two dosing banks installed. Each bank feeds 925 kg chlorine cylinders. At the time of inspection disinfection was not taking place since there was no chlorine stock. Therefore, the operational status of the disinfection system could not be verified. However, it was observed that there is lack of safety signage and equipment around the dosing area. One of the two carriage water booster pumps was out of commission. After chlorine dosing, effluent flows into the disinfection contact tank. Sludge settling was still observed in this tank, indicating that the upstream process is ineffective. Debris and some floating materials were also observed in this, further also confirming the inadequate screening at the head of works. Based on the quality of the effluent, high chlorine demand is guaranteed and introduction of chlorine to effluent of such quality may result in formation of chloramines. Serious spillage was also observed around the disinfection and contact tank area.

**Figure 16: Empty tanks connected and not dosing due to lack of stock**

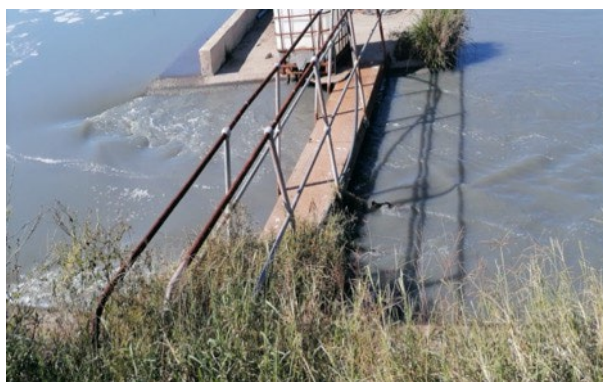
**Figure 17: Conditions at the contact tank**

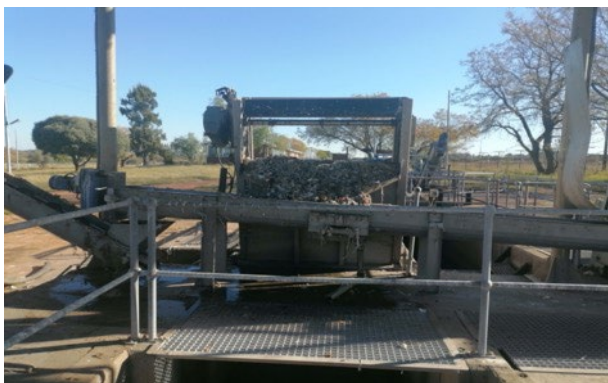
**Figure 20: Condition of inlet screens**

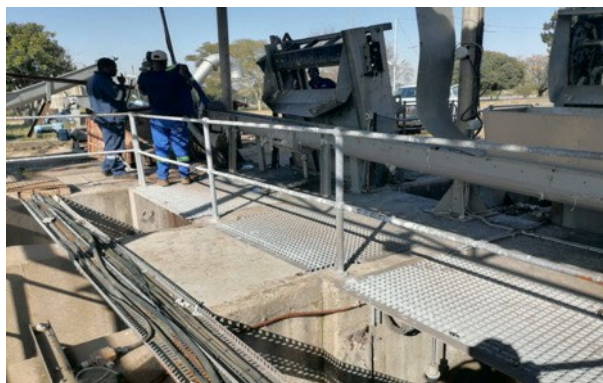
**Figure 21: Maintenance team onsite to fix the screen**

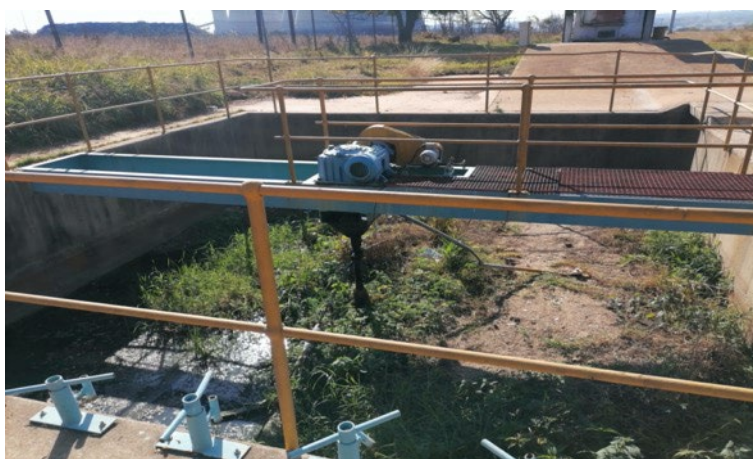
There are two vortex grit traps, both of which have been out of operation for long periods of time. The inflow currently passes through one of the traps, where excessive grit accumulation was observed. Evidently, no more grit removal is taking place. The second grit trip is out of commission with plants growing inside.

**Figure 22: One grit chamber out of commission for a long time**

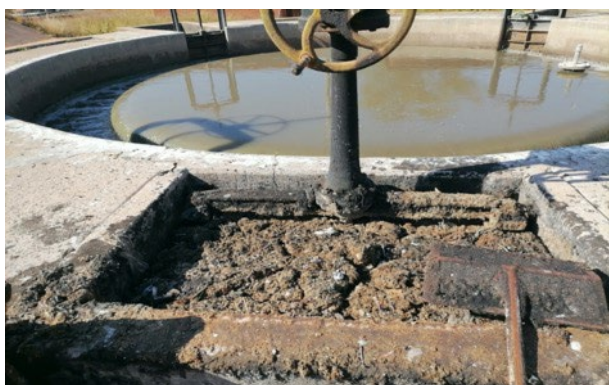
**Figure 23: Excessive scum and grit accumulation in the division box inlet chamber**

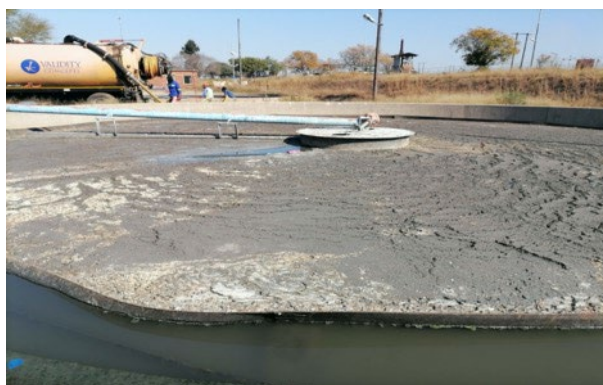
**Figure 24: Excessive scum layer observed in all PSTs and a broken-down scrapper arm**

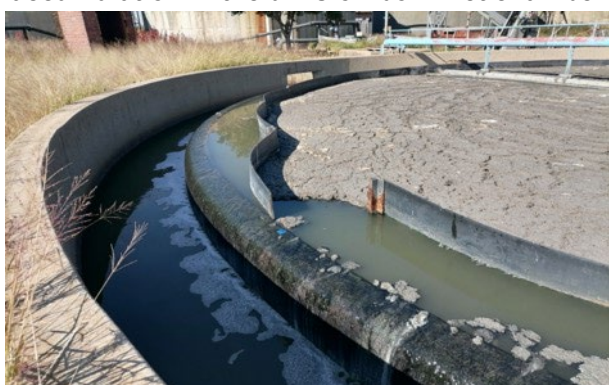
**Figure 25: Broken scum baffle resulting in scum overflowing to the biofilters**

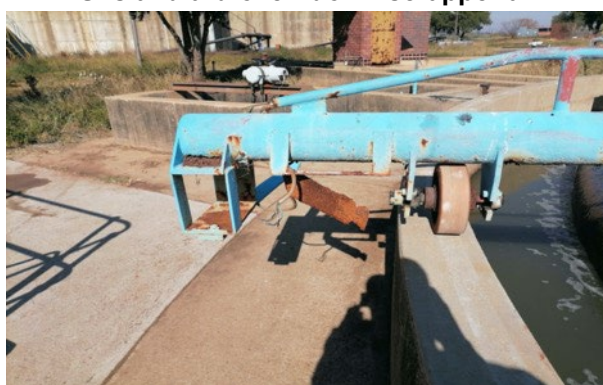
**Figure 26: Motor removed therefore scum scrapper not moving**

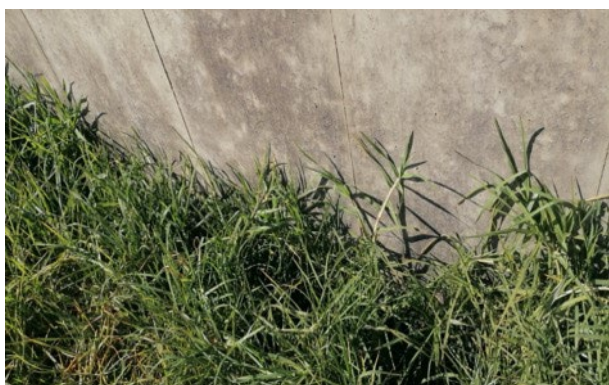
Algal growth and evidence of a thick sludge layer were observed on the surface of some filters and the filter underdrains are generally not clean, consisting of thick layers of slime, algal and vegetation growth in some instances.

**Figure 27: Poor conditions at some of the filter underdrains**

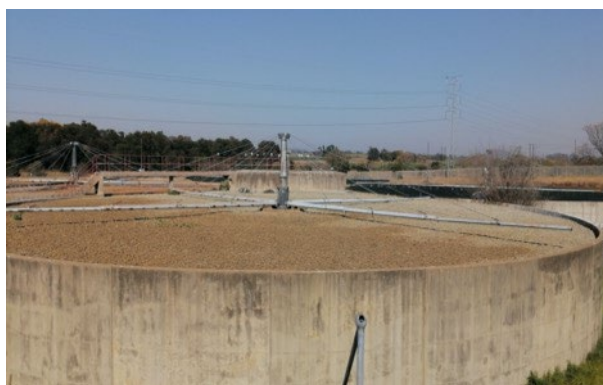
**Figure 28: Filter out of commission for a long time due to faulty centre column**

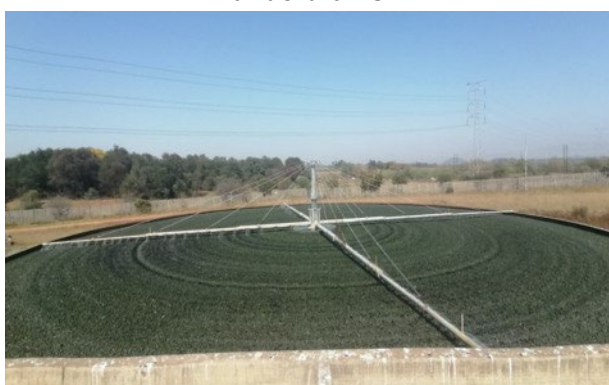
**Figure 29: Evidence of algal growth observed in some of the filters**

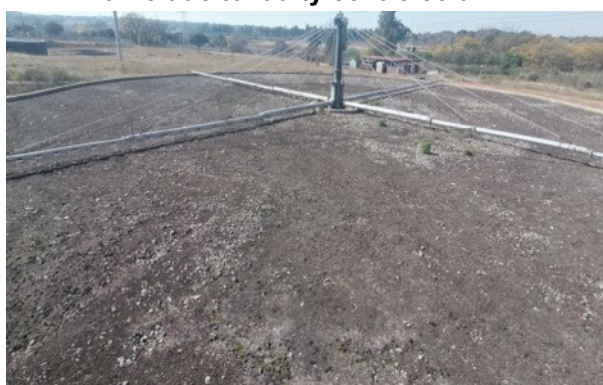
**Figure 30: A layer of sludge observed in one of the filters out of commission**

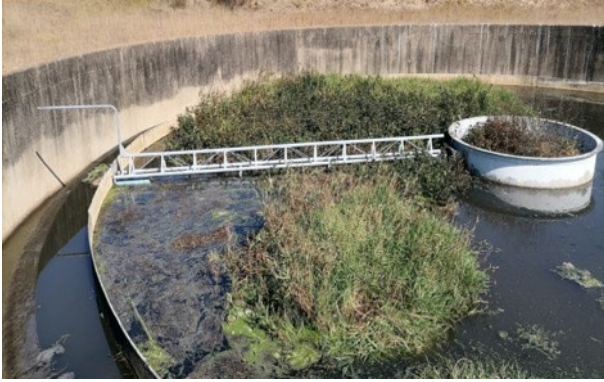
Effluent from each set of filters flows into three humus tanks. The humus tanks are generally in poor condition: Plant and algal growth was observed on the surface of several humus tanks. Some scum withdrawal equipment has long been in disuse and the sections of the weirs are broken and launders show symptoms of not being cleaned in a long time. The scum and sludge withdrawal valves are left partially open therefore impacting on the treatment process.

**Figure 31: Poor conditions apparent in most humus tanks**

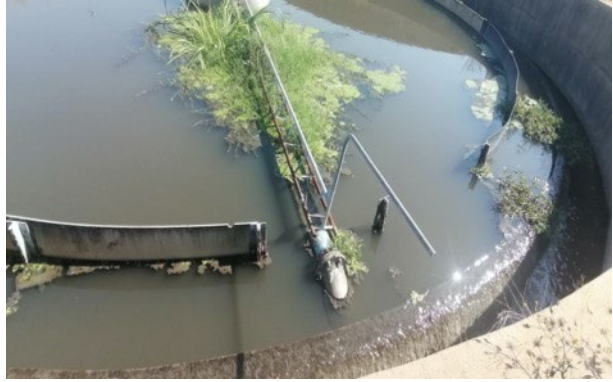
**Figure 32: Broken scum baffle resulting in solids carryover**

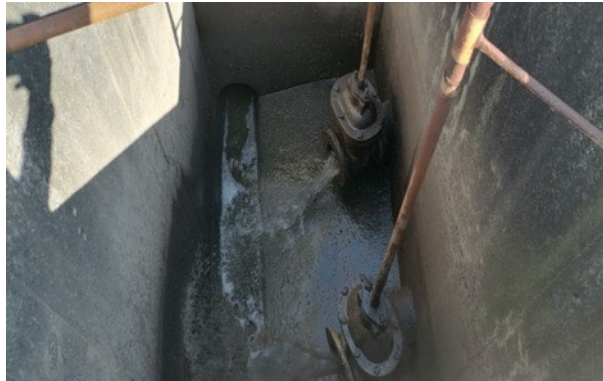
**Figure 33: Scum and sludge removal valves always left partially open for no apparent reason**

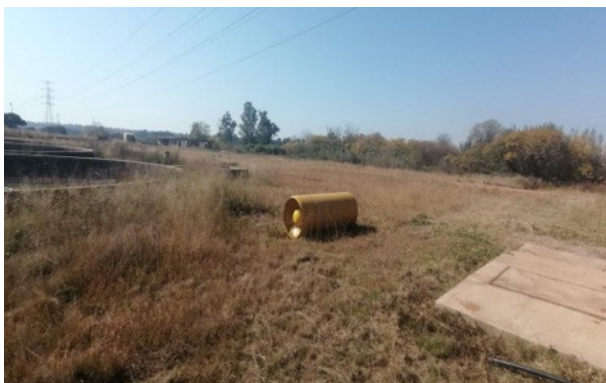
**Figure 34: Empty chlorine gas cylinder left unattended in the sun**

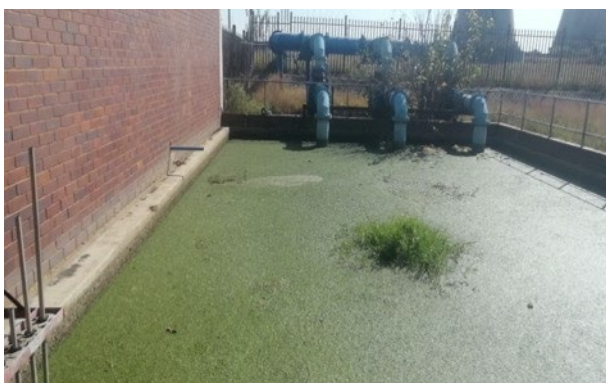
**Figure 36: Duckweed observed in the final water sump**

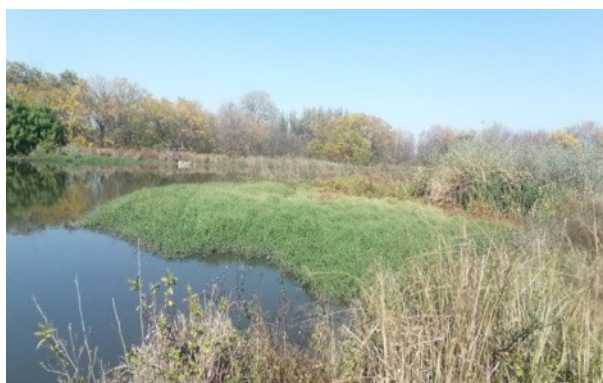
**Figure 37: Maturation Pond in poor condition and has excessive sludge accumulation**

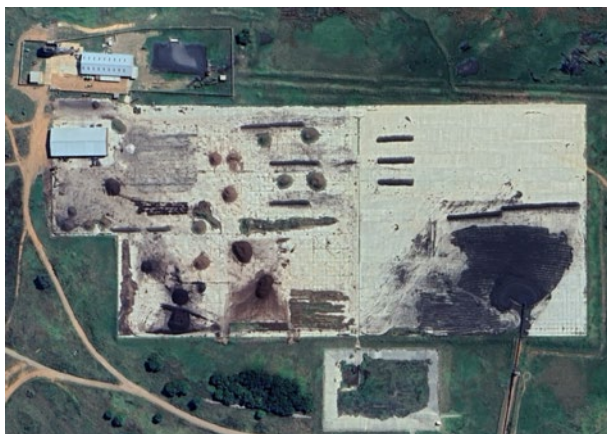
**Figure 38: Dewatered Sludge concrete slab c.  
2023**

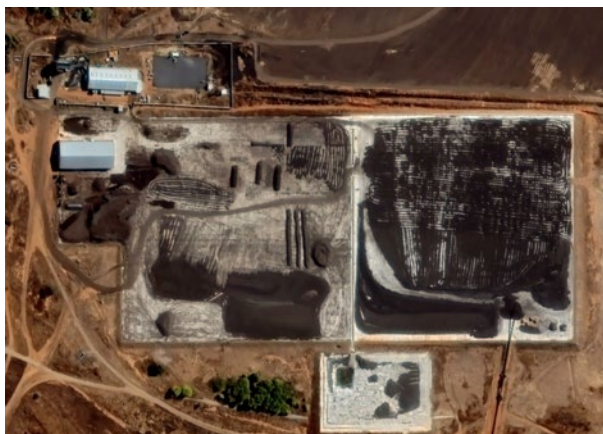
**Figure 39: Dewatered sludge concrete slab c.  
2015**

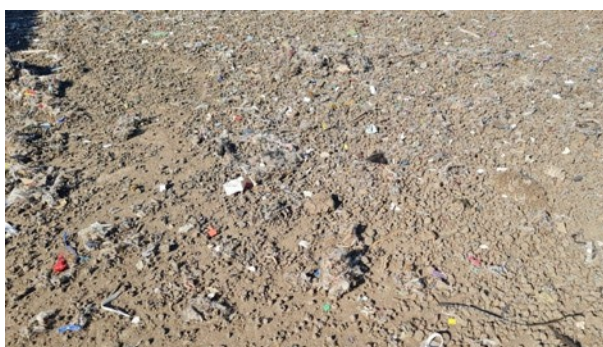
**Figure 41: Screenings seen at the composting  
plant**

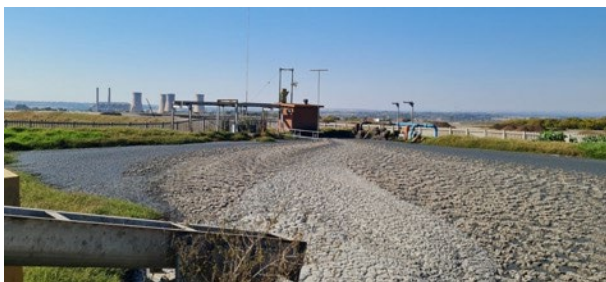
An accumulation of scum was seen at the top of the sump causing partial anaerobic conditions, as shown on Figure 42. This is exacerbated by the fact that two floating surface aerators at the sludge handling sump are dysfunctional and have been taken out of the sump, as shown on Figure 43.

**Figure 42: Accumulation of scum at the sludge handling sump**

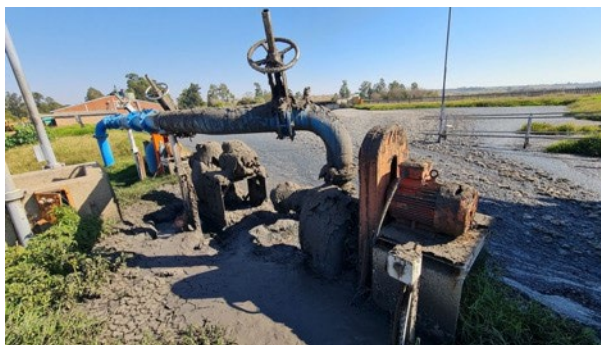
**Figure 45: Sludge transfer pumps seen (One pump works whilst the other two are dysfunctional)**

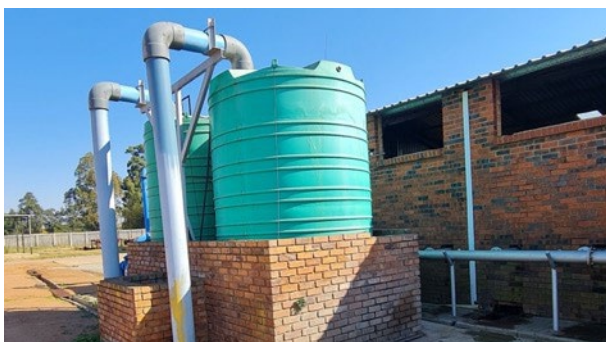
From the sludge handling sump, sludge is pumped into two storage tanks, as shown on Figure 46, which act as a buffer between the sump and belt presses for dewatering sludge. Both tanks are functional and in fair condition. Three pumps, shown on Figure 47, are installed to deliver sludge from the buffer storage tanks to the belt press. However, one of the three pumps is not working.

**Figure 46: Buffer storage tanks before belt presses**

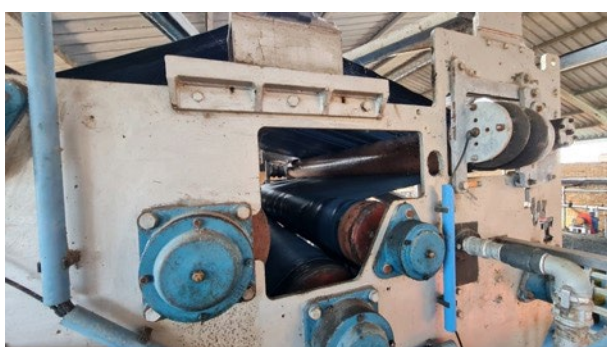
At the time of the inspection only one Lektratek Water Technology, sludge dewatering belt press, shown on **Error! Reference source not found.**, worked and processed sludge at a rate of 2.44 l/s. That is 30 percent of the design operating flow rate or capacity of the sludge dewatering belt press. At a two percent solid concentration, it means the sludge dewatering belt press was only producing around 175 kg/h of dry sludge versus 600 kg/h as per the original design.

**Figure 48: Dewatering belt press No. 1 working, but one belt is severely torn**

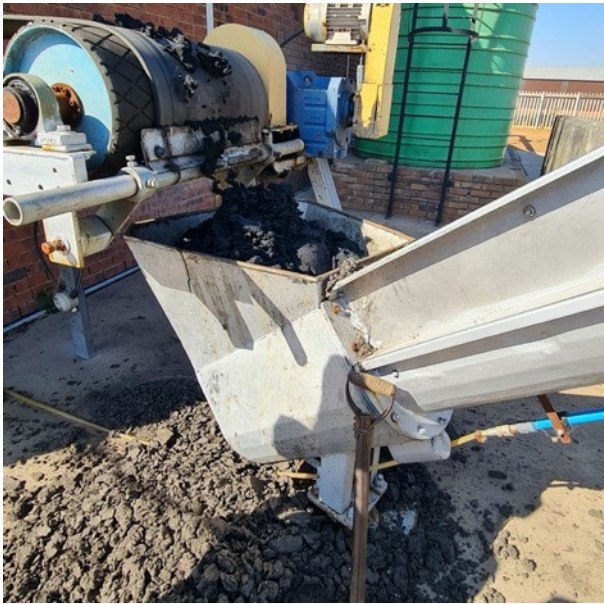
**Figure 50: Dewatered sludge overflow at screw conveyor**

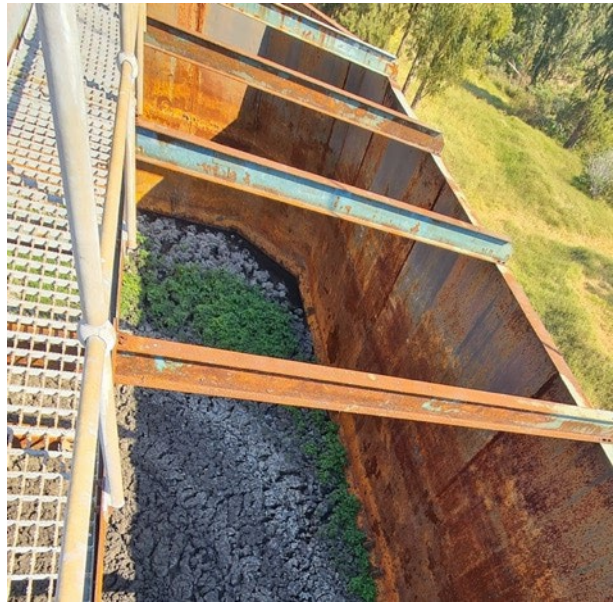
Downstream of the sludge handling plant, it was seen that the elevated dry sludge hopper was at an extremely low level and the dry sludge inside the hopper appeared to be dry or sitting at the same level for weeks, as shown on Figure 51. This indicates that the sludge handling plant is barely operated. In fact, the composting plant operators confirmed that the sludge handling plant seldom delivers dry sludge to their facility. It was also pointed out that the sludge handling plant was only started upon the arrival of inspectors.

**Figure 51: Elevated dry sludge hopper at an extremely low level**

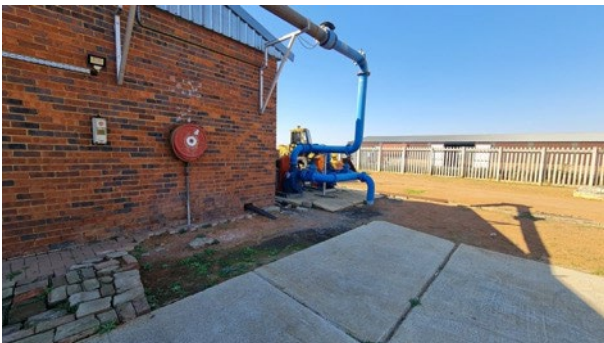
The wash water system used as part of the sludge handling plant was located and deemed to be in correct working condition. The wash water pumps, and storage tanks were in a fair condition, as shown on Figure 52 and Figure 53.

**Figure 52: Wash water pumps located and determined to be functioning and in a working condition**

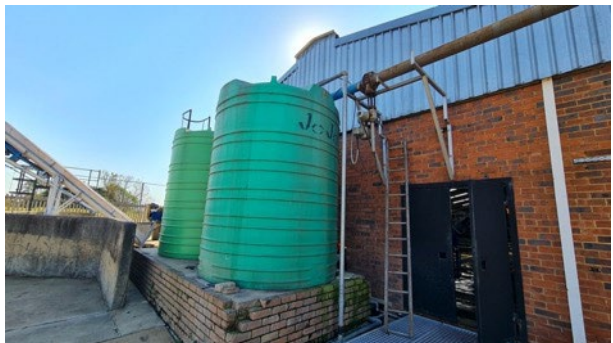
**Figure 53: Wash water storage tanks seen to be functioning and in a fair condition**

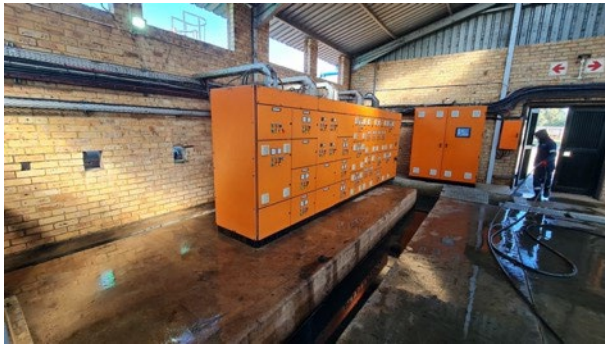
The MCC, shown on Figure 54, for the sludge handling plant is in a good condition and works. Outstanding equipment such as the second pump station and belt presses need to be installed and connected. The old MCC needs to be decommissioned if not working.

**Figure 54: Sludge dewatering plant MCC and control panel in a working condition**

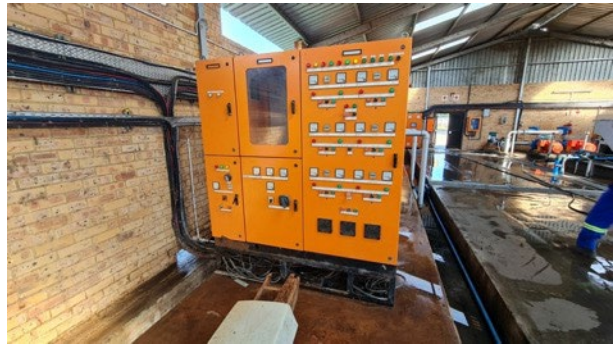
**Figure 55: Old MCC for sludge pumps, polymer station found not working**

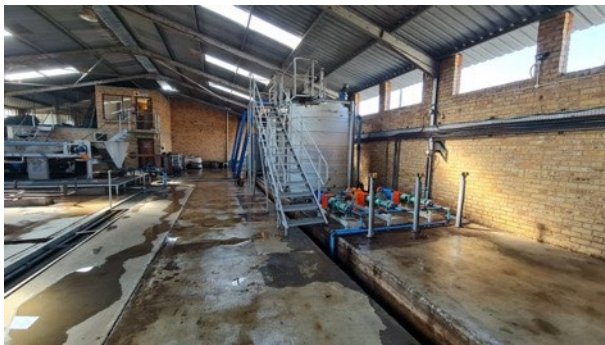
The polymer station, shown on Figure 56, is in a good working condition, however, housekeeping needs to be improved. The compressor, shown on Figure 57, was found to be in a good working condition.

**Figure 56: Polymer dosing station and pumps are functioning and in a fair condition**

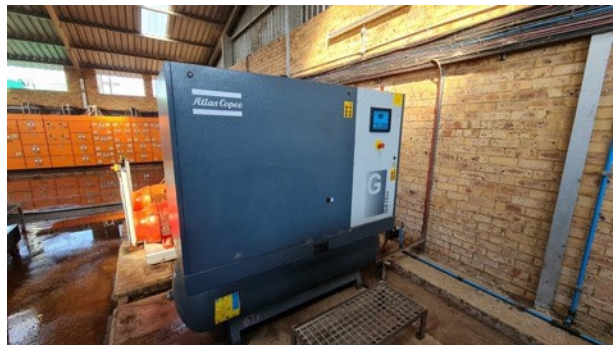
**Figure 57: Compressor for sludge dewatering belt press works and is in a fair condition**

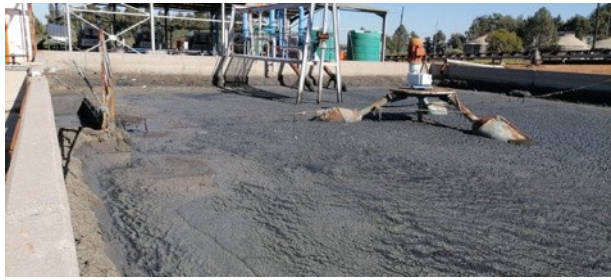
**Figure 59: Floating surface aerators not working**

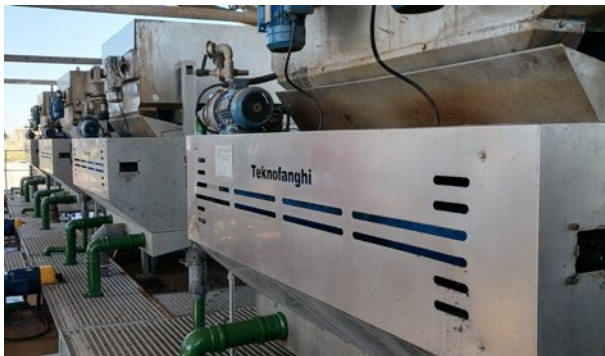
The incoming sludge is pumped to six belt presses that function, as shown on Figure 60, except for one belt press which is used for spares to fix the five operational belt presses, as shown on Figure 61. The pumps used to deliver sludge to the belt presses are in a fair and working condition.

**Figure 60: Sludge dewatering belt presses in a fair and working condition**

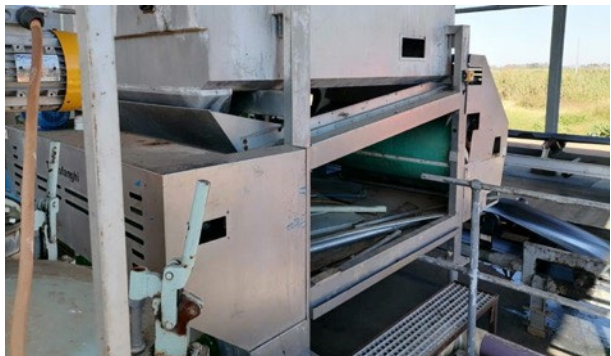
**Figure 61: Sludge dewatering belt press used for spares**

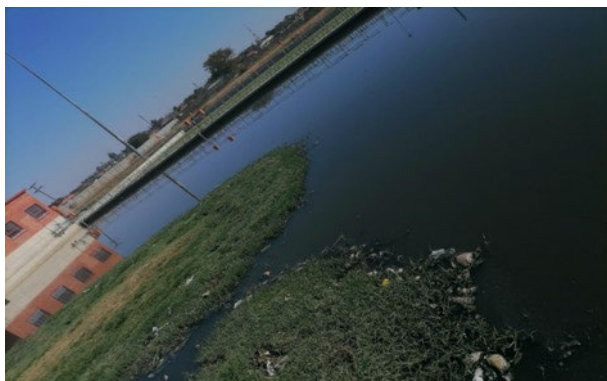
**Figure 65: Condition at one of the raw water balancing dams**

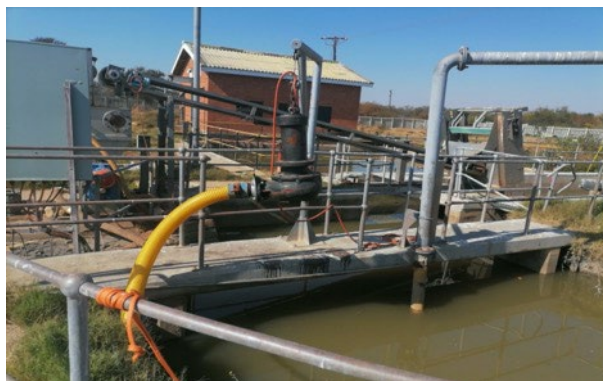
**Figure 66: The only available grit pump removed for repairs**

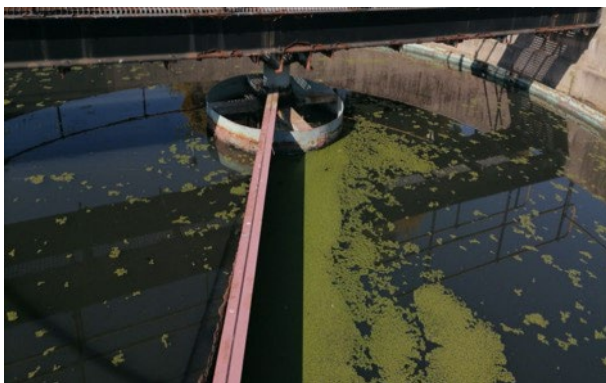
**Figure 67: Traces of duckweed indicating that there was a point where the PST was out for an extended period**

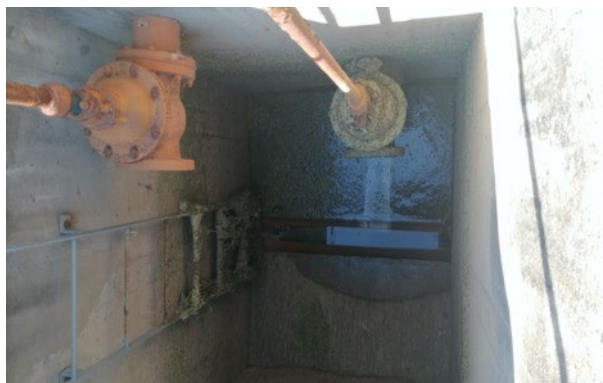
**Figure 68: Sludge and scum withdrawal equipment in working condition**

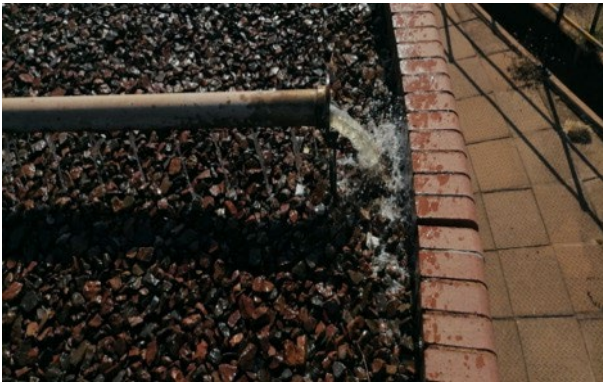
**Figure 69: No End-Caps on some filter arms**

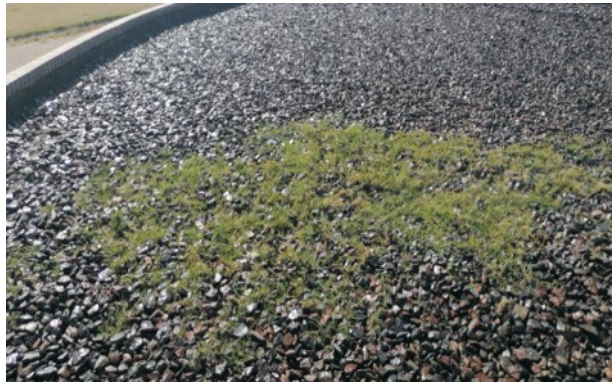
**Figure 70: A patch of grass growing on the filter media**

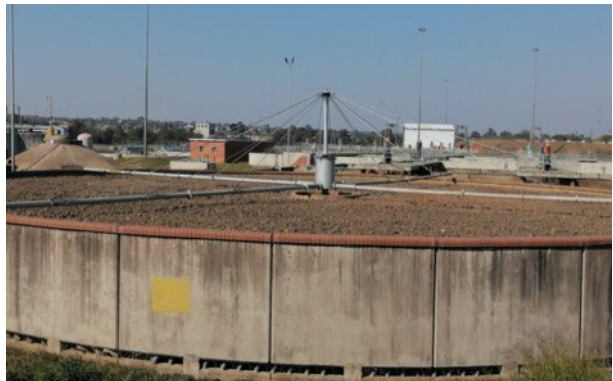
**Figure 72: Filter out of commission due to excessive leaks**

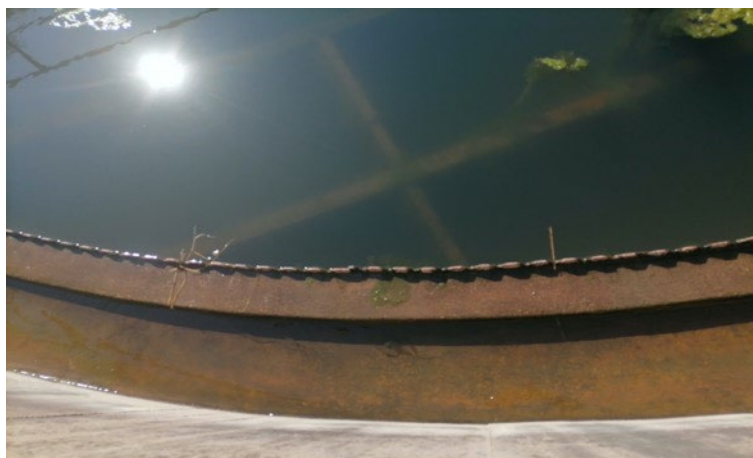
**Figure 73: Clear overflow from humus tanks, traces of algae also noted**

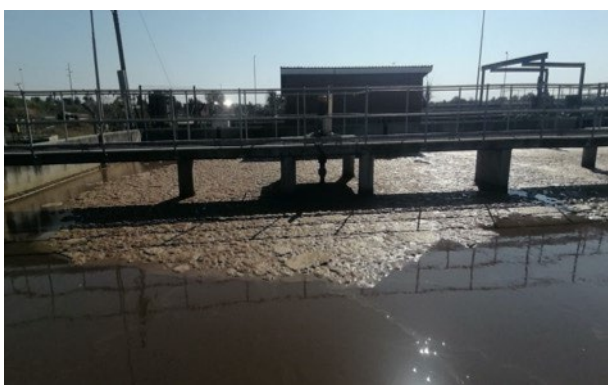
**Figure 74: Scum and sludge accumulating due to faulty mixers**

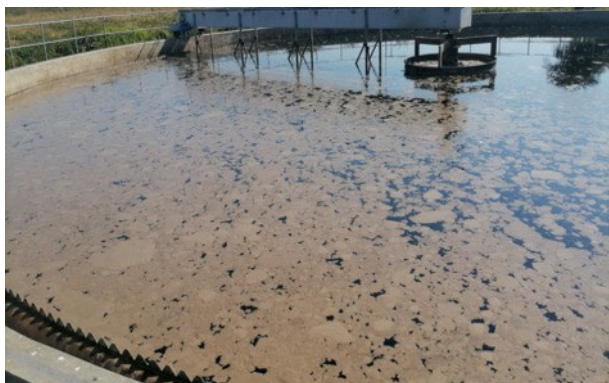
**Figure 77: Excess scum formation due to faulty clarifier bridge motor**

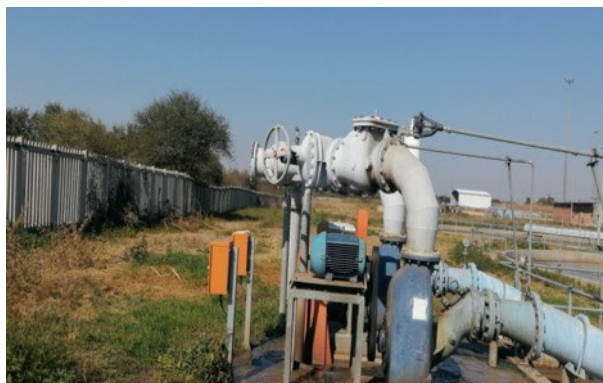
**Figure 78: Leak at the sludge pump has created a serious spillage**

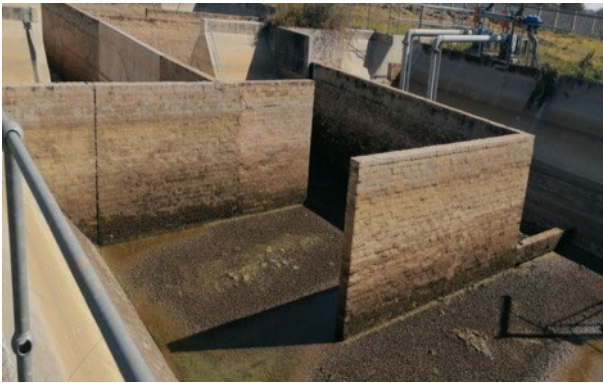
**Figure 79: Contact tank isolated for cleaning**

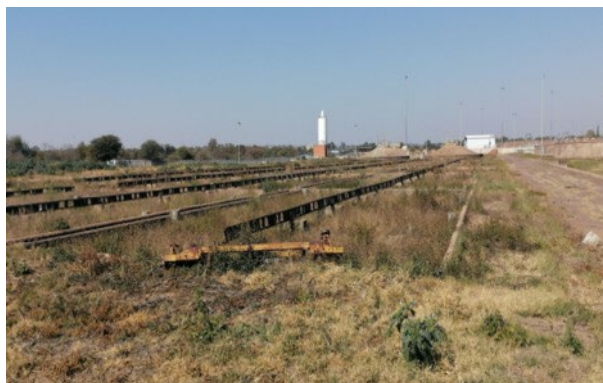
**Figure 82: Poor condition of the drying beds**

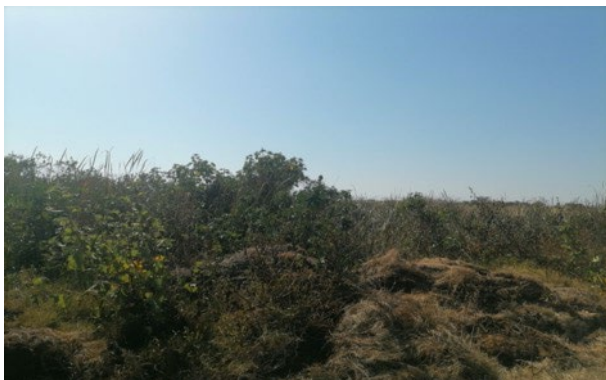
**Figure 83: Excessive reeds and vegetation growth at the sludge ponds**
