# **A Manual on Mine Water Treatment and Management Practices in South Africa**

## **APPENDIX Volume 2 Coal Mine Site Visit Reports**

**WRC Report No 527/2/96**

### Coal Mine Site Visit Reports

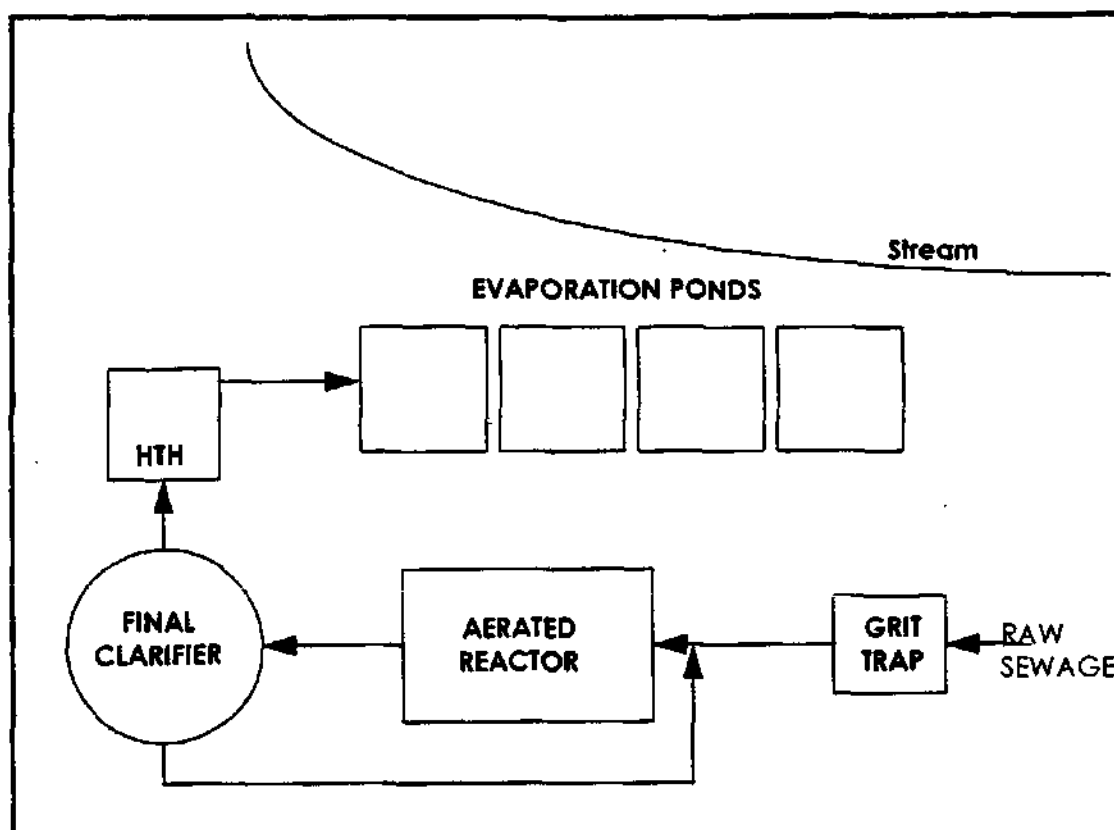
Figure 4 : Schematic Diagram of Alpha Central Sewage Treatment Plant

Alpha Central has a simple sewage treatment plant as shown in Figure 4 below. Raw sewage passes through grit traps and is then mixed with return sludge from the final clarifier before entering an aerated reactor. Overflow from the reactor discharges into the final clarifier, which discharges into evaporation ponds situated adjacent to a water course. Clarifier discharge is passed over HTH tablets. At the time of the site visit, it was noted that the reactor had almost no biomass / sludge and it was ascertained that this situation had been in existence for some time.

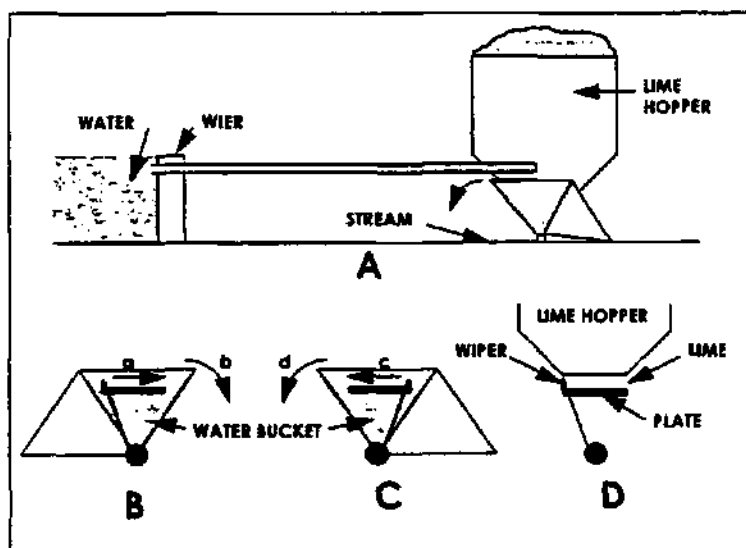
**Figure 8 : Operation of Dry Lime Feeder**

- A. A small weir is built in the stream, upstream of the lime feeder. The head of water behind the weir forms the driving force for the lime feeder. Water is fed down a pipe to fill the water buckets which drive the feeder.
- B. The water discharges into a bucket which tips over to the right hand side when it is full. This tipping action activates a wiper blade which wipes the lime off the plate below the lime hopper, into the stream flowing underneath.
- C. The water then discharges into the second bucket which tips to the left, thereby activating the wiper to the left.
- D. The gap between the lime hopper and the flat plate is such that lime does not spill out over the edges until the wiper blade is activated by the tipping of the water buckets.

The only criticism of this lime dosing system is that it is not proportional to flow. If a study were undertaken to determine the relationship between flow and

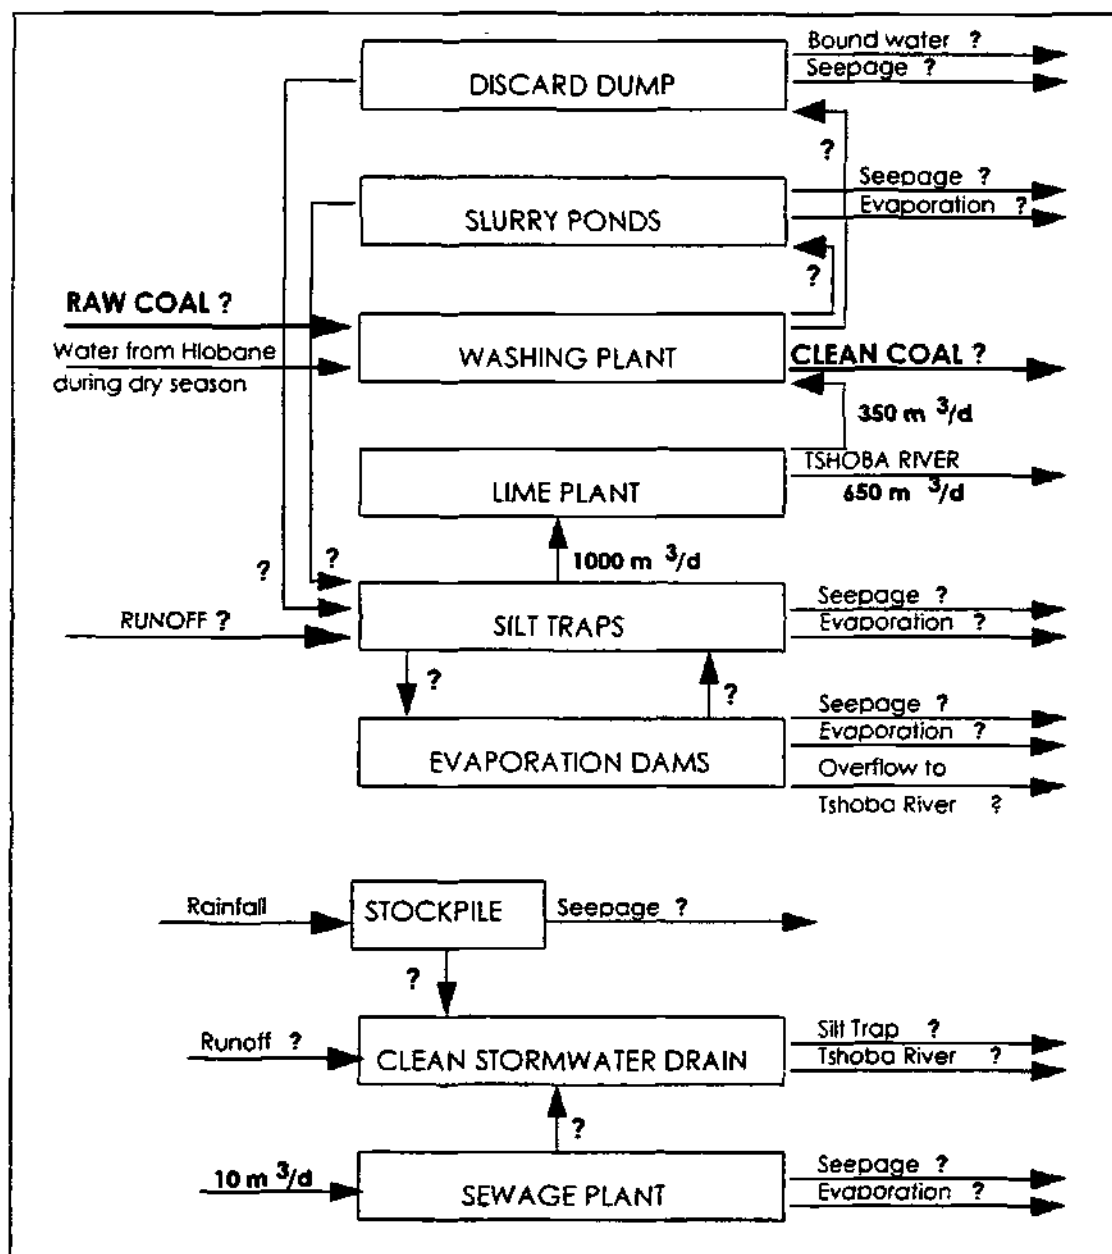
**Figure 9 : Schematic Water Balance for Plant Area**

The problems discussed in Sections 3.4.1 and 3.4.2 could be managed if the mine had access to a proper detailed water and salt balance. Such a balance must clearly identify all water and salt sources and users, together with all internal recycle systems. The balance must also accommodate hydrological and geohydrological aspects. The schematic water balance for the plant area is shown in Figure 9, indicating the extent of missing information. Similar water balances need to be prepared for all areas where coal mining activities impact on the water environment.

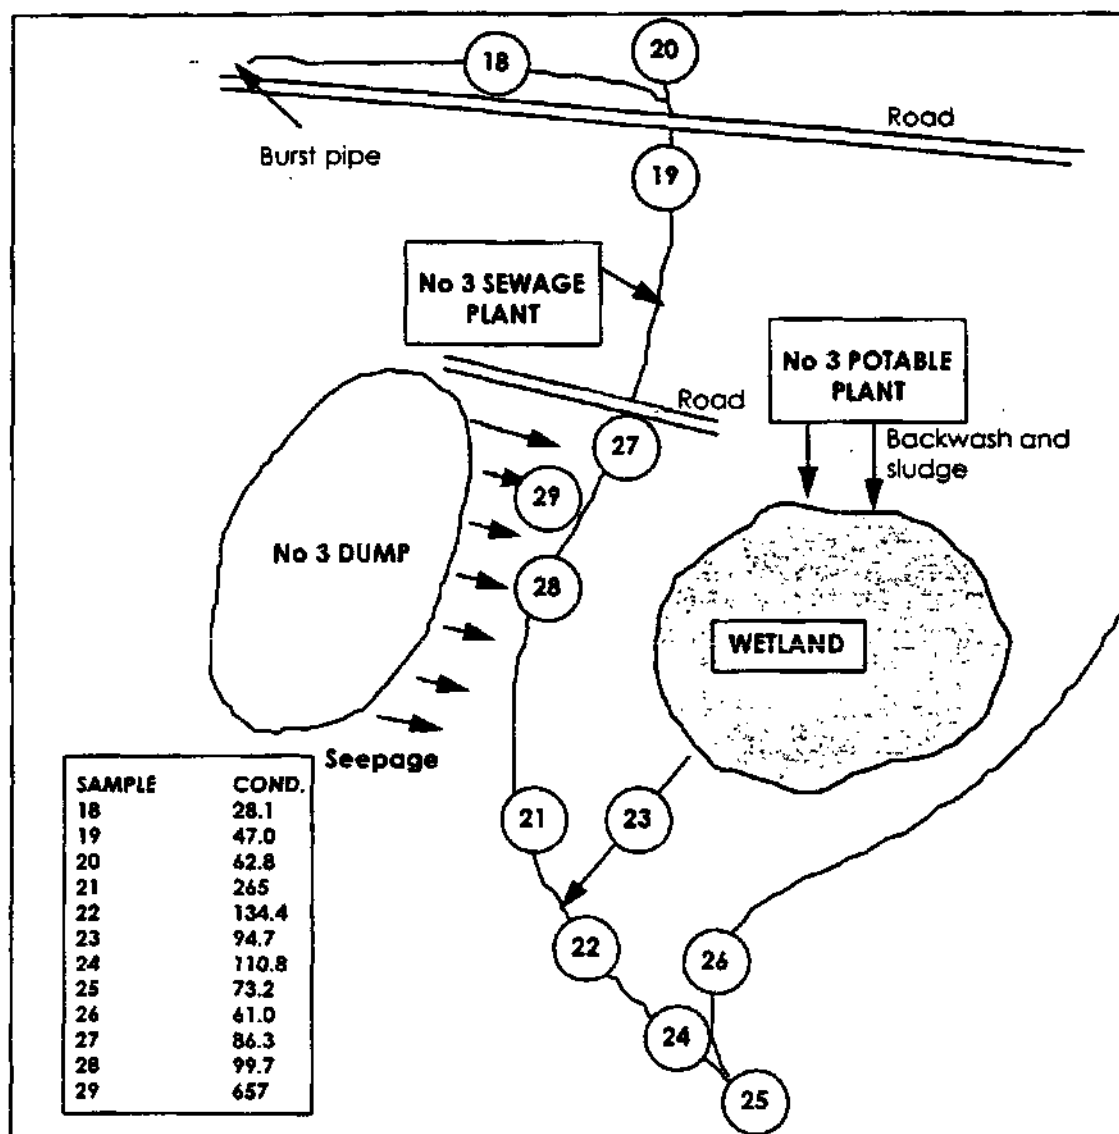
**Figure 5 : Sampling Programme Around No 3 Discard Dump**

The extent of the diffuse pollution from the No 3 discard dump is quite clearly shown in Figure 5. An extensive sampling programme was undertaken during the site visit along the tributary of the Kalabas river which runs adjacent to the No 3 dump. The results of this sampling programme, which are shown in Figure 5 and in Appendix A clearly indicate that the quality of the water deteriorates from a conductivity of 47 mS/m upstream of the No 3 dump, to a level of 265 mS/m downstream of the No 3 dump. The pollution control systems in place at the No 3 dump are clearly not succeeding in preventing diffuse pollution from this dump entering into the surface water systems.

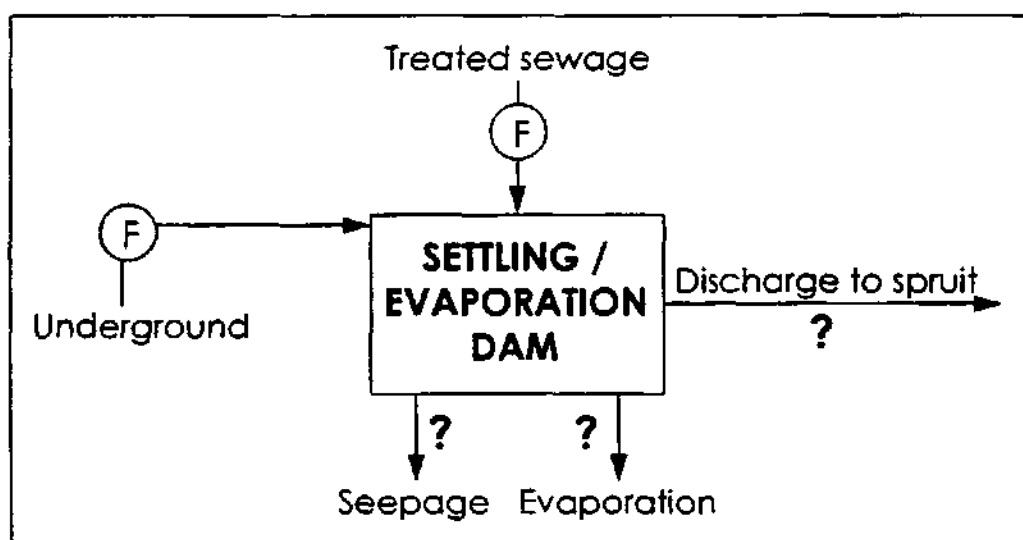
Figure 3 : Schematic Water Balance Around Settling Dams

There is also a distinct need to institute appropriate monitoring measures to enable the accurate determination of a water and salt balance around the settling dams to provide the data missing from Figure 3 below.
