# The in-depth evaluation of three filtration facilities

The filtration plants of three well-run water treatment facilities were recently scrutinised to measure their operational efficiency. When the results from these investigations were compared, it was found that certain problems were common to the three plants and that similar problems were likely to be encountered elsewhere.

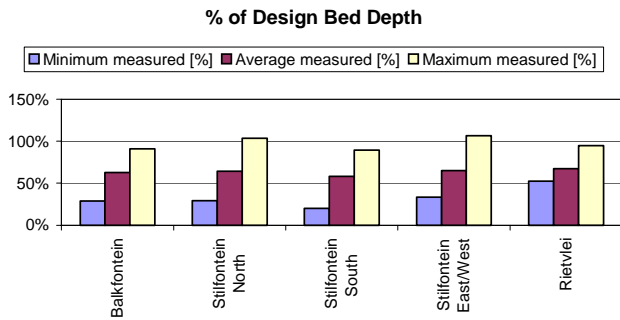
Reduced bed depths lead to reduced bed capacity in terms of suspended solids removal and reduced run lengths as well as a reduced capacity for the removal of manganese. Also, since media constitutes one of the most significant sources of head loss during filtration, a variation in adjoining bed depths can affect filtration hydraulics detrimentally. Figure 1 compares current bed depths at the various filtration plants with their respective design depths.

All plants illustrate a significant loss of media. On average only 60% of the original media remains in the filter. Some filters have as little as 20% of the original media depth remaining. It is also interesting to note that the media levels differ significantly between filters in the same plant. This suggests that the factors that lead to media loss are highly variable.

Tests to determine the cause of the media loss are ongoing. At this time it is expected that the delay between the air and water cycle during backwash, needs to be increased to avoid simultaneous air and water expulsion from the bed. The turbulence caused on the surface of the media by the simultaneous expulsion of the air and water could lead to excessive media losses. This phenomenon has been reported on elsewhere (Lombard and Haarhoff, 1995)

**Figure 1**  
Comparison of current media depths to design depths

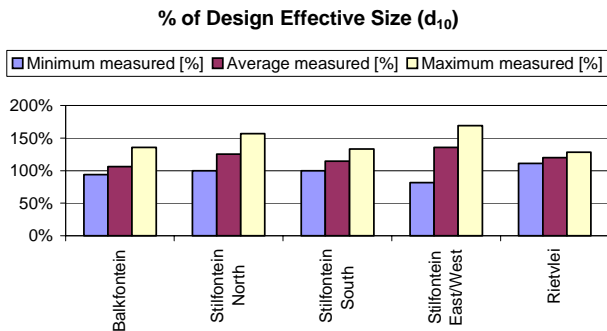
In general, media grains seem to be larger than indicated by the design specifications (Figs. 2 and 3). In the worst case, the current  $d_{10}$  is 70% larger. This has significant impacts on the backwashing requirements of a filter bed. Larger grains require higher backwash rates implying that the beds evaluated in these studies will not be washed sufficiently even if design backwash rates are maintained.

**Figure 2**  
Comparison of current media effective sizes to design values

calcite) as well as the placement of media during and after construction that is not according to specification. Intermixing of sand and fine gravel during backwash can also lead to the measurement of larger effective sizes.

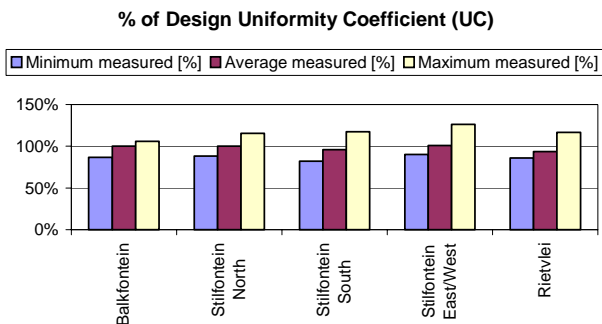
**Figure 3**  
Comparison of current uniformity coefficients with design specifications

Uniformity coefficients, in general, appear to be close to design specifications. Some filters do, however, contain media with much higher values than specified. In these specific cases, where the grains are larger than anticipated, the higher uniformity coefficients add to the insufficiency of the backwash design.

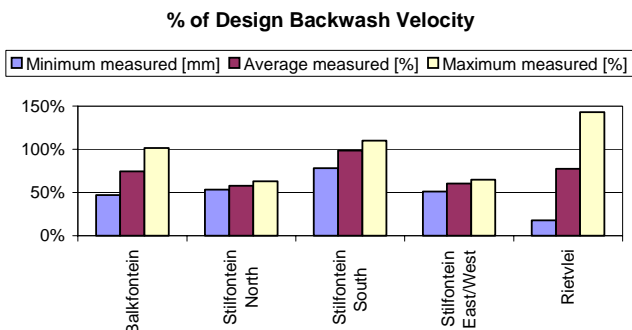
**Figure 4**  
Comparison of measured backwash rates with design rates

The results generated here are possibly the most surprising of all the results. In all plants, most of the filters experienced wash rates that were well below the design rate. In the worst case, the rate was approximately 20% of the design rate. This has obvious impacts on the amount of shear and agitation experienced by the media in the beds and therefore on the efficiency of the backwash.

At this point it is thought that the reduced rates are mainly caused by the failure of backwash isolation valves on the backwash manifold to close completely. A large volume of the backwash water is lost to other filters. Detailed measurements at Stilfontein indicated that average losses on the different filtration facilities ranged from 11 to 26.5% of the total volume of water delivered by the backwash pumps. The remainder of the reduction in backwash rate can be attributed to wear and tear on the backwash pumps, increased head losses due to the deterioration of the backwash manifold, as well as increased losses due to the partial blockage of nozzle caps by grains lodged in the slots. The last cause listed here has the potential for the creation of significant additional head losses.

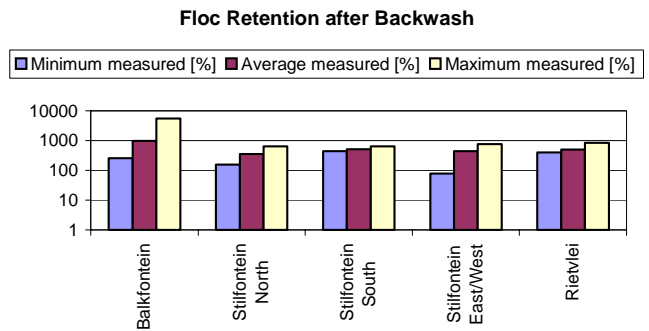
The floc retention test gives an indication of how well the filter is cleaned during backwash. For this test, the equivalent of 100 g of sand is rinsed with 500 ml of water, and the turbidity of the water returned as the result. The guideline values for interpretation state that below 60 NTU is indicative of a clean filter, 60 to 120 NTU indicates a reasonably clean filter, 120 to 300 NTU is a dirty filter and above 300 NTU is very dirty with potential mudball problems. The average turbidity for the floc retention analysis performed on the three plants is consistently above 300 NTU (Fig. 5). At Balkfontein several filters exceeded turbidities of 1 000 NTU.

However, the extensive mudballing encountered at the three plants, as reflected in the visual inspection confirms that mudballing is a common occurrence. This is considered to be a result of the low backwash velocities used.

Figure 5  
Floc retention results for the three plants

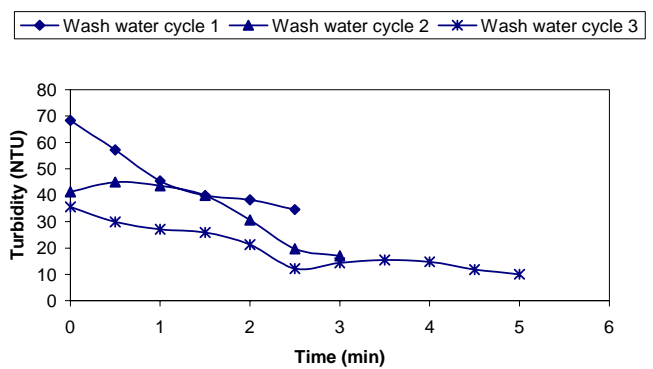
An evaluation of the backwashing procedure, done by logging the wash effluent quality during backwash, revealed that wash water was being used inefficiently (Fig. 6). After approximately 3 min the backwash water quality remained constant. This indicates that solids were being removed from the bed at a constant rate. Based on these findings long water washes were divided into shorter washes at the Balkfontein plant. An additional air scour cycle was also introduced between water cycle 3 and 4. In this way the same amount of water is used, but an increased rate of solids removal is attained (Fig. 7). This figure illustrates that the water originally used after 3 min removes turbidity from the filter more efficiently if used in a new wash cycle after air scour.

Figure 6  
Wash water turbidity profile indicating reduced removal after 3 min

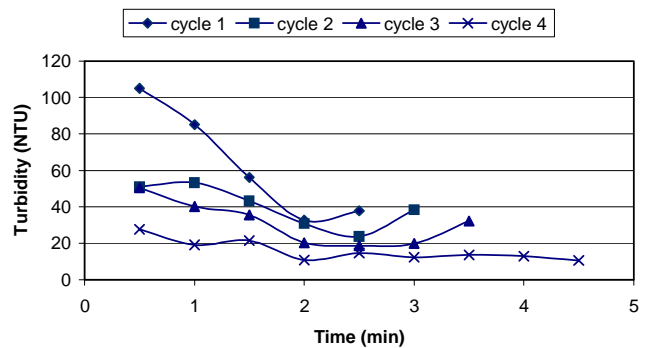
Figure 7  
Wash water turbidity profile after introduction of the 4<sup>th</sup> water cycle
