**INVESTIGATION INTO THE DEGRADATION
OF MORTAR LININGS AND CONCRETE
BY MICROORGANISMS IN
INDUSTRIAL WATER SYSTEMS**

**CONTRACT REPORT TO THE
WATER RESEARCH COMMISSION**

**ESKOM TECHNOLOGY RESEARCH AND INVESTIGATIONS
PRIVATE BAG 40175
CLEVELAND
2022**

WRC REPORT No 398

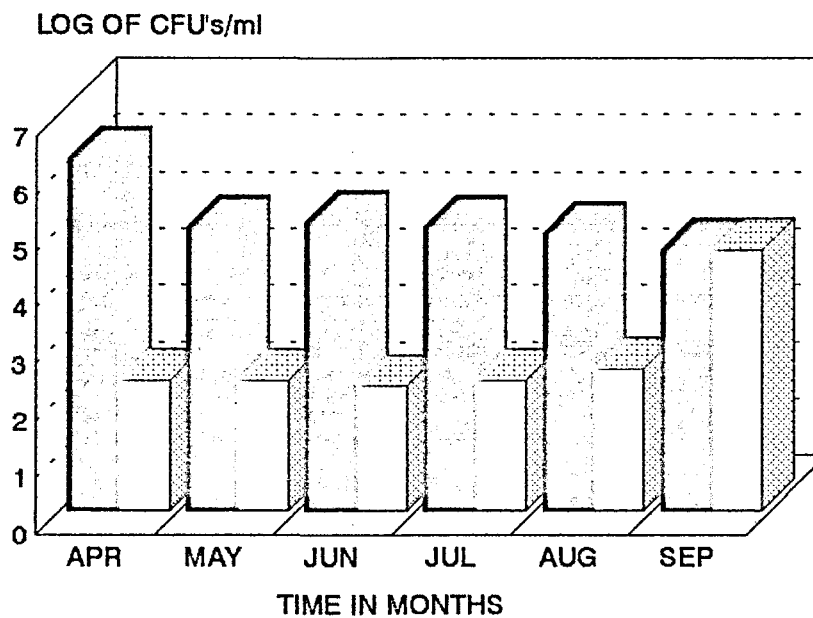
Figure 8 : Microbiological analysis of bulk water during the first phase of the investigation

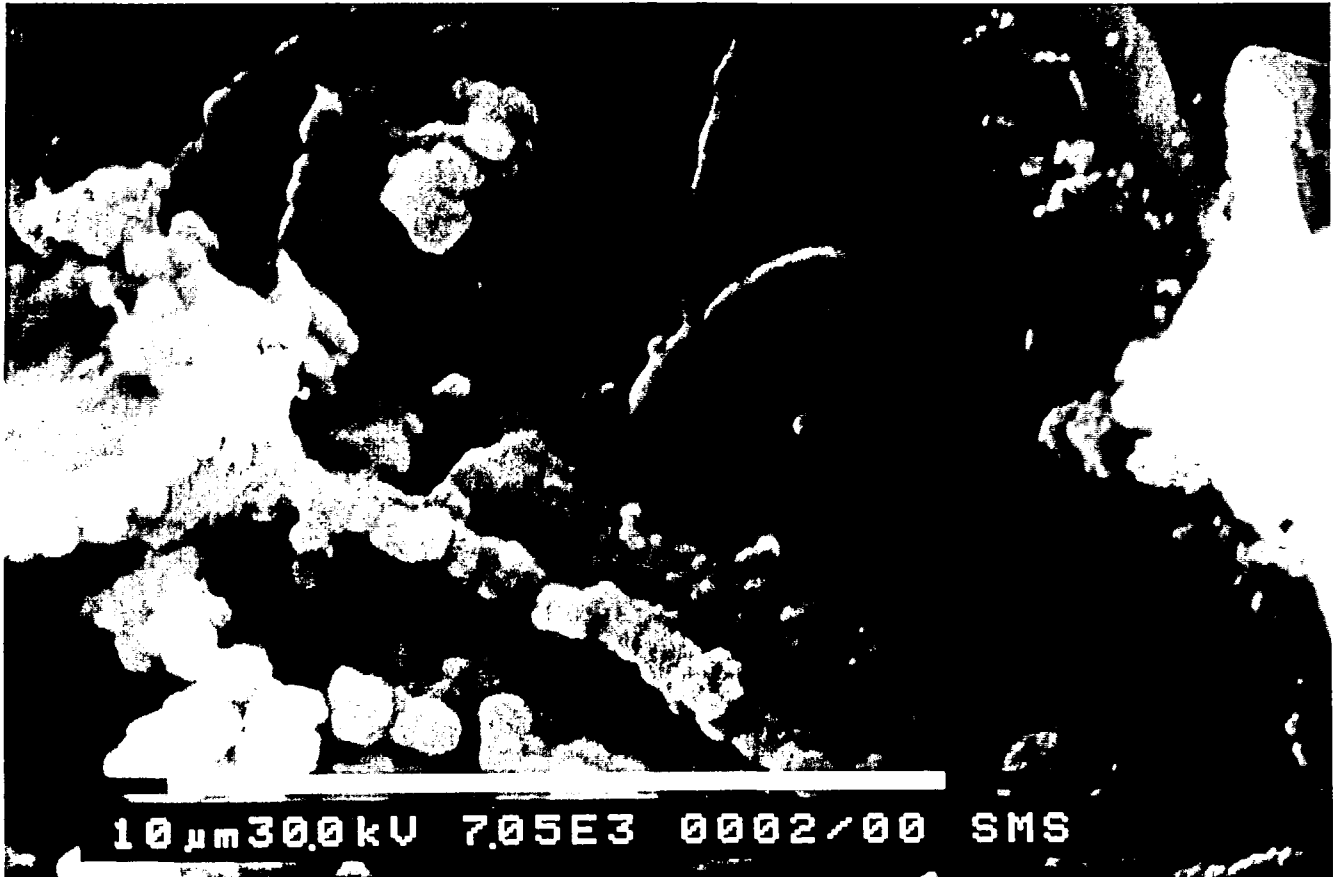
FIGURE 11 SCANNING ELECTRON MICROGRAPH SHOWING ATTACHED BACTERIA ON THE SURFACE OF A MILD STEEL SAMPLE

On examination under the SEM, no visible differences in the attachment of bacteria on the various sample surfaces was observed (Figure 11). Bacterial attachment also occurred in the non-sterile rig. The SEM technique cannot be used to determine biofilm thickness. Therefore, no variances in the extent of bacterial attachment were distinguished.

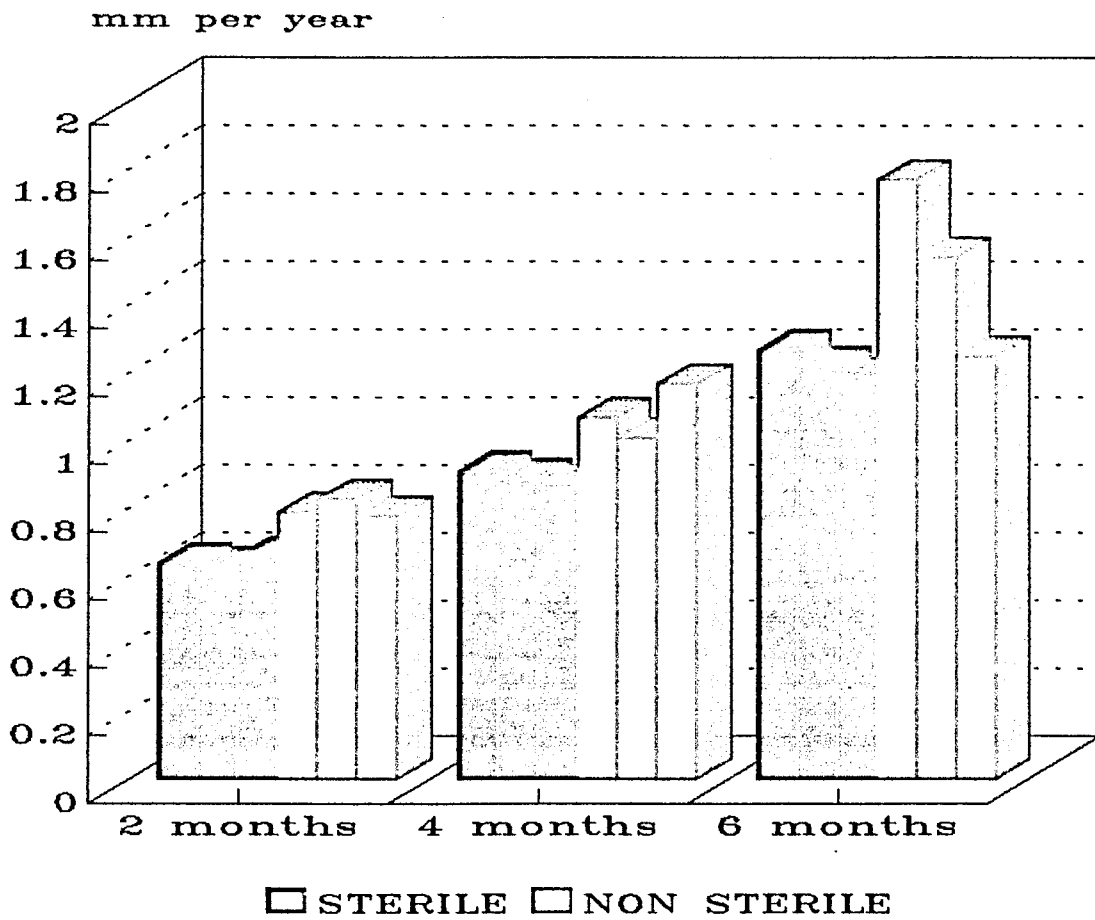
Figure 12 : Corrosion rates on the mild steel panels - Phase 1

The corrosion rates of the panels removed in Phase 1 are illustrated in Figure 12. It can be clearly seen, that in all cases the corrosion rates are higher in the non-sterile samples than in the sterile samples. The difference in these rates can be attributed to MIC, although a small proportion of the corrosion rates on the sterile samples may be due to MIC as complete sterility was not achieved.
