# **WET-OutcomeEvaluate**

**An evaluation of the  
rehabilitation outcomes at six  
wetland sites in South Africa**

WRC Report TT 343/09  
March 2009

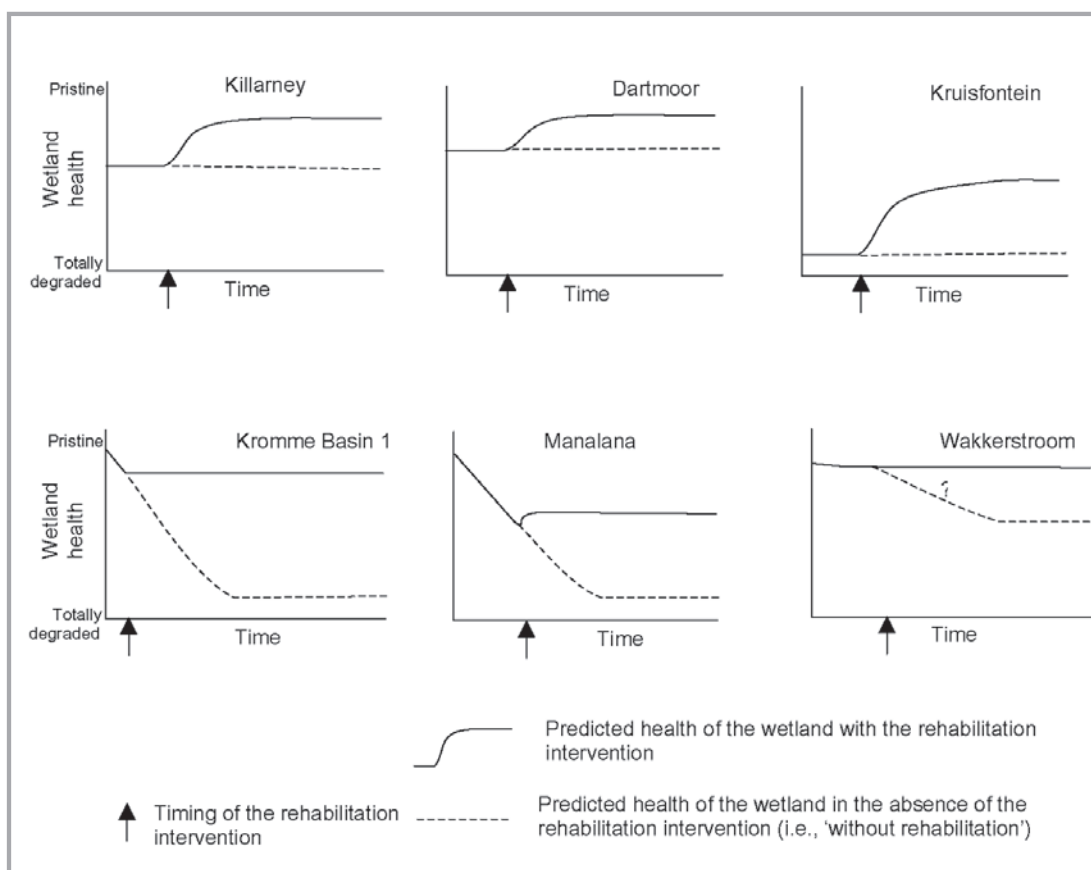
Figure 1: Schematic summary of the effect of rehabilitation interventions on the health trajectory of six selected wetlands

Of the three examples where health has been re-instated, Kruisfontein represents the greatest improvement in health. Kruisfontein Wetland, which had been very effectively and fully drained through cut-off drains and ridge and furrows across the wetland surface, was rehabilitated by plugging the cut-off drains and some of the ridge and furrowed areas. However, some of the influence of the drains and ridges and furrows still remain. Thus, it still falls well below a pristine state. Of the rehabilitation projects reviewed, it is noteworthy that none were found to move a system from being close to degraded to being close to pristine. This is probably owing to the difficulty, resources and time that are typically required to 'move' the health of a system such a great 'distance'.

Killarney and Dartmoor are similar in that both start in a much less degraded state than Kruisfontein and finish in a close to pristine state, although the Killarney system moves slightly further than Dartmoor. This has resulted from the fact that at Killarney the rehabilitation involved a greater density of plugs in the channels that were causing the desiccation of the system.

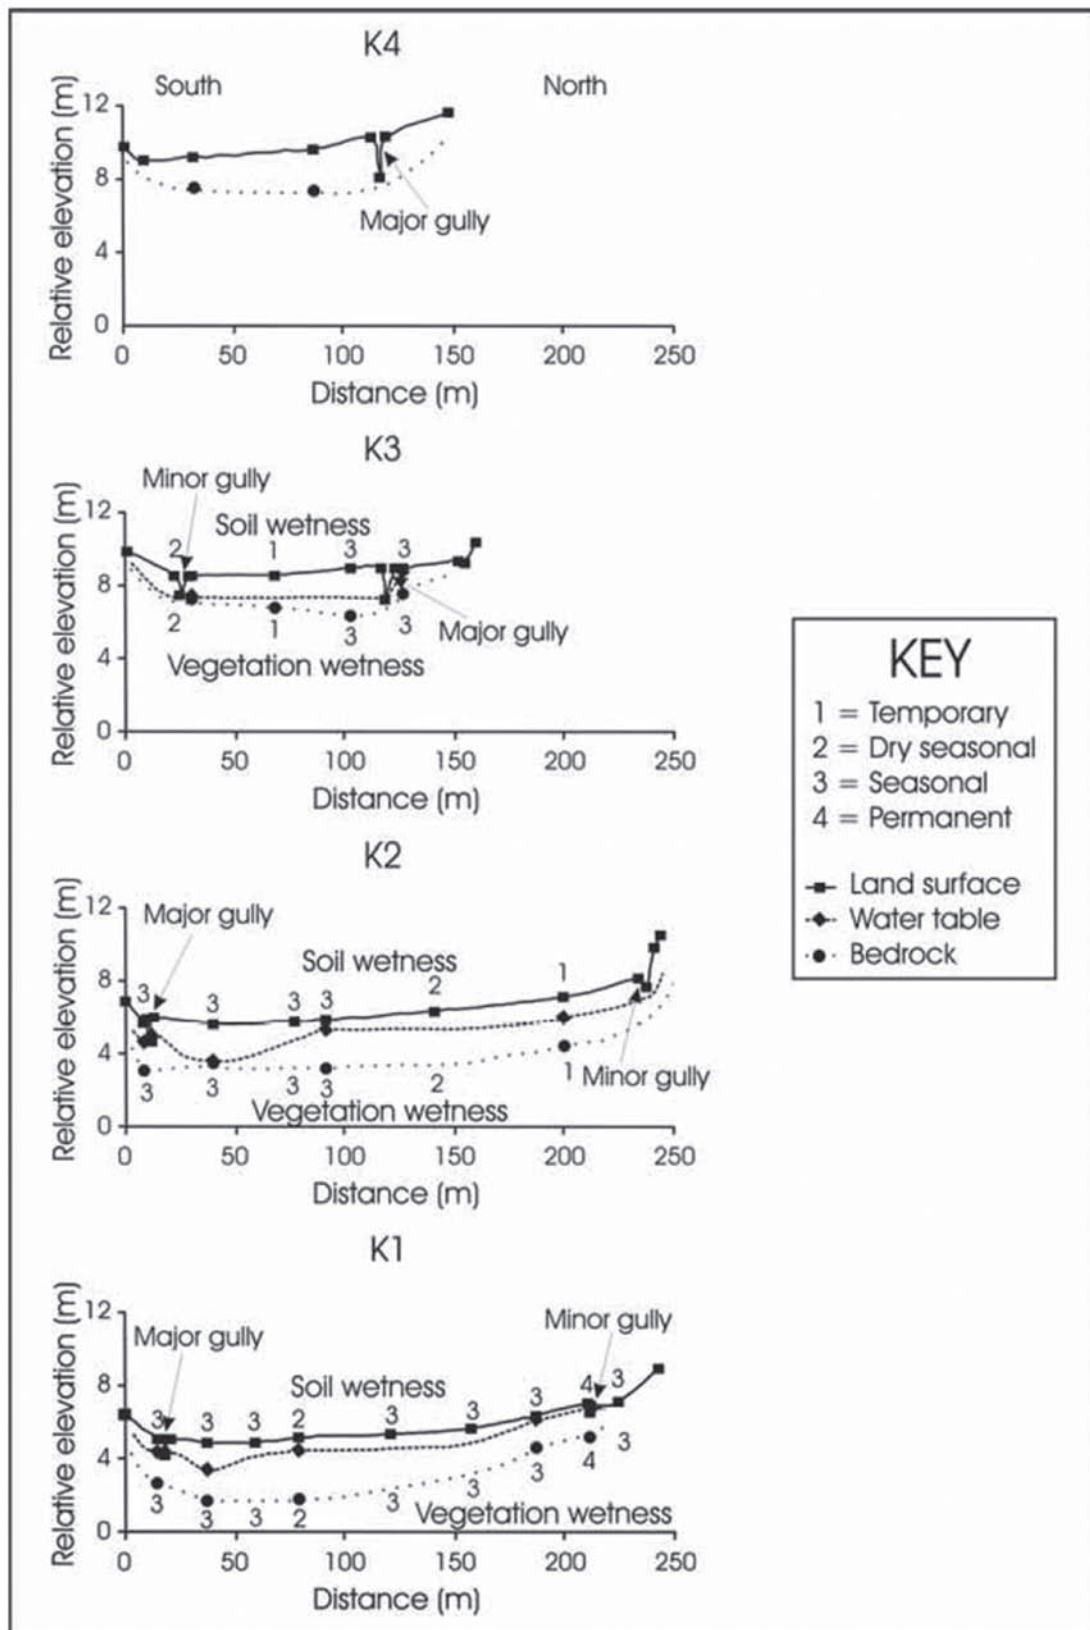
Figure 3: Cross-sections of Killarney Wetland displaying topography, soil and vegetation wetness, and depth to water table and bedrock

Based upon soil characteristics it is possible to determine the degree of wetness of the site (Table 1; modified after Kotze *et al.*, 1994), the results of which are summarised in Figure 3. There was surprising co-incidence of the indications of wetness based upon vegetation and soils, suggesting that the present site conditions have been present for years to decades.

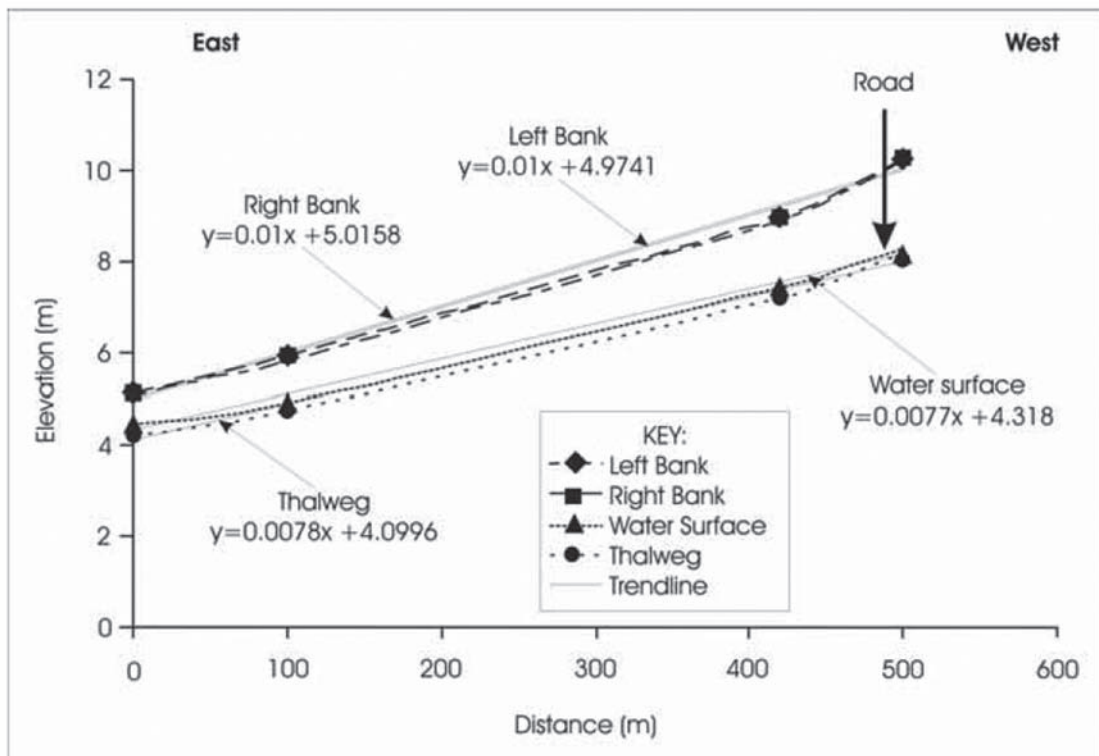
Figure 4: Longitudinal profile of the gully bed (thalweg), water surface and both banks of the Killarney Wetland

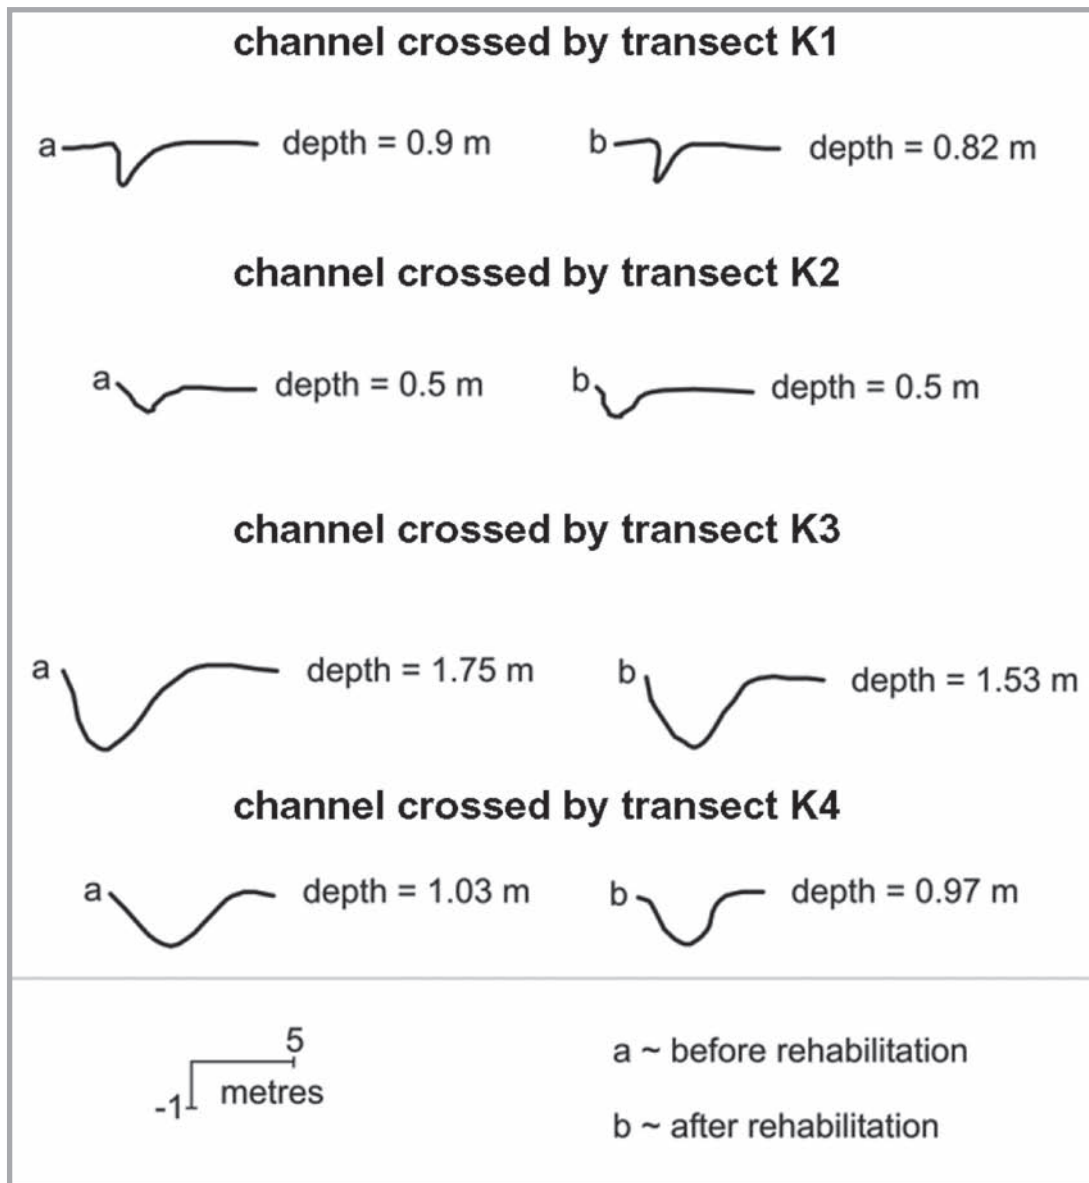
typically decreased as a result of the trapping of sediment generated from the collapse of the gully walls between the structures. The structures are therefore effectively trapping sediment.

Figure 10: Cross sections of gullies before (a) and after (b) rehabilitation

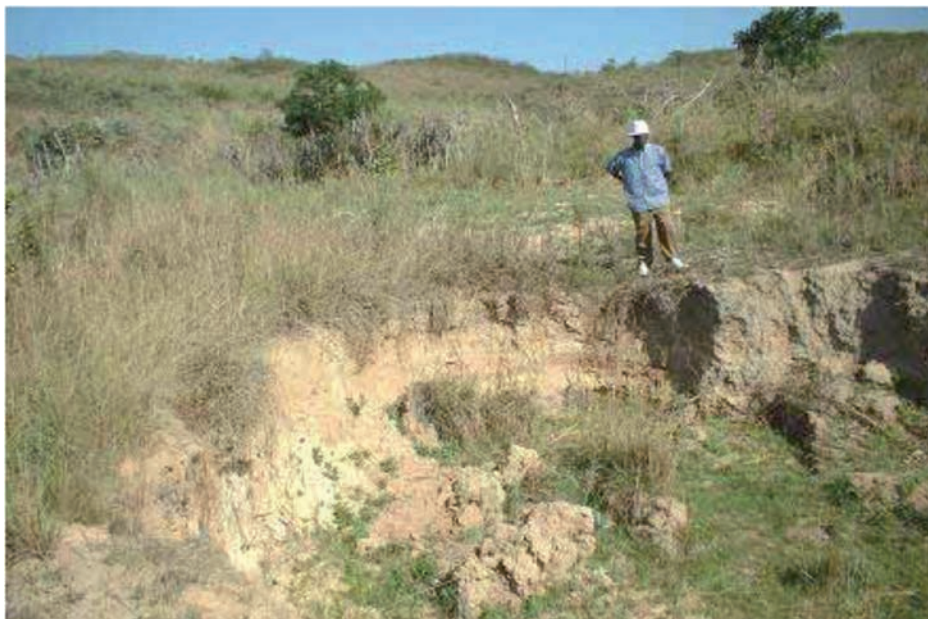
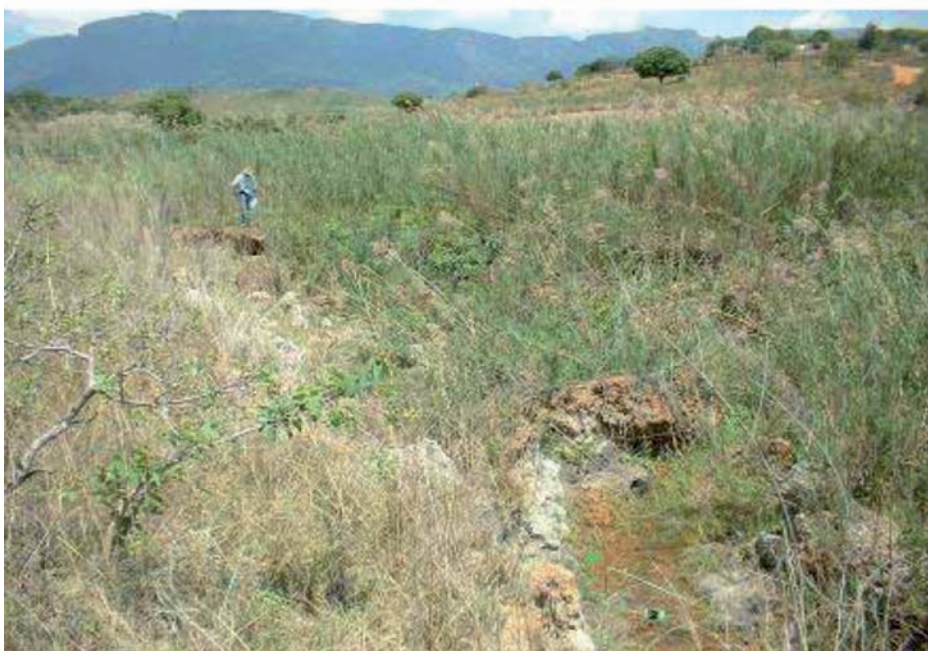
Figure 2: The two main erosion headcuts threatening the Manalana Wetland (a) Portion 1, and (b) Portion 2. The photographs were taken in 2004 prior to the rehabilitation interventions.

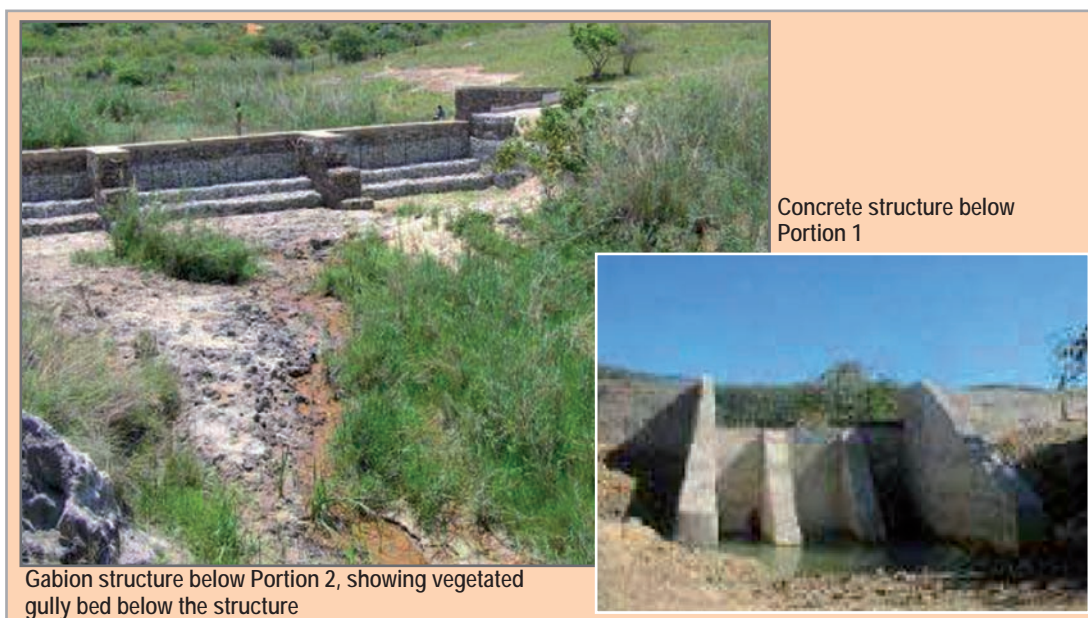
Figure 7: The two principal rehabilitation structures in the Manalana wetland

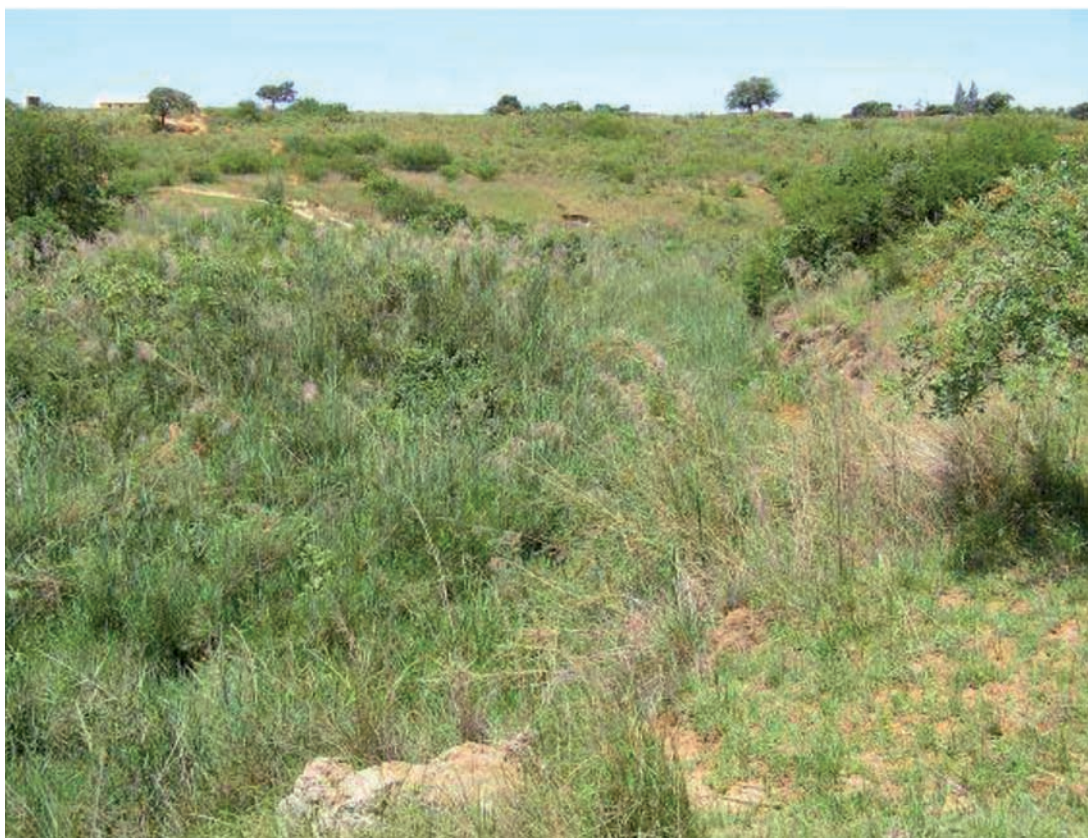
Figure 9: View shortly downstream of the second headcut, showing the bed of the gully which is well-vegetated with hydric species, notably *Phragmites mauritianus*

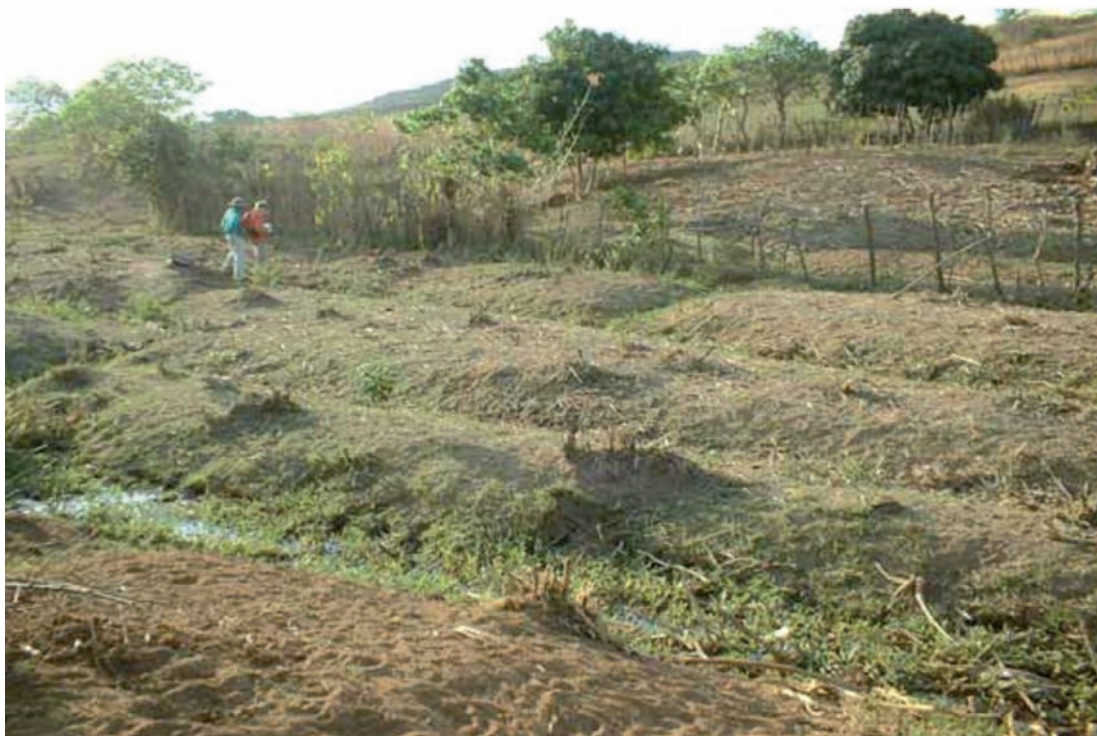
Figure 10: Actively-cultivated raised beds in Portion 2 of the wetland, photographed shortly before the planting season

structure contributes to the maintenance of diffuse flows then it is also likely to contribute to the effectiveness of the wetland in assimilating pollutants. Table 3 shows that the greatest contribution made by the rehabilitation intervention was to the provision of cultivated crops (Figure 10). The rehabilitation also made a moderately high contribution to streamflow regulation, sediment trapping and erosion control and an intermediate contribution to several ecosystem services, including flood attenuation, carbon storage, water supply for human use, natural resources (grazing and sedges), and education and research. Overall, therefore, the rehabilitation structures have made a significant contribution to a broad range of ecosystem services, particularly to provisioning services, with this contribution being quantified in Part 3B.

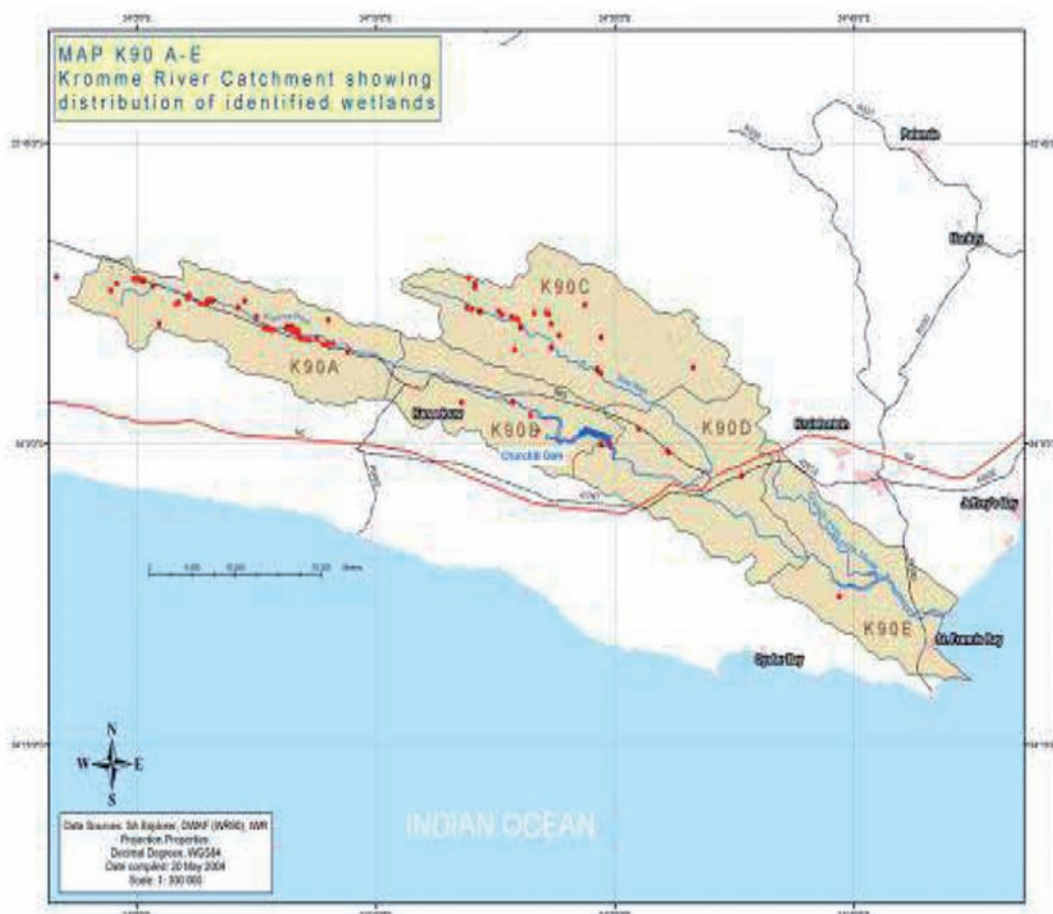
Figure 1: Map of the Kromme River Catchment. The wetlands of the study area are located in catchment K90A

The Kromme River Catchment (K90) is situated on the southern coast of the Eastern Cape of South Africa (Figure 1) The river enters the sea at St Francis Bay in the east and is an important water resource for the Nelson Mandela Metropole, which lies to the east of St Francis Bay. The Churchill Dam (34°00'S 24°29'E; capacity 35 710 106 m<sup>3</sup>) situated south-east of Kareedouw, and the Mpofu Dam (34° 05'S 24° 42'E; capacity 10 706 106 m<sup>3</sup>) situated near Humansdorp below the confluence with the Diep River, deliver about 34% of the water requirements for Port Elizabeth, the major city of the Nelson Mandela Metropole. The wetlands described in this study are situated in sub-catchment K90A. The land-use in the catchment is predominantly private farming (orchards, cultivated crops and pastures) with small areas of nature reserve in the upper-catchment of K90A.

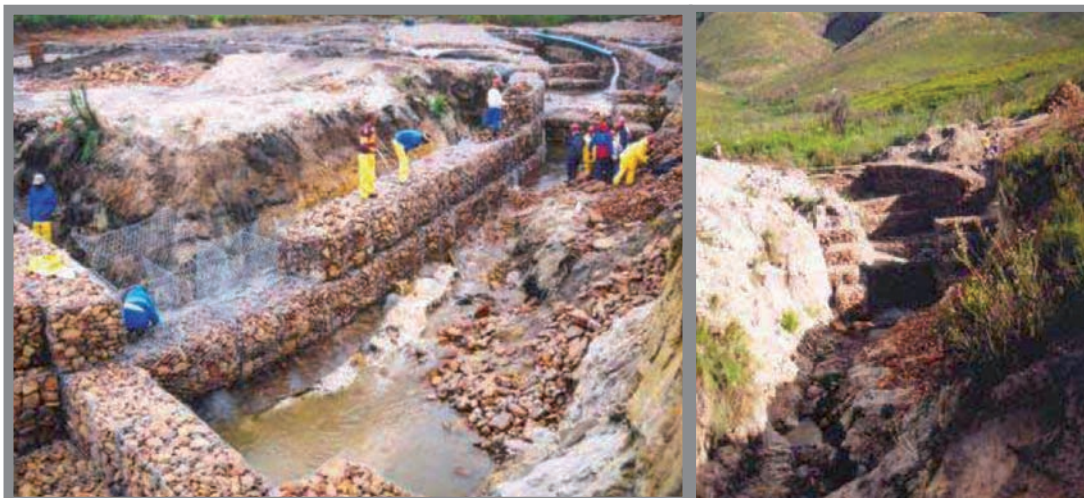
Figure 7: Gabion complex A1-4, at left under construction, at right after completion (2001). It was very stable and well vegetated by 2005, and was slightly damaged in the 2006 flood.

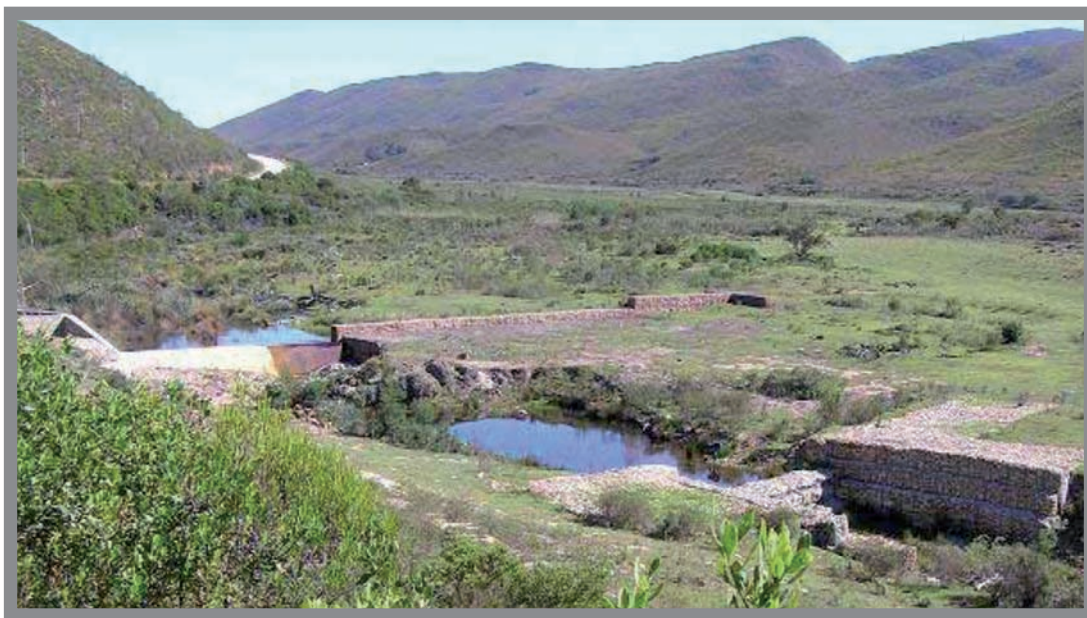
Figure 9: Structures B3 (left) and B1 (right) at Companjesdrift, May 2006. Note the leakage where the concrete abuts the stone gabion on B3. The overflow level on B1 was lowered after the collapse during the 2001 flood.

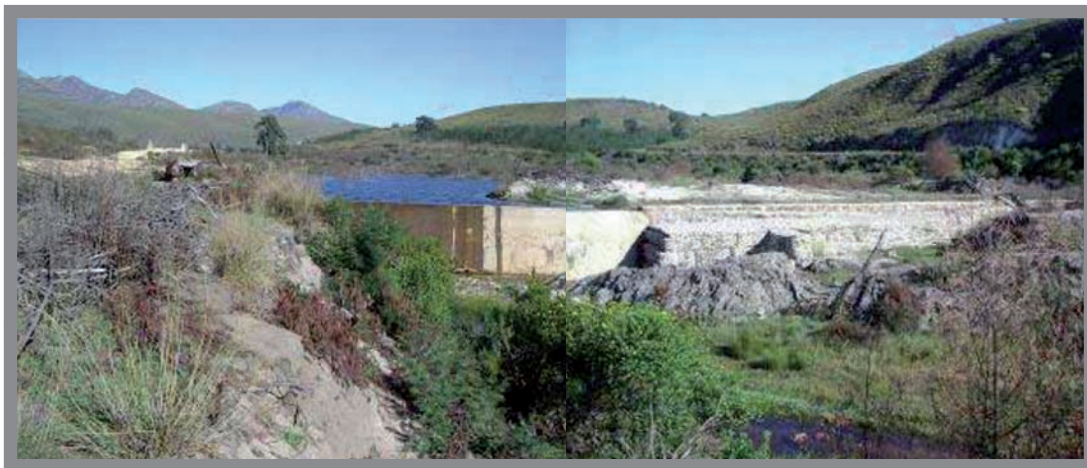
Figure 10: Weir B3 of concrete and rock gabion in the key point at Companjesdrift, below the confluence with the Eerstedrif River (2004)

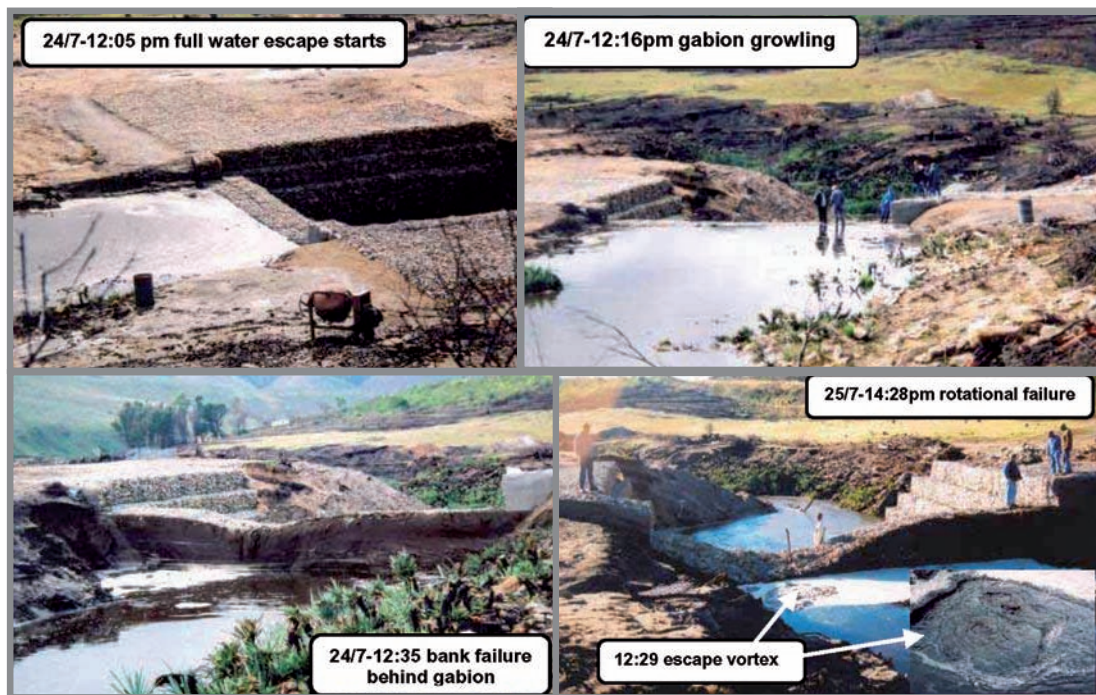
Figure 12: The collapse of an unfinished gabion structure B1. It rained on 22-25 July 2001 and at 11h00 on 24 July 2001. The pool behind the structure started filling up, by 12h00 water had reached the top of the gabion (top left). In the following 15 minutes water seeped under the gabion instead of overtopping the structure (top right) as can be seen by the surface disturbance. By 13h26 the people standing on top of the structure felt movement and heard groaning and soon afterwards the bank behind the gabion failed (bottom left). Overnight subsidence and rotational failure followed (bottom right). When the gabion was repaired, the height of the overflow was lowered by 2 m. After that the structure remained stable until 2006.

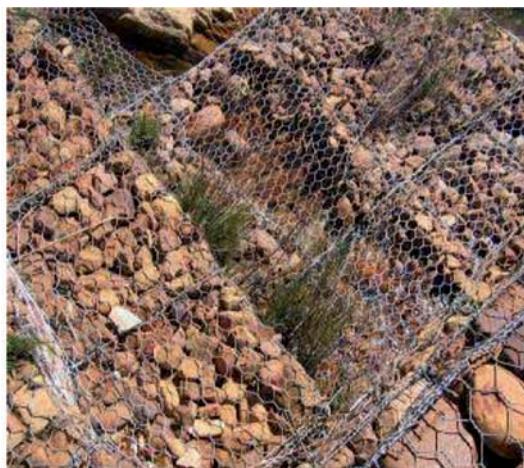
Figure 13: A view of gabion baskets with clasts missing at the Dwarsrivier structure (A1)

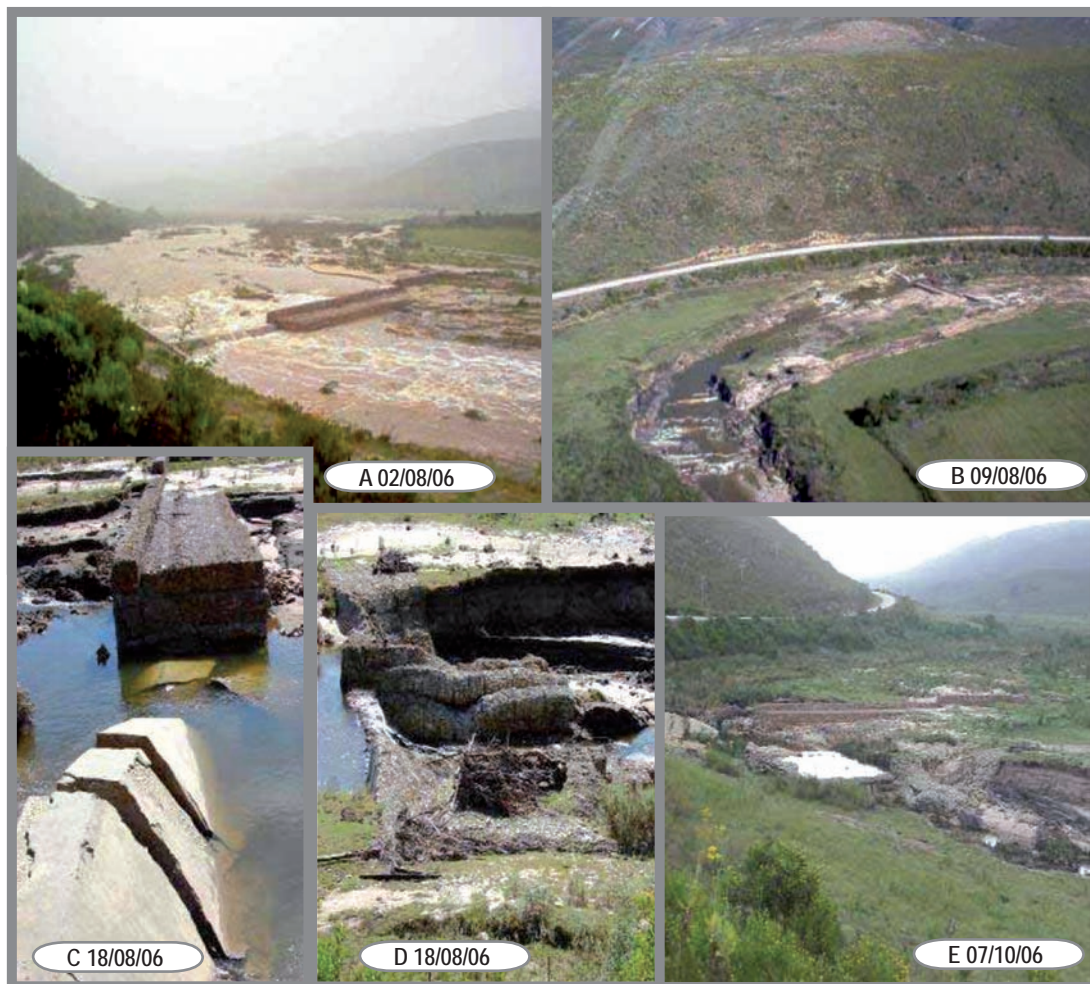
Figure 15: Sequence of events at the weirs B1 and B3 at Companjesdrift on the Kromme River, August 2006.

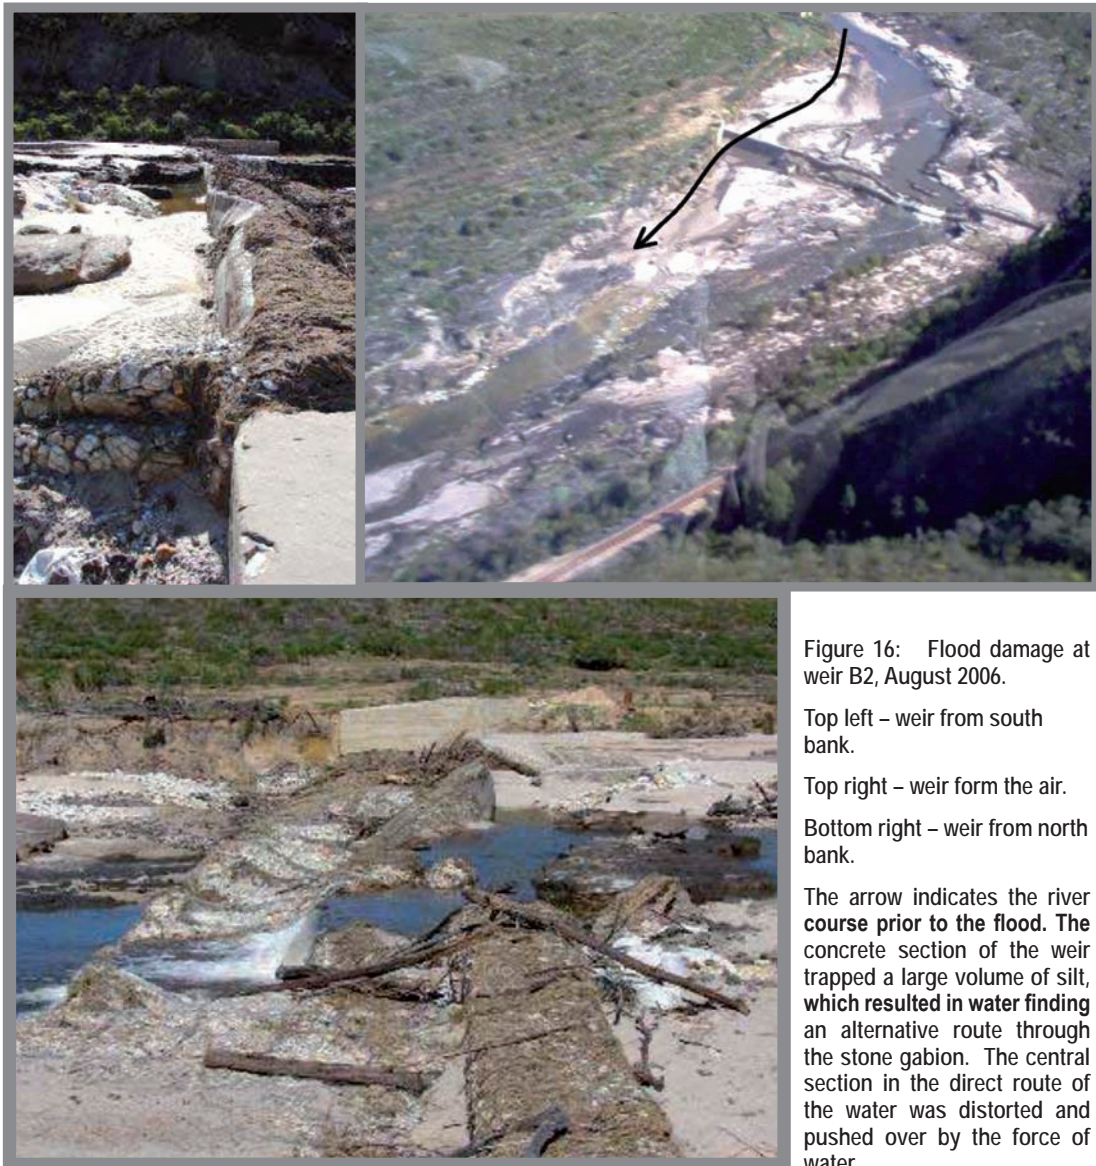
Figure 17: Flood damage at gabion C at Hudsonvale. The water forced past the southern arm of the gabion. The cross marks approximately the same spot in each photograph.

D3 Hendrikskraal (lower)	9728.1	0.4	Bedrock present. Unvegetated sand deposits present.	A new structure was being built at the site of an earlier one.	
C Hudsonvale	15145.4	0.4	The structure is located immediately upstream of the confluence of the Witelsrivier with the Kromme River.	The gabion baskets had subsided at the terminal end of one of the shoulder walls (Figure 17). The cement apron downstream of the main wall had been damaged by flood waters. The latter damage is believed to have occurred at the time of the more recent flood, on Monday 5 March, 2007 and during the previous week. Erosion of unconsolidated sediment had taken place adjacent to the structure.	Good

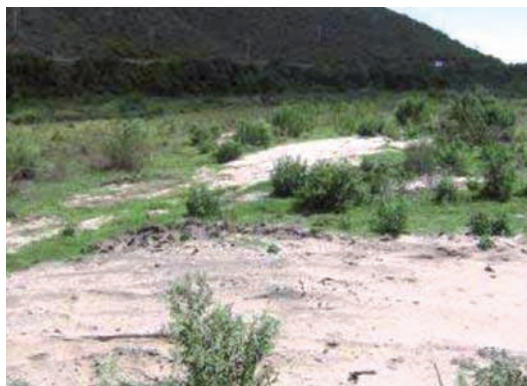
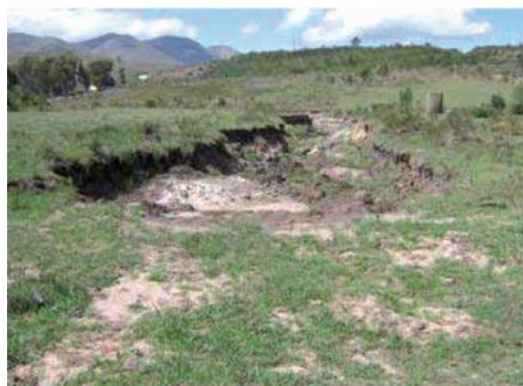
Figure 20: Floodplain at Companjesdrift.

Left – view of the unvegetated sediment deposits on the left bank of the wetland above the uppermost structure.
