FACTORS INFLUENCING UNDER-UTILISATION OF SMALLHOLDER IRRIGATION SCHEMES AND OPPORTUNITIES TO IMPROVE THE SCHEMES' PRODUCTIVITY IN LIMPOPO PROVINCE, SOUTH AFRICA

Water Research Commission

Report No. TT 787/19 ISBN 978-0-6392-0100-9

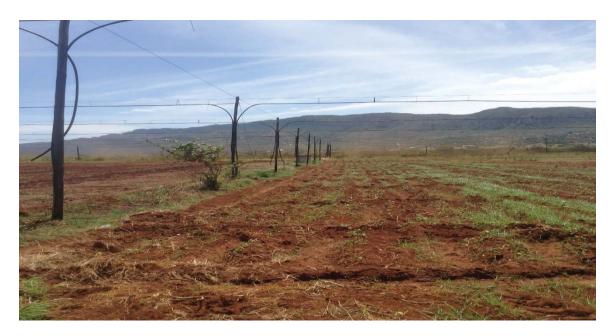
Figure 3: The current floppy irrigation systems used Mbahela irrigation scheme.

The overhead floppy irrigation pipes have been damaged due to non-use. The farmers have reverted back to the previous flood irrigation method to keep their crops in good conditions on a small portion of the field. It was observed that the makeshift flood irrigation system was beginning to cause significant soil erosion which was a concern to the farmers and local government officials. The system does not allow for individual blocks demarcation for farmers.

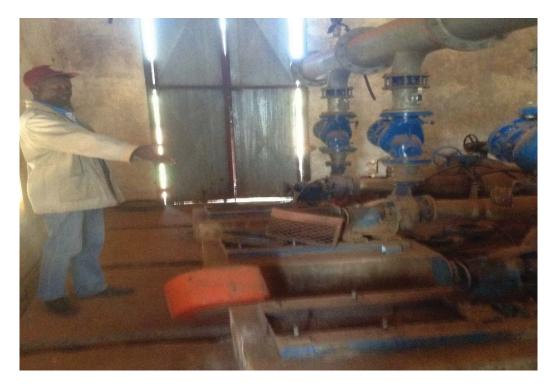
Figure 4: A farmer pointing to the vandalized motors at the water pump house: All 3 motors were stolen

Currently, the irrigation scheme is not functional due to vandalism of the pump station. The pump station was vandalised, the centrifugal pumps stolen and the overhead pipes damaged. Furthermore, the transformer was vandalised and stolen.

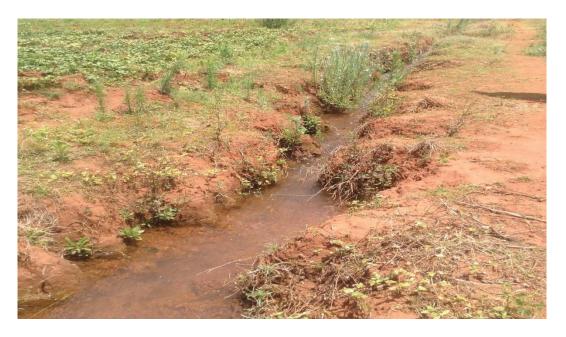
Figure 5: Soil erosion challenges at the scheme due to flood irrigation

Currently the project has received funding from the Department of Rural Development and Land Reform. They have recently purchased inputs, a tractor and erected a fence. Their biggest challenge is the floppy irrigation system which is not functional at the moment due to stolen system components at the pump station. The farmers have resorted to opening channels from the canal that run through the field and diverting the flow onto the fields using make-shift furrows due to the absence of a proper irrigation system. This procedure is now resulting in soil erosion as the soils are sandy.

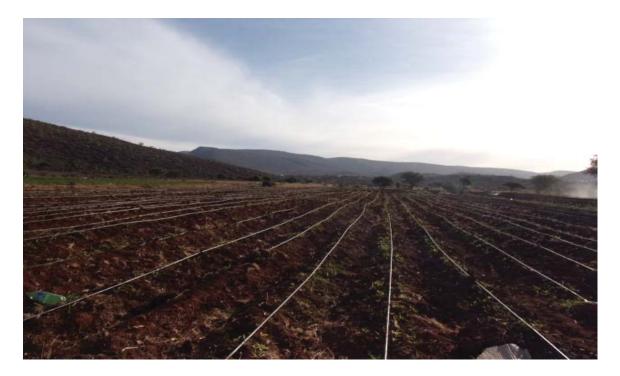
Figure 8: The drip irrigation systems used at Mphaila irrigation scheme.

During the study, it was reported that the scheme is in the process of changing the sprinklers to drip irrigation due to the challenges of high wind speeds prevalent in the area. Currently both systems are being used as shown in Figure 8 and 9.

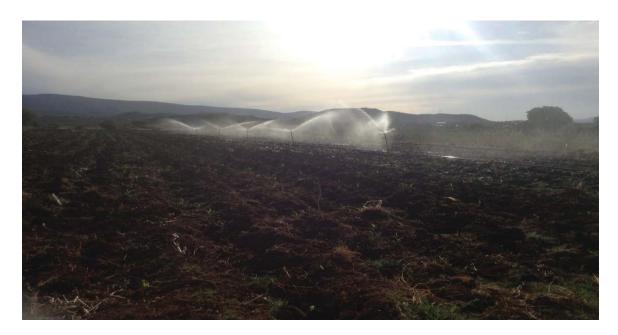
Figure 9: The sprinkler systems used at Mphaila irrigation scheme.

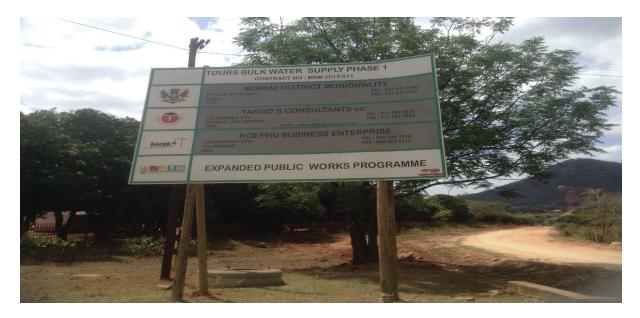
The scheme was under drip irrigation for the entire 120 ha. All the irrigation infrastructure has been completely vandalised. The major challenge facing the scheme is lack of water for irrigation. There is no water to the scheme due to the broken pipe which was caused by the contractor (see the photo below) who is constructing pipes for domestic water along the same area.

Figure 11: A Sign board showing a contractor at the Tours Irrigation scheme

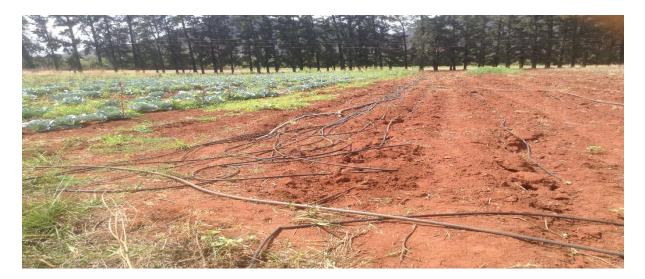
Figure 12: Showing vandalised drip irrigation lines at the scheme

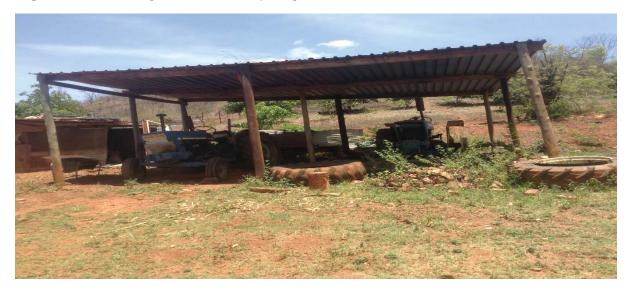
Figure 13: Showing the remains of the tractors which have been vandalised

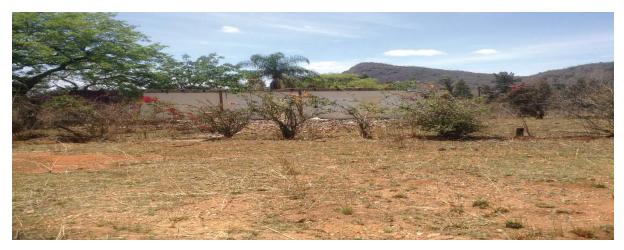
Figure 14: Vandalised coffee pack house

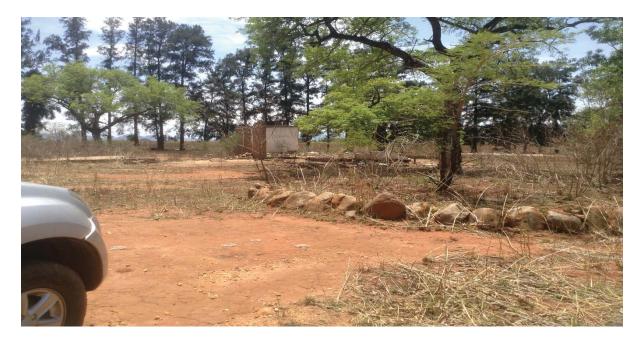
Figure 15: Vandalised office and administration block

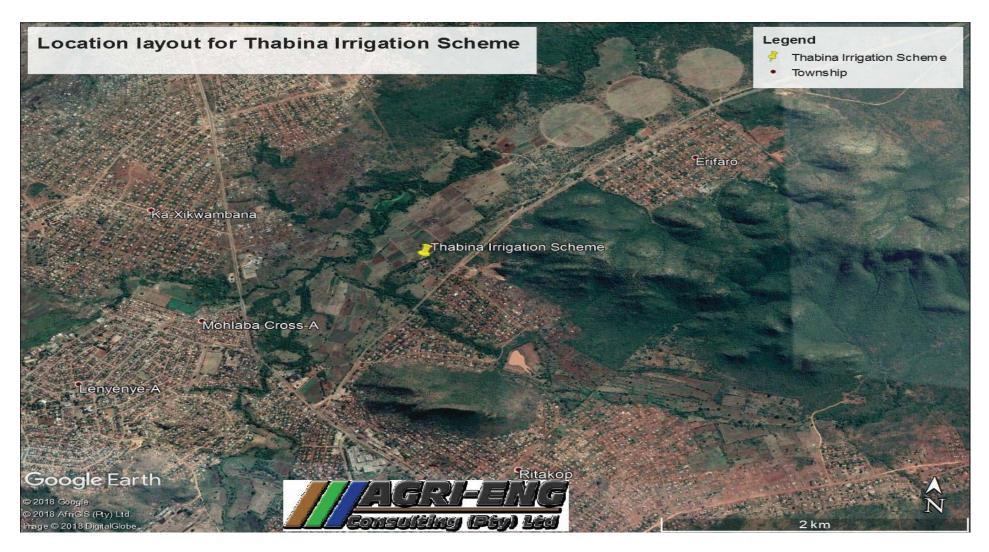
Figure 16: Layout map for Thabina Irrigation Scheme

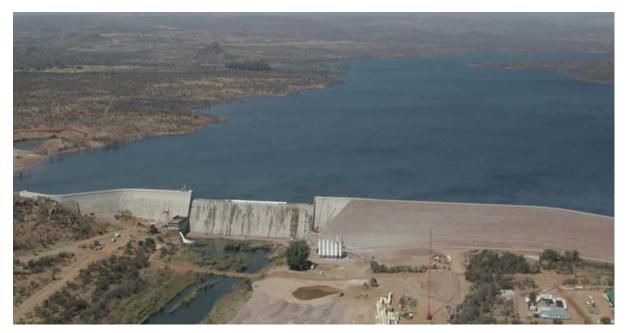
Water is pumped into several balancing dams and then to the floppy irrigation system through a booster pump station.

Figure 18: Flag Bushelo dam which supplies water to Phetwane irrigation

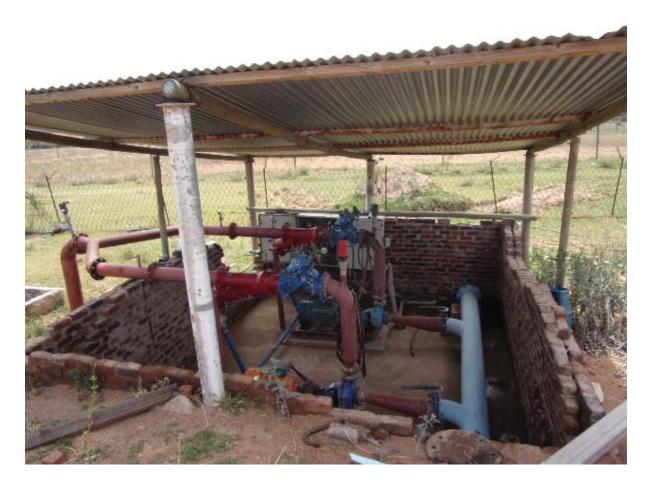
The pump station consists of two (2) 37 kW centrifugal pumps. The pump station requires repairs to the control box and the pumps. The pump house building needs renovation to cover the pumps which are currently exposed to the weather vagaries particularly driving rainfall which can damage the motors.

Figure 19: Poor condition of pump station at Phetwane irrigation scheme

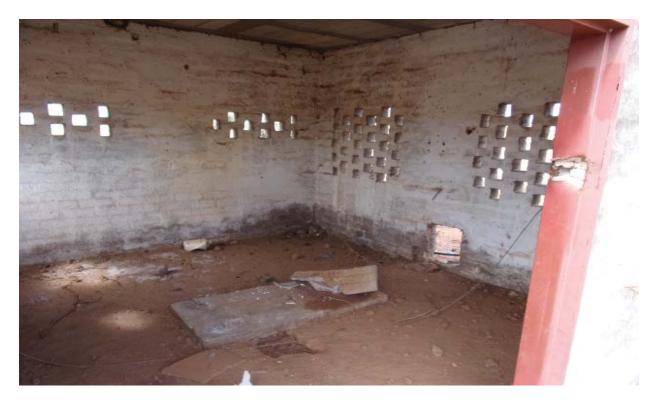
During the study, it was found that there has been a total damage to the overhead infrastructure of the scheme. This is mainly due to theft / vandalism and a little fire damage. The following has occurred in both blocks:

Figure 21: The original pump station which is now vandalized

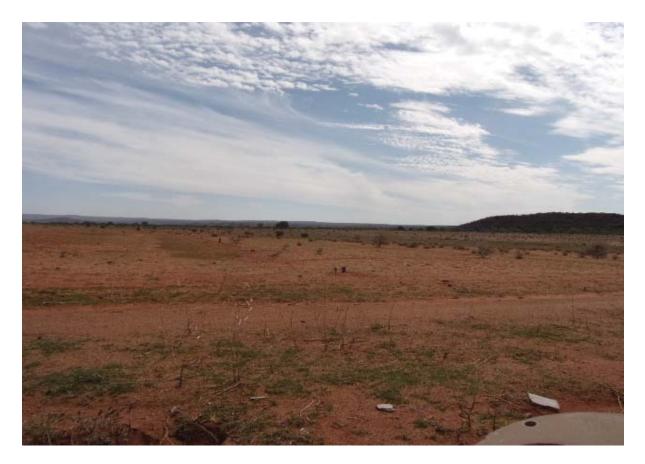
- A number anchor poles, anchor cables and anchor rods for the overhead infrastructure have been removed and stolen
- Support poles have been cut and stolen
- Sections of poly pipe and floppy sprinklers have been removed and stolen
- The pipe hangers have broken due to sun exposure
- The pump station has been vandalised

Figure 22: Showing floppy poles which have been cut

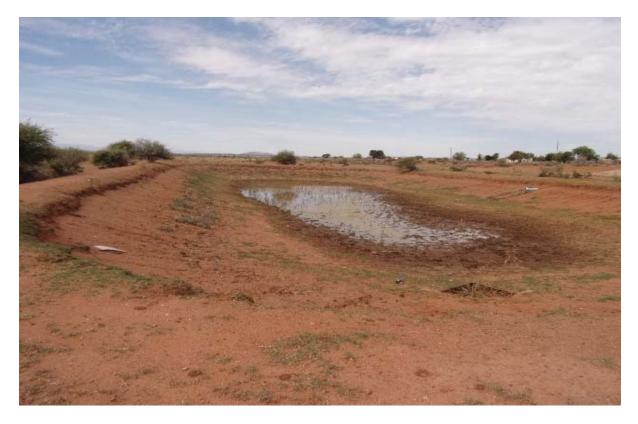
Figure 23: Showing the position of the balancing dam which is now non-functional

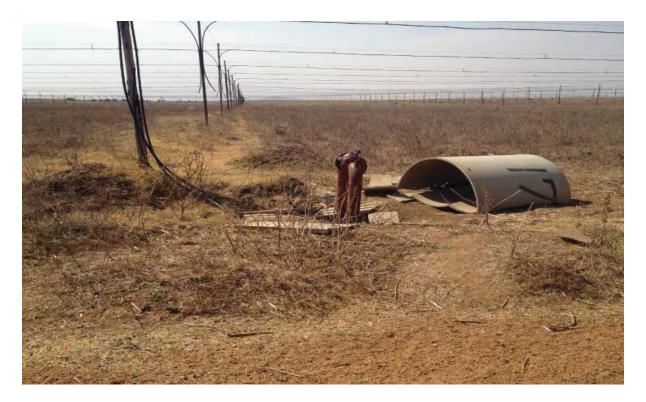
Figure 24: The manhole around this cluster valve in 2012, which now has been completely vandalized.
