LESSON
SERIES
September 2013

SANITATION SERVICES IN INFORMAL SETTLEMENTS

Sewering Lessons From Western Cape

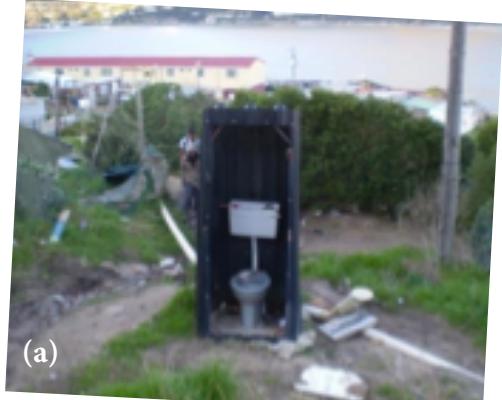
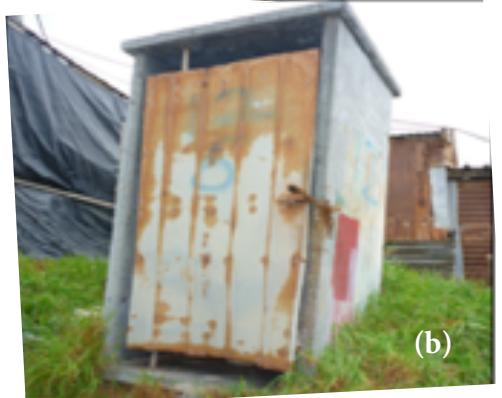
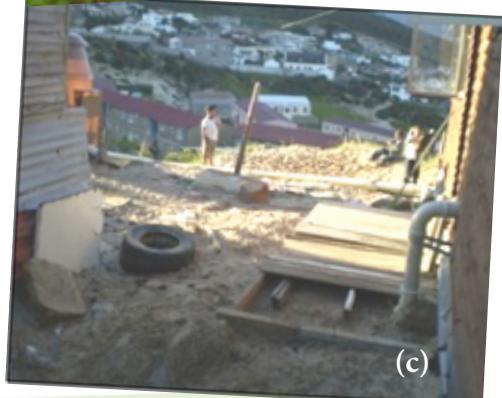
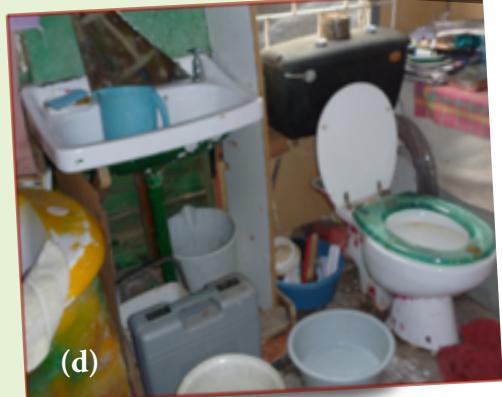
Municipal and private sanitation facilities in Hangberg informal settlement. From top left clockwise:

(a) a shared toilet without a door, (b) a toilet with an unstable structure due to an eroded base, (c) a bathroom in a resident's bungalow and (d) an unauthorised private connection to the exposed sewers.

Dissatisfied with the municipally-provided facilities, some residents stopped using them altogether after they built or paid a skilled neighbour/contractor to connect their homes to the simplified pipe network. By 2006, over 40% of the residents had installed toilets in their homes while close to 80% had connected to the water supply network. It is significant to note that some residents have taken it upon themselves to 'upgrade' their services independent of subsidies from South Africa's Free Basic Services policy. By installing their own service, residents thus assumed responsibility for maintaining the household connection themselves.

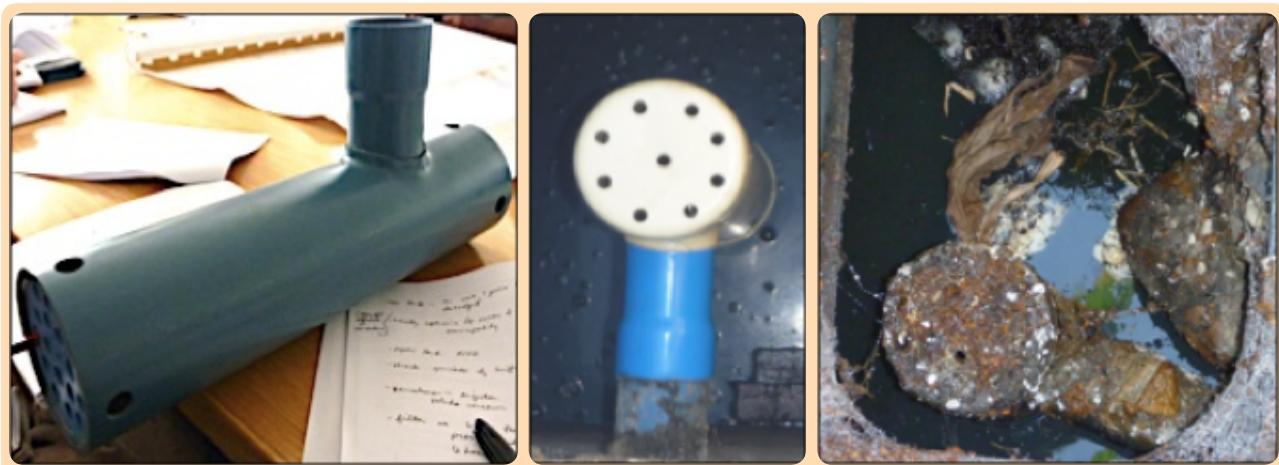
The 63 mm outlet filter (left) that is installed in Hermanus' properties. The middle photo is of a filter on a new tank that was just commissioned and the photo on the right is of a settled tank that has been in operation for several years (Photos by Ashipala (2010) and Taing (2012)).

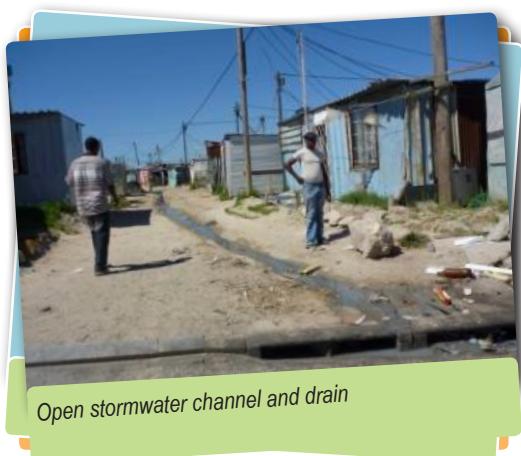
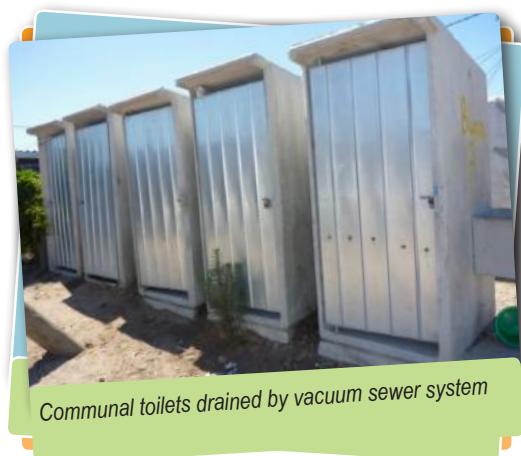
Location of Kosovo vacuum sewer system toilet clusters (CoCT, 2010b)

Each toilet cluster has between six and fourteen toilets, and is drained by a 110 mm diameter gravity sewer conveying wastewater to an adjacent 40-litre collection chamber sump. The collection chambers' 63 mm diameter interface valves connect to vacuum sewer mains which range from 90 mm to 250 mm in diameter. Pre-cast concrete rings with lockable lids were placed over the collection chamber / interface valve assemblies as a security feature to help protect them from damage.

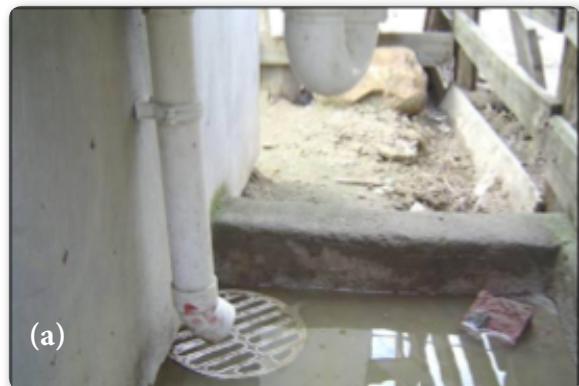
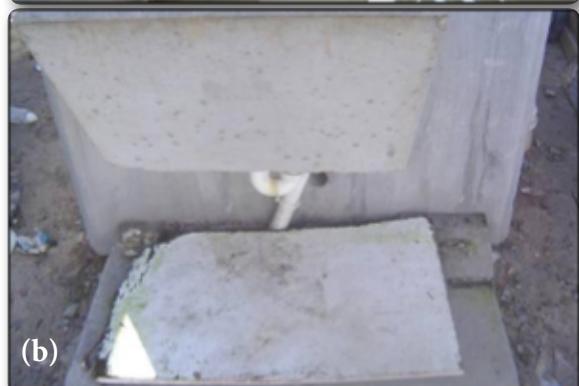
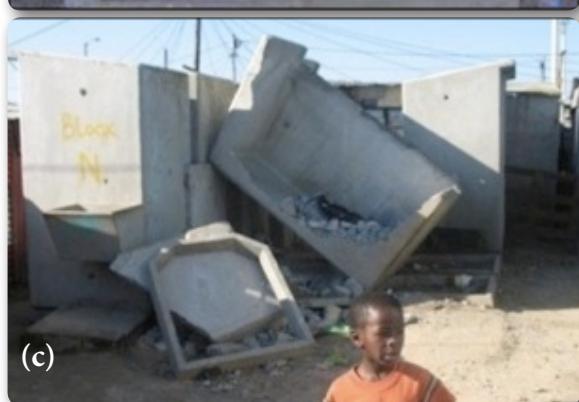
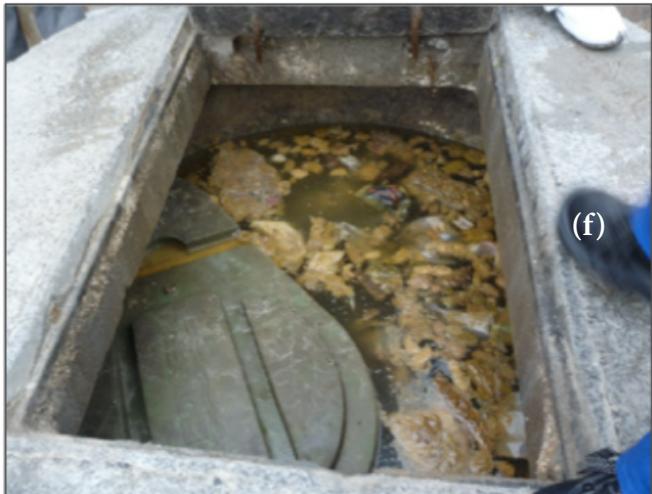
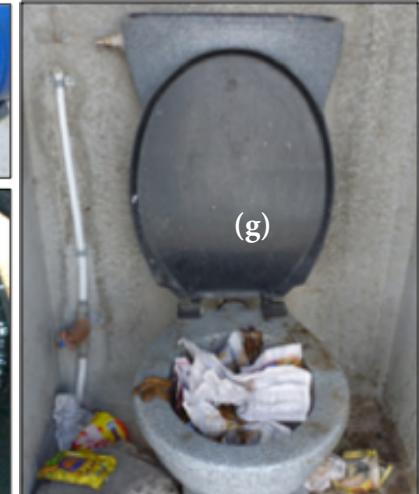
Photos of Kosovo's vacuum system and connected toilets. From the top: (a) raw sewage overflow from washbasin drain in June 2009, (b) attempts by residents to prevent spillage by covering drains with wooden boards in June 2009, (c) a used but disconnected toilet in November 2010, (d) a spoon piercing an interface valve diaphragm, (e) a brick in a sump, (f) a submerged collection chamber in a flooded concrete ring in June 2010 and (g) destroyed toilets in July 2010

Since inception, the system has been hampered by users' (Kosovo residents') and service provider's (CoCT's) poor management. Residents continually complained about how the system was of inferior quality and as a result got blocked very easily. For example, sewage overflows regularly emanated from the toilets and drained directly below the washbasins that had been installed at the communal toilets. In some cases, the overflowing sewage flooded neighbouring shacks.

Nevertheless, blockages continued rendering most of the toilets completely unusable. Residents' disposal of items such as cutlery and bricks into the system sometimes caused flooding when interface valve diaphragms, pierced by sharp objects, remained closed, and bulky items blocked sumps. Wastewater thus regularly inundated the collection chambers and seeped through the covering concrete rings into the local environment. Sensor controllers also malfunctioned due to fats and dirt clogging pilot tubes, or were rendered completely useless from waterlogging; and the vacuum pumps were overworked due to air leakages in the vacuum line.

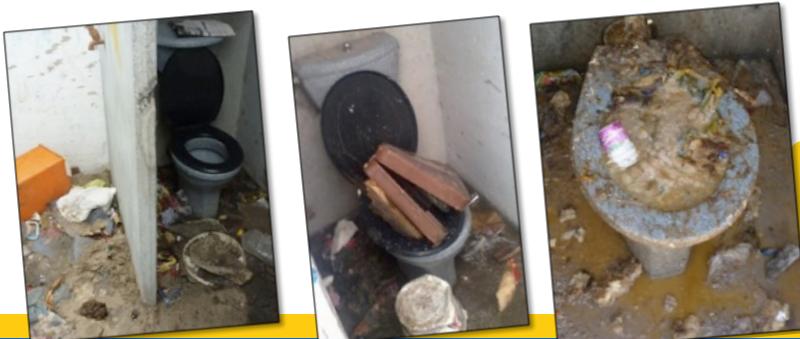
Evidence of greywater, food waste and solid waste disposal in Kosovo toilets connected to the vacuum sewer (Photos by Taing, 2010, 2011).

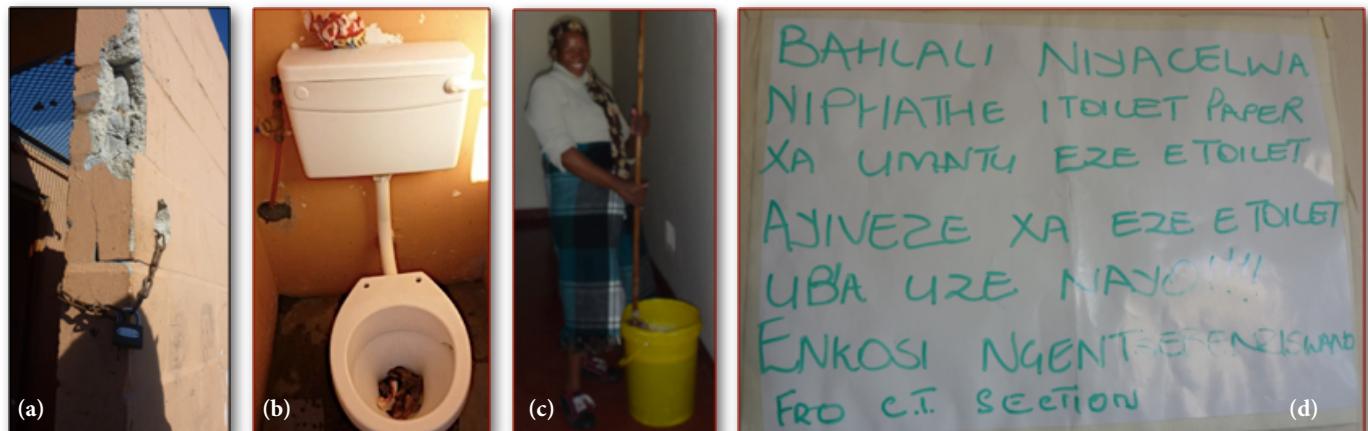
from left to right: (a) evidence of infrastructural damage from a break-in at TR Section's ablution facility, (b) a toilet in TR Section where newspaper was used as an anal cleanser, (c) a janitor at the CT facility, and (d) a sign posted at the facility's entrance entreating users (in IsiXhosa) to use toilet paper.
