ASSESSMENT OF THE LONG-TERM RESPONSE OF TWO WETLANDS TO WORKING FOR WETLANDS REHABILITATION

Report to the
Water Research Commission

**WRC Report No. 2035/1/13
ISBN 978-1-4312-0396-3**

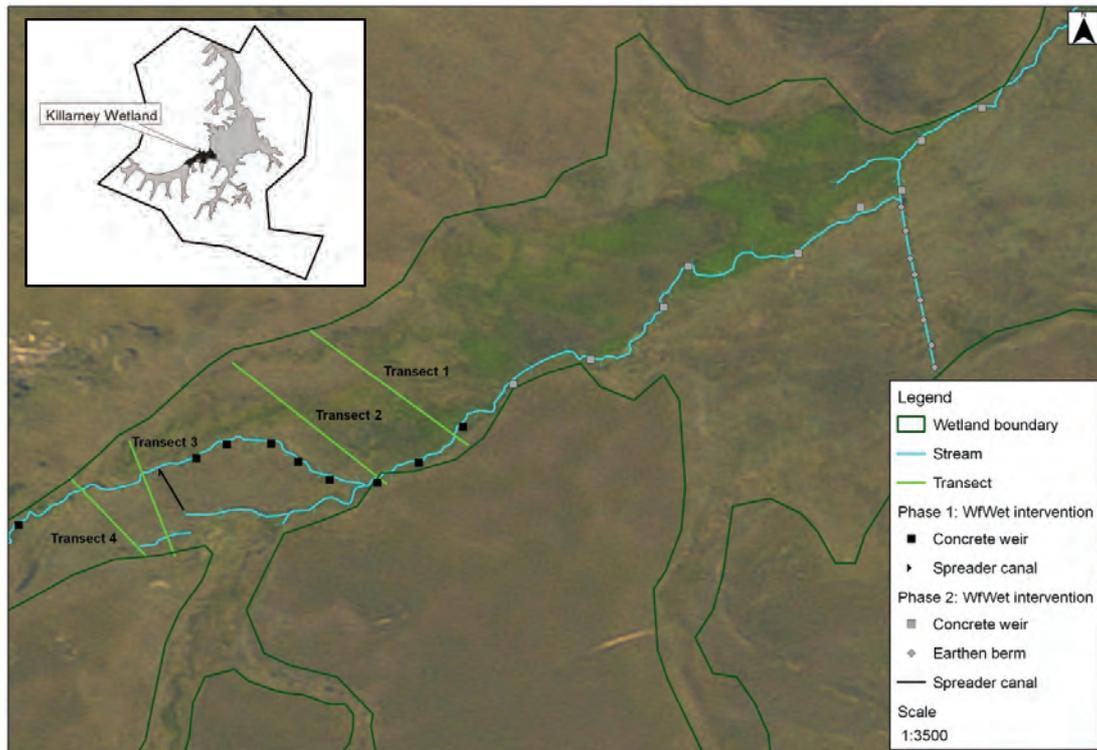
Figure 2-1. View of the Killarney wetland with the interventions and transects, with the inset showing the location of wetland within the Ntsikeni Nature Reserve.

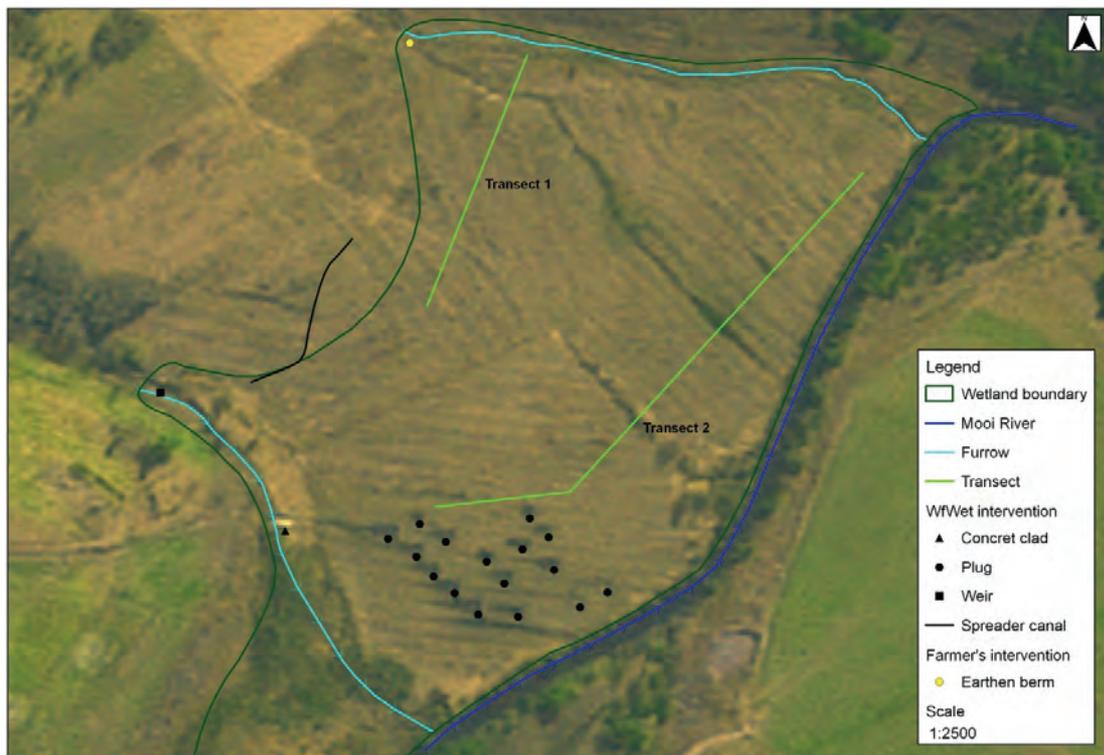
Figure 2-2. View of the Kruisfontein wetland with the interventions and transects

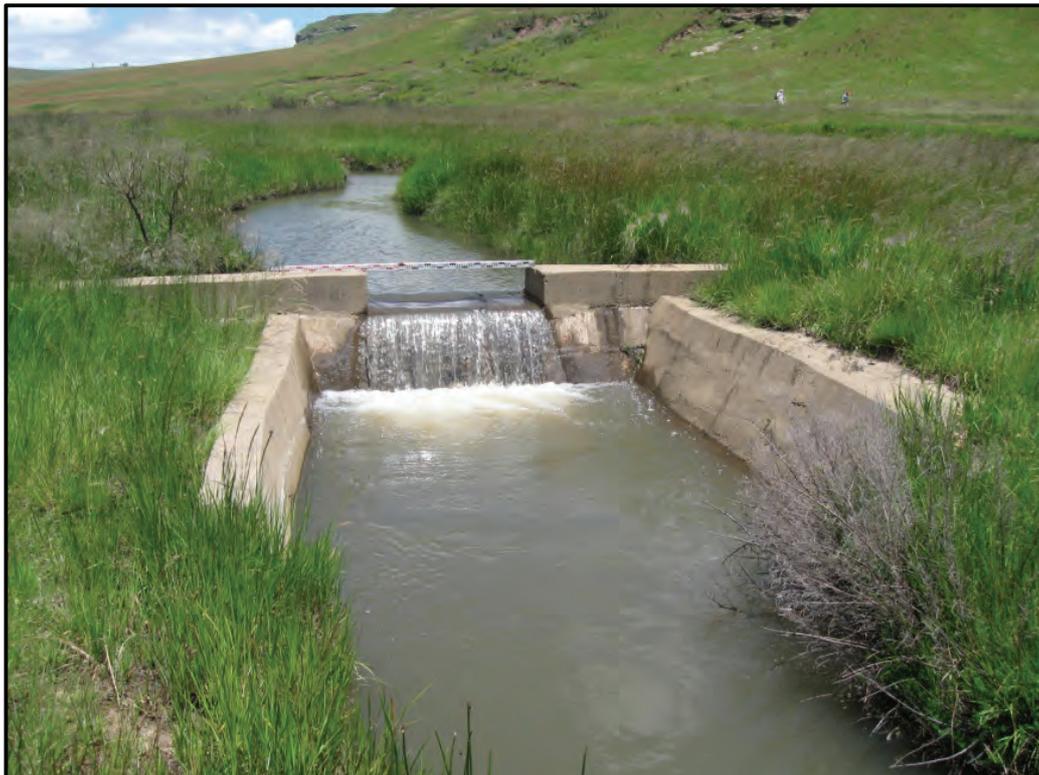
Based on the rainfall recorded at nearby Department of Water Affairs (DWA) rainfall stations, it is anticipated that the interventions in the Killarney wetland would have been exposed to a flood event beyond their design specifications. While the interventions within the Kruisfontein wetland have been exposed to high flows, rainfall has not exceeded the levels that would be equivalent to the flood event accounted for in the design specifications. In addition, the rehabilitation strategy adopted at Killarney wetland needs to be acknowledged as contributing to intervention success, with concrete weirs being planned with water from the downstream interventions back-flooding halfway up the interventions upstream (Figure 4-1). Currently, the same cannot be said for the interventions within the Kruisfontein wetland as flows have not exceeded the design specifications, although the interventions have withstood elevated flows.

Figure 4-1. View of water back-flooding to the base of an intervention in Killarney wetland

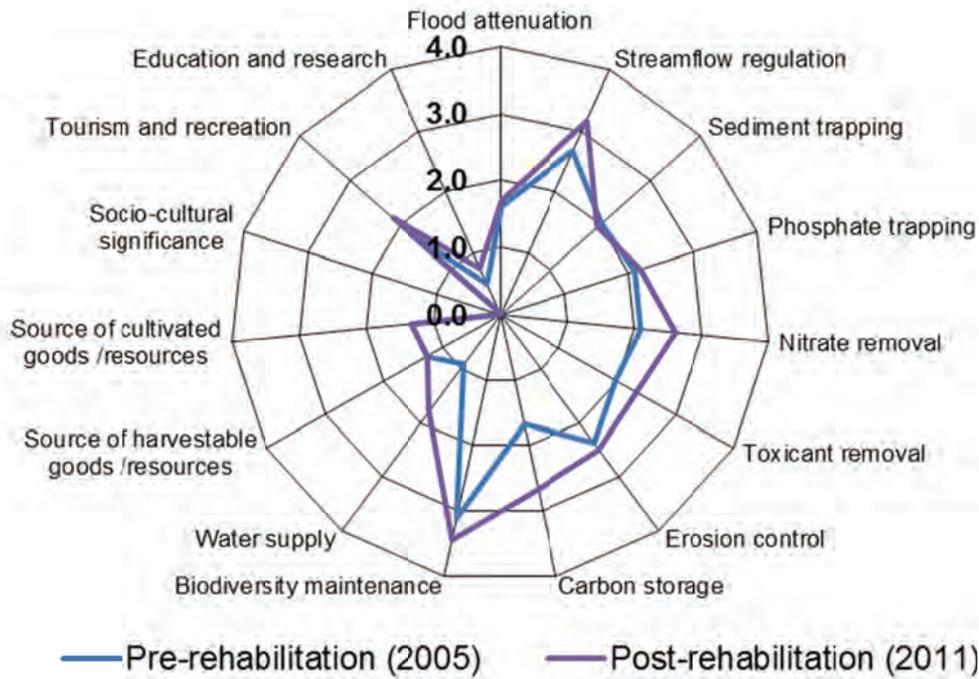
Figure 4-2. Levels of ecosystem service delivery pre- and post-rehabilitation in Killarney wetland

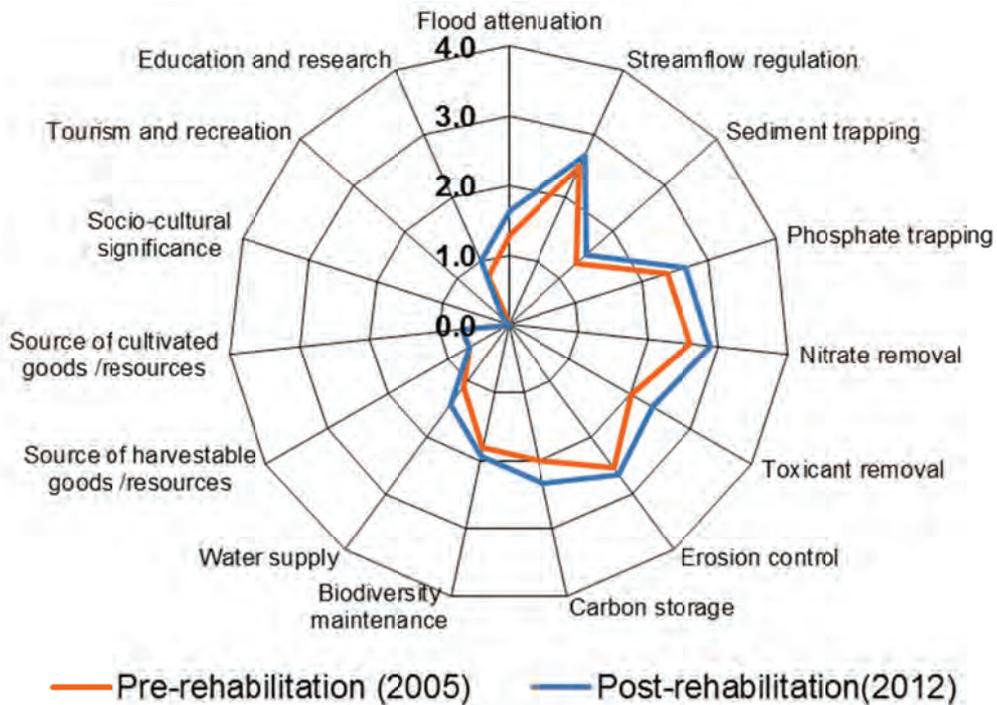
Figure 4-3. Levels of ecosystem service delivery pre- and post-rehabilitation in Kruisfontein wetland

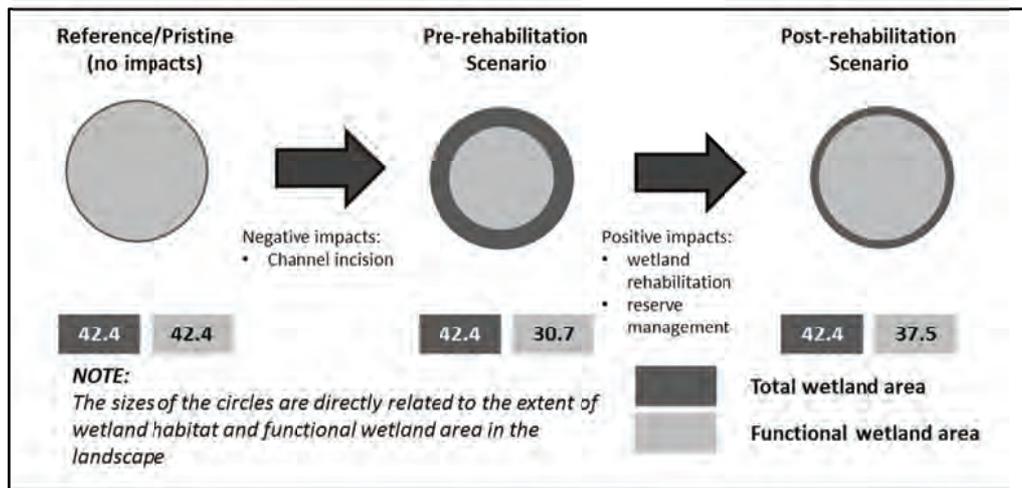
While the changes in ecological integrity depicted as changes in impact category, serve to illustrate the improvements in the wetlands' condition linked to the rehabilitation, the use of hectare equivalents (ha equiv.), as described in Section 3.2.2, provides an effective 'currency' for assessing the gains in wetland integrity. Based on the recorded impact scores, the Killarney wetland improved from 30.7 ha equiv. to 37.5 ha equiv. while the Kruisfontein wetland improved from 8.2 to 11.5 ha equiv. (Table 4-6, and Figure 4-4 and Figure 4-5).

Figure 4-4. A graphic representation of the Killarney wetland, in terms of both spatial extent and functional area, from pre-rehabilitation conditions through to the rehabilitated conditions.

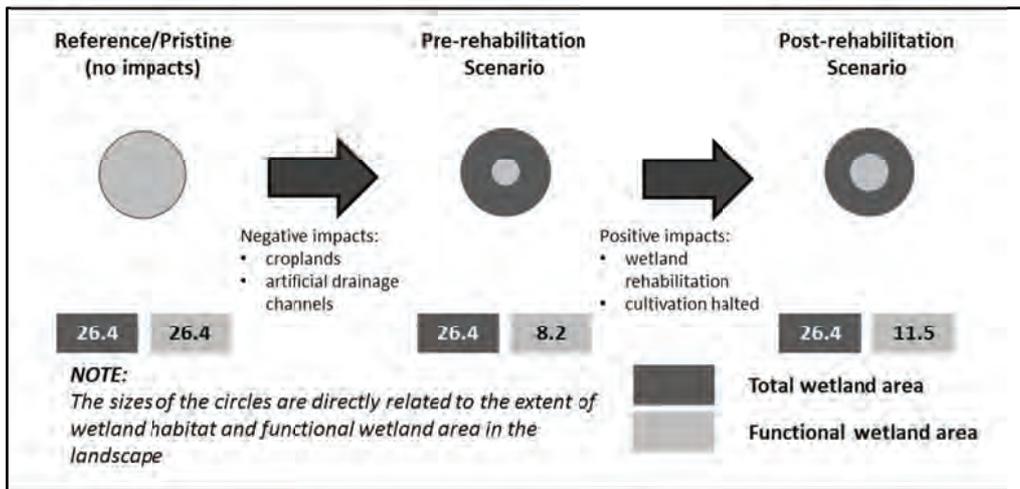
Figure 4-5. A graphic representation of the Kruisfontein wetland, in terms of both spatial extent and functional area, from pre-rehabilitation conditions through to the rehabilitated conditions.

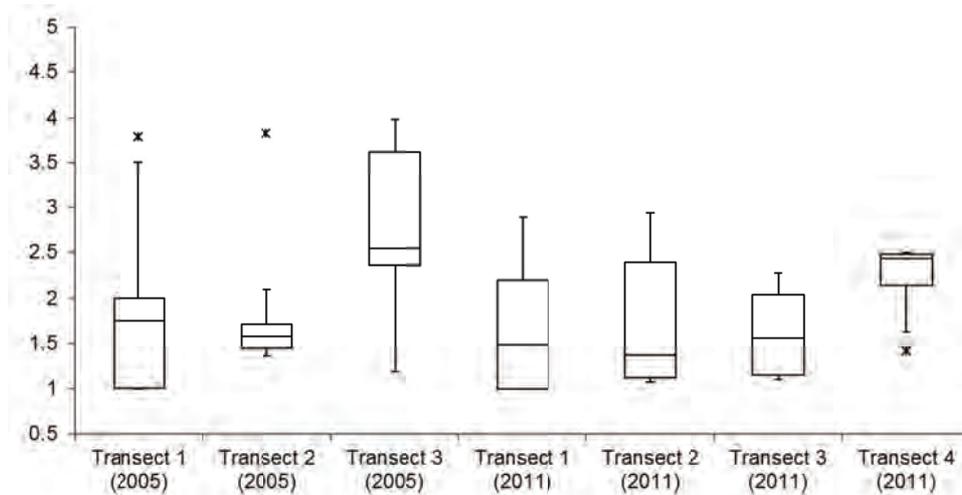
Figure 4-7. Box-and-whisker plot of the WIV values recorded for the different transects within the Killarney wetland for the respective years. *Central horizontal lines* indicate median WIV values, while the *boxes* show 25th and 75th percentiles respectively. *Whiskers* indicate maximum values, while maximum and/or minimum outliers are shown individually.

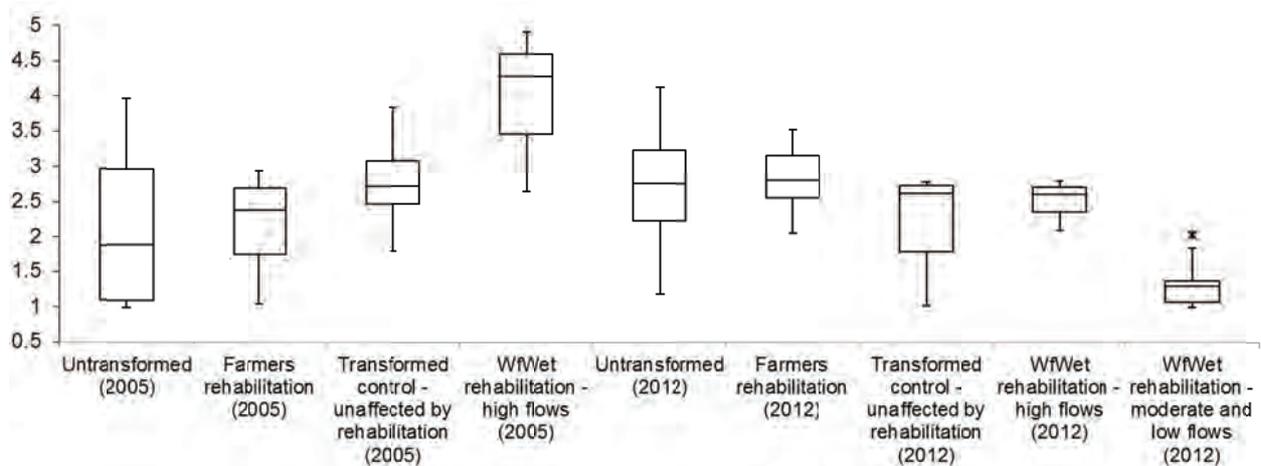
Figure 4-8. Box-and-whisker plot of the WIV values recorded for the different 'treatment areas' within the Kruisfontein wetland for the respective years. *Central horizontal lines* indicate median WIV values, while the *boxes* show 25th and 75th percentiles respectively. *Whiskers* indicate maximum values, while maximum and/or minimum outliers are shown individually.

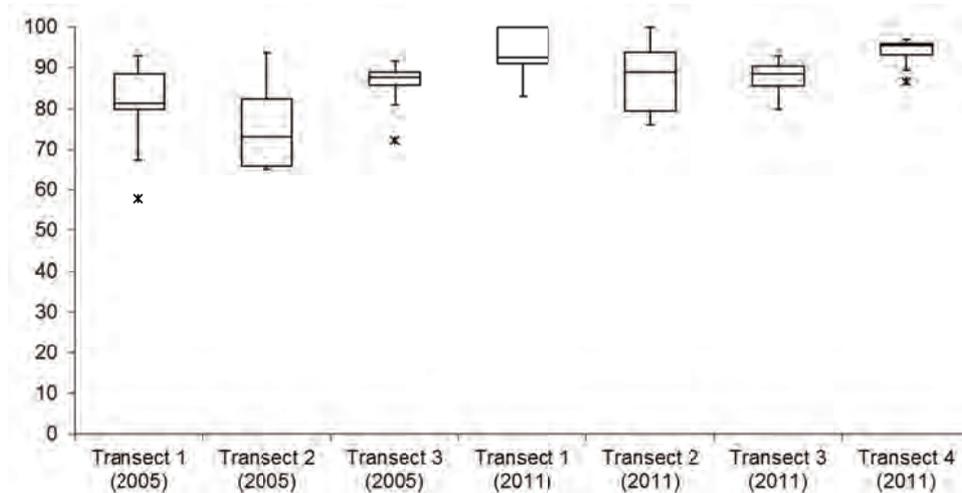
Based on box-and-whisker plots of the FQAI values per transect (Figure 4-9), the vegetation composition within the Killarney wetland vegetation has altered towards non-opportunistic plant species with the recorded FQAI values increasing for Transect 1, 2 and 3. Generally the FQAI values recorded for Kruisfontein wetland are similar from 2005 to 2012, except for the area receiving low and moderate flows following the implementation of the rehabilitation, which has increased markedly (Figure 4-10).

Figure 4-9. Box-and-whisker plot of the FQAI values recorded for the different transects within the Killarney wetland for the respective years. Central horizontal lines indicate median WIV values, while the boxes show 25th and 75th percentiles respectively. Whiskers indicate maximum values, while maximum and/or minimum outliers are shown individually.

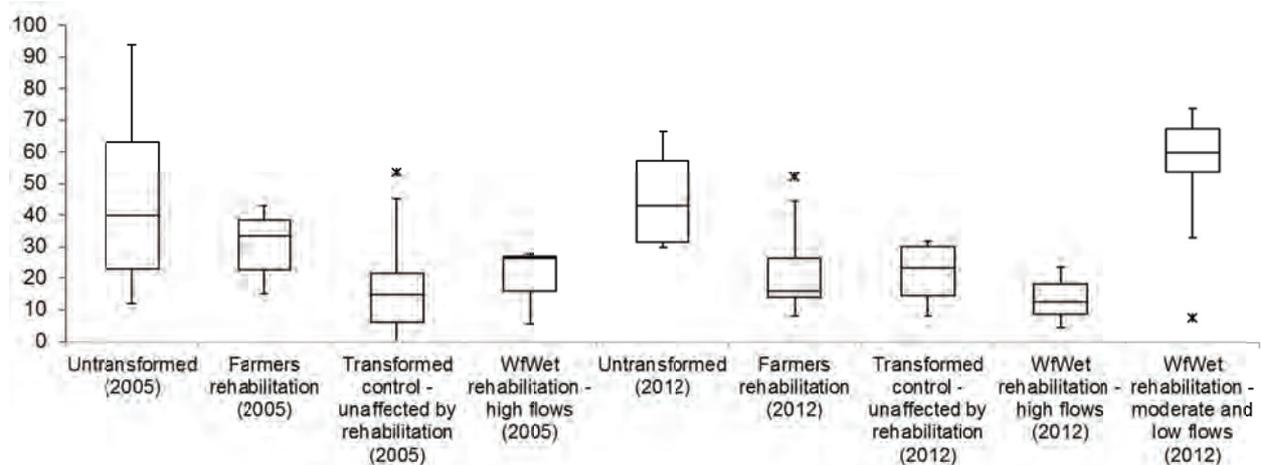
Figure 4-10. Box-and-whisker plot of the FQAI values recorded for the different ‘treatment areas’ within the Kruisfontein wetland for the respective years. *Central horizontal lines* indicate median WIV values, while the *boxes* show 25th and 75th percentiles respectively. *Whiskers* indicate maximum values, while maximum and/or minimum outliers are shown individually.

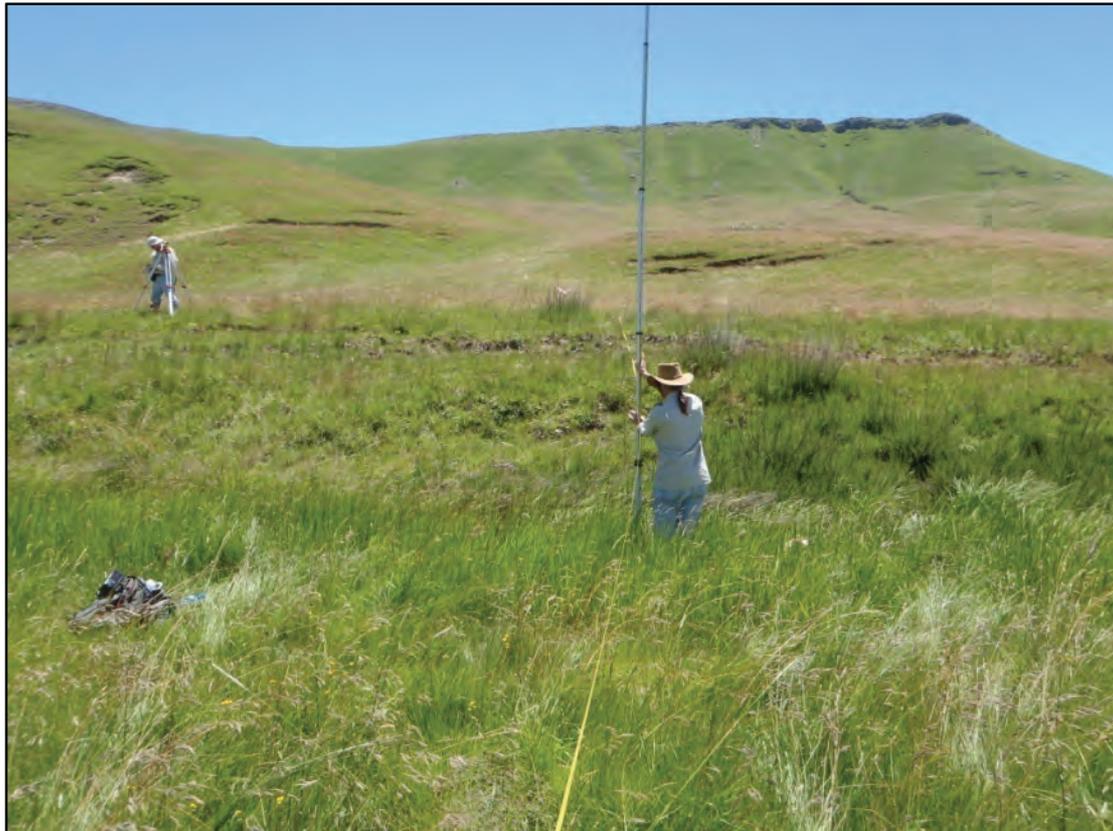
Figure 4-11. Recording gully cross sections along the transects in Killarney wetland

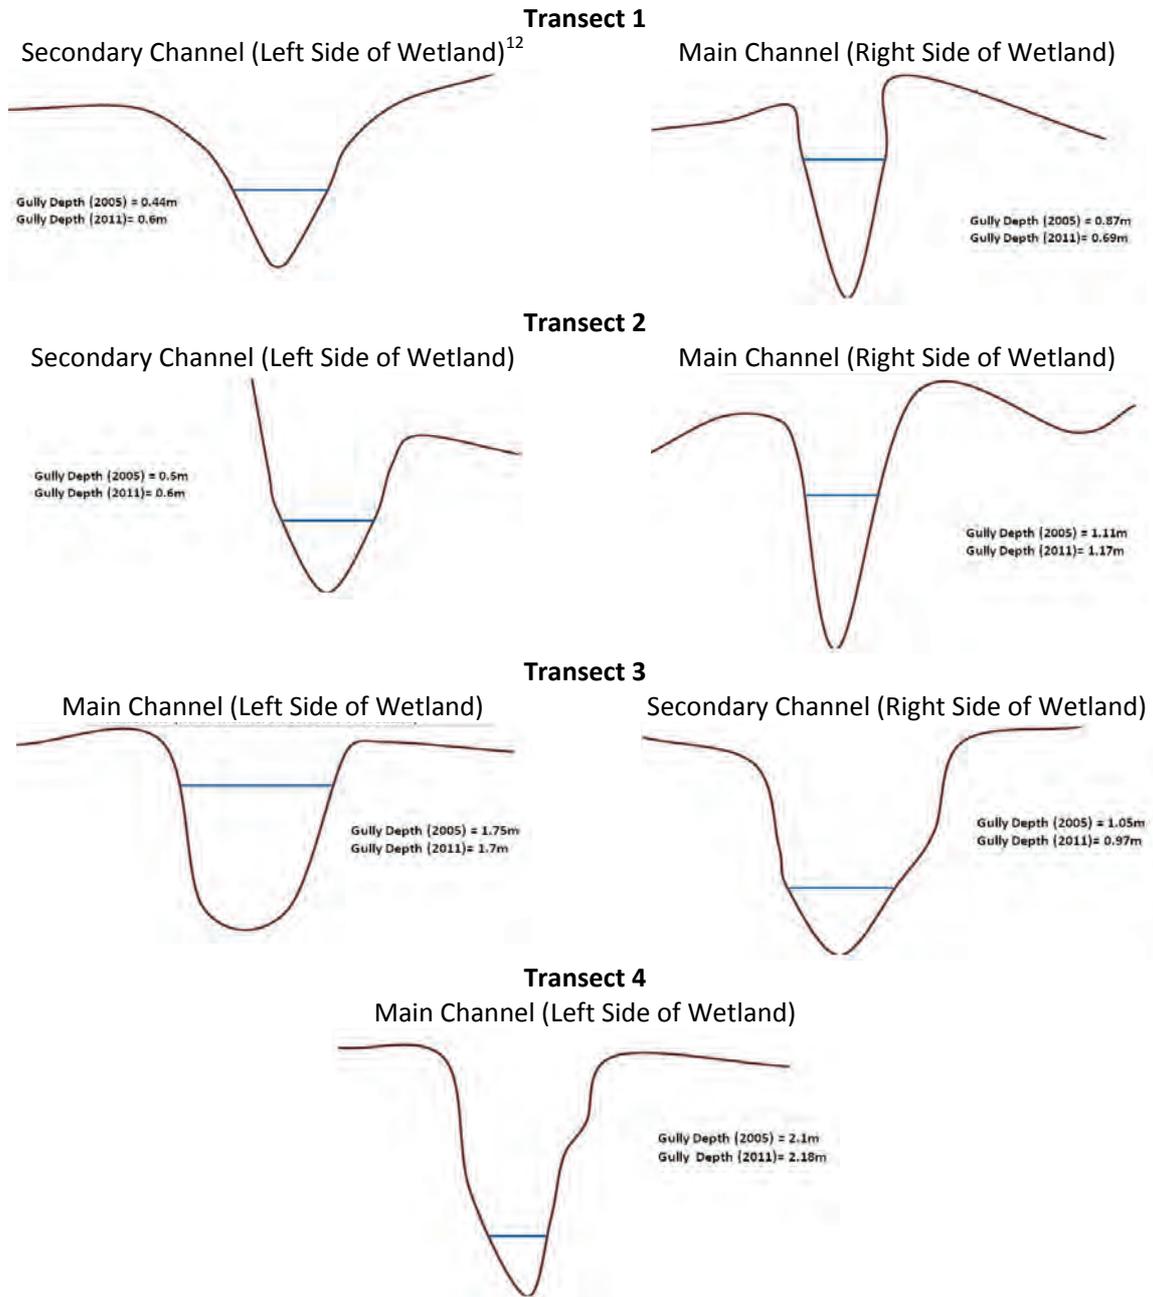
The cross sectional profiles of the channels within the Killarney wetland were recorded (Figure 4-11 and Figure 4-12) and compared with the original measurements. The recorded values for 2005 and 2011 appear to be relatively similar, with minor changes in depths of the profile, with increases and decreases in depth being recorded. This would suggest that the long-term sediment deposition within the channels has not necessarily increased as a result of the rehabilitation activities despite the interim findings described by Cowden *et al.* (2009). The lack of sediment accumulation is attributed either due to a lack of sediment supply within the catchment or sediment being trapped by upstream interventions.

Figure 4-12. Gully cross sections along each of the transects in Killarney wetland with the recorded depths for 2005 and 2011

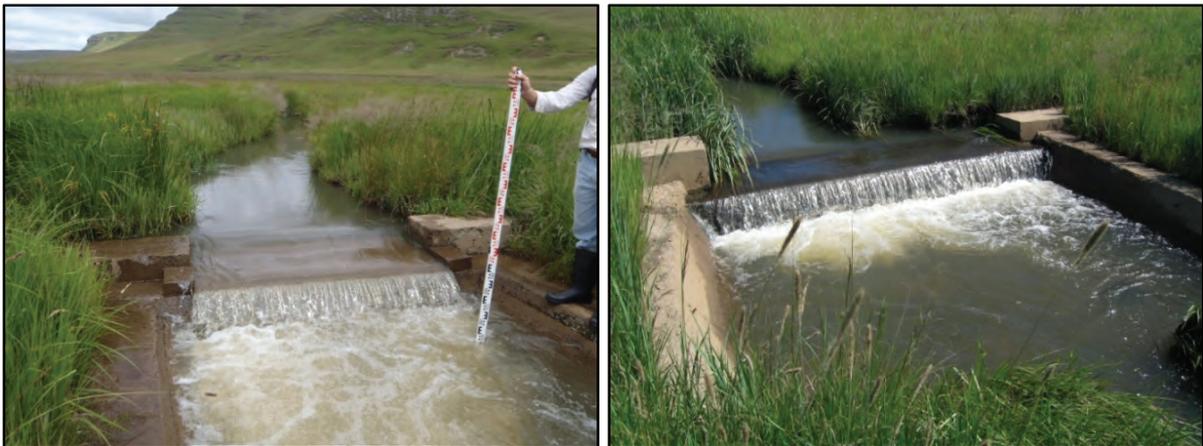
Figure A1-1: Concrete weirs in the main channel of the Killarney wetland

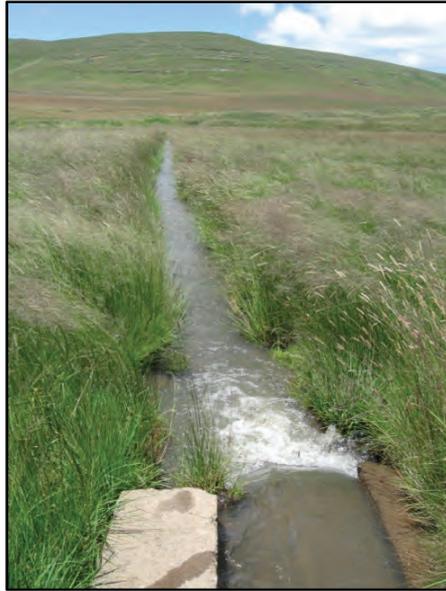
Figure A1-2: A spreader canal diverting a portion of the base flows out of the main channel

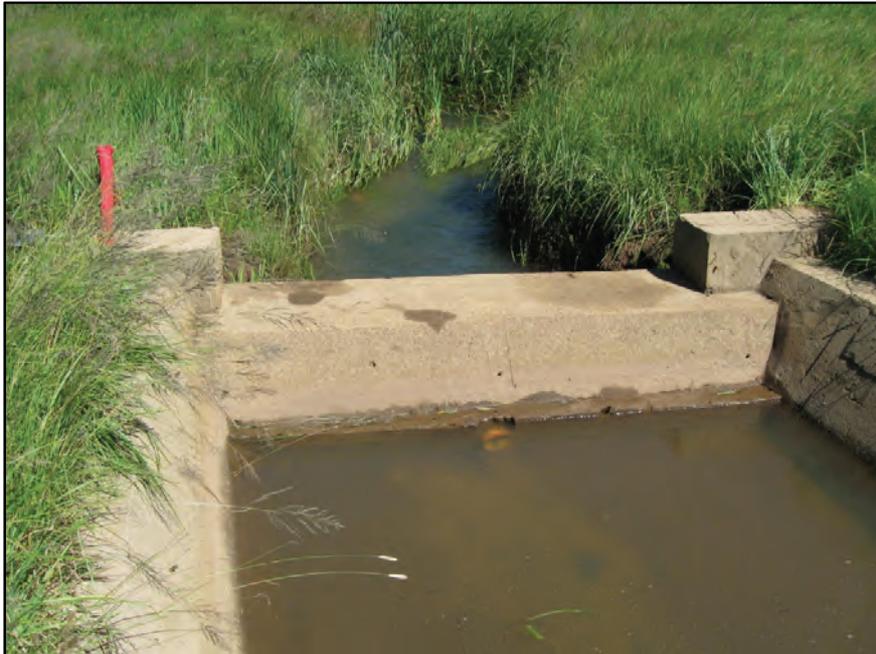
The structural stability of the concrete weirs was investigated with only one of the seventeen weirs requiring maintenance (intervention T51H0026) where tunnelling had occurred (refer to Figure A1-3 below):

Figure A1-3: Photo showing weir T51H0026 where tunnelling has occurred allowing base flows to pass under the structure

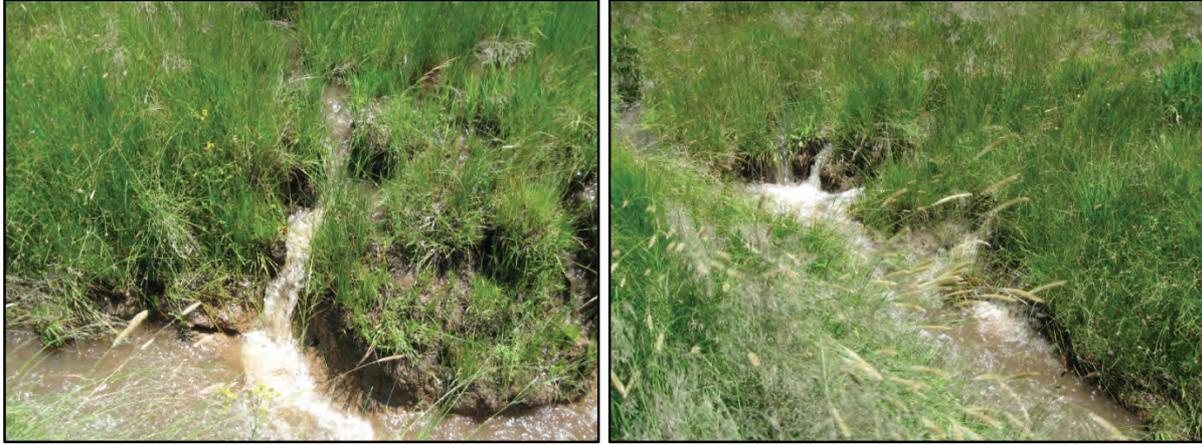
A single spreader canal was constructed across the upper portion of the Killarney wetland to divert a portion of the base flows out of the main channel from the upstream side of intervention T51H00A. The spreader canal allowed for a continual supply of water to be available for improving the hydrology within the wetland adjacent to the main channel. The site inspection revealed that the end of the spreader canal had breached and the majority of the water was flowing out the end of the canal rather than being spread across the wetland. The water that was being discharged at the end of the spreader canal was flowing into a secondary channel on the right hand side (facing downstream) of the wetland. The point of entry of the water into the secondary channel was showing signs of erosion with the development of numerous nick points. The photos below show the nick points that are developing as a result of the concentrated flows from the spreader canal entering the secondary channel. Modifications to the spreader canal will be required to prevent further erosion from occurring, as well as to utilise the available water to enhance the hydrology of the wetland.

Figure A1-4: Photos showing the development of nick points where water from the spreader canal enters the secondary channel

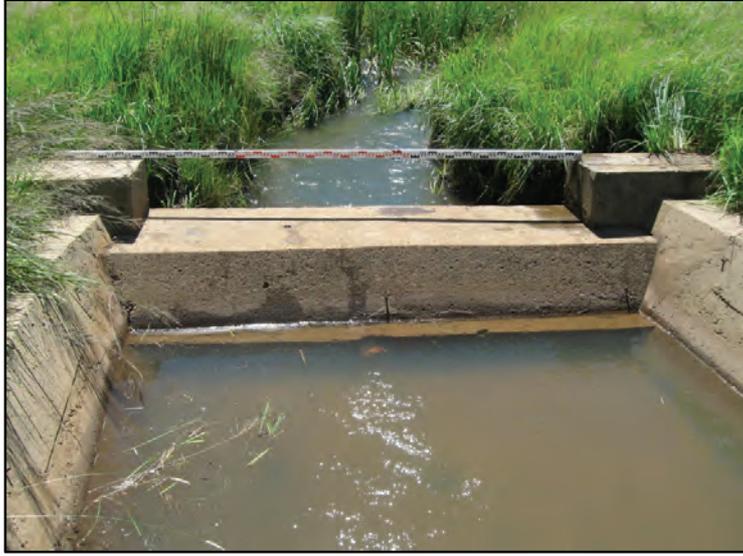
Figure A1-5: View of intervention T51H0026, looking upstream, with no water flowing over the spillway

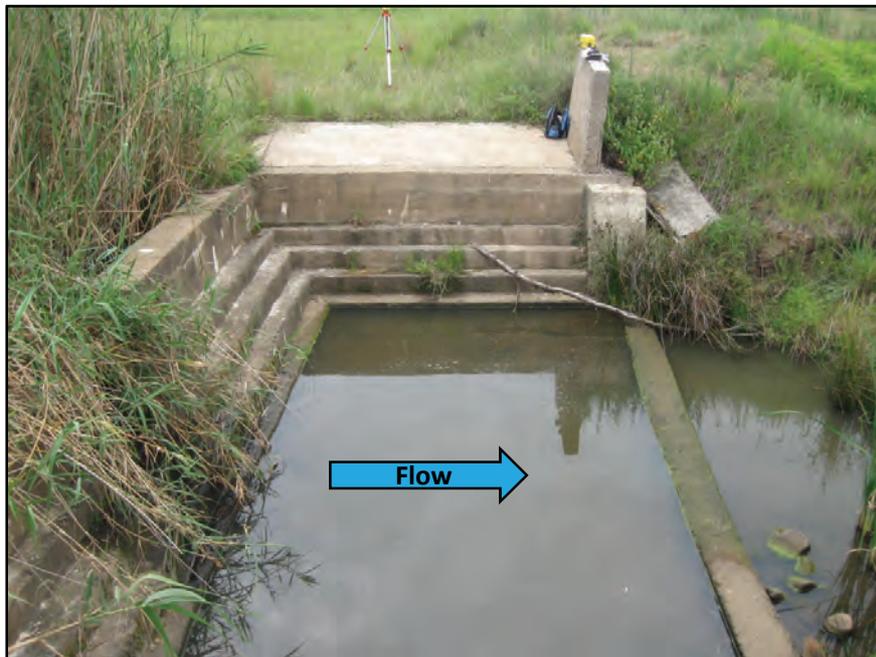
Figure A1-6: Concrete weir constructed across the main channel

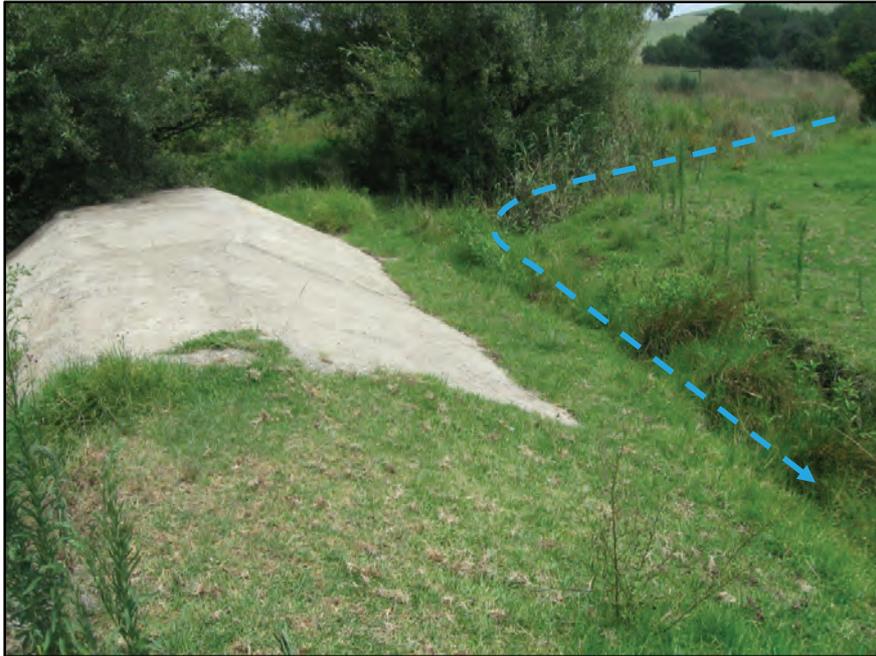
Figure A1-7: A concrete covered earthen berm diverting flows out of the main channel

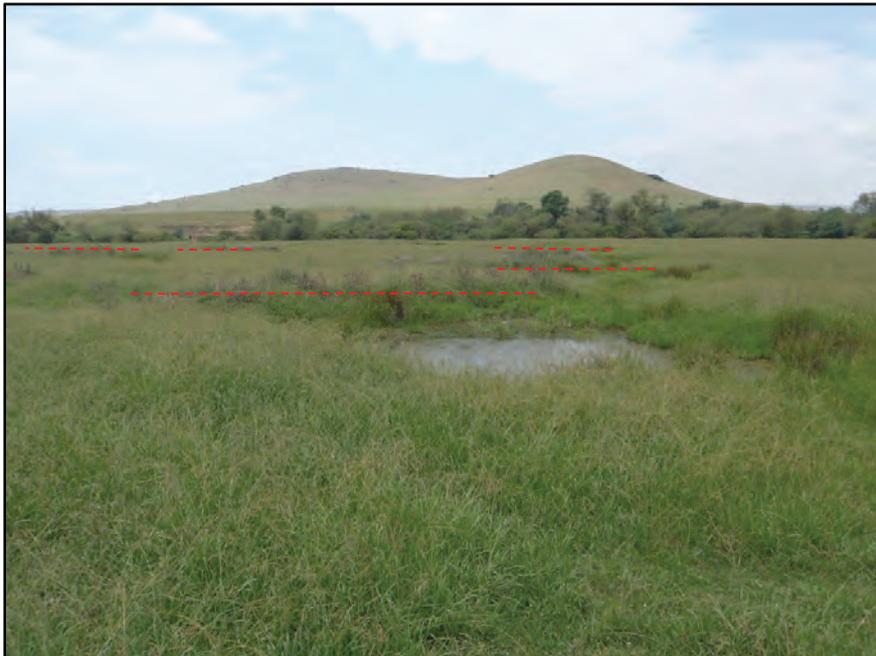
Figure A1-8: A series of earthen berms (red lines) used to deactivate the ridge and furrow drainage system

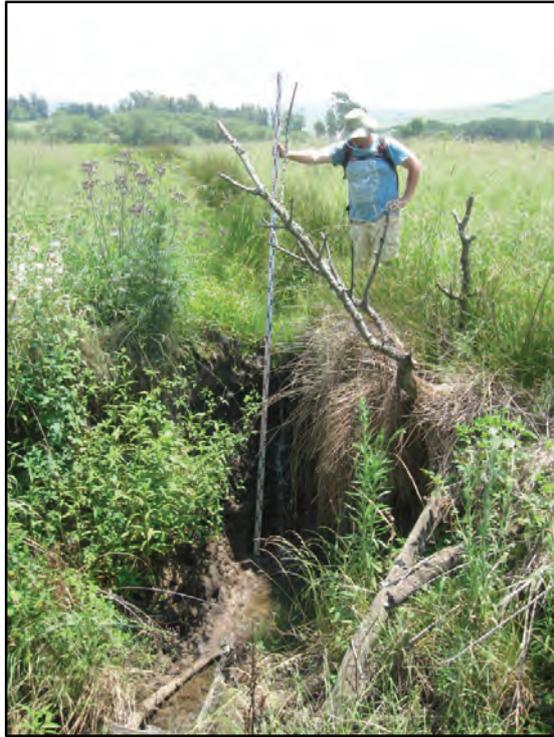
A series of spreader canals were constructed at the wetland with the intention of diverting a portion of the base flows out of the main channel and into the adjacent wetland. None of the spreader canals were functioning as intended as flows were not being spread in a diffuse manner across the wetland. A single discharge point had developed along the spreader canals and this has resulted in the development of preferred flow paths within the wetland. The water in the preferred flow path from the lower spreader canal discharges into the Mooi River and this has led to the development of a headcut (refer to figure A1-9 below). An intervention will be required at the headcut to prevent the erosion from advancing into the wetland system.

Figure A1-9: Headcut erosion as a result of concentrated flows discharging over the bank of the Mooi River

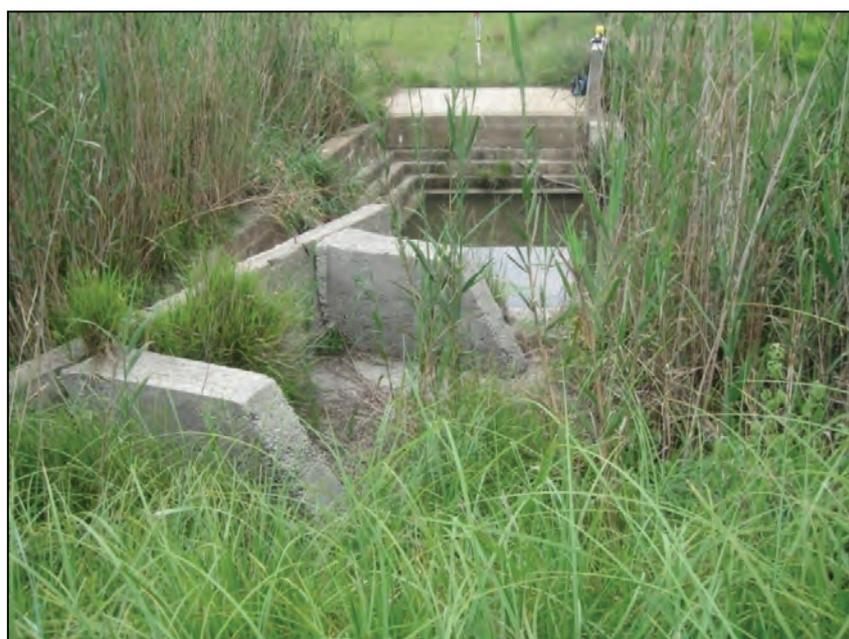
Figure A1-10: Concrete mass gravity weir – Intervention V20E017

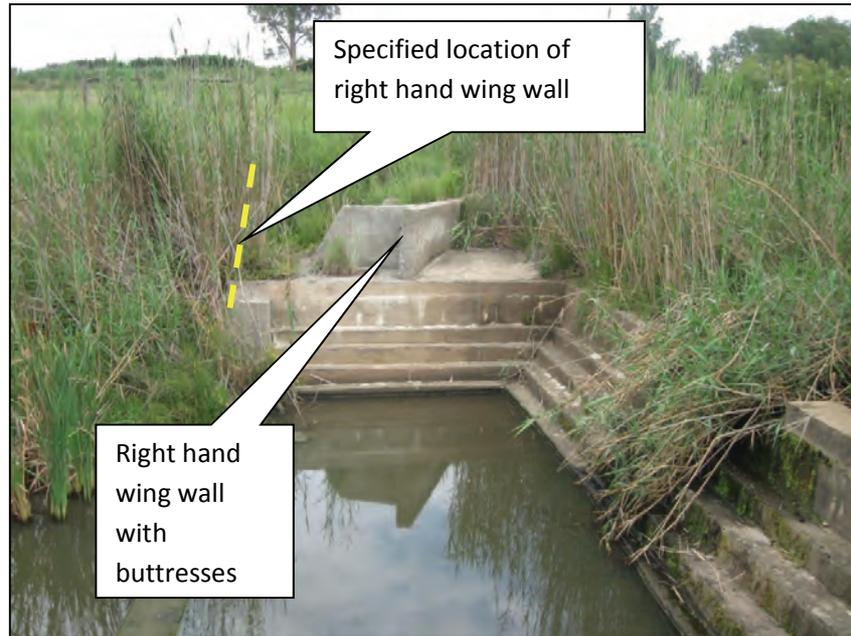
In terms of the implementation of the design, the right hand wingwall is located approximately midway along the shoulder and not at the end of the shoulder as was specified in the design. Two buttresses along the wingwall (which were not specified in the design) were also implemented during the construction phase (**Figure A1-11**).

Figure A1-11: Showing location of right hand wing wall in relation to the specified location

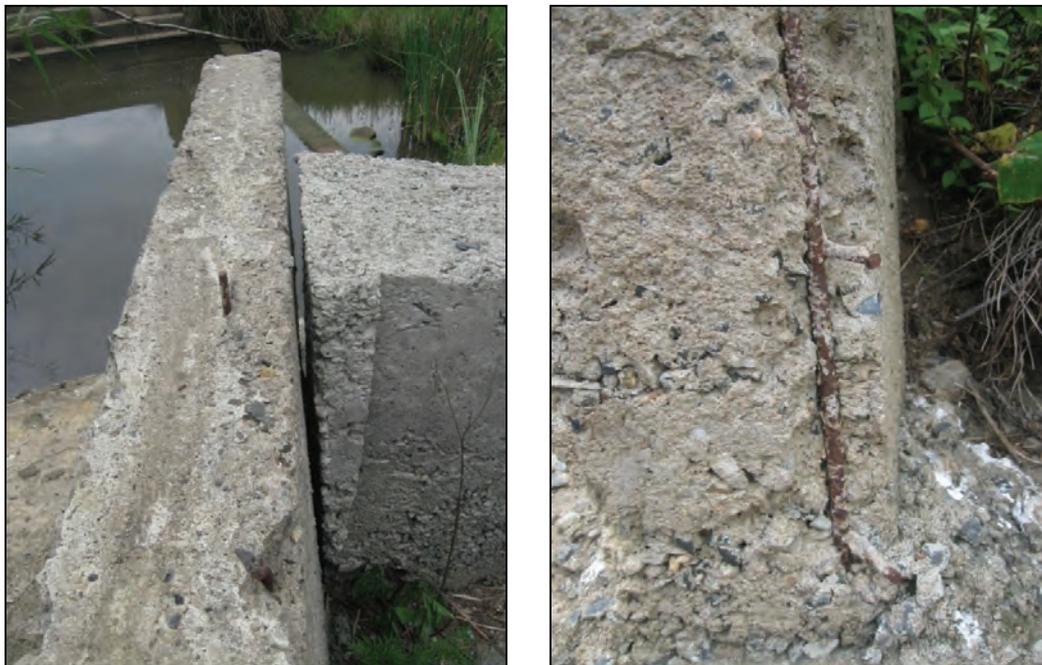
The structure appeared to be structurally stable and no remedial actions are proposed to improve the structural integrity of the weir; however signs of poor workmanship were identified (Figure A1-12):

Figure A1-12: Poor workmanship with exposed steel reinforcing and poor contact between the buttress and the right hand wing wall (Left) and poor quality concrete and exposed reinforcing steel in the left hand wing wall (Right).

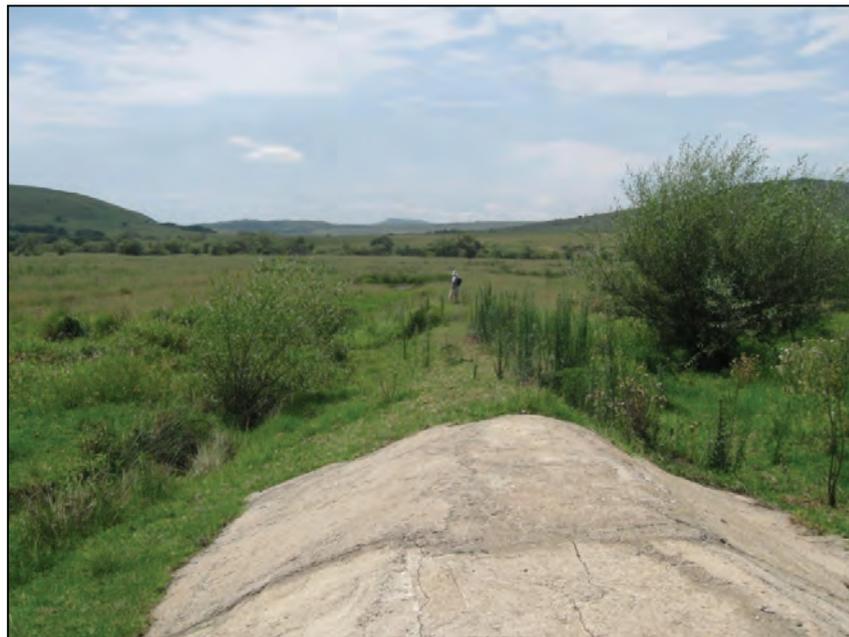
Figure A1-13: Concrete geocell-covered diversion berm

The diversion berm is structurally stable and there is no evidence of erosion along the structure. A slight incised channel (approximately 300mm deep) is located on the upstream side of the berm, however, this does not currently pose a risk to the intervention's structural integrity. No corrective actions are therefore proposed for the berm in terms of securing its structural integrity.

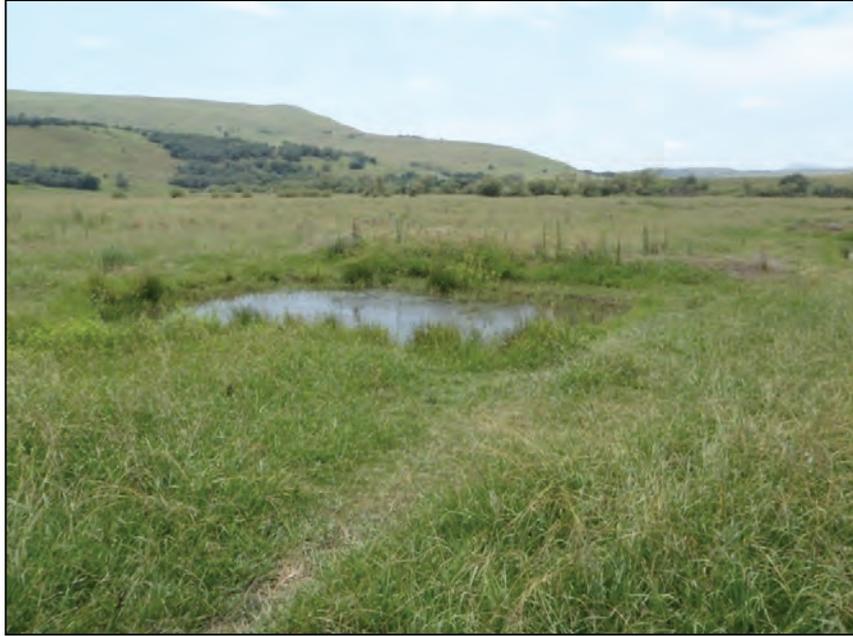
Figure A1-14: A typical earthen plug within the Kruisfontein wetland

It should be noted that at the time of the site inspection (February 2012), all of the earthen plugs apart from Plug 15 and Plug 16, contained standing water on the upstream side. The earthen plugs were all structurally intact and showed no signs of erosion. No corrective actions are therefore proposed for the plugs in order to secure their structural integrity.
