New housing unit designed for ceramic water filters in rural and peri-urban communities in South Africa

Report to the
WATER RESEARCH COMMISSION

WRC Report No. 2195/1/14

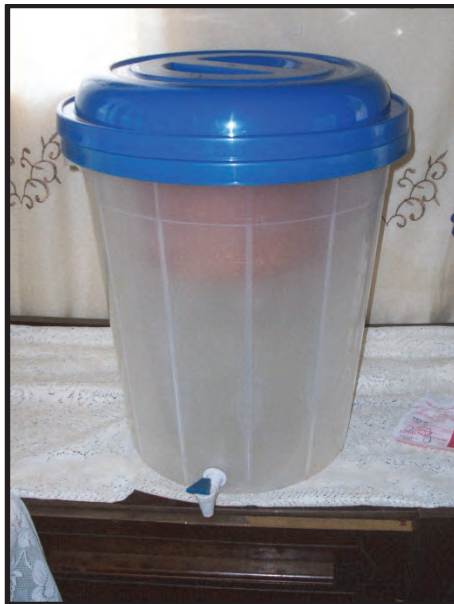
Figure 2.1 Potpaz Potters-for-Peace ceramic water filter implemented in the Vhembe region of the Limpopo province

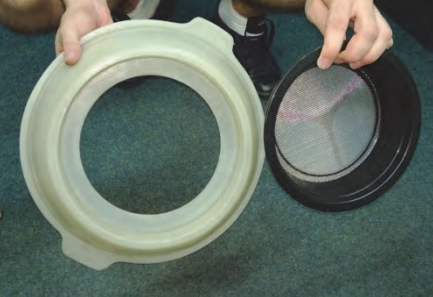
The primary filter with the sieve part removed from the actual filter.
Lid

This shows the assembled primary filter. To reduce costs this was not moulded as one part but as two. This design is however more versatile and robust for use in the field.
Primary filter separate

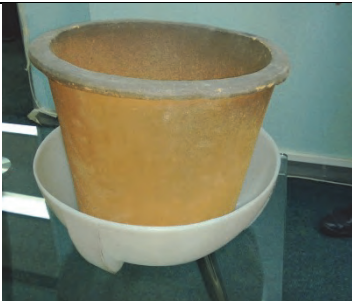
The lid turned upside down showing how the ceramic filter will fit into it when the filter is washed.

The lid was designed not just to be a lid for the water container but also a container that can be used to clean the ceramic pot. The lid is a dome shape lid with three feet extrudes on the outside making a tripod stand when turned around. This makes the lid very sturdy so that the ceramic pot can be cleaned in it safely without it toppling over. This feature was included since it was noted that when the plastic parts were cleaned the users did not always know where to place the ceramic filter. This can not only lead to the filter accidentally breaking but also that the filter can be contaminated on the outside thus contaminating the filtered water as it enters the water container. With all the changes highlighted, the design completed and the fit of all the parts shown theoretically with the technical drawings it was decided to start the production of the housing unit parts.

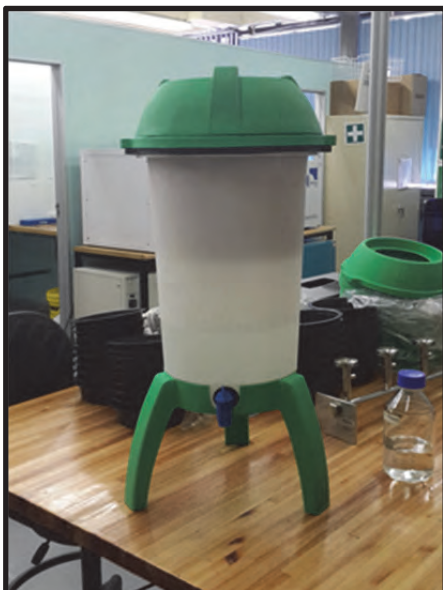
Figure 2.4 Final produced housing unit assembled in the laboratory

For the final product the colour decided on for some of the plastic parts was green but can be changed to any colour decided on (Figure 2.4). Due to the material used for the production, the colour of the receptacle units was opaque and not clear. This can be altered if a different material or production manner (rotor vs. injection moulding) is used. Despite the fact the fact that that the colour is opaque, it should be noted that this method of production contributes to the strength of the assembled housing unit. The unit can also be coloured which would theoretically reduce the changes of algal growth within the receptacle container.
