**THE EVALUATION OF SLURRY REVERSE OSMOSIS FOR  
THE DESALINATION OF CALCIUM SULPHATE  
SCALING MINE SERVICE WATER**

Contract Report No. WRC 245/1/91

**EVALUATION OF SLURRY REVERSE OSMOSIS FOR THE  
DESALINATION OF CALCIUM SULPHATE SCALING MINE  
SERVICE WATER**

**REFERENCE REPORT NO. 18/91**

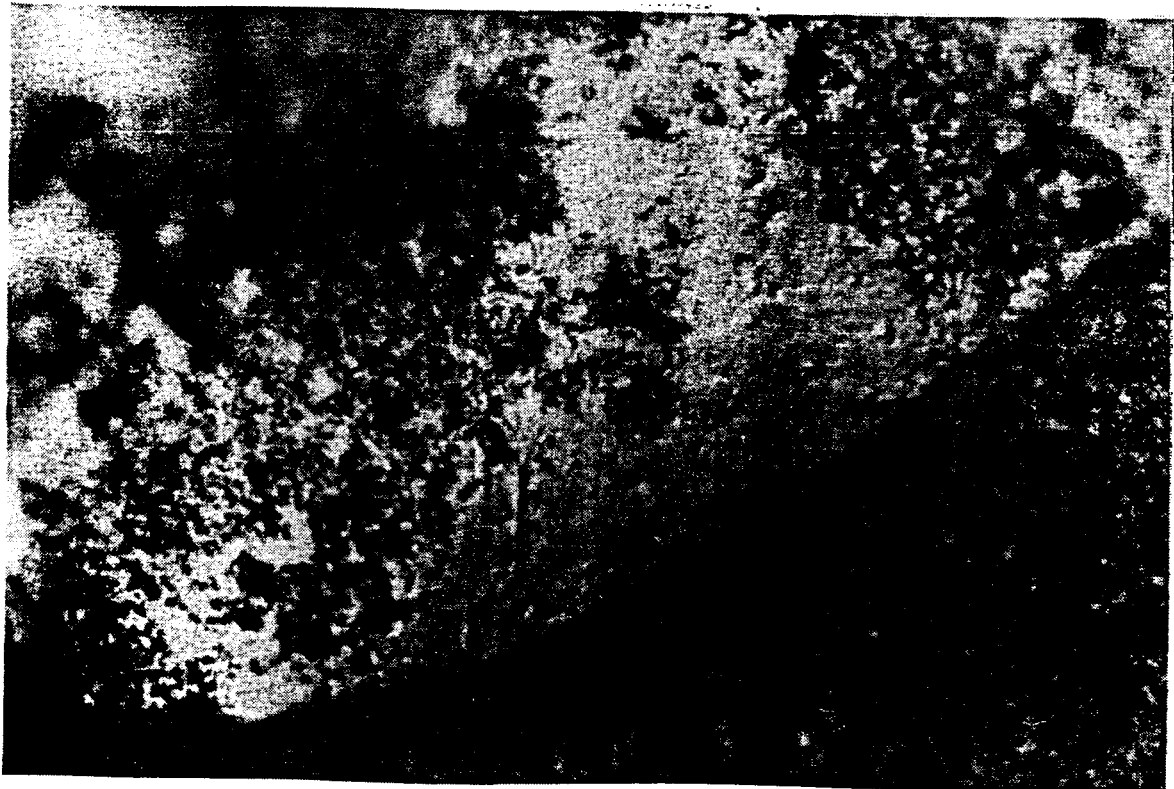
Figure 4 SURFACE DEPOSITS FOUND PRESENT IN MODULE 3 AND 4 (Module 3: Inlet, centre)

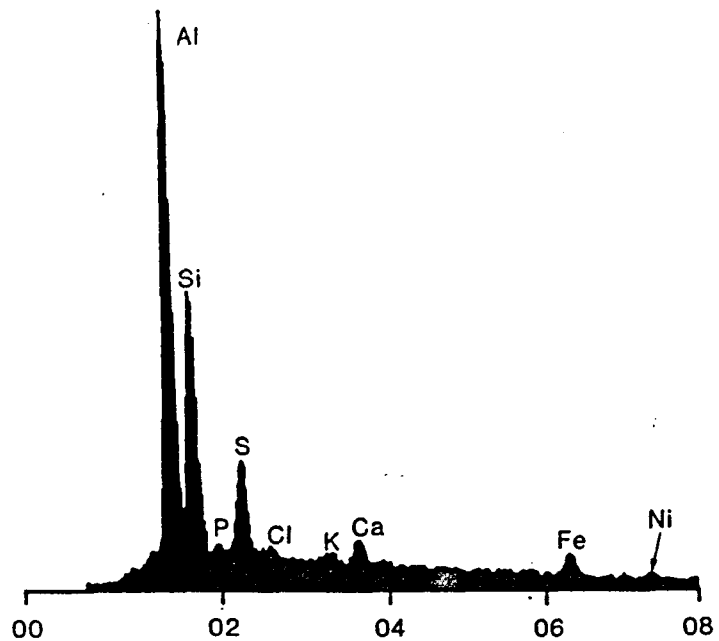
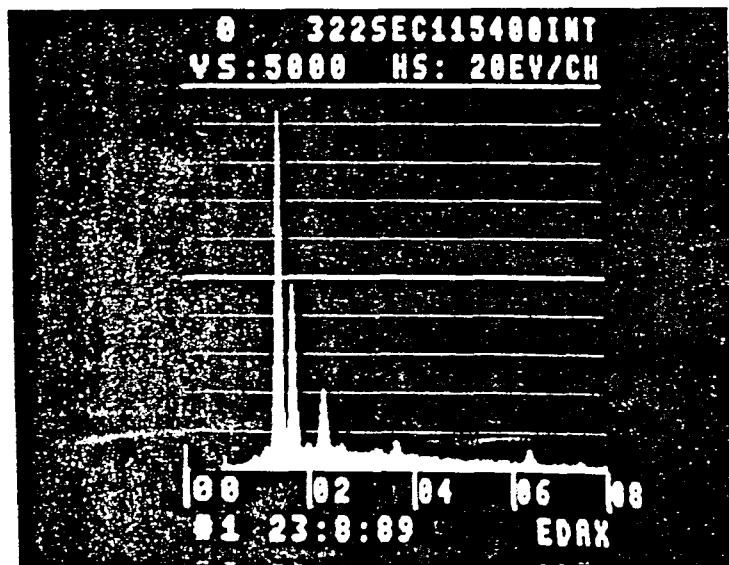
Figure 6 EDAX SPECTRA AND EXPLANATION OF ELEMENTAL ANALYSIS  
REPRESENTATIVE OF FOULANT LAYER FOUND IN MODULE 4
