# **AN INDEPENDENT INVESTIGATION AND ADVISORY ON THE ROLE OF WATER, SANITATION AND HYGIENE IN THE 2023 CHOLERA OUTBREAK IN HAMMANSKRAAL, SOUTH AFRICA**

## **WORK PACKAGE 3: WATER, SANITATION AND HYGIENE (WASH) SERVICES MAPPING**

Final Report to the  
**Water Research Commission**

**WRC Report No. 3167/3/24  
ISBN 978-0-6392-0653-0**

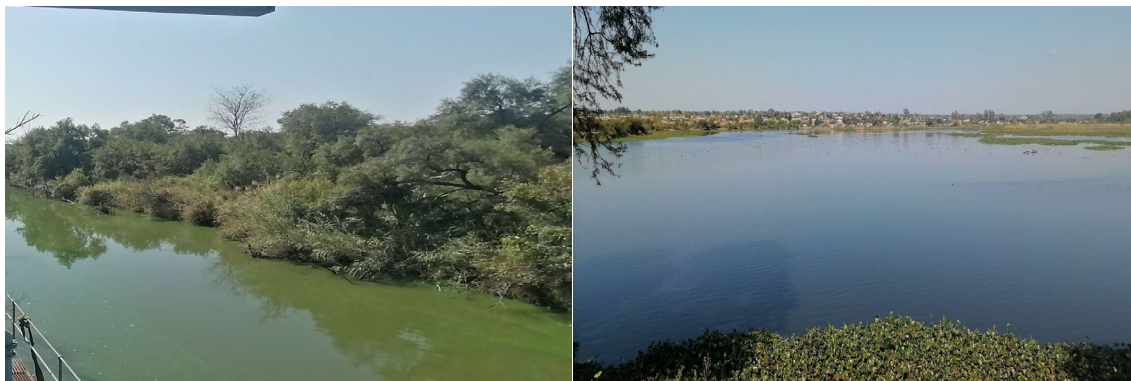
**Figure 8: Blue-Green Algae as observed at Pienaar River and Leeukraal Dam**

raw water from the Leeukraal dam in the Apies River and directly from the Pienaars river respectively. Blue-green algae (Cyanobacteria) and water hyacinths have been shown to be good carriers of *Vibrio cholerae* bacteria (Islam et al., 2004). As observed during the inspection of the raw water sources on the 7th of June 2023, the presence of excessive levels of blue-green algae in both the Pienaars river and the Leeukraal dam was evident (Figure 8).

Although the water hyacinth was not observed during the inspection of the Pienaar River, the Roodeplaat Dam which is upstream of the Klipdrift WTW is known to be characterised by excessive water hyacinths growth. It is therefore plausible for traces of hyacinth to find their way to the Klipdrift WTW abstraction point. The Leeukraal dam's inspection on the other hand, an abstraction point of the Temba WTW, revealed the presence of both water hyacinths growth and blue-green algae. As it has been demonstrated that the presence of cyanobacteria (i.e. blue-green algae) and water hyacinths correlates with the proliferation of *vibrio cholerae*, the two WTW should have the necessary technology in place to treat raw water effectively and, as a result, minimise the risk of cholera transmission through the consumption of drinking water from these WTW.

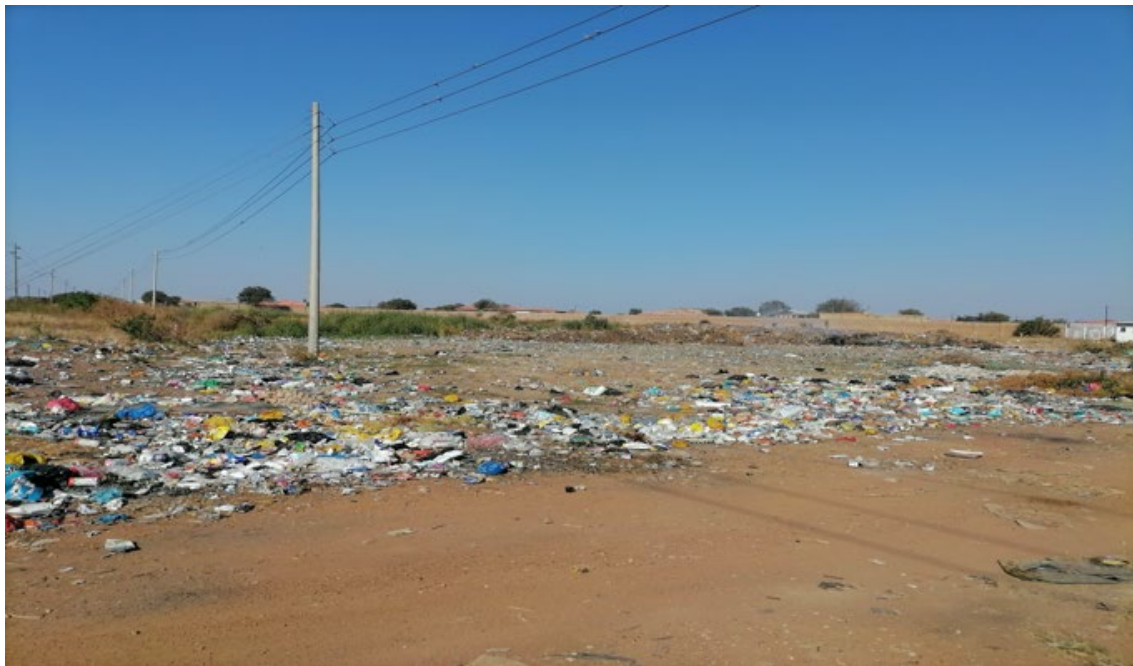
**Figure 9: Illegal Dumping site in the Stinkwater Area**

During the site visit, the team noted with great concern the prevalence of illegal dumping sites in the area, some near the river. Illegal dumping sites play a significant role in the transmission of cholera. Illegal dumping sites as they often contain hazardous waste and pollutants that can leach into the surrounding environment, including the river. Additionally, flies and other vectors attracted to the dump sites can carry the bacteria from the contaminated waste to nearby food or water sources, further increasing the risk of cholera transmission (Fotedar, 2001). Therefore, addressing and preventing illegal dumping sites is crucial in reducing the spread of cholera and other waterborne diseases.

In the long term, should the issue of illegal dumping sites and sewage be left unresolved, it can lead to a worsening public health crisis and environmental degradation. It is critical for the City of Tshwane to take swift action to prevent further contamination, implement proper waste management systems and educate the community about the importance of preserving the cleanliness and health of their environment.

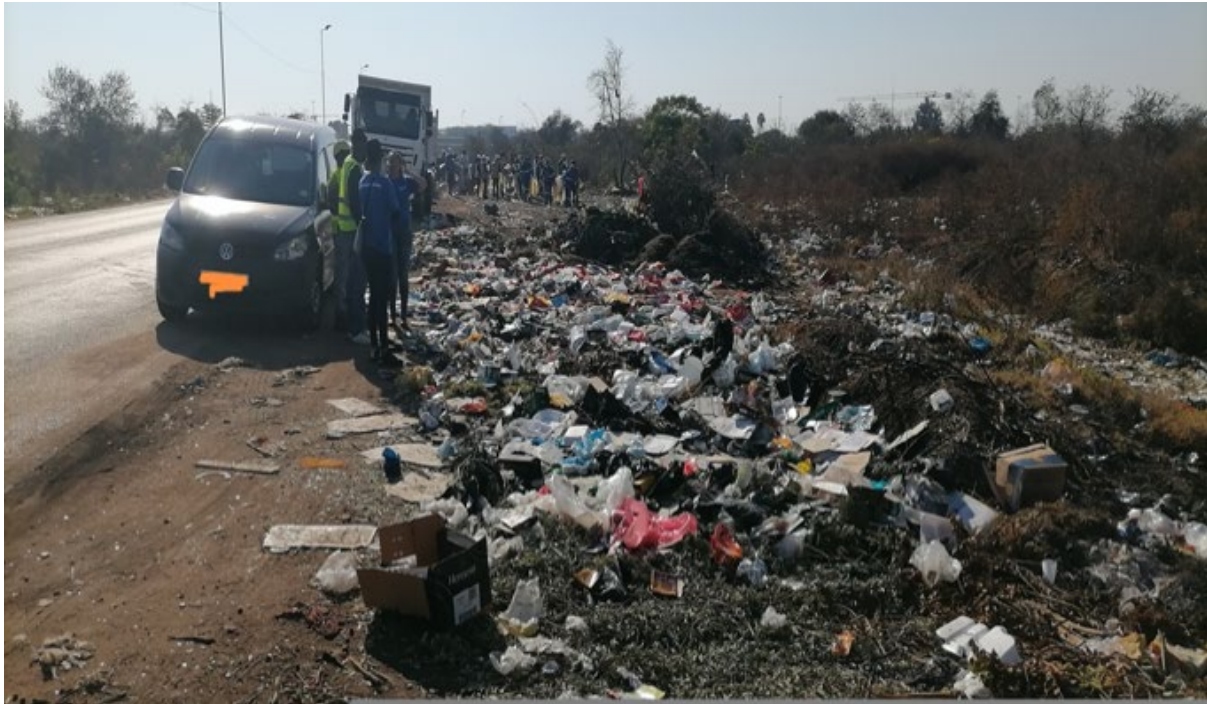
**Figure 10: Clean-up drive in the vicinity of Apies River**

To minimise the risk of cholera transmission, a clean-up drive was embarked upon as shown in Figure 10 below. These initiatives, if carried out regularly with the involvement of the community are crucial in combating illegal dumping by fostering a sense of ownership and responsibility towards maintaining a clean and healthy environment.

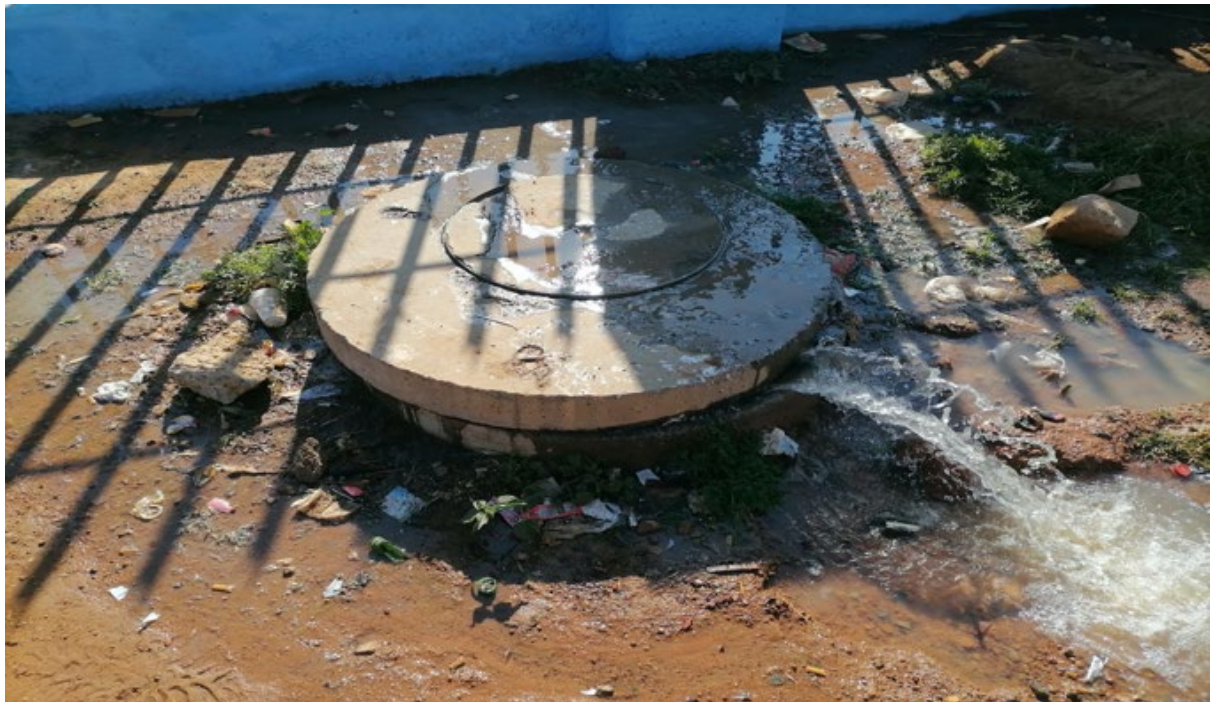
**Figure 11: Overflowing sewage manhole**

Sewage overflowing from manholes (Figure 11), as observed during the site visit, introduces a high concentration of pathogens, further increasing the risk of cholera transmission. The combination of illegal dumping sites and sewage creates an ideal breeding ground for disease-causing organisms and emphasizes the urgent need for effective measures to address and prevent contamination to protect public health.

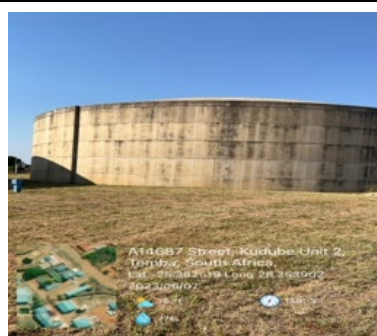
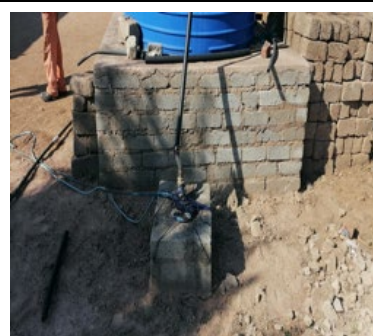
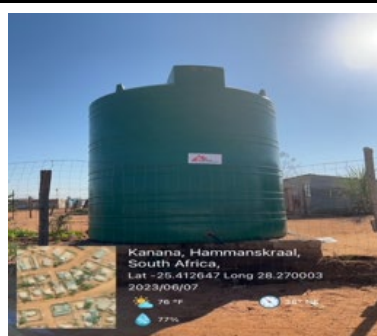
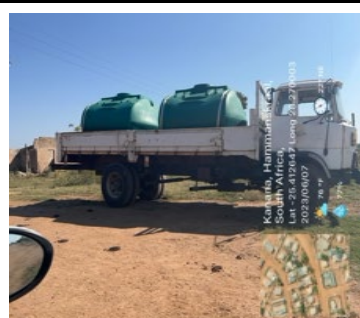
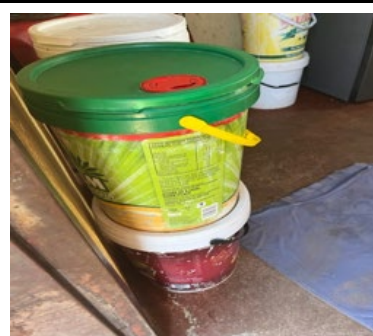
### Water sources and storage facilities

The WASH facilities in the study area as observed during the site visit are visually presented below:
