Division of Mining Technology

WATER RESEARCH COMMISSION

A STUDY ON A MINE WATER RECLAMATION TEST PLANT

WRC Report No. 322/1/95
ISBN 1 86845 160 7

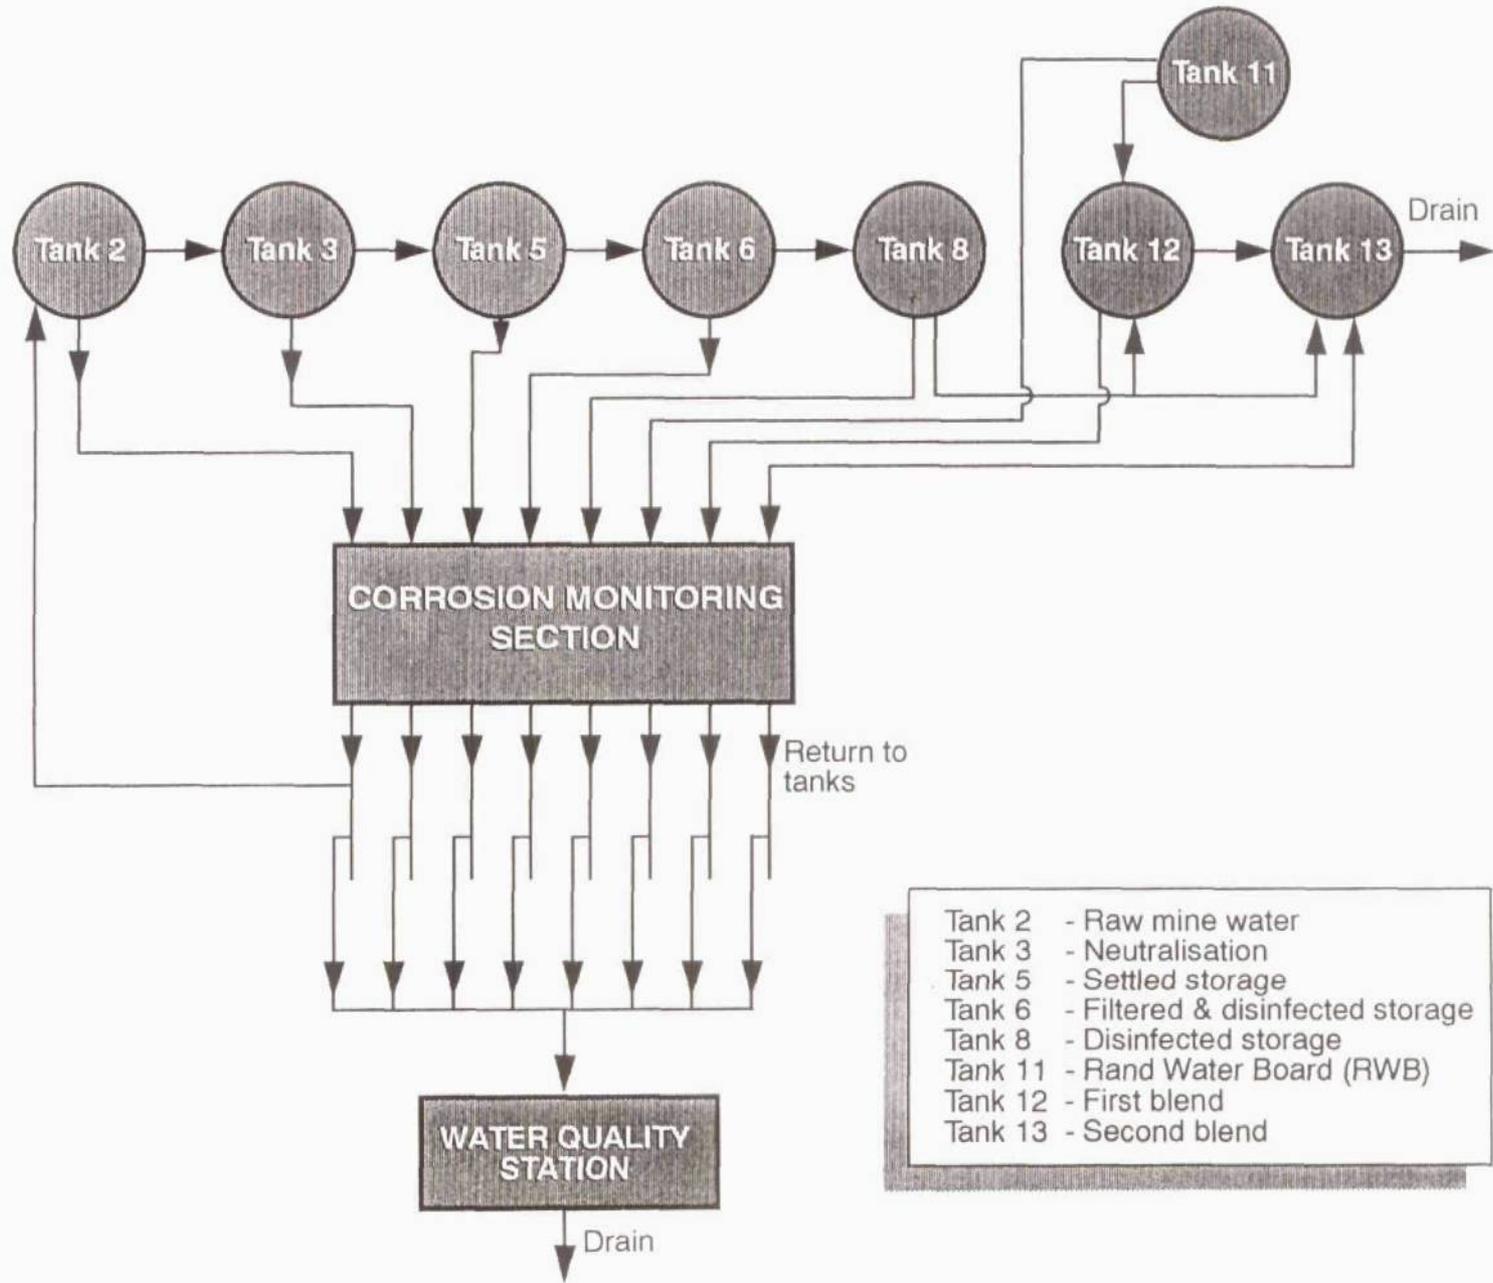
Figure 1: Schematic presentation of the mine water reclamation plant.

A simplified block diagram of the proposed COMRO Water Reclamation Test Plant is given in Figure 1. Eight different waters are tested in terms of corrosion and microbiological fouling. The different water qualities/processes are:

Water from each of the eight unit processes pass through a line containing corrosion coupons to measure long term general and localized corrosion,

Robbins devices to measure bio-fouling and pipe sections to monitor scale formation. The Water Reclamation Test Plant also incorporates a water quality rig for monitoring flow, temperature, pH, conductivity, turbidity and dissolved oxygen for each of the unit process product streams.

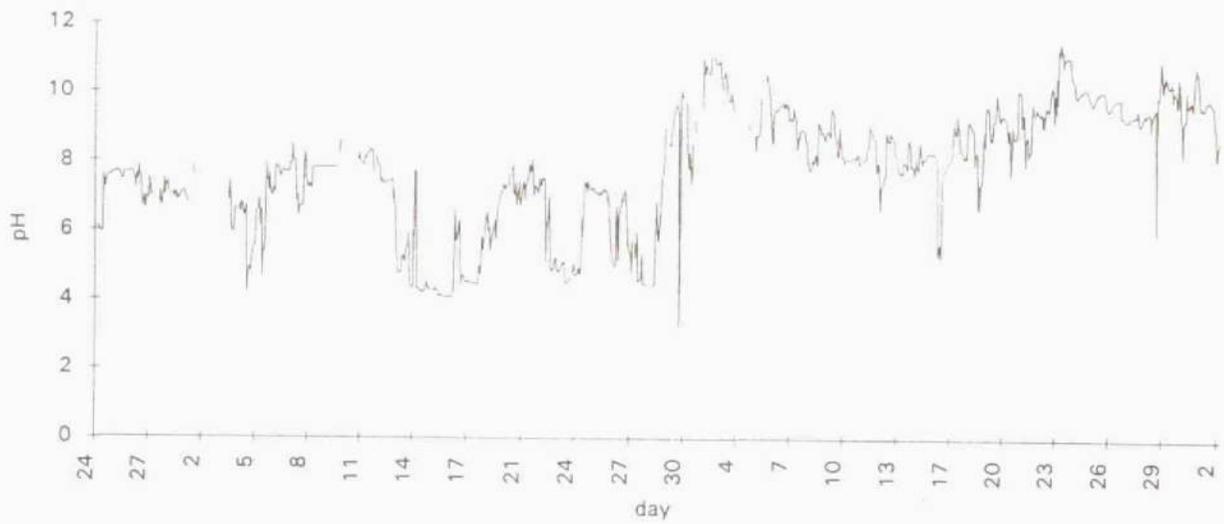
Figure 2: The pH of raw mine water for the period 24.02.1992 to 02.05.1992 (Phase 1).

The pH of the mine water is shown in Figure 2 for the period 24.02.1992 to 02.05.1992. It is evident that the pH fluctuates through a range from about four to almost twelve over this time period. The pH of the neutralized water over the same time period is shown in Figure 3. The large variations in pH indicate that neutralization of the mine water was not effective. The pH values for the raw mine water and the neutralized water during the period 10.04.1992 to 26.04.1992 are plotted on one graph in Figure 4 and here it is illustrated that excessive amounts of acid was sometimes dosed into the system resulting in low pH values for the neutralized water. Also, for certain periods the pH of the neutralized water follows that of the raw mine water while it is outside the design limits, indicating that neutralization did not always take place when it should have. The analyses performed in the laboratory confirmed these observations because the PH values of

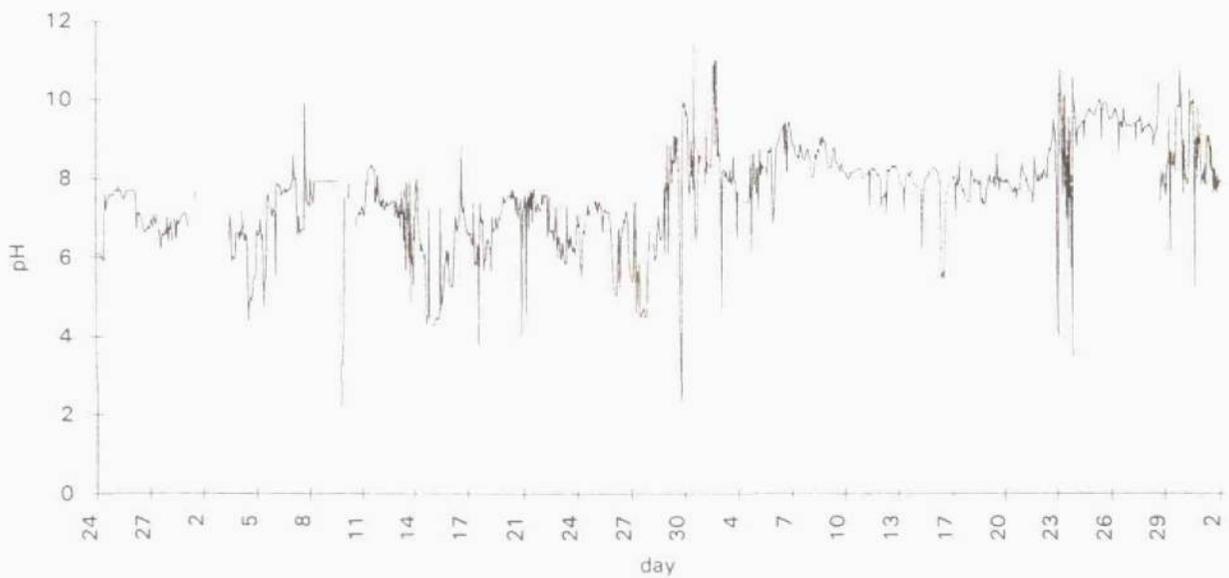
Figure 3: The pH of neutralized water over the period 24.02.1992 to 02.05.1992 (Phase 1).

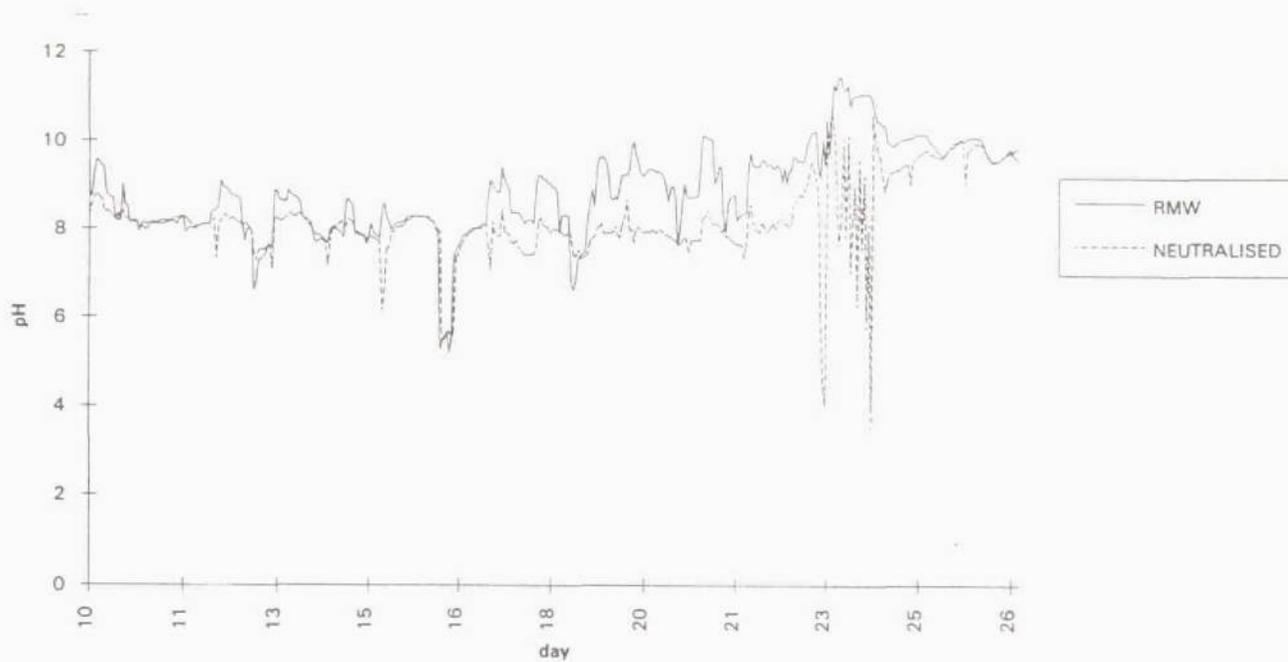
Figure 4: The pH of raw mine water and neutralized water (Phase 1) for the period 10.04.1992 to 26.04.1992.

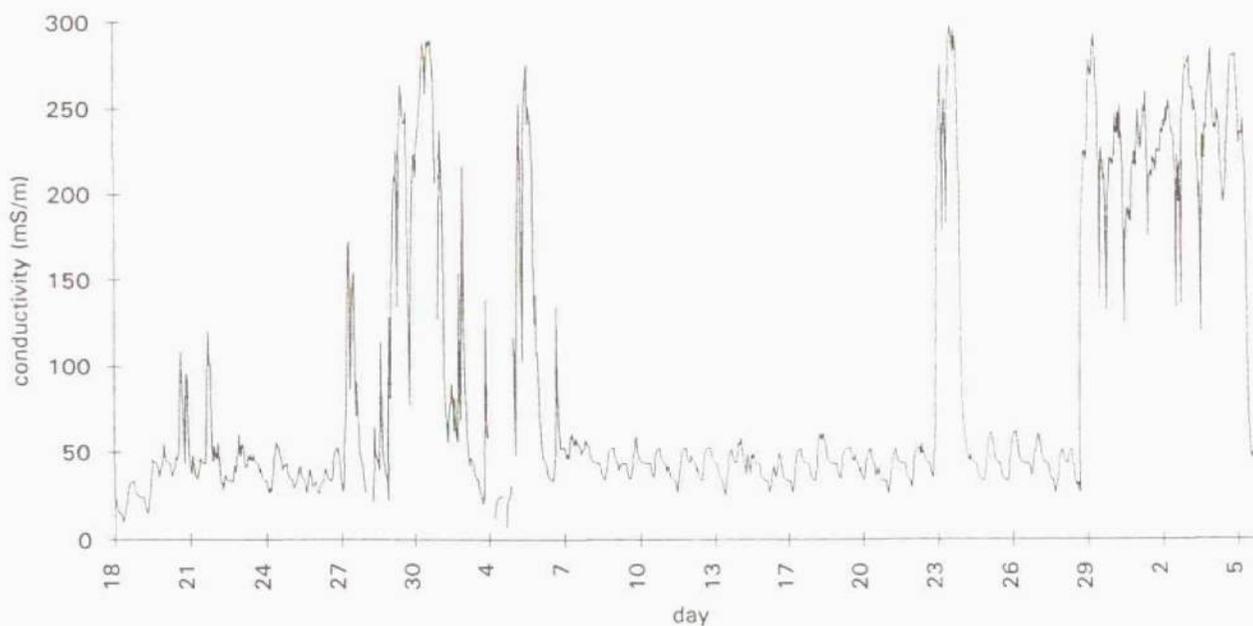
Figure 5: The conductivity of neutralized water for the period 18.03.92 to 05.05.92 (Phase 1).

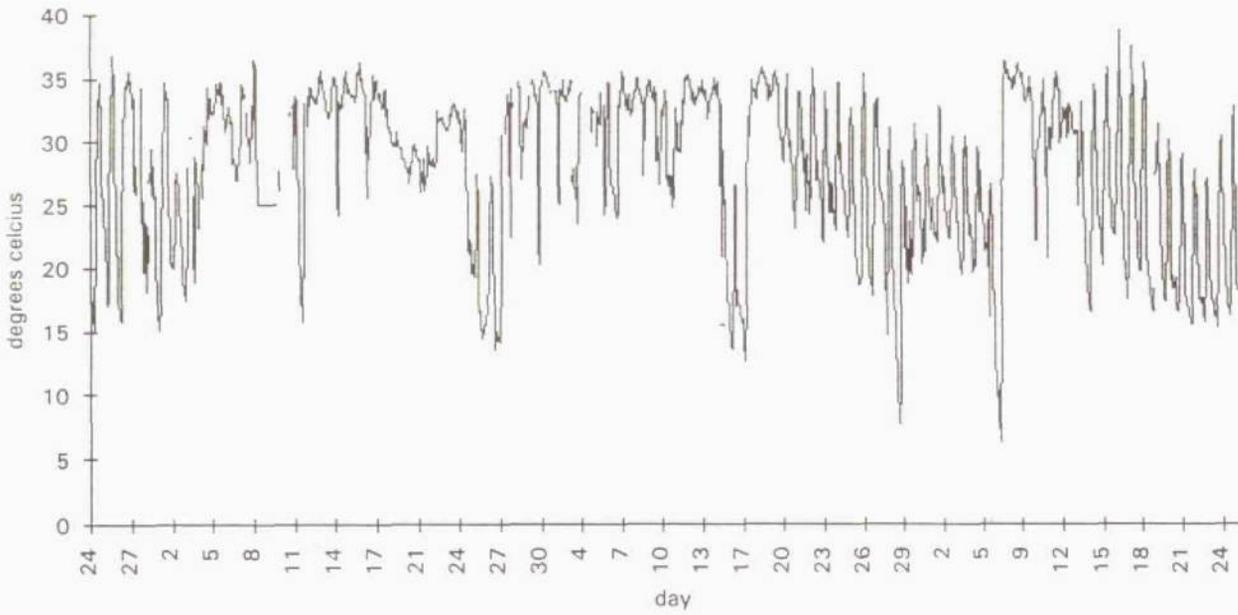
Figure 6: The temperature of the raw mine water during Phase 1.

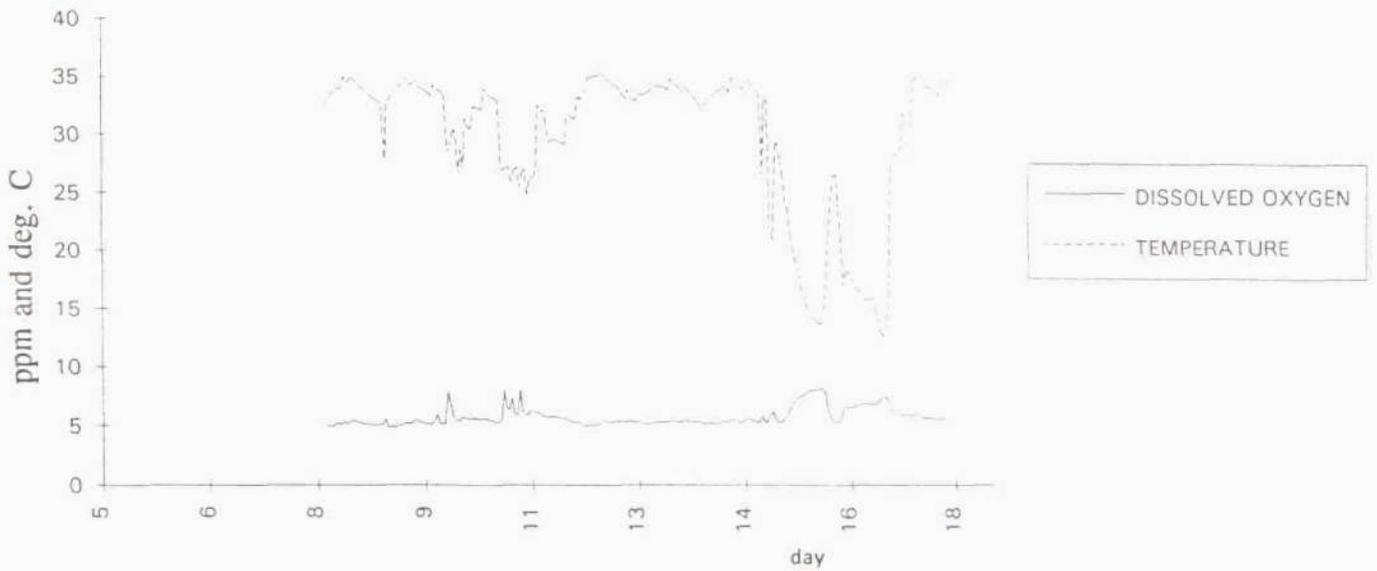
Figure 7: Temperature and dissolved oxygen of raw mine water for the period 8.04.1992 to 18.04.1993.

Problems were also experienced with the continuous measurement of turbidity during Phase 1. Of greater importance in terms of interpreting corrosion data is the measurement of dissolved oxygen and temperature. The temperature of the raw mine water during Phase 1 varied between a minimum of almost 5°C to a maximum of almost 40°C (Figure 6). There is a general decrease in the daily minimum temperatures as the winter months approach. Dissolved oxygen is a function of temperature and the dissolved oxygen content and the temperature of raw mine water for the period 08.04.1992 to 18.04.1992 are plotted on one graph in Figure 7. As expected the dissolved oxygen content increases as the temperature decreases. All the tanks showed similar trends as shown in Figure 7 for temperature and dissolved oxygen.

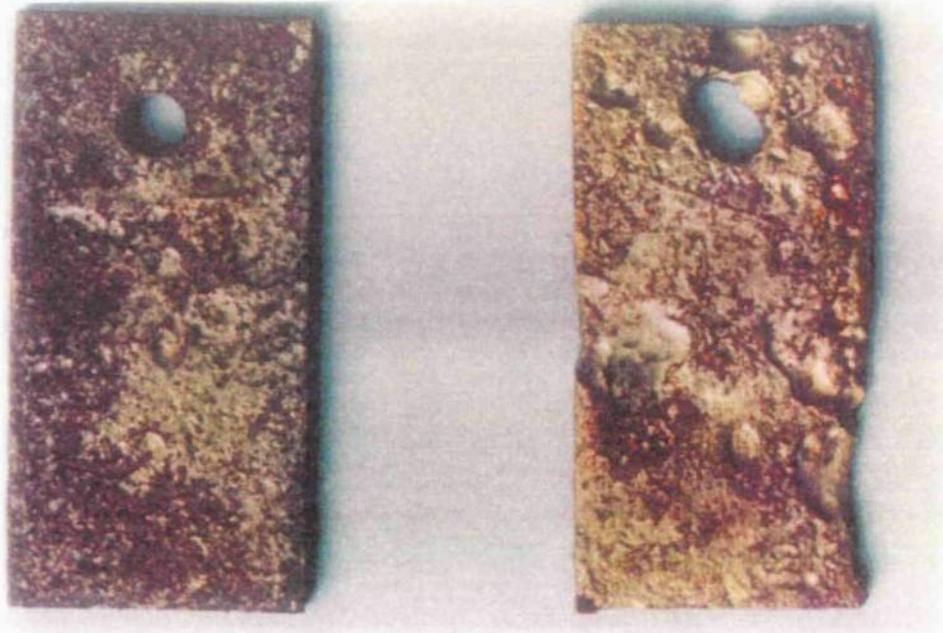
Figure 8: General corrosion of a mild steel coupon (LHS) and localized and pitting corrosion of mild steel (RHS).

The classifications of the corrosion mechanism and its severity as used in Table 6 are illustrated by the photographs of various coupons presented in Figures 8,9 and 10.

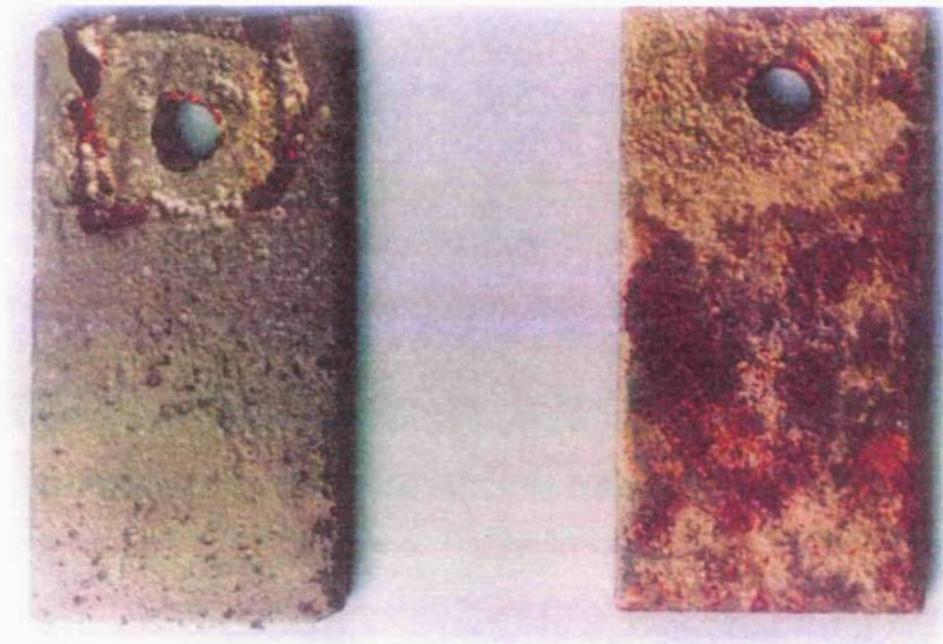
Figure 9: Crevice corrosion around the mounting hole of a galvanized steel coupon (LHS) and red rust on a galvanized steel coupon (RHS).

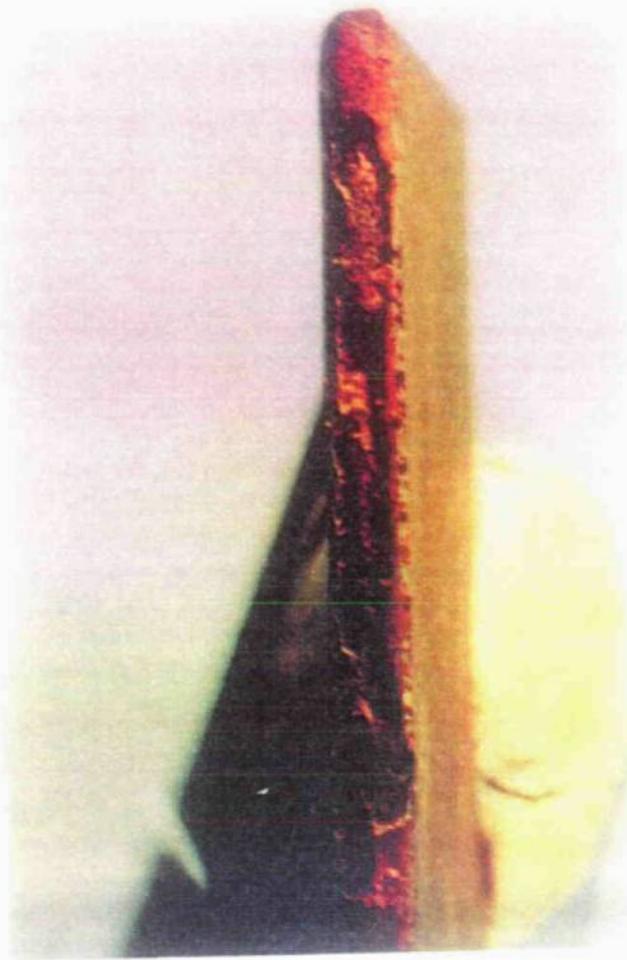
Figure 10: Severe edge attack of a 3CR12 coupon.

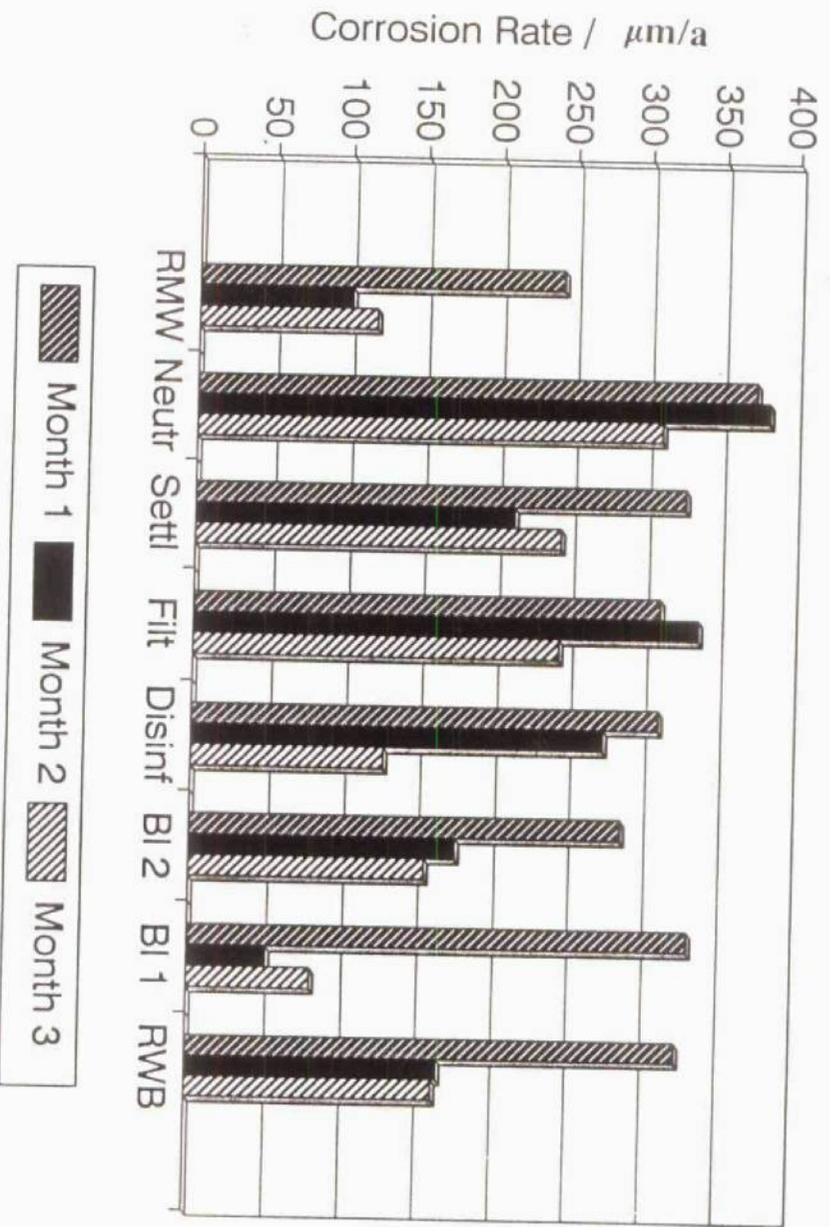
Figure 11 : Mild steel corrosion rates for months 1, 2 and 3 (Phase 1).

The corrosion rates for mild steel and galvanized steel coupons are presented graphically in Figures 11 and 12. Intuitively, the corrosivity of the various waters are expected to decrease in the order

In Figure 11 it is apparent that there is a decrease in corrosion rate for the 2 month exposure compared to the 1 month exposure. It is only in the

neutralized and filtered water that this trend is not observed. The decrease in corrosion rate with exposure time can be ascribed to high initial corrosion rates on the clean steel surface with a decrease in the rate as protective corrosion product and scale form on the surface of the steel until a stable corrosion rate is achieved. It is evident from Figure 11 that if the corrosion rates are averaged over the 1, 2 and 3 month periods, the neutralized and filtered waters are the most aggressive. The more aggressive the medium, the sooner corrosion rates will stabilize and this could be the explanation for these two waters not exhibiting the same phenomenon as described above.

In Figures 11 and 12, the intuitive trend in corrosion rates is not observed. Contrary to expectations, the treated waters (neutralized, settled, filtered and disinfected) generally have the highest corrosion rates for both materials. The increased corrosivity of these four waters is also clearly illustrated by the galvanized steel coupon evaluations presented in Table 6. It is only in these four waters that red rust was observed on the galvanised steel coupons. In the raw mine water, first and second blends and Rand Water Board water, only staining and general corrosion was observed indicating that the zinc coatings did not fail in these media.

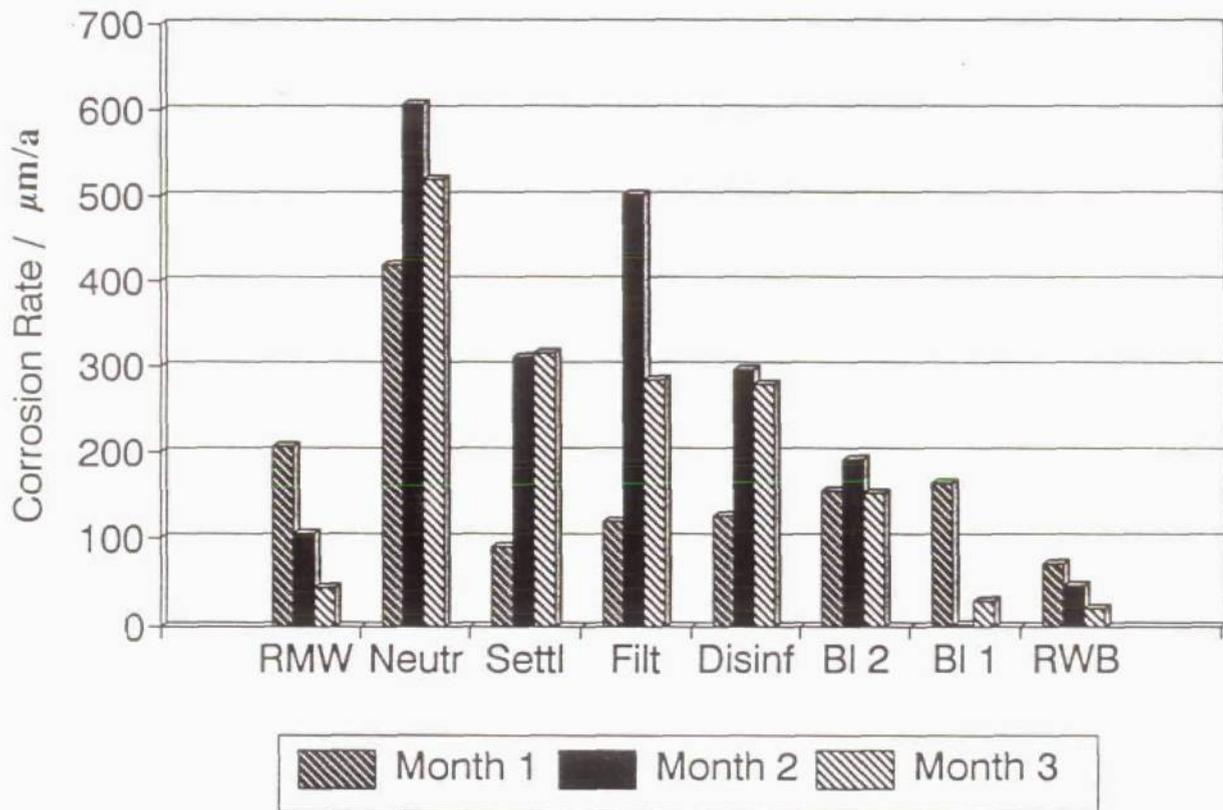
Figure 12: Galvanized steel corrosion rates for months 1, 2 and 3 (Phase 1).

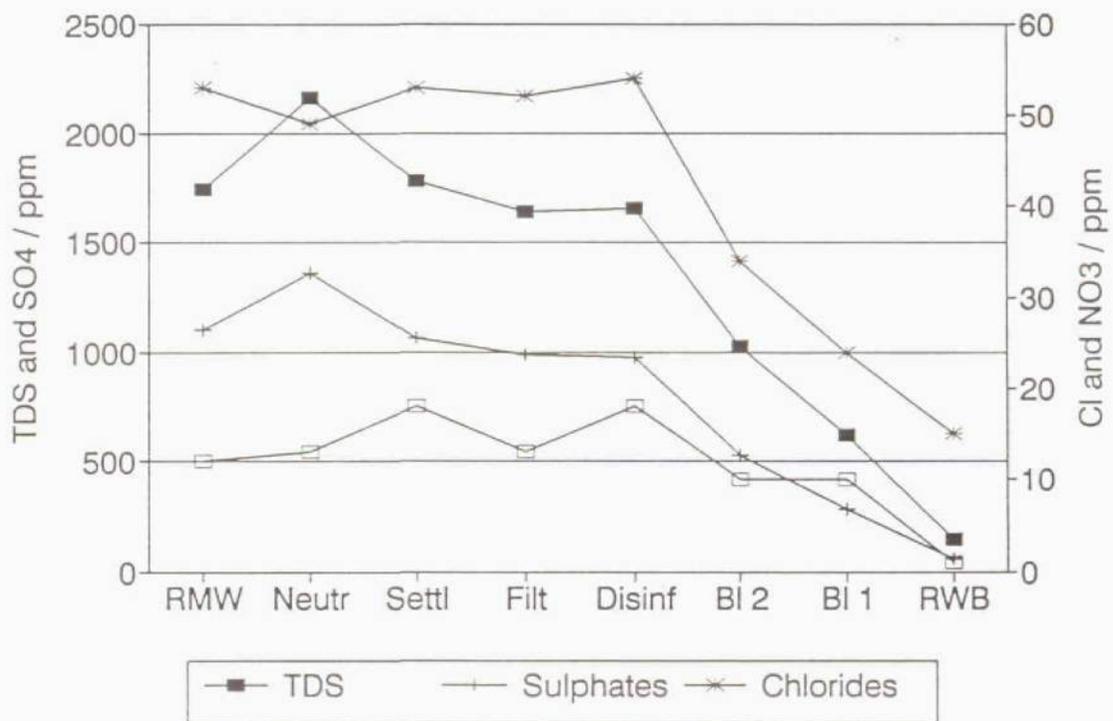
Figure 13: Sulphate, chloride, nitrate and total dissolved solids contents of the various waters tested during Phase 1.

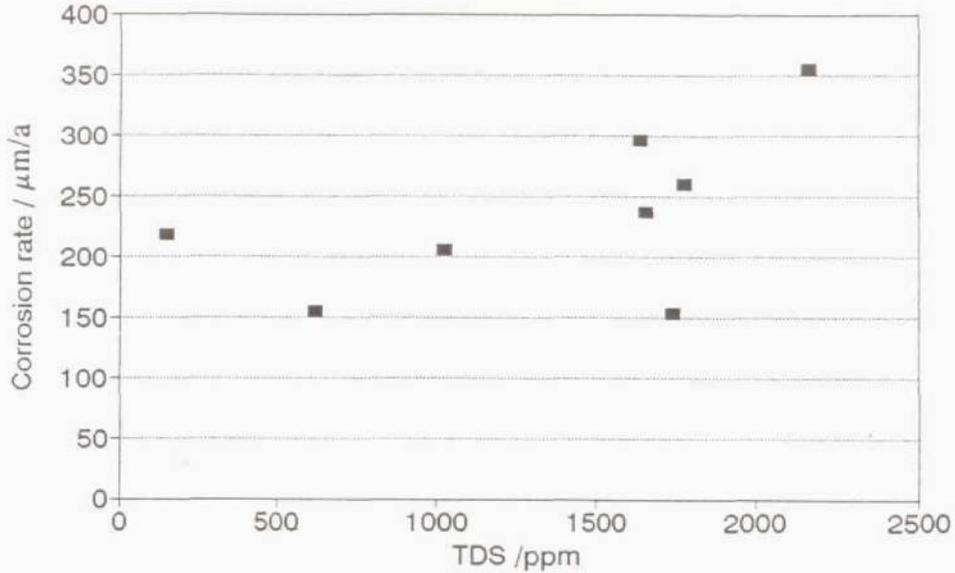
Figure 14: Average mild steel corrosion rates as a function of total dissolved solids (Phase 1).

Average corrosion rates calculated from the 1, 2 and 3 month data for mild steel and galvanised steel are plotted against total dissolved solids contents in Figures 14 and 15 respectively. A general increase in corrosion rate with increasing TDS is evident.

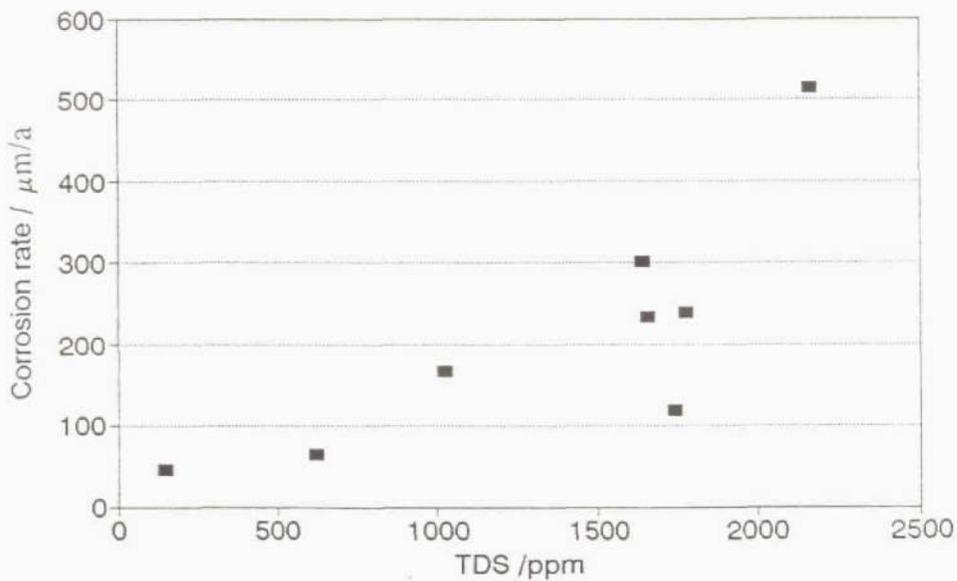
Figure 15: Average galvanized steel corrosion rates as a function of TDS (Phase 1).

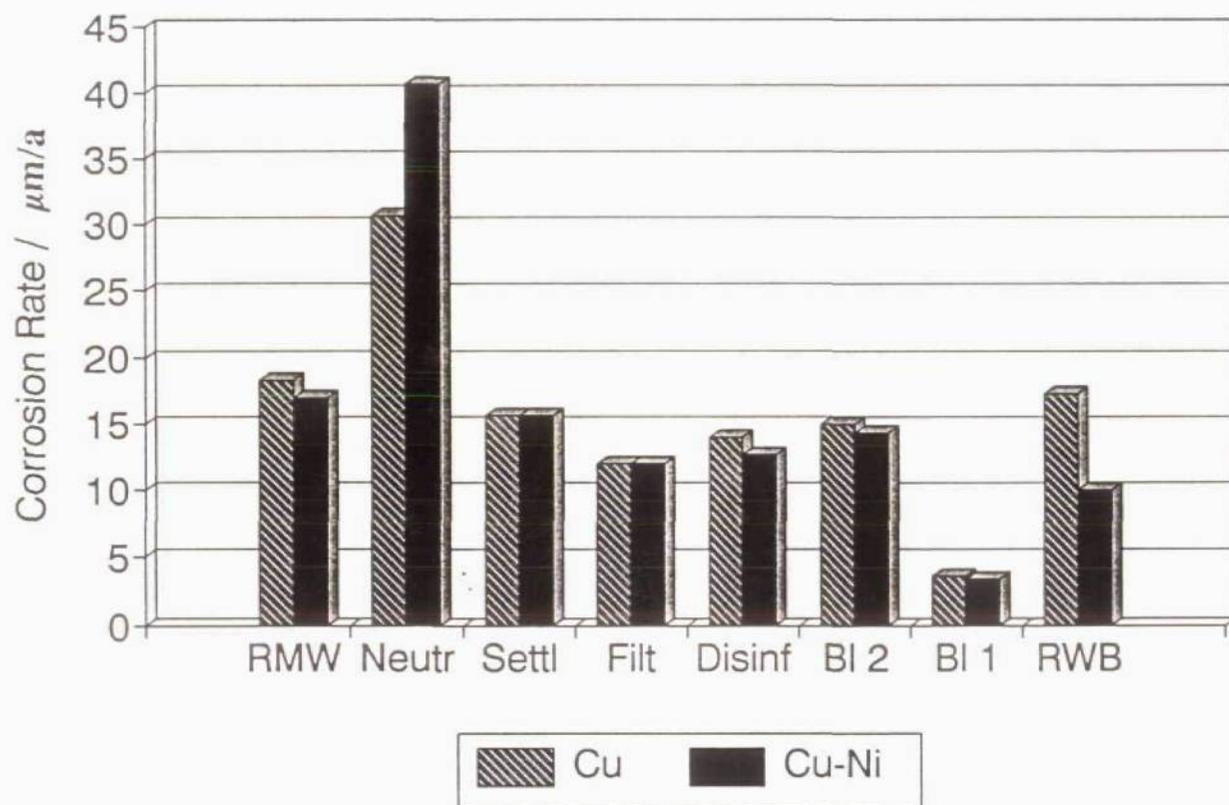
Figure 16: Average copper and copper-nickel corrosion rates measured in the various waters during Phase 1.

The copper and the Cu-Ni coupons all had low corrosion rates as shown by the data in Table 5. The average corrosion rates calculated from 1, 2 and 3 month data are presented in Figure 16 for Cu and Cu-Ni. The highest corrosion rate is once again exhibited in the neutralized water. The low corrosion rate of the first blend could not be explained. With the exception of the neutralized water and blend 1, the corrosion rates are all between 10 and 20 μm per year.

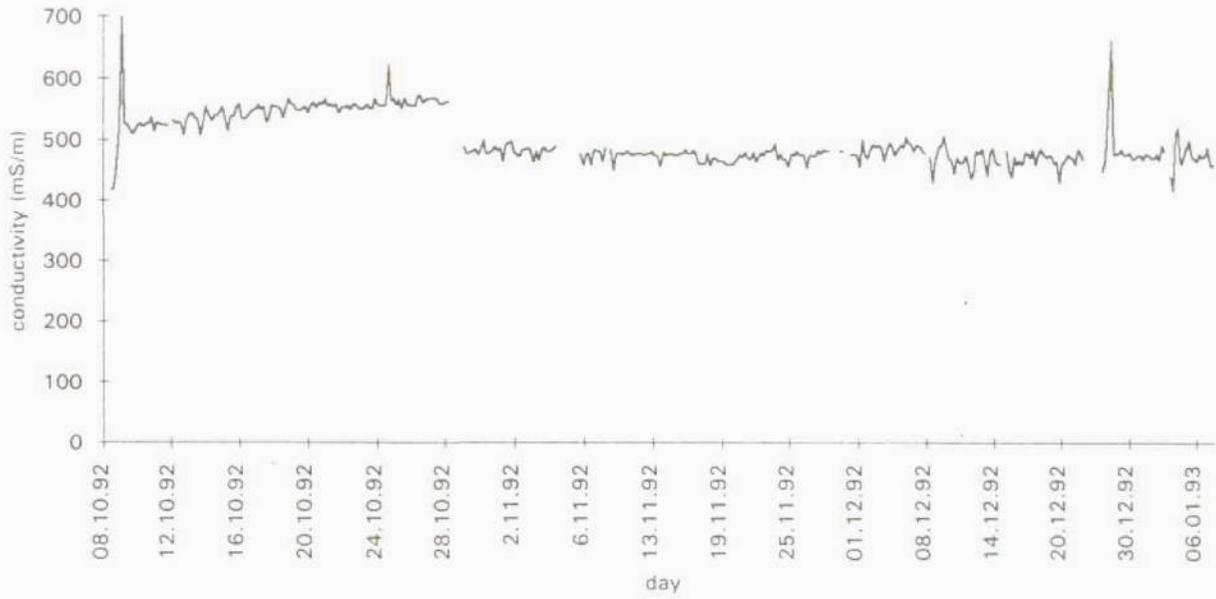
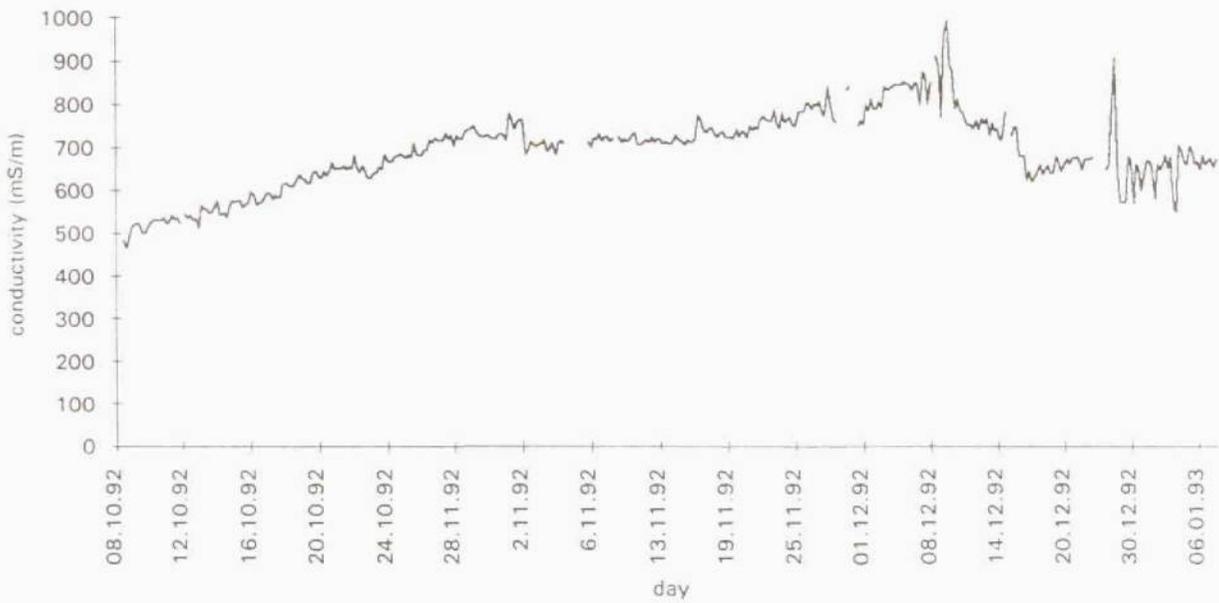
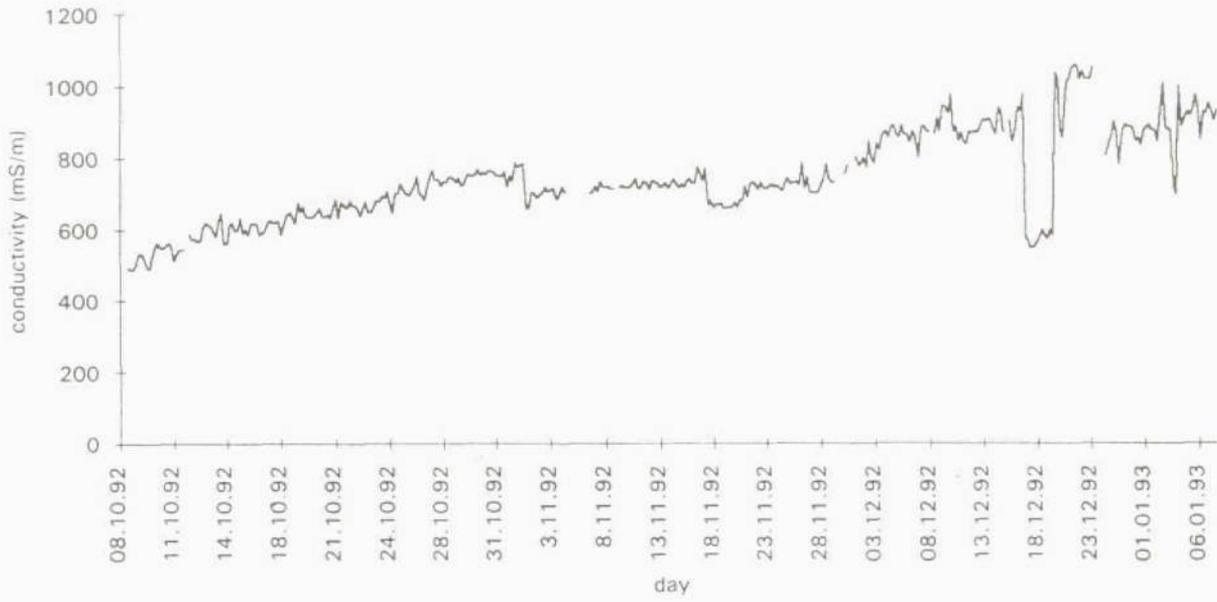
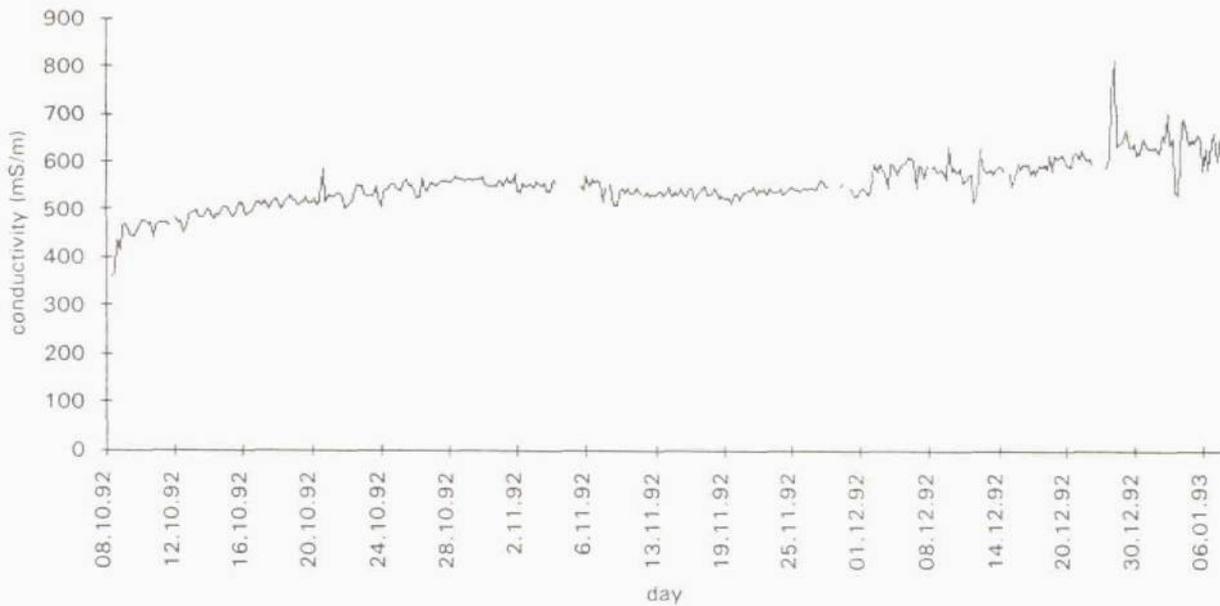
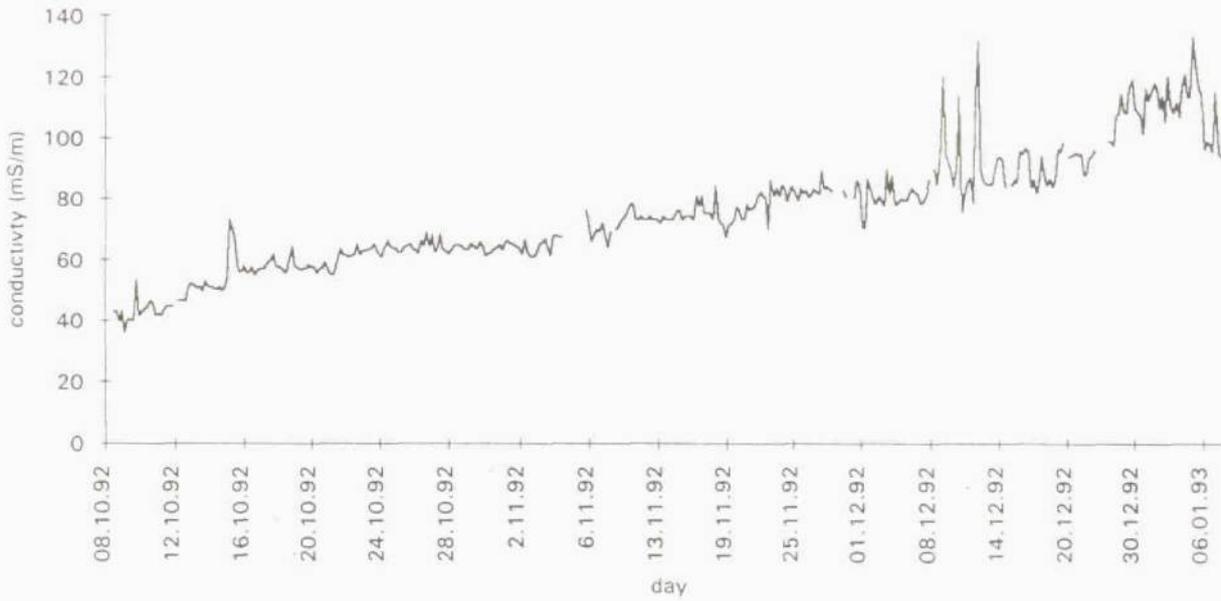
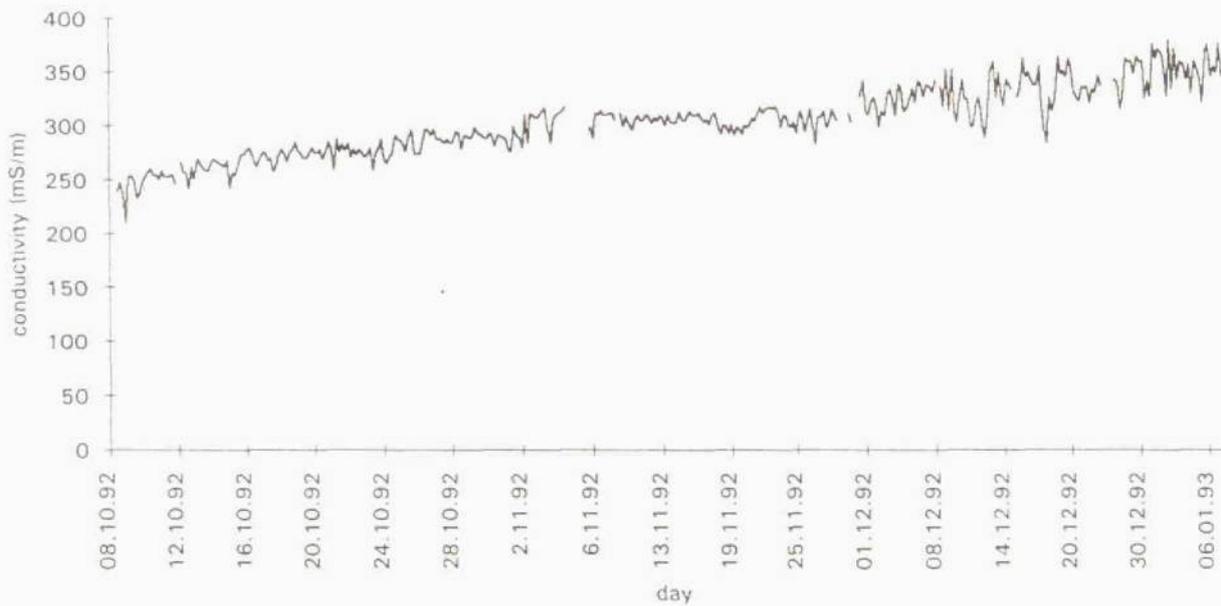
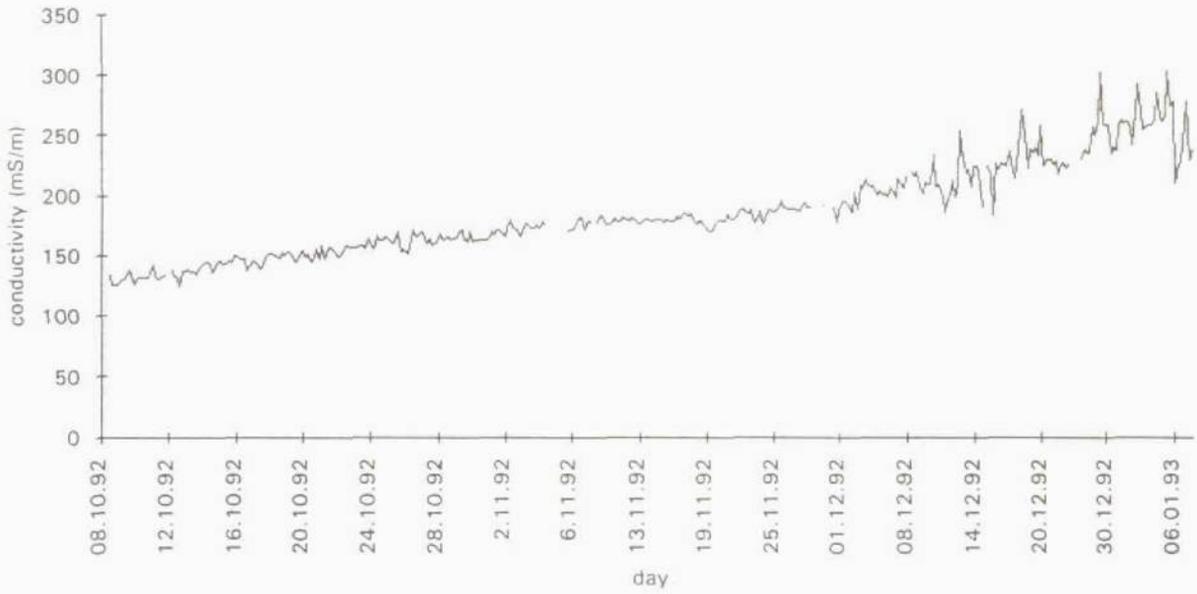
Figure 17: The conductivity of raw mine water during Phase 2.

Figure 18: The conductivity of neutralized water during Phase 2.

Figure 19: The conductivity of settled water during Phase 2.

Figure 20: The conductivity of disinfected water during Phase 2.

Figure 21: The conductivity of Rand Water Board water during Phase 2.

Figure 22: The conductivity of first blend water during Phase 2.

Figure 23: The conductivity of second blend water during Phase 2.

Recirculation of water ensured a much more constant water chemistry than during Phase 1. Conductivity data for each unit process measured on-line is shown in Figures 17 to 23. From these graphs it is clear that the conductivity curve of the various waters remained fairly smooth over this time period. Typical pH data recorded during Phase 2 can be seen in Figure 24 (pH of the neutralised water). Clearly the large pH fluctuations observed in Phase 1 is absent here.

The conductivity data presented in Figures 17 to 23 illustrate the effect of evaporation and subsequent make-up with either RWB water or raw mine water. Although the curves remain quite smooth (i.e. no sudden changes are observed), a steady increase in conductivity throughout the period of testing is apparent for all the tanks except raw mine water. It is therefore apparent that although the water chemistry was constant over short time periods, there was a gradual increase in the level of total dissolved solids

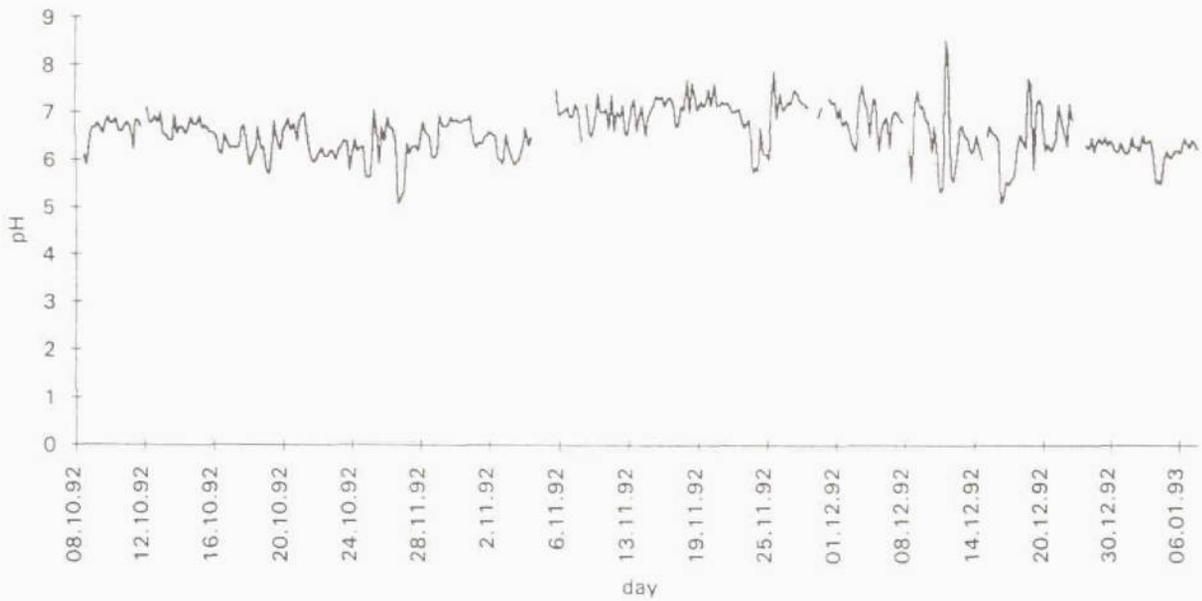
Figure 24: The pH of neutralised water during Phase 2.

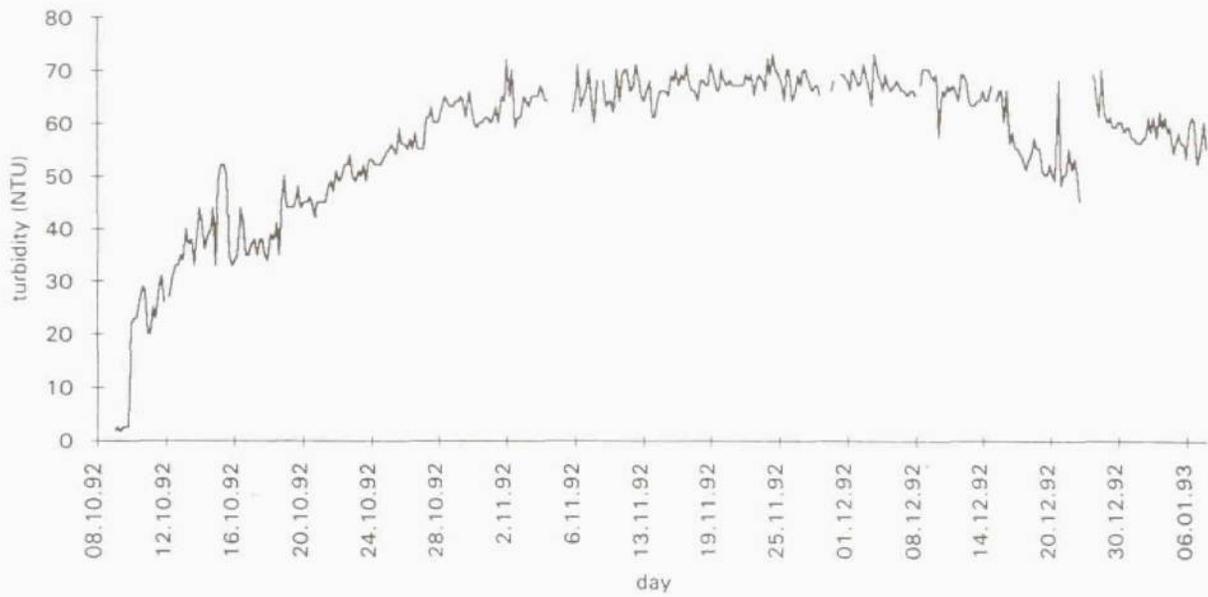
Figure 25: The turbidity of the settled storage tank during Phase 2.

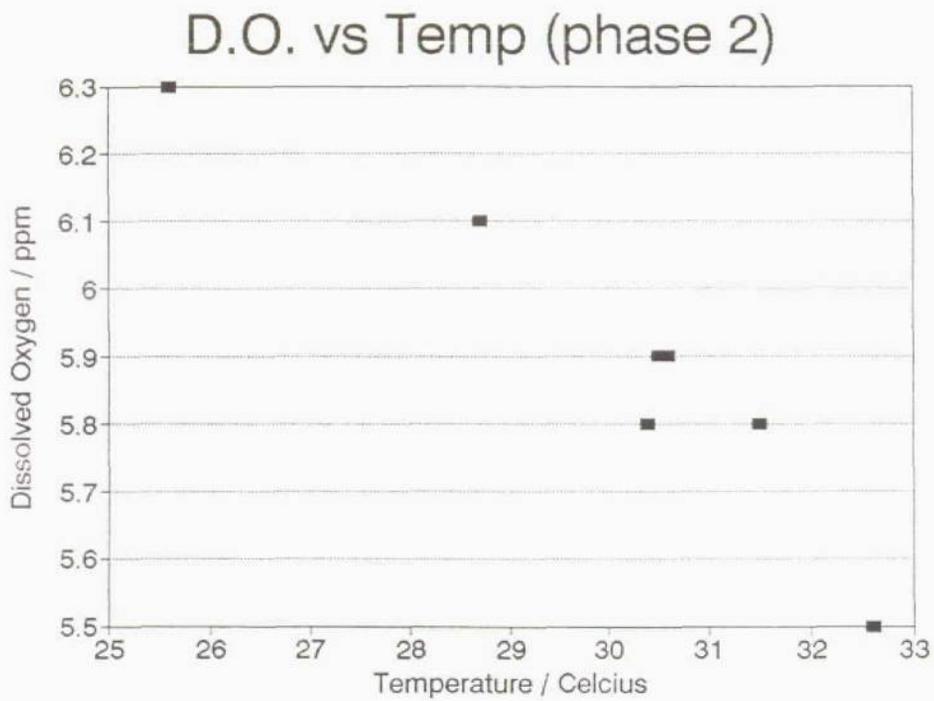
Figure 26: Dissolved oxygen content as a function of temperature for the various waters in Phase 2.
