Division of Mining Technology

WATER RESEARCH COMMISSION

A STUDY ON A MINE WATER RECLAMATION TEST PLANT

WRC Report No. 322/1/95
ISBN 1 86845 160 7

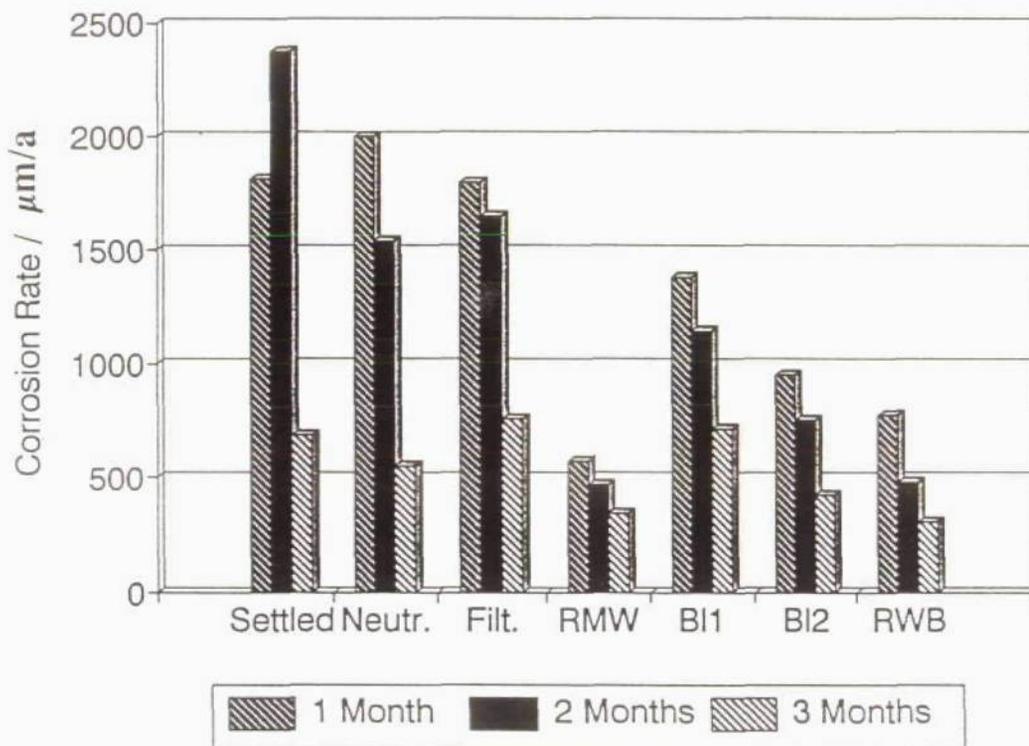
Figure 27: Mild steel corrosion rates after 1, 2 and 3 months (Phase 2).

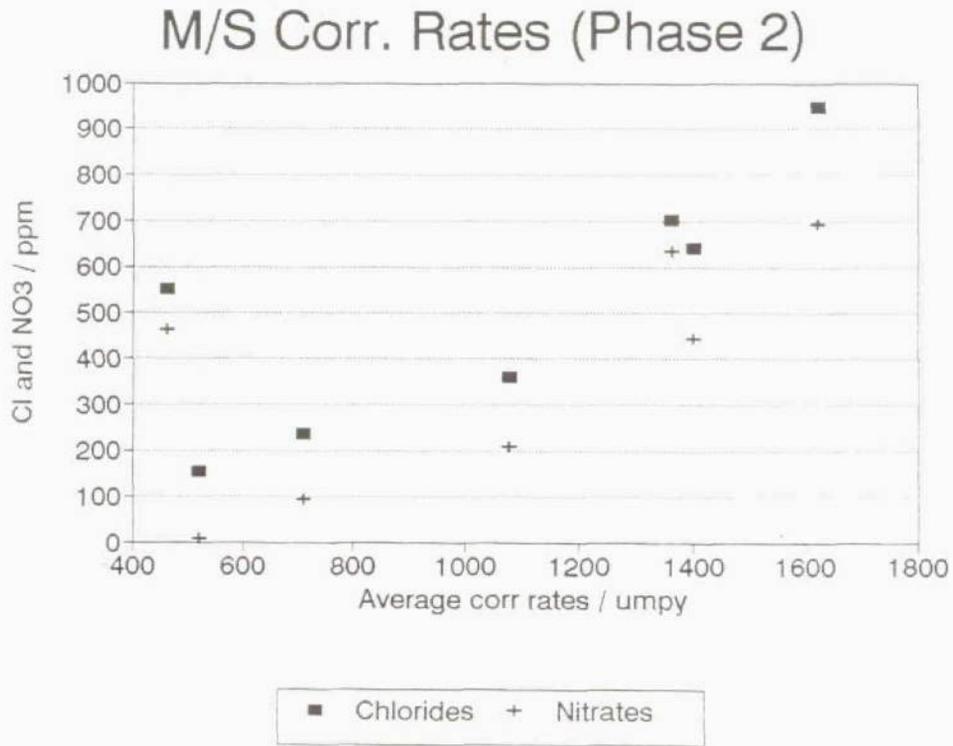
Figure 28: The effect of chloride and nitrate contents on corrosion rate of mild steel (Phase 2).

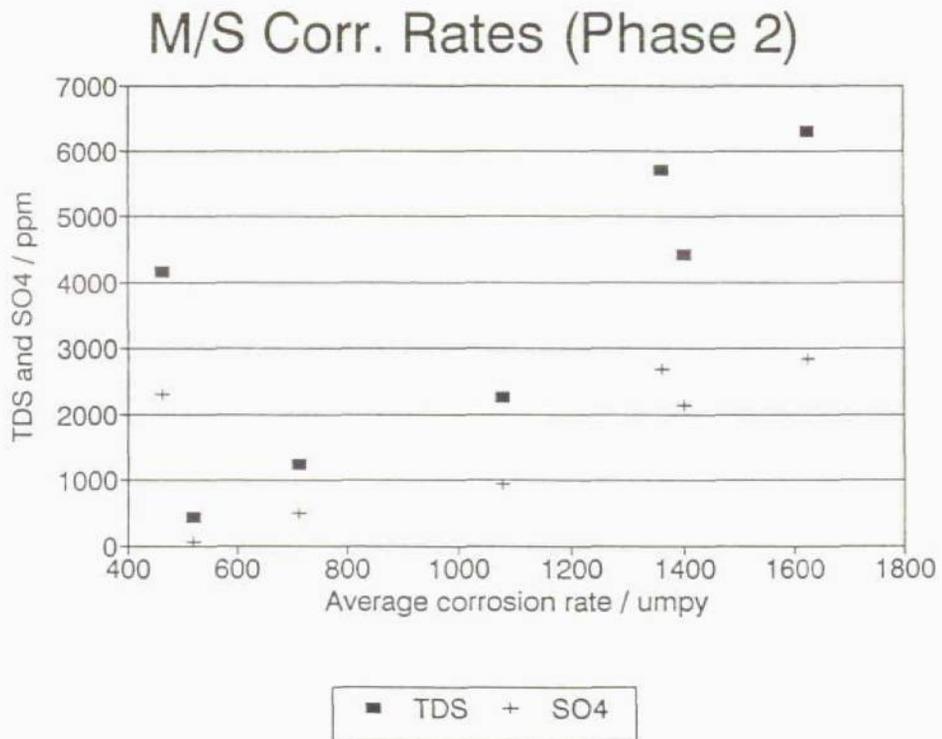
Figure 29: The effect of sulphates and total dissolved solids on corrosion rate of mild steel (Phase 2).

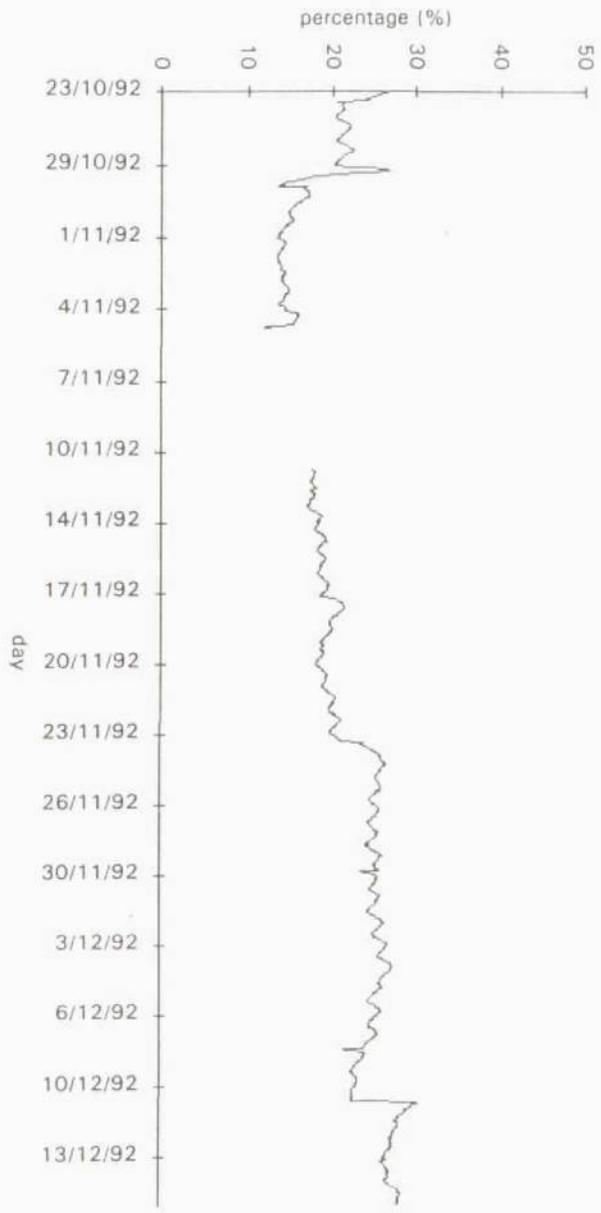
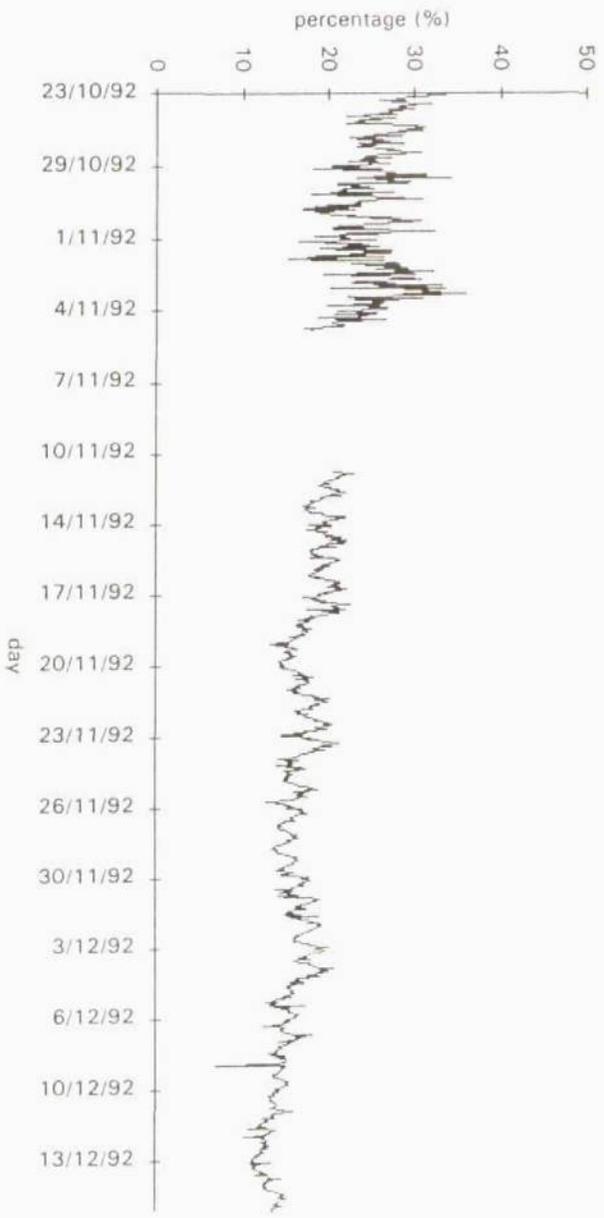
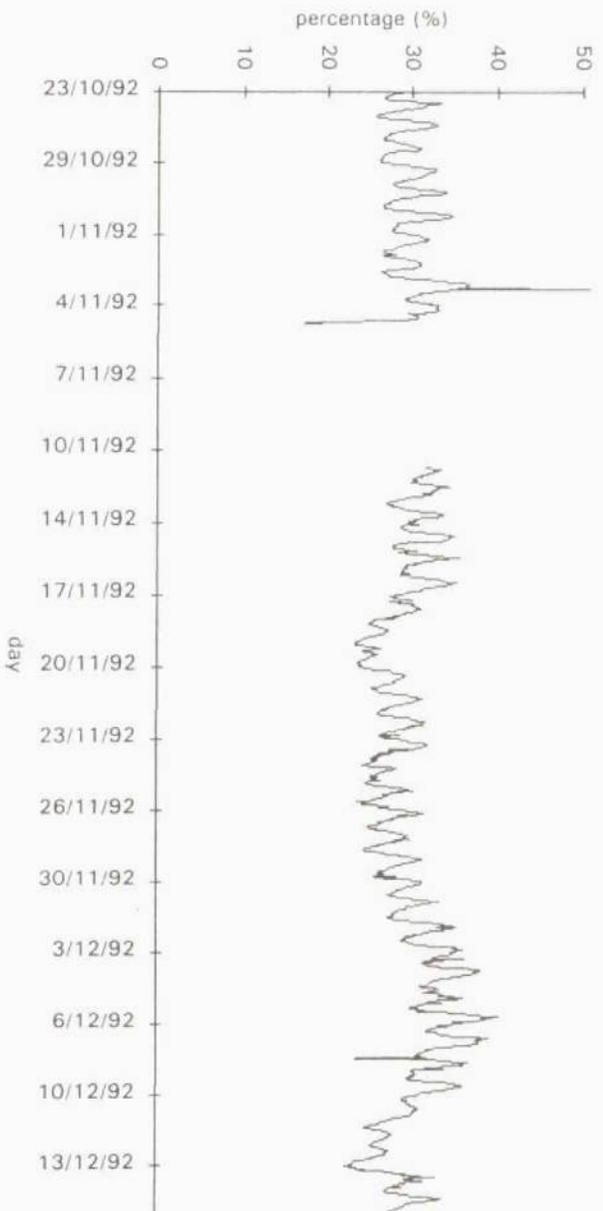
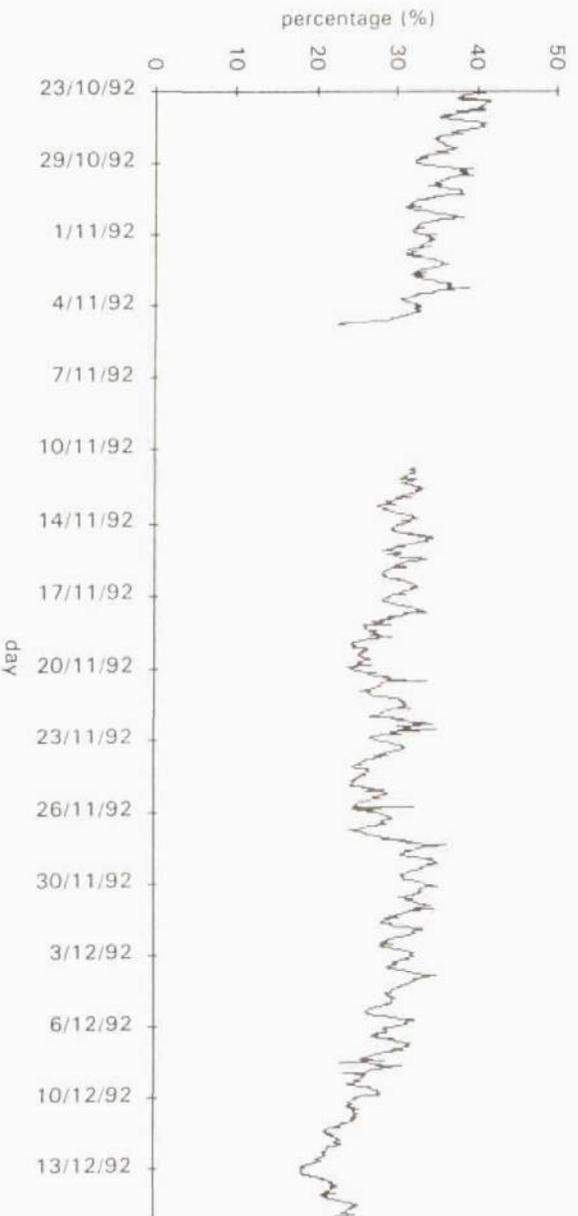
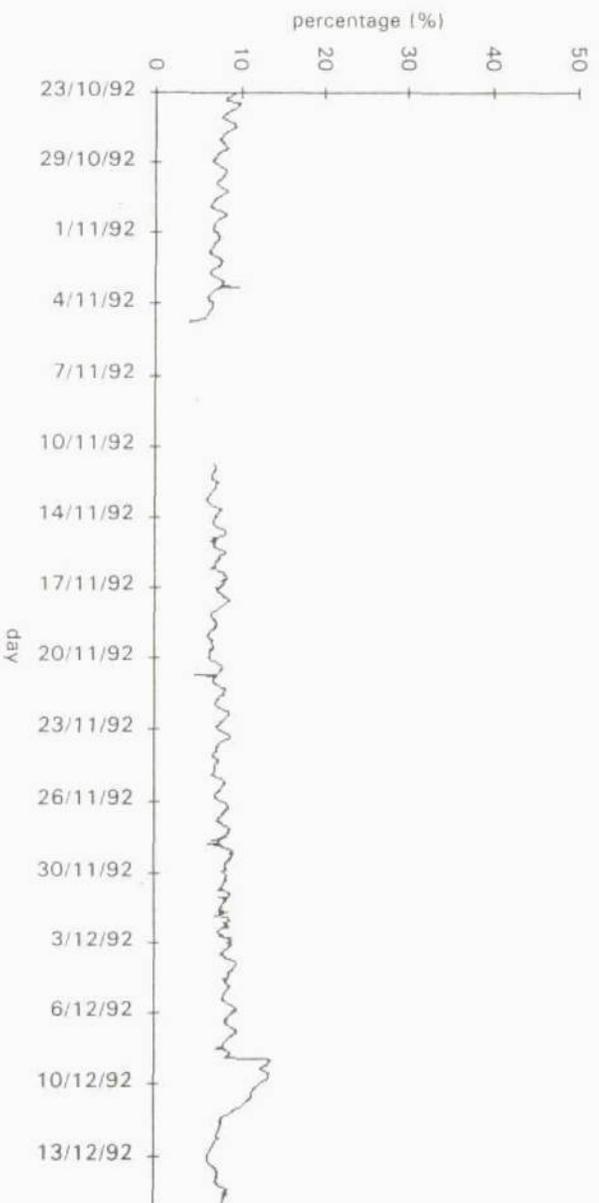
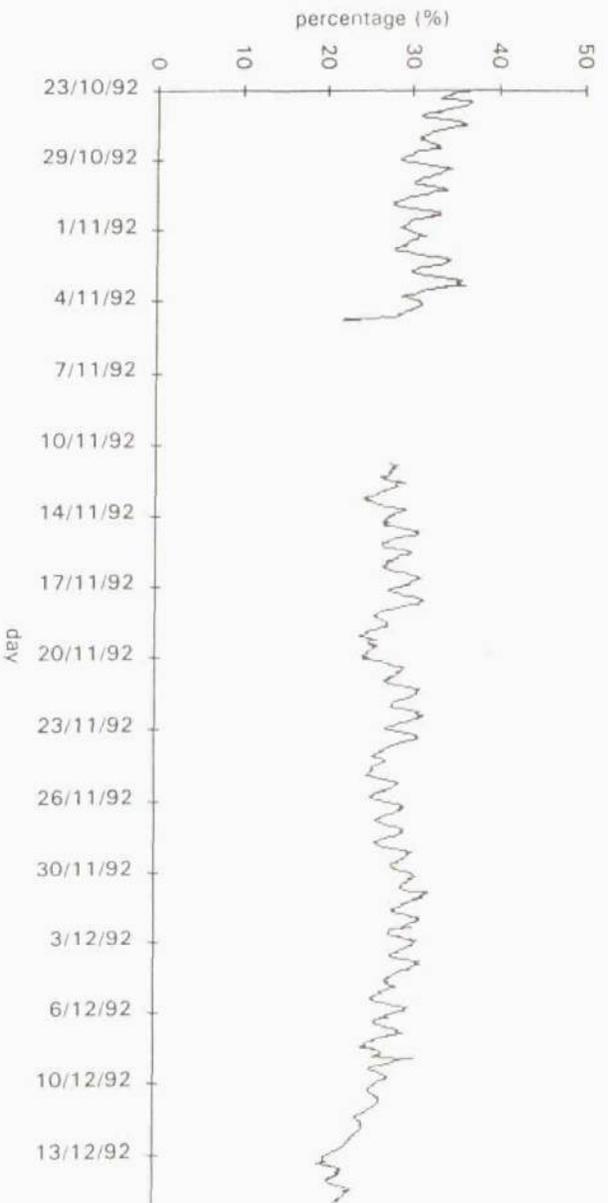
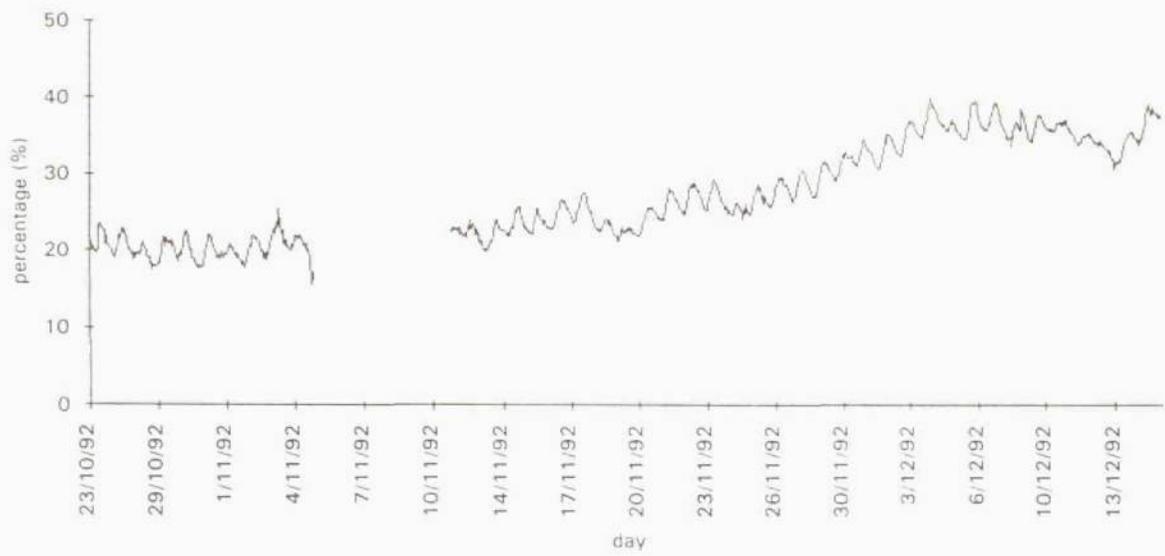
Figure 30: LPR data of raw mine water (Phase 2).

Figure 31: LPR data of neutralized water (Phase 2).

Figure 32: LPR data of settled water (Phase 2).

Figure 33: LPR data of disinfected water (Phase 2).

Figure 34: LPR data of Rand Water Board water (Phase 2).

Figure 35: LPR data of first blend water (Phase 2).

Figure 36: LPR data of second blend water (Phase 2).

It is clear from Figures 30 to 36 that the corrosion rates remained fairly stable throughout the measurement time. Daily maxima and minima, related to the temperature fluctuations of the water, are evident.

For a constant water chemistry, one would expect the corrosion rates to show a gradual decrease with exposure time as corrosion products build-up and stabilize. However, as discussed in the previous section, the conductivity and turbidity of all the tanks increased with exposure time and the LPR data therefore reflects the combined effect of this changing water chemistry and exposure time. The net result was that the corrosion rates in the settled storage, RWB and first blend lines stayed constant while a slight decrease in corrosion rate with time is evident for the disinfected storage and neutralized water lines. In the second blend and RMW lines, the corrosion rate increased with time.

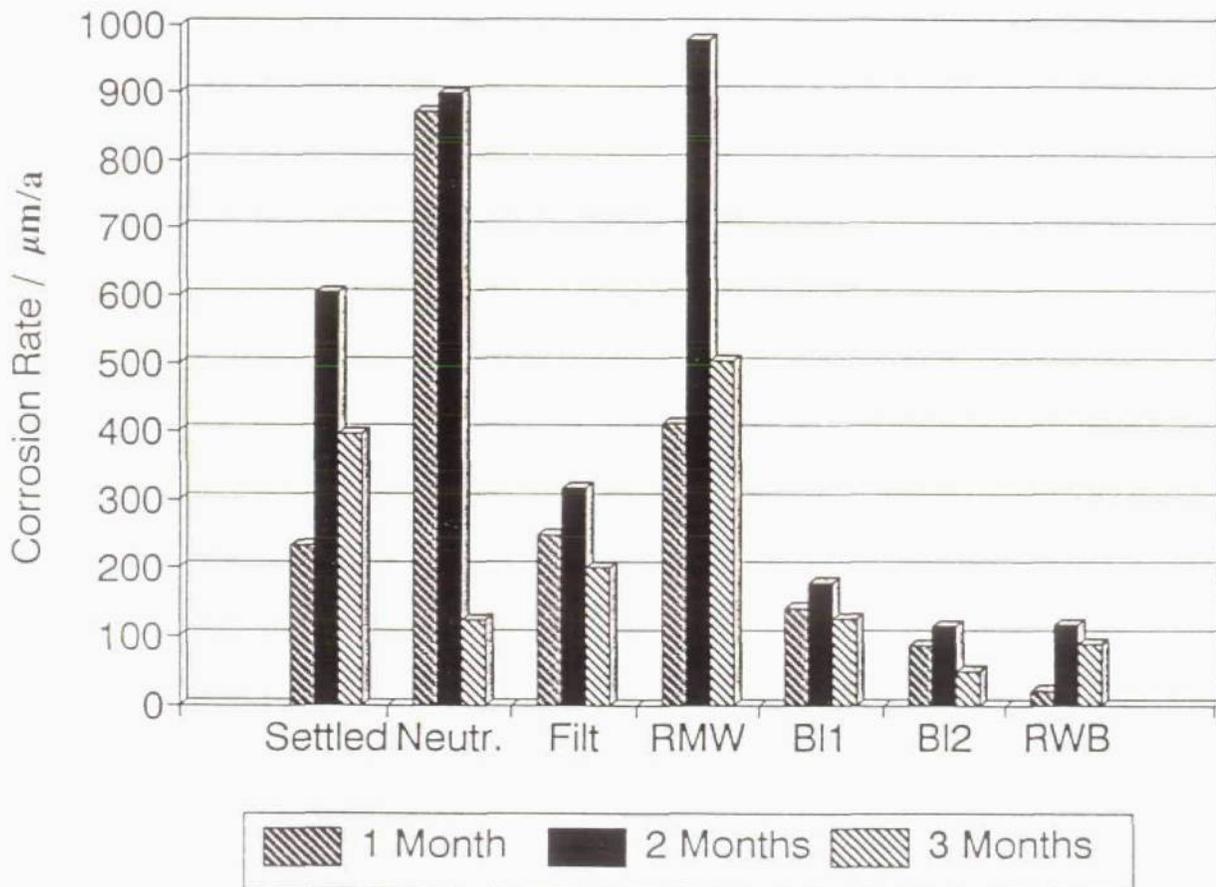
Figure 37: Galvanized steel corrosion rates after 1, 2 and 3 months (Phase 2).

exhibited in any of the waters. It is also apparent that the raw mine water is one of the most corrosive waters for galvanized steel while it was the least corrosive to mild steel.

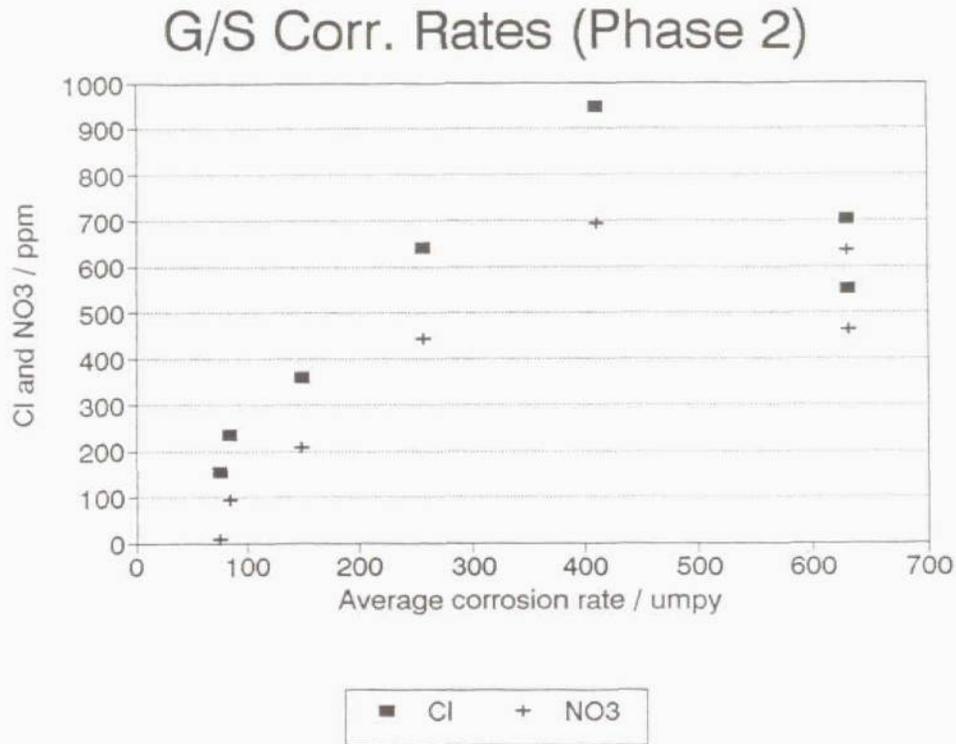
Figure 38: The effect of chloride and nitrate content on the corrosion rate of galvanized steel (Phase 2).

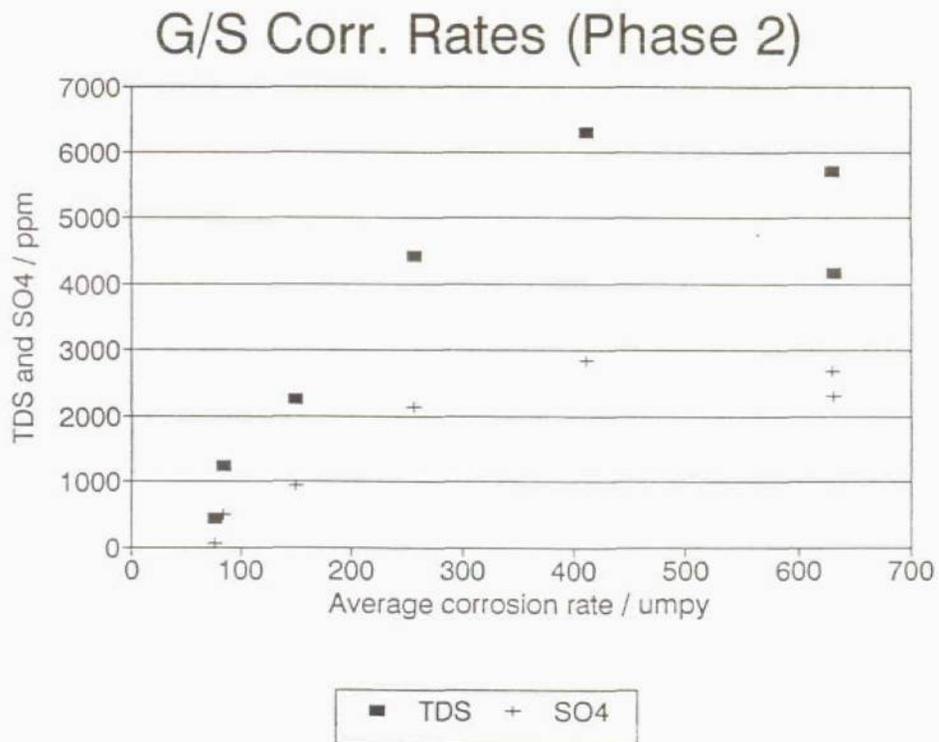
Figure 39: The effect of sulphates and total dissolved solids on the corrosion rate of galvanized steel (Phase 2).

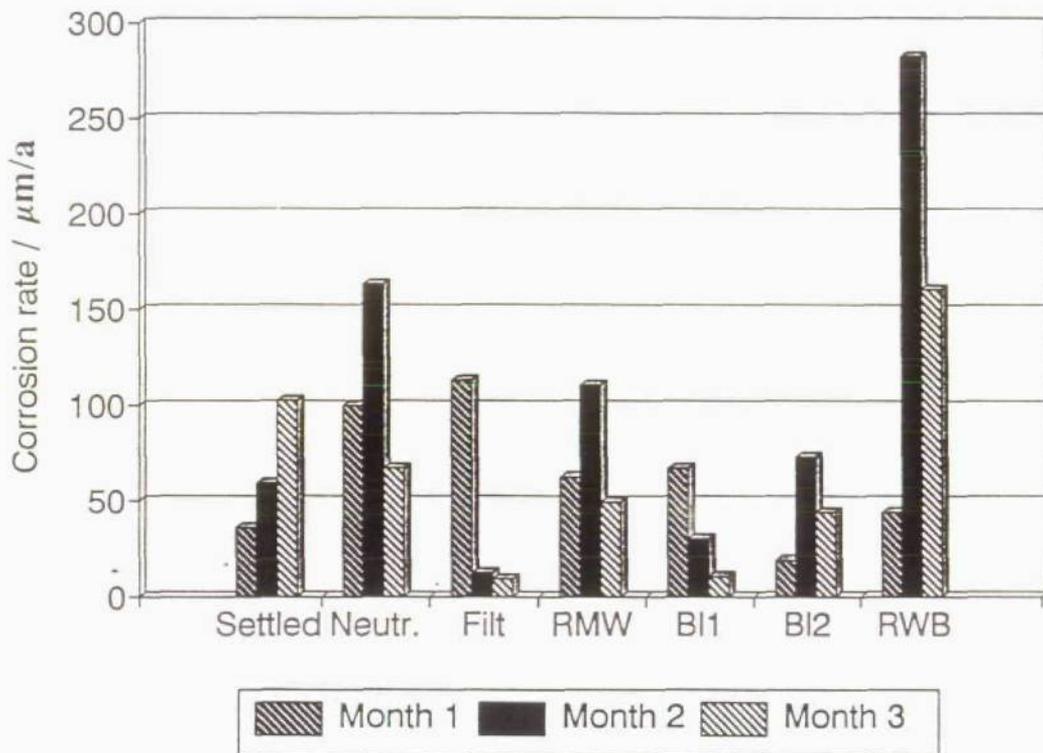
Figure 40: Cu corrosion rates after 1, 2 and 3 months (Phase 2).

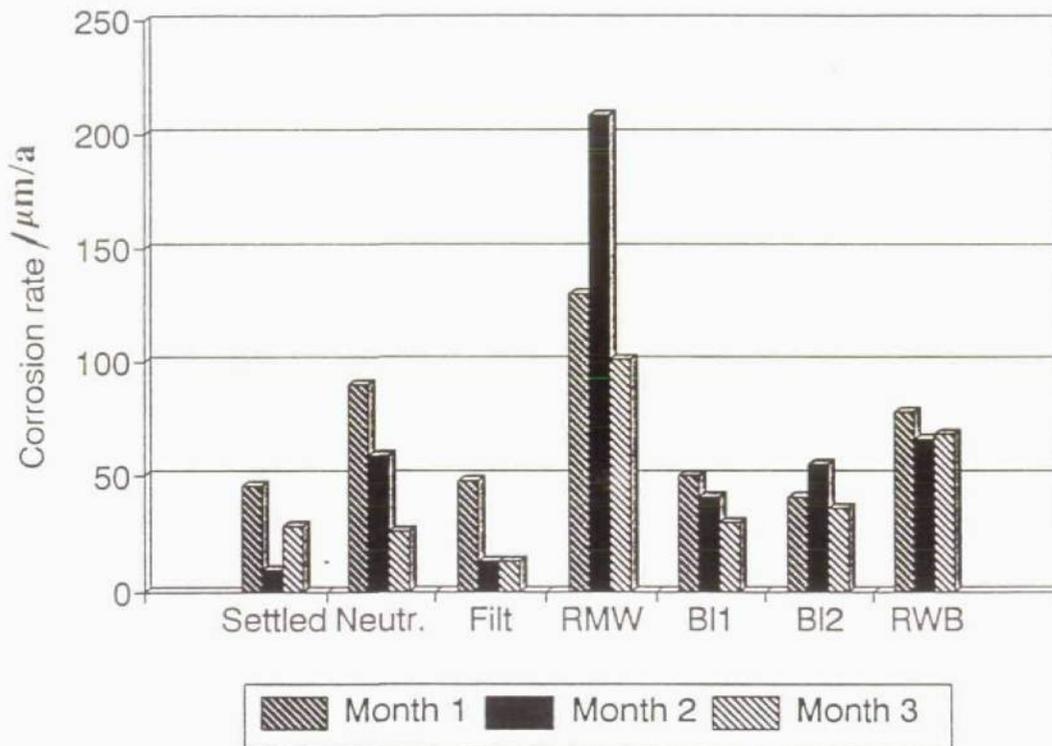
Figure 41: Copper-nickel corrosion rates after 1, 2 and 3 months (Phase 2).

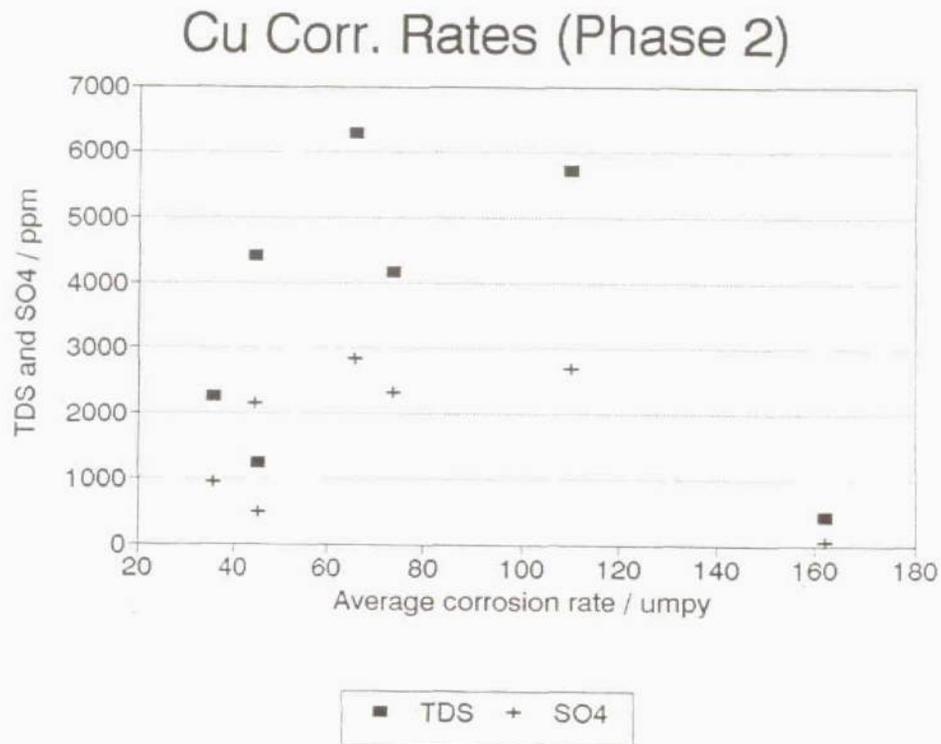
Figure 42: The effect of sulphates and total dissolved solids on the corrosion rate of copper (Phase 2).

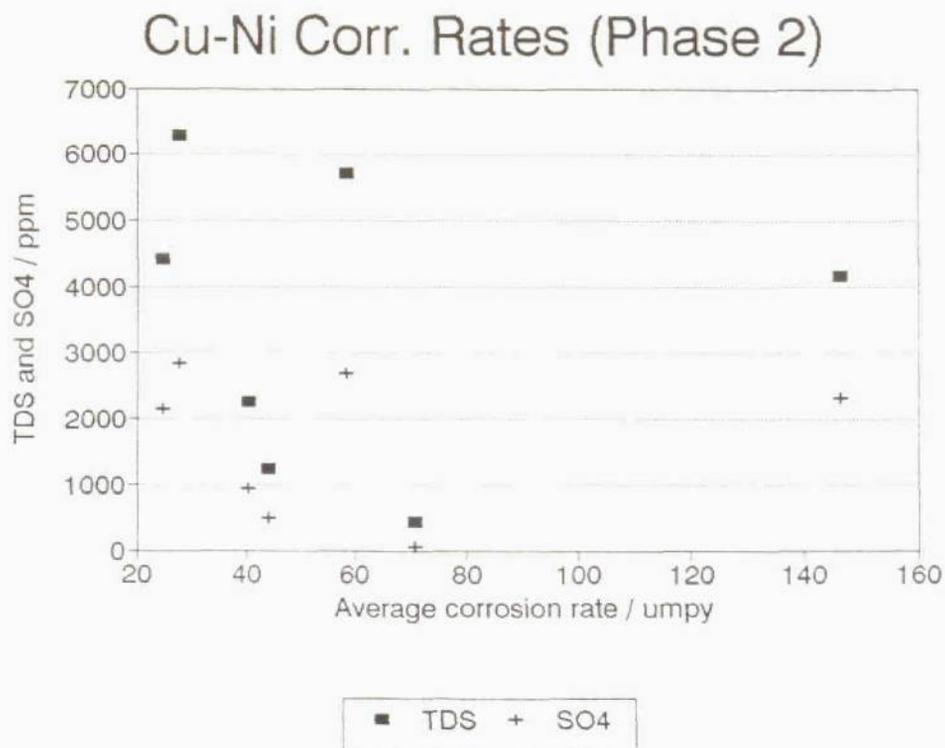
Figure 43: The effect of sulphates and total dissolved solids on the corrosion rate of copper-nickel (Phase 2).

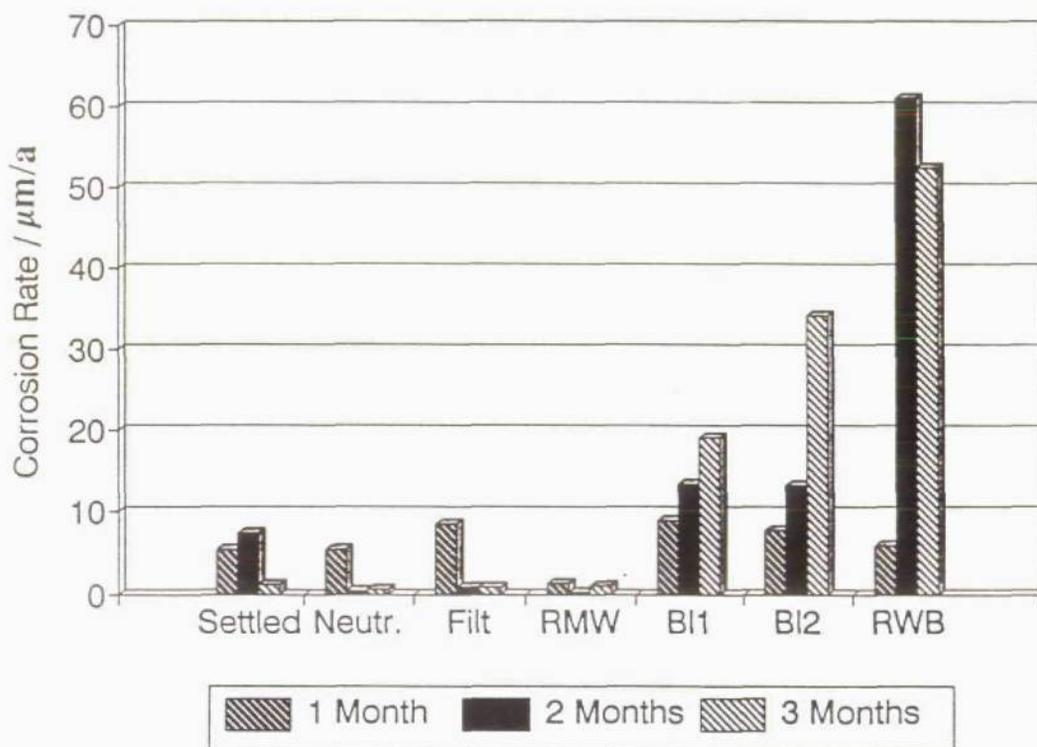
Figure 44: 3CR12 corrosion rates after 1, 2 and 3 months (Phase 2).

Corrosion rates and the visual appearance of 3CR12 coupons are summarized in Tables 14 and 15. The corrosion rates are presented graphically in Figure 44. The high TDS waters (settled, neutralized, disinfected and RMW) have very low corrosion rates (less than 10 $\mu\text{m/a}$). This is confirmed by the visual inspection results which indicate that the coupons removed from these waters exhibited very little signs of corrosion. In the RWB, 1st and 2nd blend waters a significant amount of localized attack was evident and this is also reflected by the weight loss data.

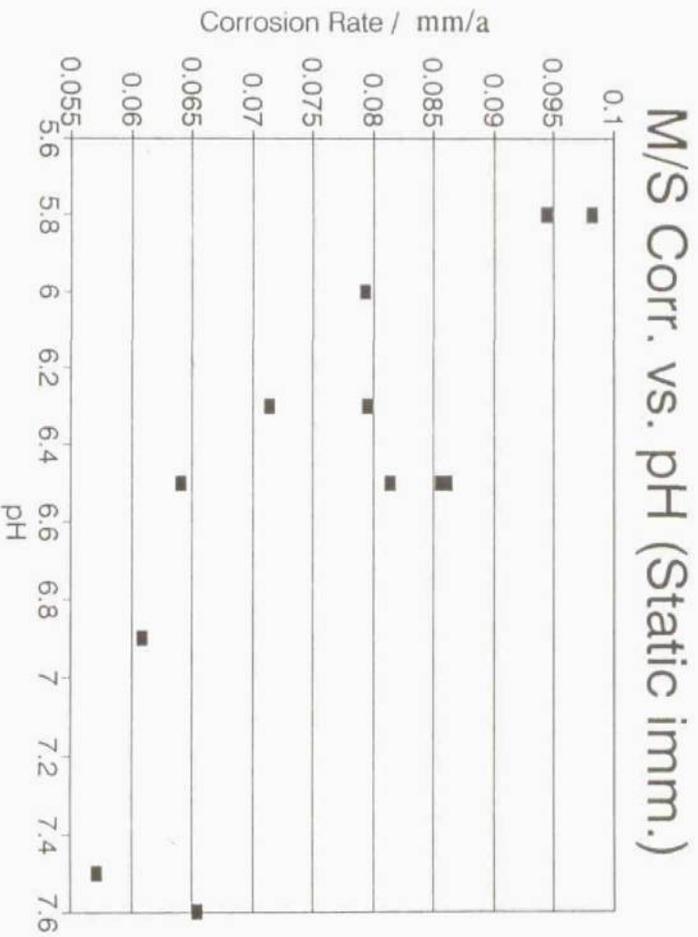
Figure 45: Mild steel corrosion rate as a function of pH (static immersion tests).

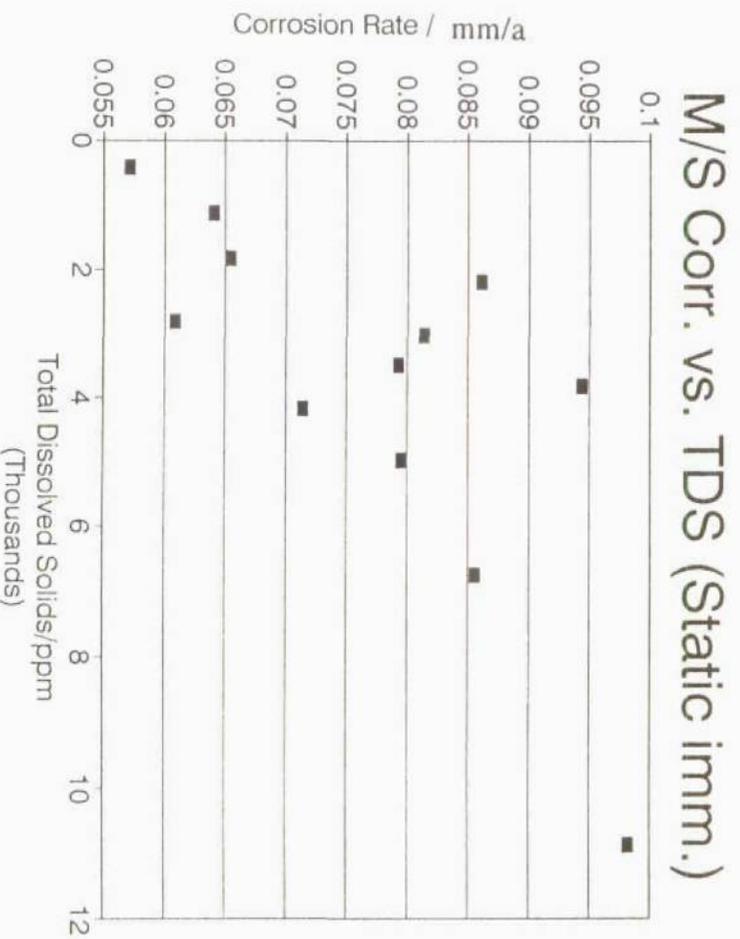
Figure 46: Mild steel corrosion rate as a function of TDS (static immersion tests).

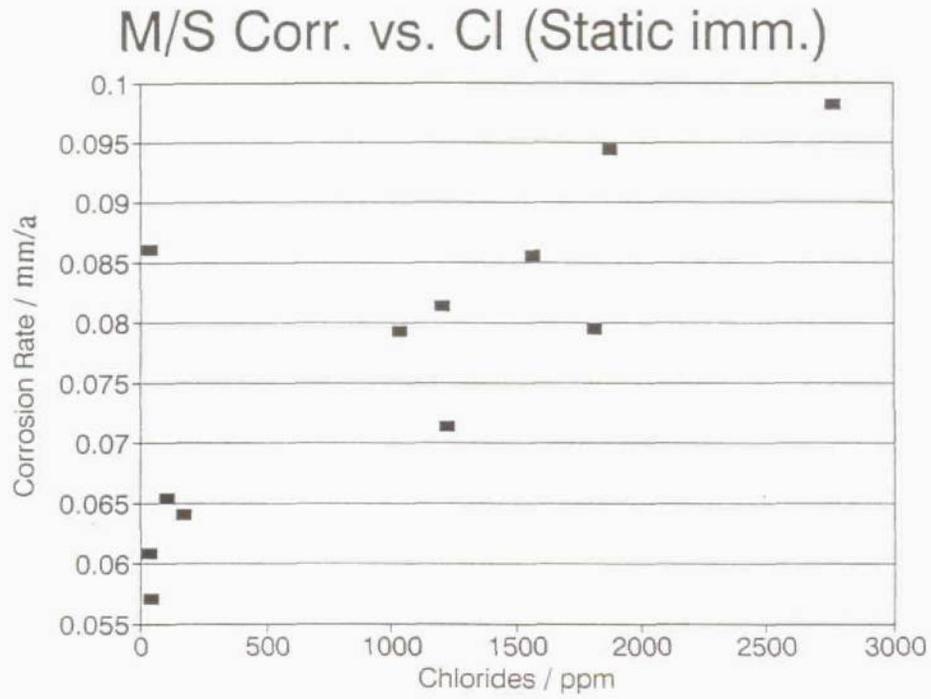
Figure 47: Mild steel corrosion rate as a function of chlorides (static immersion tests).

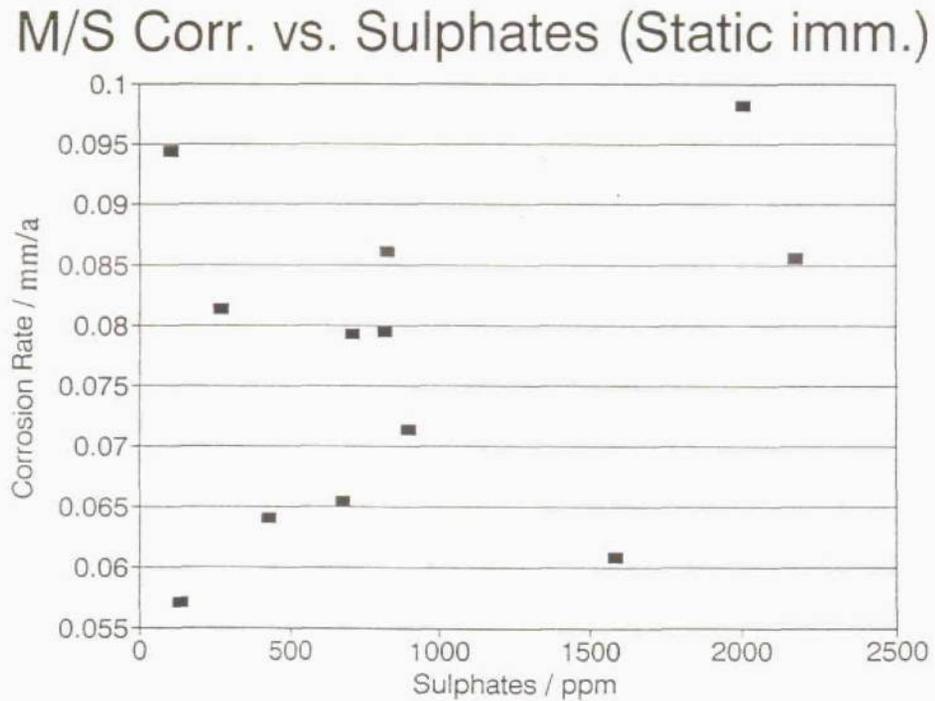
Figure 48: Mild steel corrosion rate as a function of sulphates (static immersion tests).

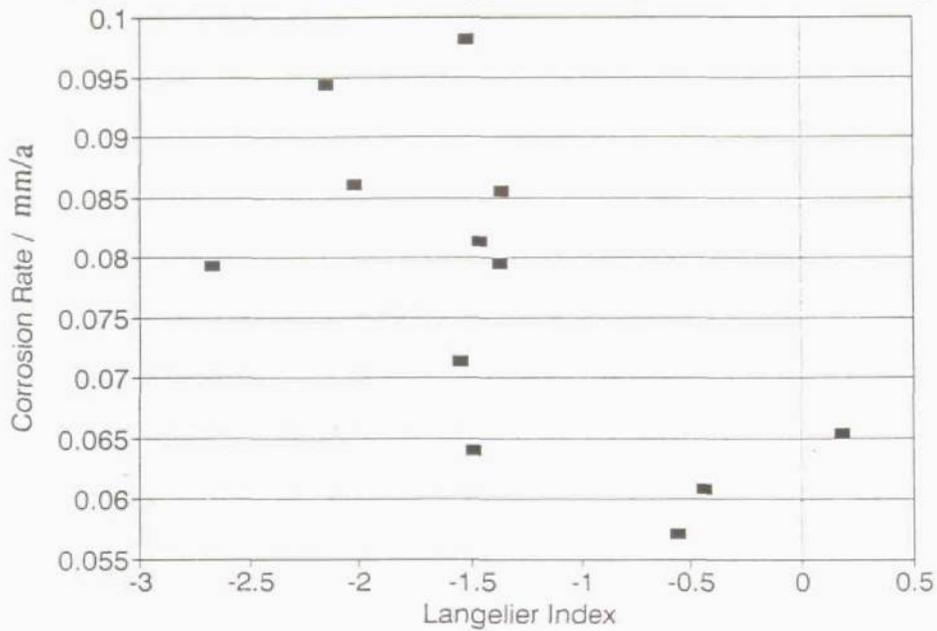
Figure 49: Mild steel corrosion rate vs Langelier index (static immersion tests).

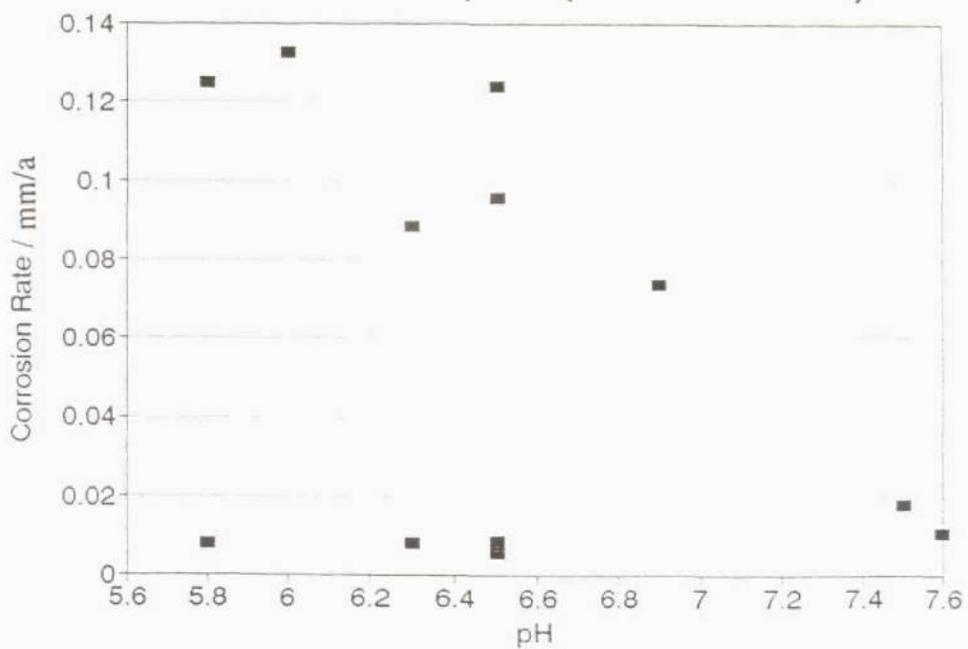
Figure 50: Galvanized steel corrosion rate vs pH (static immersion tests).

The best correlation for galvanized steel was corrosion rate vs pH (Figure 50). However, some of the waters did not follow this trend at all and the lowest corrosion rates were observed in the lower pH waters.

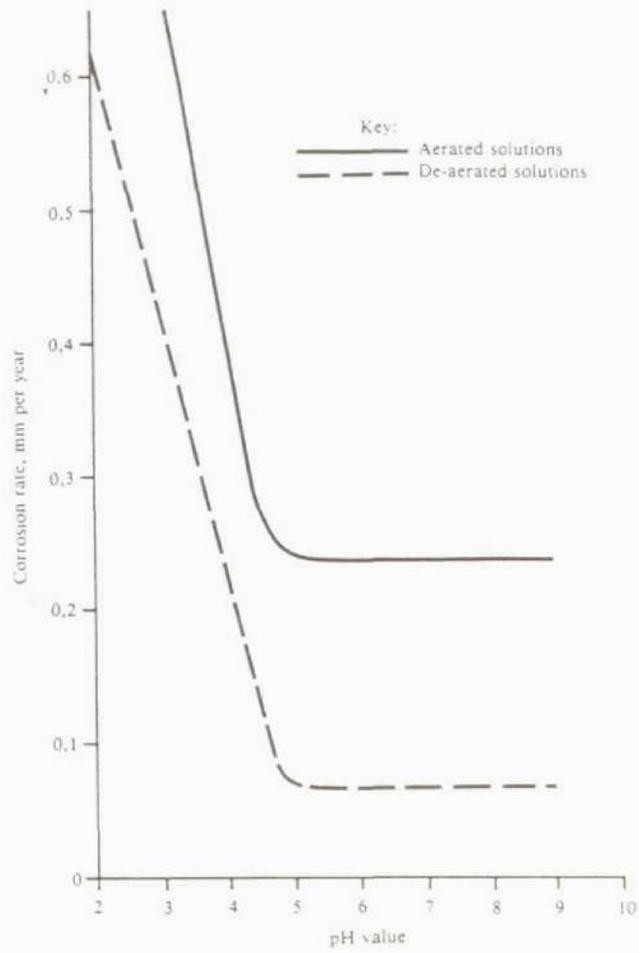
Figure 51: Corrosion rate versus pH for mild steel in mine water.

Despite the lack of data on the effect of pH on corrosion rate from this study, sufficient data exists in the literature to determine the requirements for pH control in mine waters. The control of pH also has a large influence on scale formation and the Langelier Index is used to predict the tendency of a water to precipitate or dissolve calcium carbonate. This index is often used to predict the corrosivity of waters and waters tending to precipitate calcium carbonate (positive index) is generally considered less corrosive. During this study, no correlation between corrosion rate of mild steel and Langelier Index could be found. This is in agreement with other studies where no correlation could be found in mine waters^[4] or in potable waters^[5].
