SFD Promotion Initiative

Ugie

SFD Lite Final Report

SFD Lite Report Ugie, South Africa, 2018

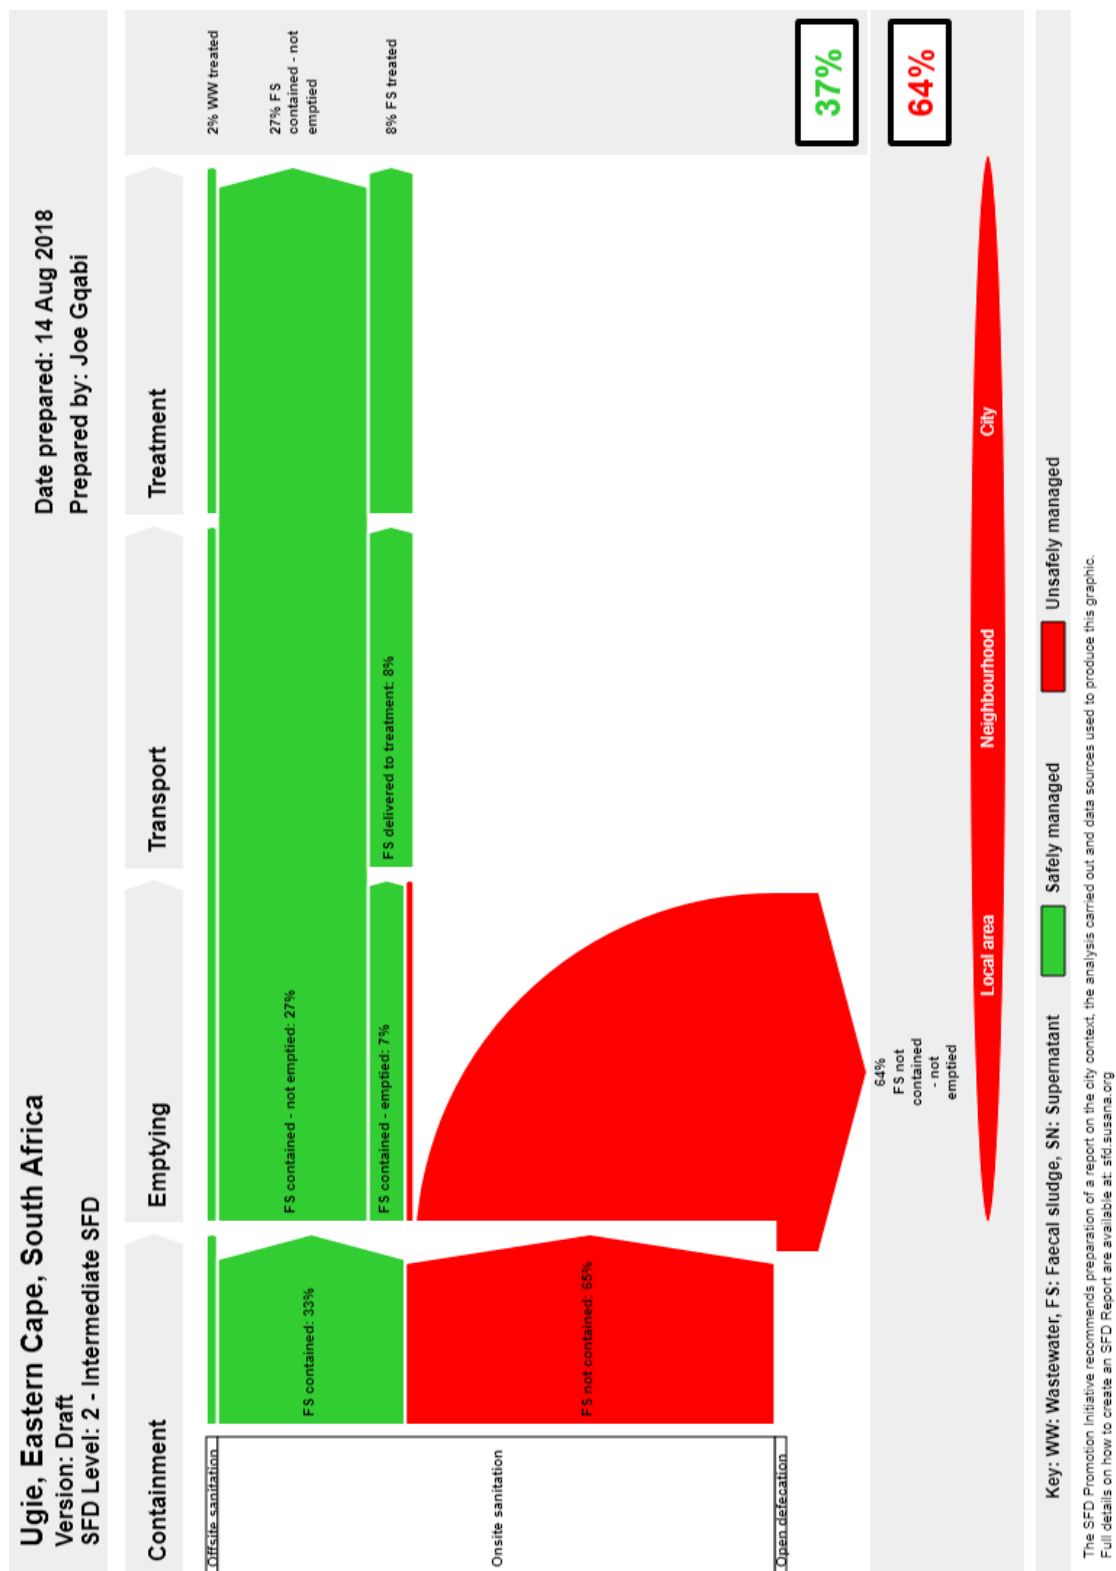
Figure 5: SFD matrix

The final SFD for Ugie is presented in **Appendix 6.1**.

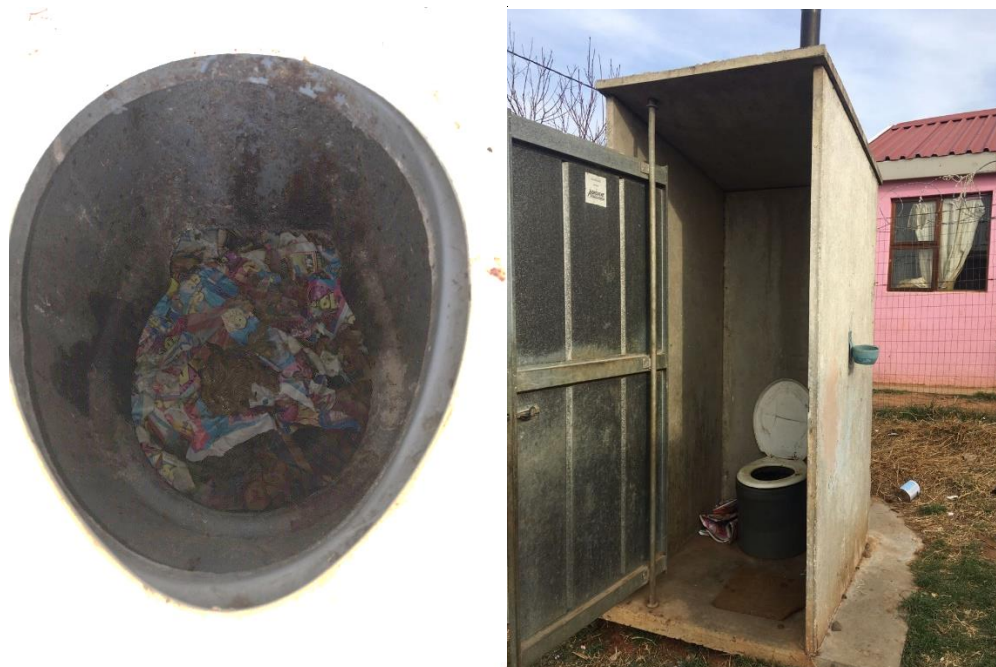
There are parts of Ugie urban and rural areas where communities use VIP toilets. To-date, these toilets have never been emptied. In rural areas, communities are used to covering up and abandoning a full VIP and relocating the VIP to a new location. In the urban context, limited space could prohibit this practice.

Figure 6: Example of near full VIP

There is a need to create awareness among the rural people about the need to ensure that pit latrines/VIPs are adequately sealed when closed/moved/new pit dug, and of the effects of using polluted water.

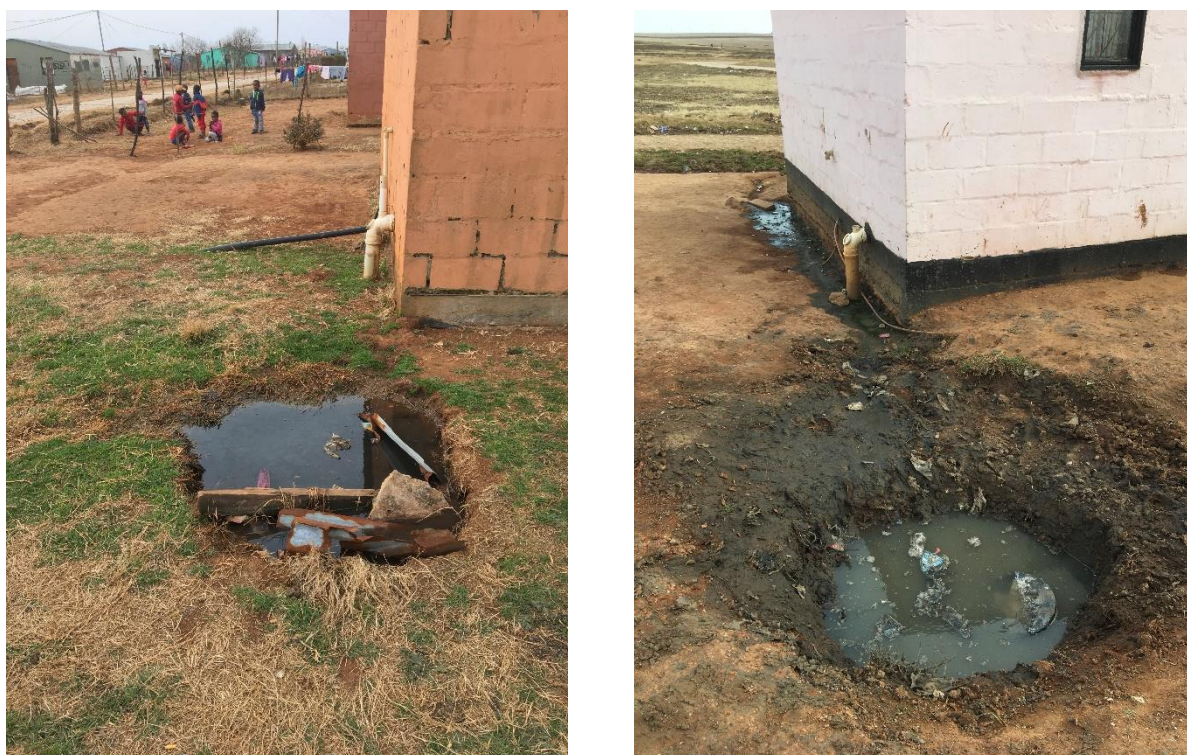
There are communal concrete tanks (~2.5 m x 2.5 m x 2 m) in Popcorn Valley serving approximately 56 low-income houses. These tanks often overflow/leak (blocked lines) resulting in unhygienic conditions and possible impacts on the Wildebeest River (distance of approximately 100 m to the river, and this is upstream of the drinking-water treatment plant inlet). These houses are provided with individual water connections. Each house has at least one flush toilet and a hand washbasin as standard sanitary fixtures. In Ugie Park, the community is served via communal concrete tanks, with flush toilets for approximately 8 to 10 households served by a communal concrete tank. These tanks regularly overflow/leak resulting in unhygienic conditions in large parts of the township. In other areas (e.g. Old Township, Ntokozweni, Mandela Park) flush toilets are either connected to a plastic or concrete tank. Regarding communal tanks, questions arising include:

Of concern, is that in the Popcorn Valley area, sanitation systems were overflowing (old concrete tanks, blocked sewerage lines), and that the pollution could reach the Wildebeest River. As this point is upstream of the intake to the drinking-water treatment plant, a concern exists that the Wildebeest River could be contaminated, and that the drinking-water supply could be compromised.

Figure 7: Evidence of full and overflowing containment tanks

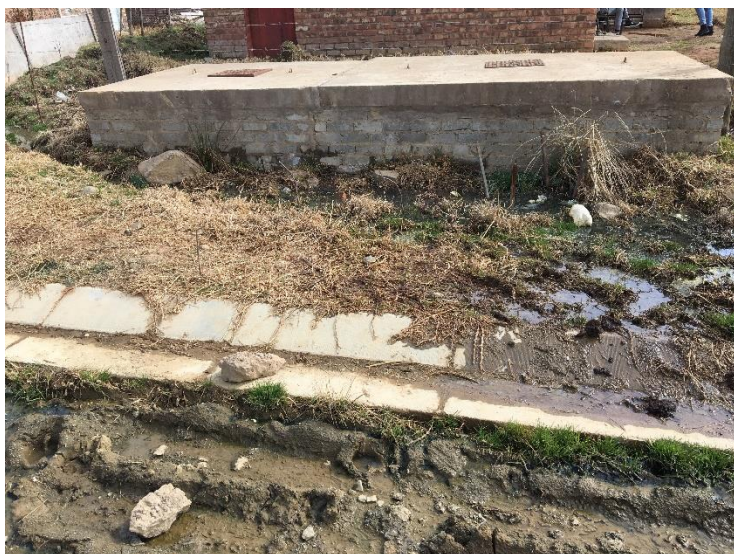
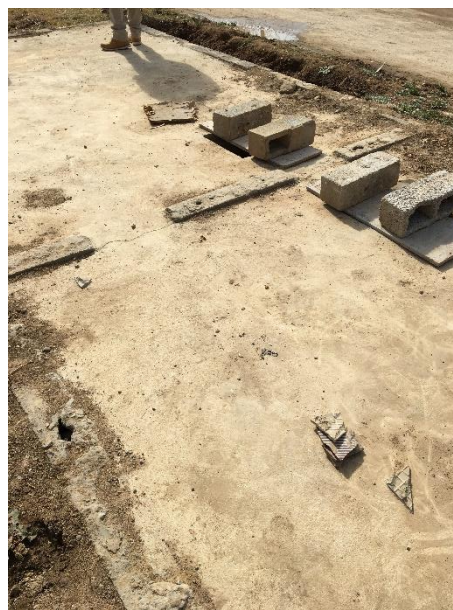
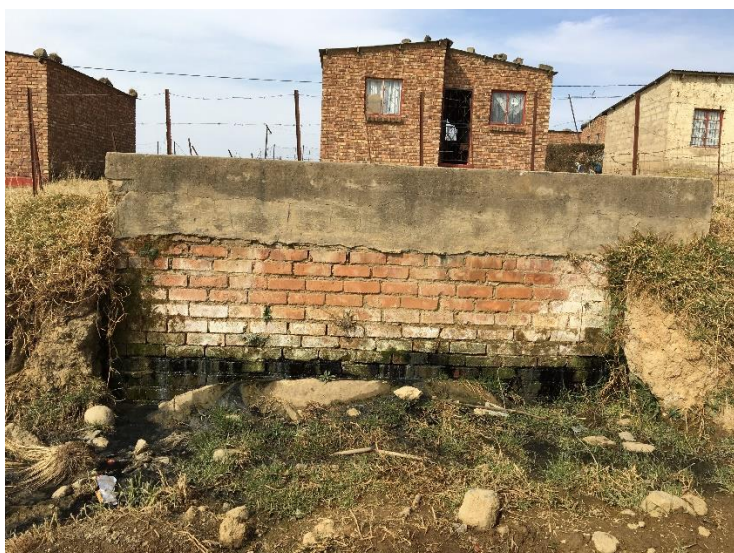
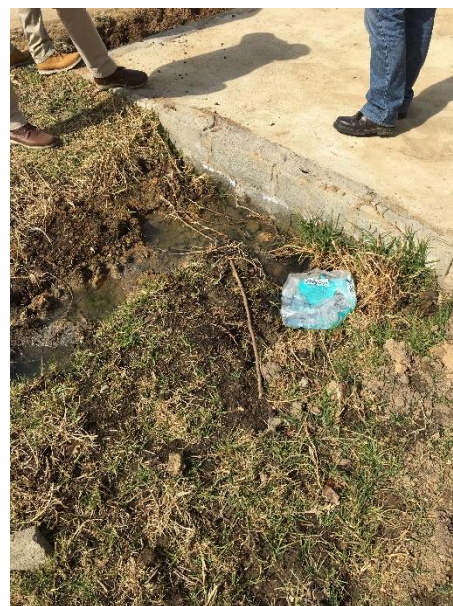
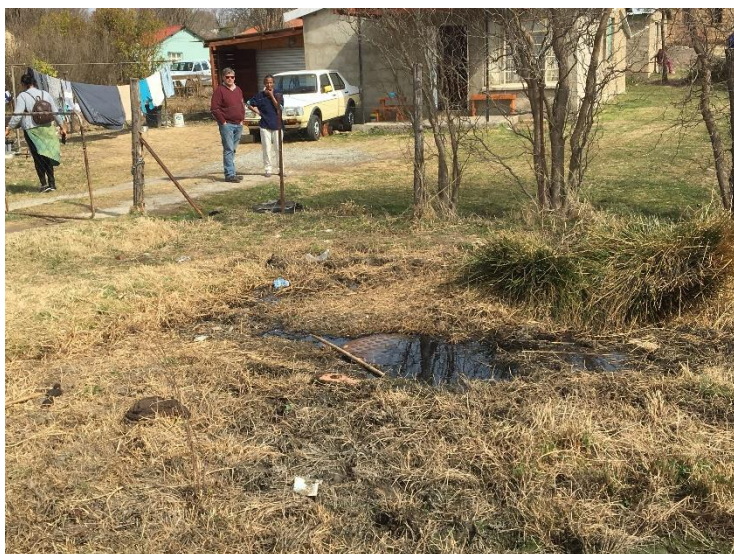
- Containment (fully lined tanks, partially lined tanks and pits, and unlined pits failed, damaged, collapsed or flooded – with no outlet or overflow – these are the tanks made from cement blocks with two compartments. Seepage emanating from these tanks through these blocks was noted.

Figure 8: Evidence of poorly constructed and leaking containment tanks

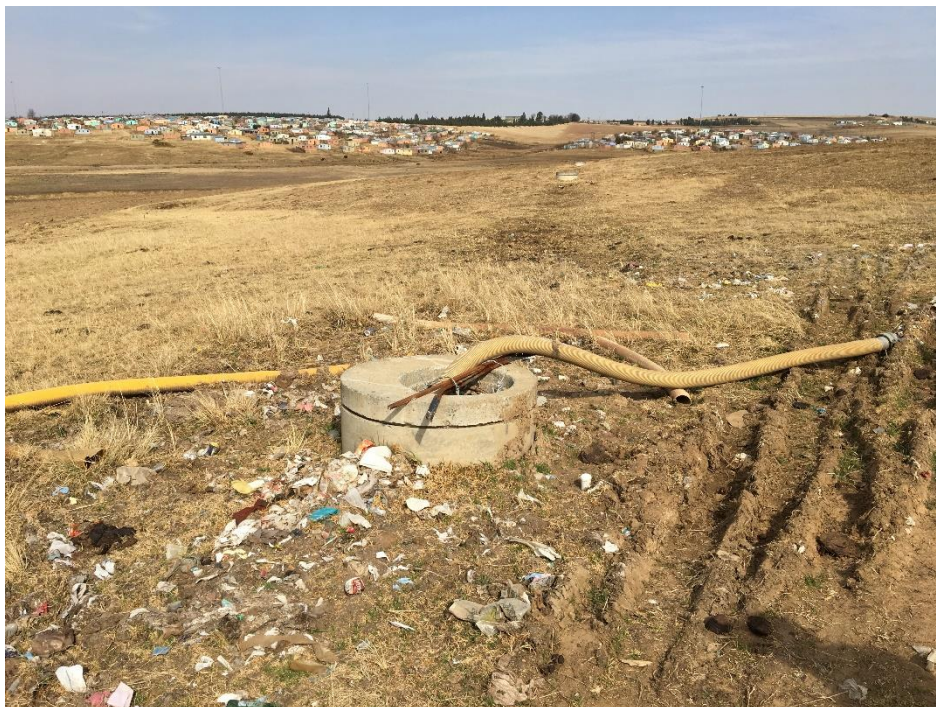
From the site inspection, there appeared to be some evidence of recent emptying at the Prentjiesberg WWTW, while there was little evidence of recent emptying at the Ugie Ponds. The staff at the Prentjiesberg WWTW indicated that to their knowledge only 2 vacuum trucks are operational, and that they deliver their sludge to the Ugie Ponds, and not to the Prentjiesberg WWTW.

Figure 9: Tanker discharge point at Prentjiesberg WWTW

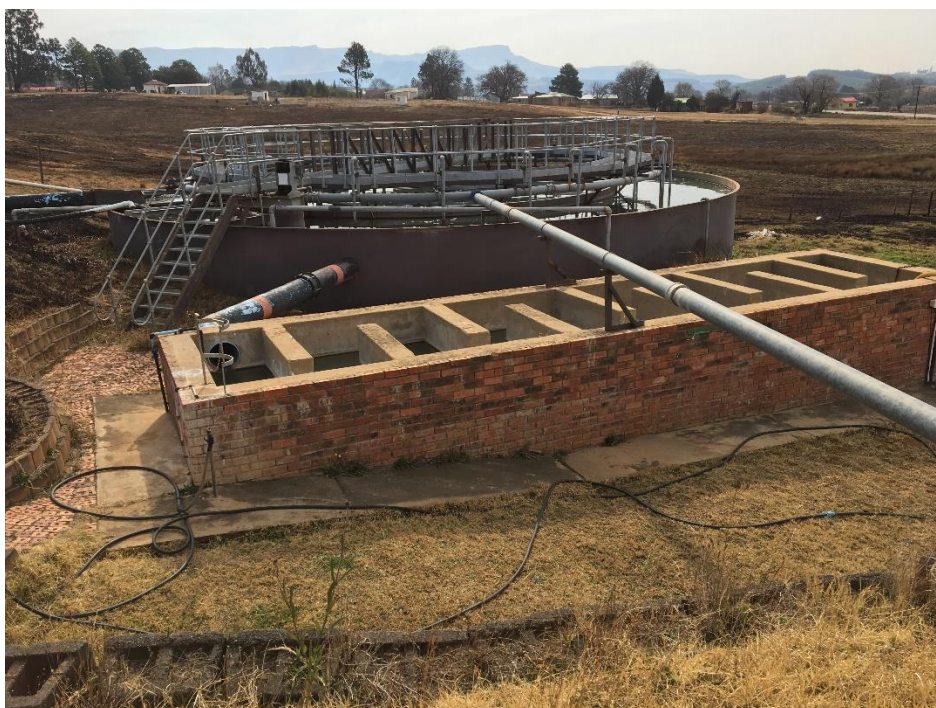
As previously noted, there is a limited sewerage network which conveys wastewater to the Prentjiesberg WWTW (design capacity: 0.59 ML/d). The works is based on activated sludge treatment

technology, with secondary treatment (aeration) and settling undertaken in one tank. Final effluent is disinfected before it is released to the Wildebeest River. The works are properly fenced with controllable access. At the time of the site inspection, the flow to the Prentjiesberg WWTW was very low. Evidence of effluent/sludge discharge from tanker trucks at the noted discharge point before the works was also visible. The on-site drying beds were empty, and appear to not be in use. The site was manned by a security officer, one process controller and a supervisor. A log-book with monitoring records of basic effluent quantity and quality parameters (e.g. flow, pH, free chlorine residual) was noted in the control room.

Figure 10: Prentjiesberg WWTW

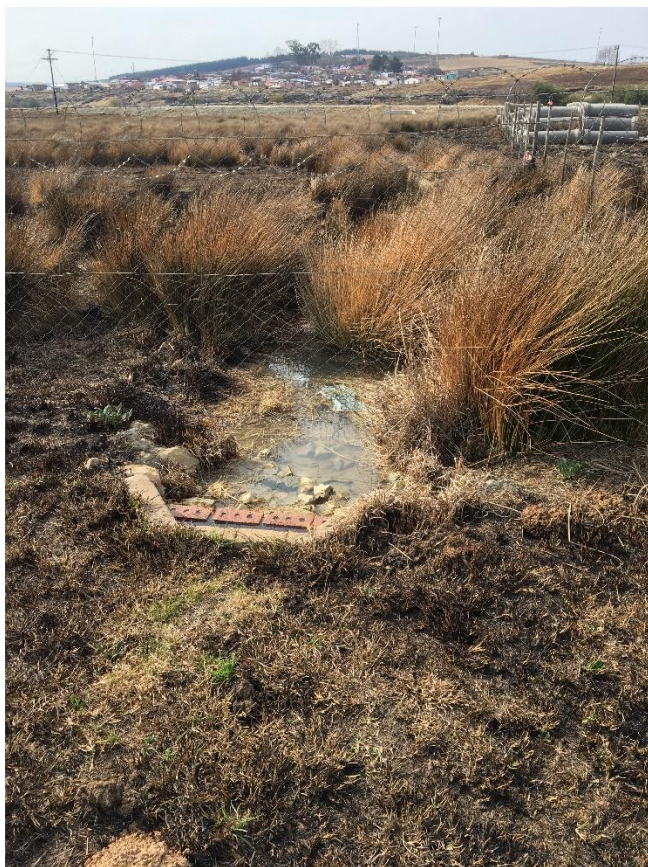
Figure 11: Treated effluent discharge from Prentjiesberg WWTW

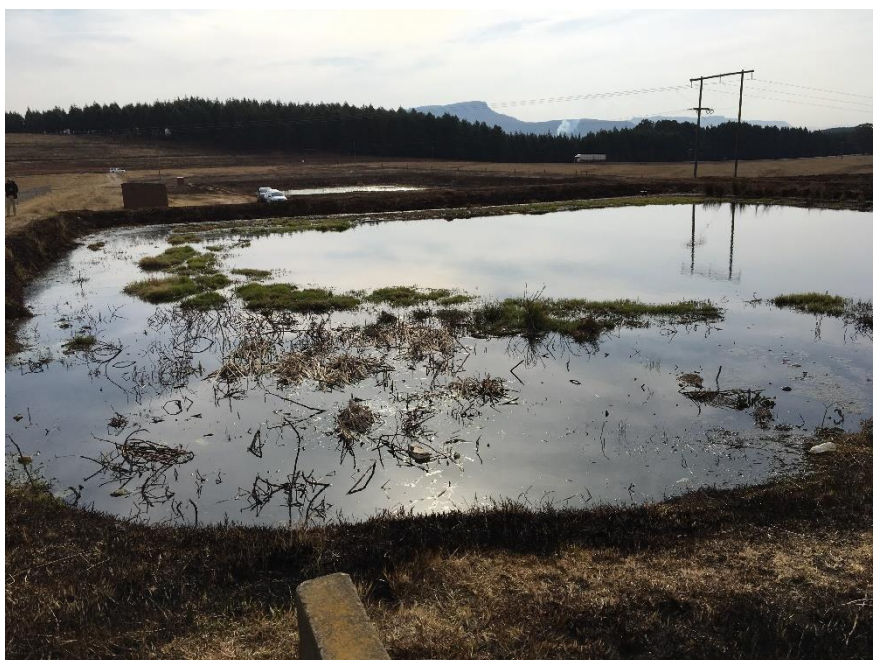
The Ugie Wastewater Oxidation Ponds (design capacity: 0.7 ML/d). The Ugie Ponds currently only accepts tankered effluent. It is planned that the Ugie Ponds will be phased out in the future and sewage/sludge will be redirected to the Prentjiesberg WWTW. The works are properly fenced and locked. At the time of the site inspection, no evidence of recent effluent/sludge discharge from tanker trucks at the noted discharge point to the Ugie Ponds was visible. Although sludge appears to be accumulating in the ponds (islands starting to be visible), the final maturation pond still appears to have sufficient capacity. The site was not manned, and no control room was noted (i.e. no monitoring records available on-site).

Figure 12: Ugie Ponds showing accumulated sludge
