GUIDELINES FOR PERMEABLE INTERLOCKING CONCRETE PAVEMENTS (PICP) IN SOUTH AFRICA

Volume 1: Clogging in Permeable Interlocking Concrete Pavement (PICP)

Report to the
WATER RESEARCH COMMISSION

WRC Report No. TT 913/1/23
ISBN 978-0-6392-0403-1

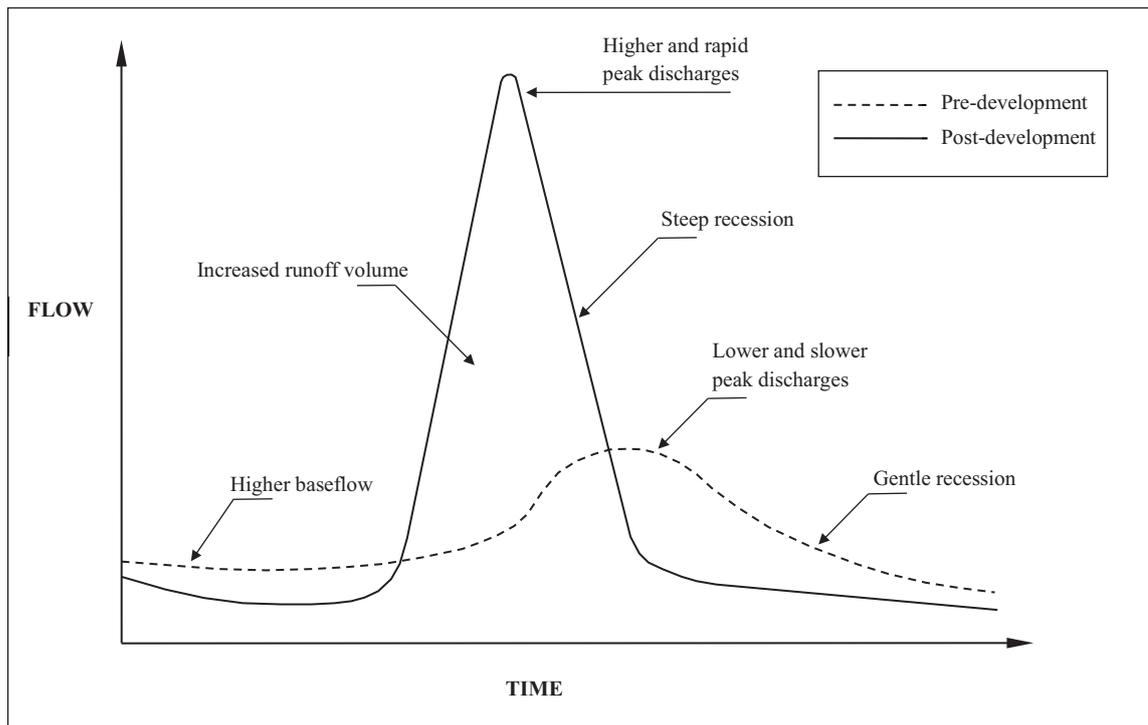
Figure 2-2: Pre-development versus post-development hydrology
(Armitage *et al.*, 2013)

Figures 2-1 and 2-2 show the general impact of development on the natural hydrology of an area. Meantime, there is increasing demand for access to water that needs to be brought into the urban environment over ever greater distances and higher costs. A more sustainable way of managing urban water is therefore required. This may be achieved through Water Sensitive Design (WSD) that strives to restore the pre-development hydrological conditions and encourage water reuse. The stormwater component of WSD is known as Sustainable Drainage Systems (SuDS) in SA and the United Kingdom (UK), Low Impact Development (LID) in the United States of America (USA), and Water Sustainable Urban Drainage (WSUD) in Australia.

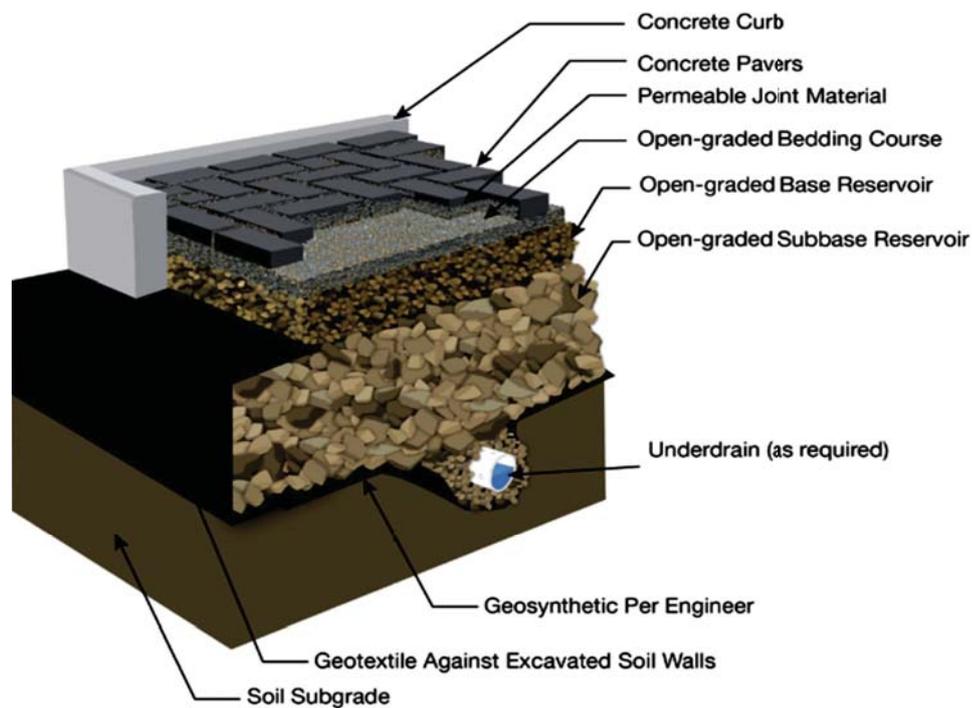
Figure 2-5: Typical PICP section (Smith, 2019)

Permeable Interlocking Concrete Pavement (PICP) comprises of modular paving blocks that have vertical grooves down their sides to create highly permeable ‘joints’ laid on open-graded or single-sized aggregate sublayers (Figure 2-5.). The grooves are filled with 2-5 mm gritstone to ensure high rates of runoff infiltration while trapping most sediments (Beecham *et al.*, 2010; Armitage *et al.*, 2013). A geotextile is sometimes fitted between the bedding layer and the base layer, and between the subbase and subgrade, to prevent the migration of different sized aggregate, improve the infiltrated runoff water quality, and protect the subgrade (CMAA, 2010).

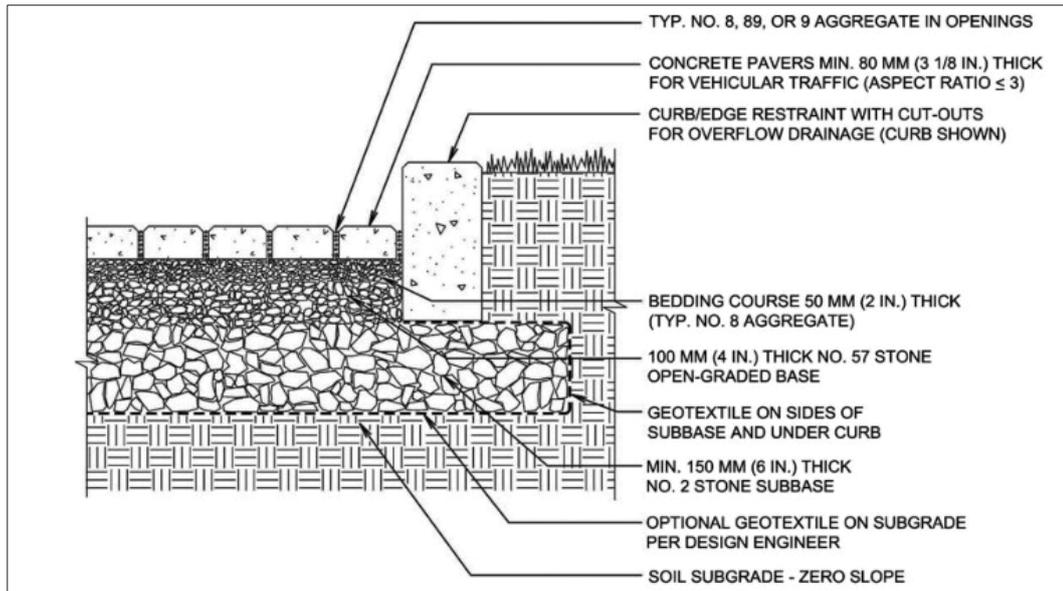
Figure 2-7: Typical full infiltration system design (ASCE, 2018)

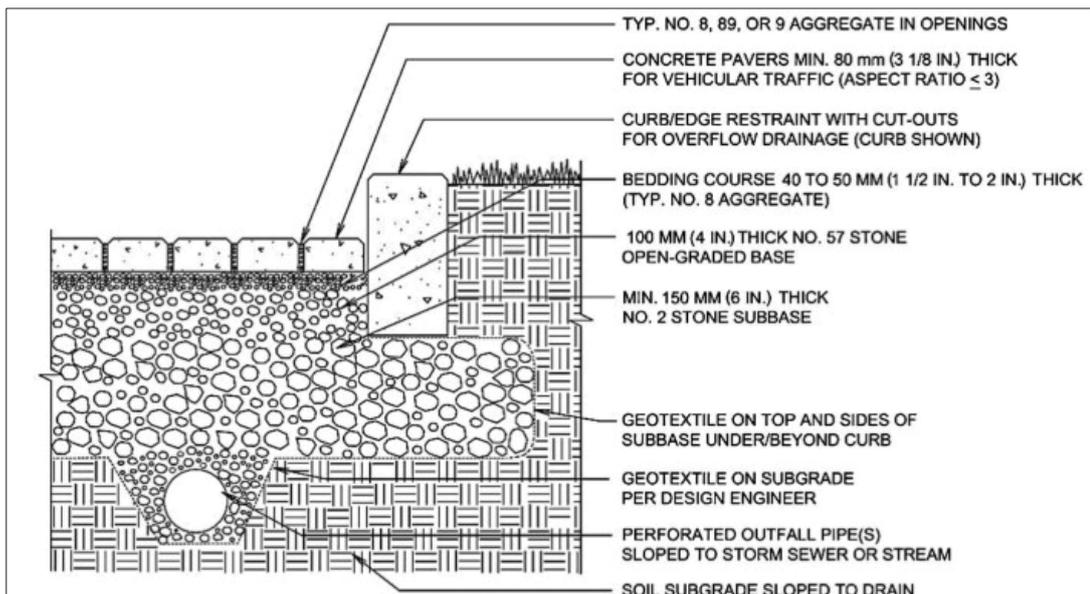
Figure 2-8: Typical Partial infiltration system design (ASCE, 2018)

Figure 2-8 illustrates the partial infiltration PICP system. This type of PICP cross-section is selected when the subgrade infiltration capacity is limited (Table 2-2). When it rains, runoff percolates into the pavement through the paver joints, into the aggregate storage, and partially into the subgrade. An underdrain is laid either on the subgrade or in the subbase to drain the excess runoff from the aggregate stone storage. The underdrain may be connected to a conventional stormwater line or discharged into other road site SuDS options such as a swale (Armitage *et al.*, 2013).

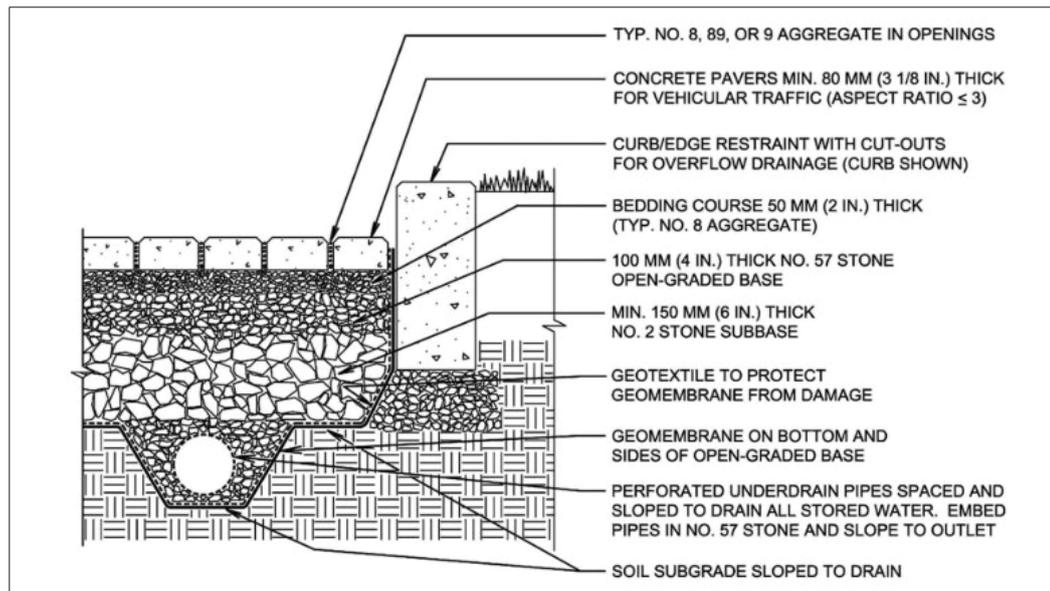
Figure 2-9: Typical no-infiltration system design (ASCE, 2018)

A no-infiltration PICP system design is shown in Figure 2-9. This system is used when the ground conditions are not suitable for stormwater ingress. The reasons may include *inter alia*: a water table is within 1 m of the pavement formation, the rainwater is to be harvested for further reuse, the pavement is situated on expansive or contaminated underlying soils, where the runoff is highly polluted, or when the pavement is installed within 3 m of a building wall (ASCE, 2018). Some of the criteria for this type of pavement cross-section are shown in Table 2-2.

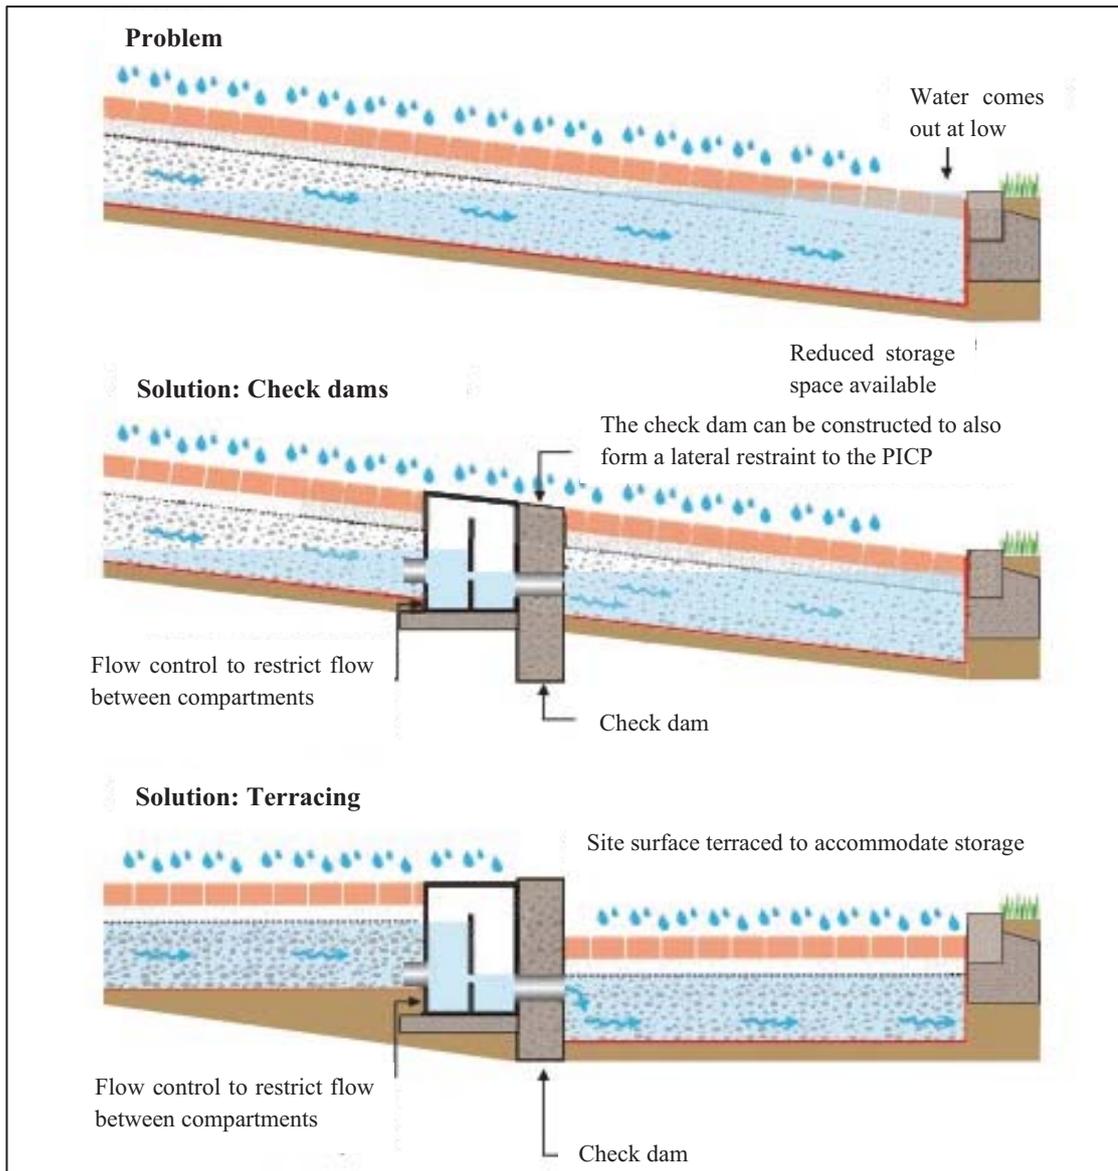
Figure 2-10: Managing runoff on a sloped subgrade
(After Interpave, 2018)

At times, it might be necessary to install PICP on sloped sites. Ideally, the PICP should be laid as flat as possible to maximise the available storage in the stone reservoir created by the single-sized aggregates, maximise the infiltration into the subgrade, and restrict lateral flow within the pavement structures (BSI 2009; WDNR, 2021), however, slopes less than 2% can usually be tolerated (Bruinsma *et al.*, 2017; NCDEQ, 2020). Once the surface slope of the PICP exceeds 5% there is a risk of water from running along the surface (ASCE, 2018). One way of reducing the effective slope is to lay the PICP in a series of level terraces with ramps linking them (NCDEQ, 2020). Alternatively, the PICP should be compartmentalised to maximise storage. Figure 2-10 presents the various options.

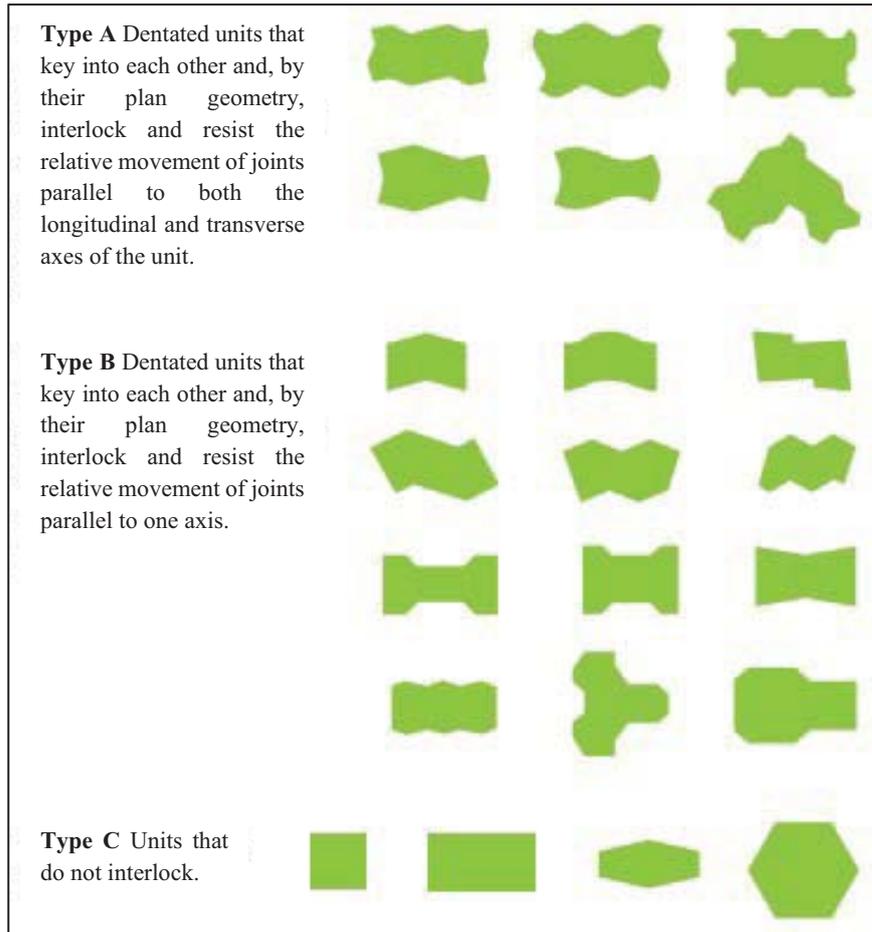
Figure 2-12: Some paver shapes (After CMAA, 2014)

It is recommended that pavers are laid at either 45° or 90° to the pavement edges in a herringbone laying pattern which is considered to have the best load transmission and interlock relative to other laying patterns such as parquet and stretcher bonds (CMAA, 2010; ASCE, 2018) (Figures 2-12 and 2-13). CMAA (2014) suggest that dentated geometry pavers have a better interlock than rectangular shaped pavers and better resist longitudinal and transverse movements due to vehicular dynamic movements through transference of traffic load between adjacent pavers. For example, pavers with nibs, for instance, e.g. the Priora® block, have the potential to restrict vertical, horizontal and rotational movements due to increased block-to-block contact by as much as 40% over a standard PICP block (Marshalls, 2013).

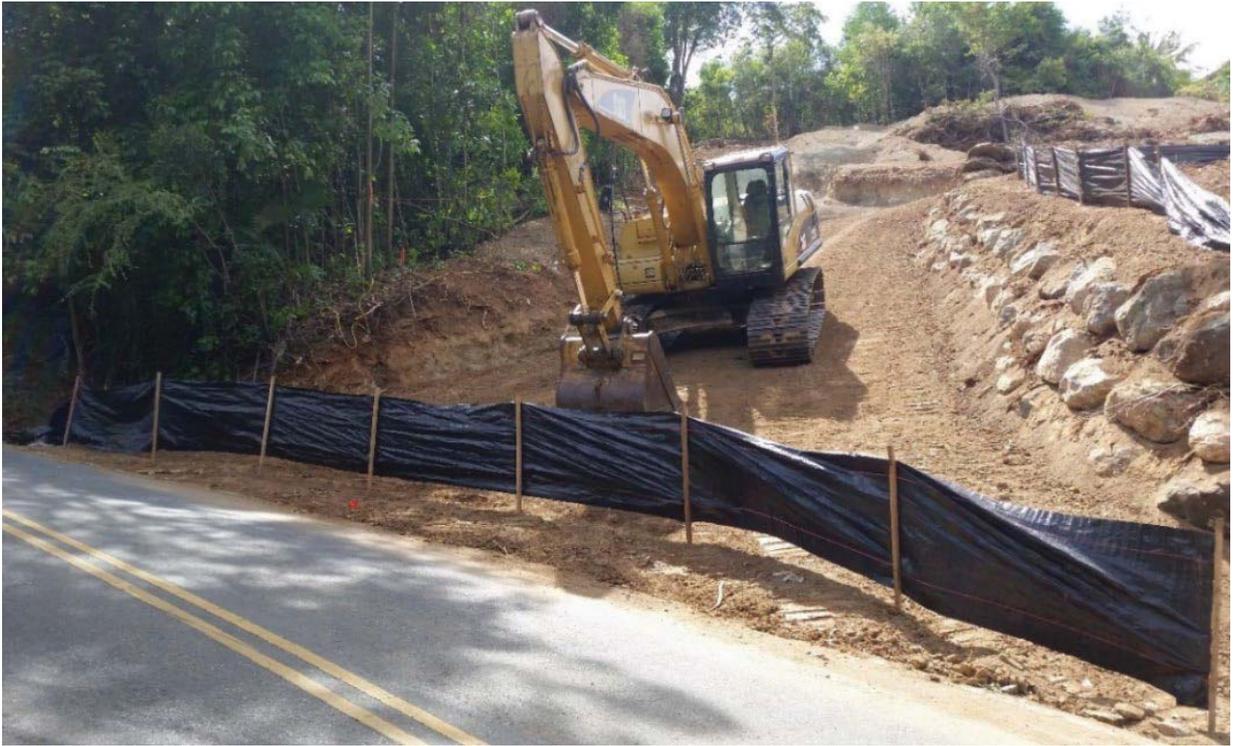
Figure 2-20: Inadequate sediment trap installation (St John Source, 2022)

Special care is required to install these measures as inappropriate installations could lead to catastrophic pavement sediment exposure. Figure 2-20 shows a sediment trap geotextile that has been incorrectly installed with a gap underneath that will allow sediment to flow onto the pavement.

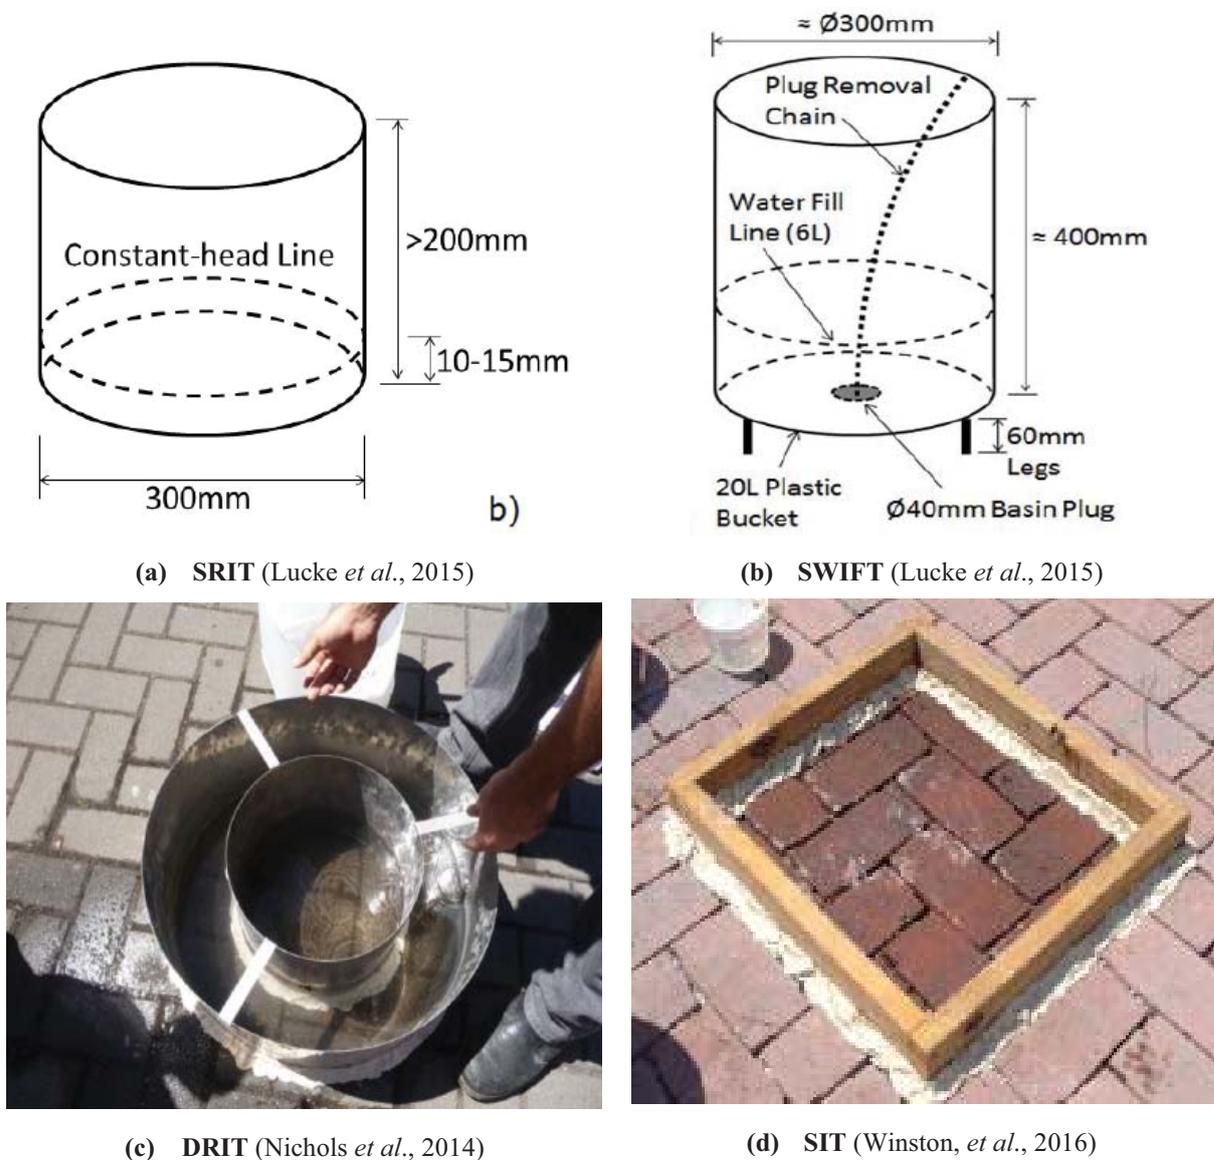
Figure 2-23: Different infiltration tests

The hydraulic performance of PICP installation is generally measured using surface infiltration tests. A commonly used standard infiltration test procedure is the Single Ring Infiltrometer (SRIT) (ASTM C1781-2017) (Lucke *et al.*, 2015; ASCE, 2018). Other tests include the: the Double Ring Infiltrometer (DRIT) (ASTM D3385-2009) (Nichols *et al.*, 2014); the Stormwater Infiltration Field Test (SWIFT); the Simple Infiltrometer Test (SIT); and the Full-Scale Infiltration Test (FSIT) (Lucke *et al.*, 2015; Marchioni & Becciu, 2015; Veldkamp *et al.*, 2022). The tests are all presented in Figures 2-23 and 2-24. The four most common methods are summarised in Table 2-6. More detailed information follows.

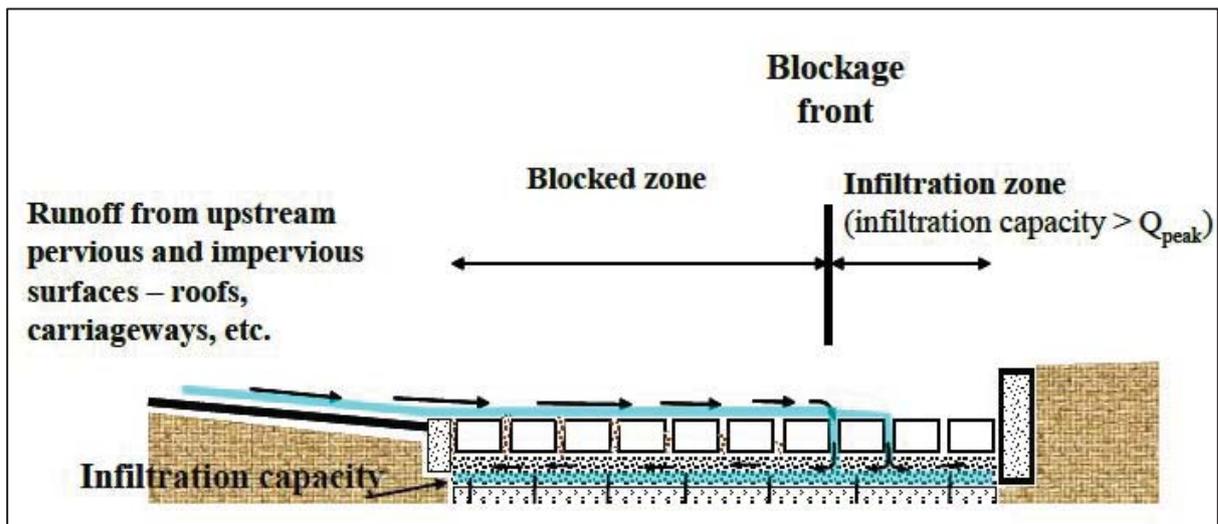
Figure 2-26: Summary of the PICP clogging process (Beecham *et al.*, 2010)

Stormwater runoff carries many different types of sediment such as: flakes off vehicle tyres, plastics, loose fine material, tree leaves and cigarette butts, and these may get trapped between the joints. The material tends to build up on the PICP from the edges – that generally receives the heaviest sediment loading – towards the central part in the form of a clogging front between the relatively blocked zone and the relatively unblocked zone (Figure 2-26). For practical reasons, a measured infiltration capacity of less than 250 mm/hr is usually considered to be effectively blocked with a need for restorative maintenance (ASCE, 2018; Tirpak *et al.*, 2021). The infiltration capacity of the restored pavement should be greater than 250 mm/hr or increased by at least 50% of the pre-maintenance infiltration rate (ASCE, 2018; WDNR, 2021).

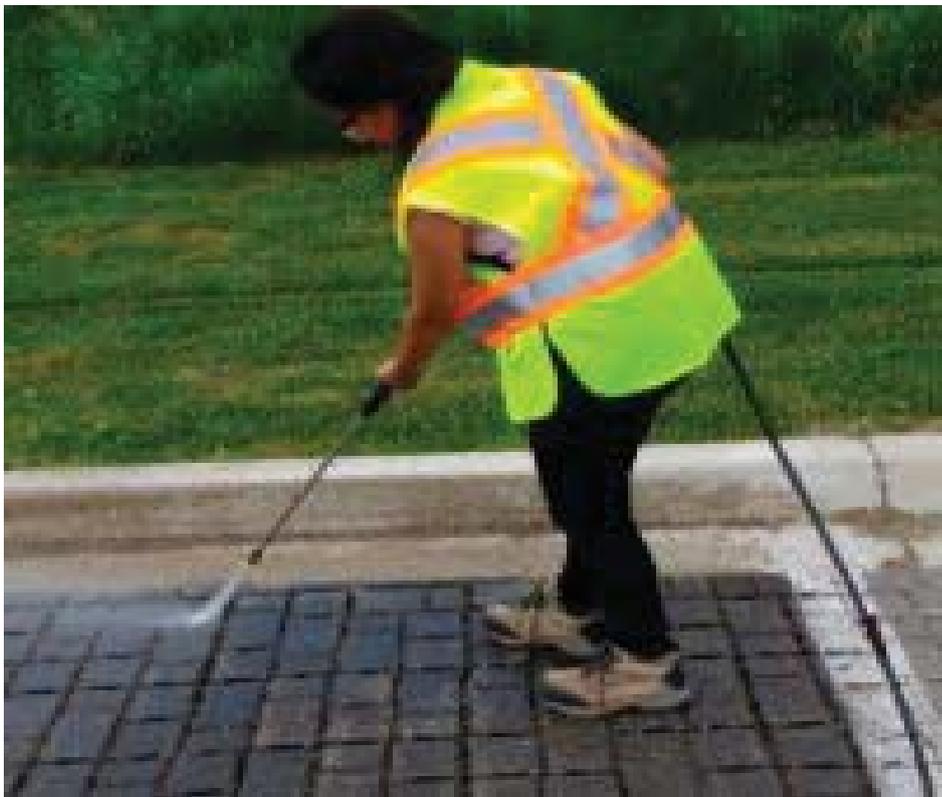
Figure 2-33: Water jetting (Sehgal *et al.*, 2018)

Power washing consists of a forcing water at high pressure through a nozzle to form a jet directed along the joints of the pavement to loosen the sediment (Drake *et al.*, 2020) (Figure 2-33). The sediment is picked up by vacuum suctioning (Sehgal *et al.*, 2018). When used in combination with either a manual vacuum or regenerative sweeper, it can restore the PICP infiltration capacity between 25% and 505% (Drake *et al.*, 2020; Simpson *et al.*, 2021). Danz *et al.* (2020) found that power washing can improve the surface infiltration of PICP by 172% when used in conjunction with application of three vacuum sweeper passes. Simpson *et al.* (2021) showed that the power washer alone can restore infiltration rates in wide-jointed pavers (13-14 mm) by up to 149%. Despite its significant surface improvement, the power washer is however likely to push some fine sediments deeper into the pavement structure consequently contributing to the long-term clogging of the pavement.

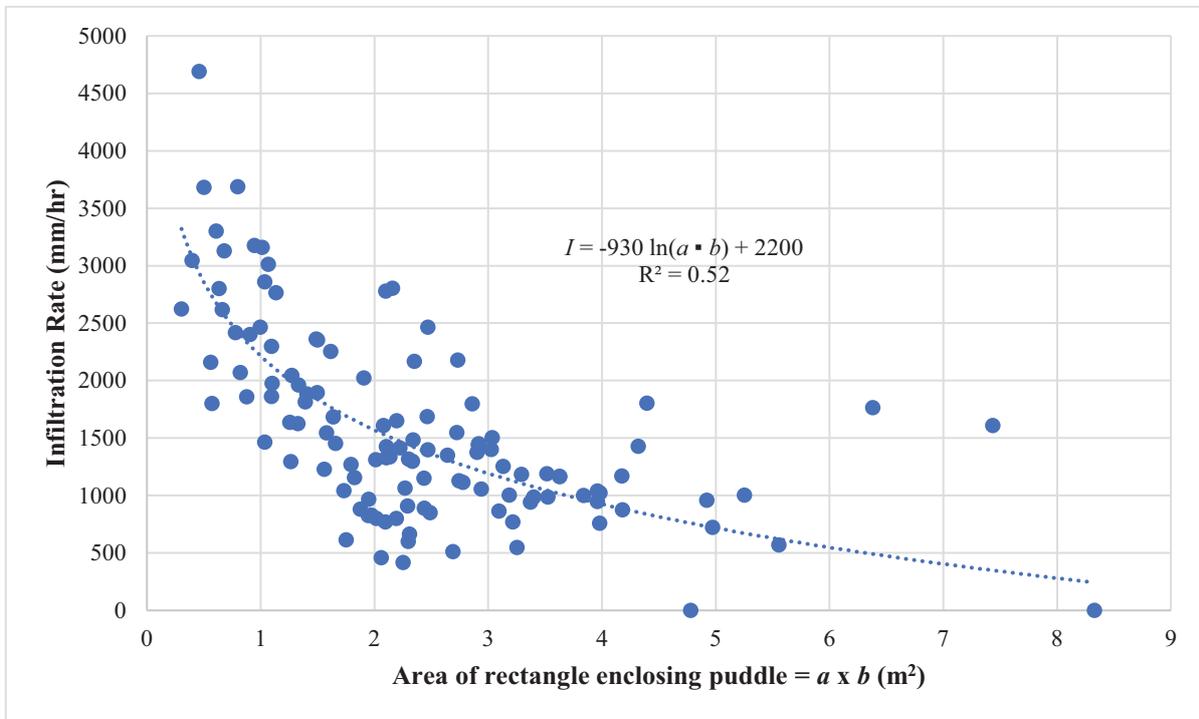
Figure 3-5: Plot of Mod-ASTM infiltration rate to representative wetted area in the Mod-SWIFT (Armitage, 2019)

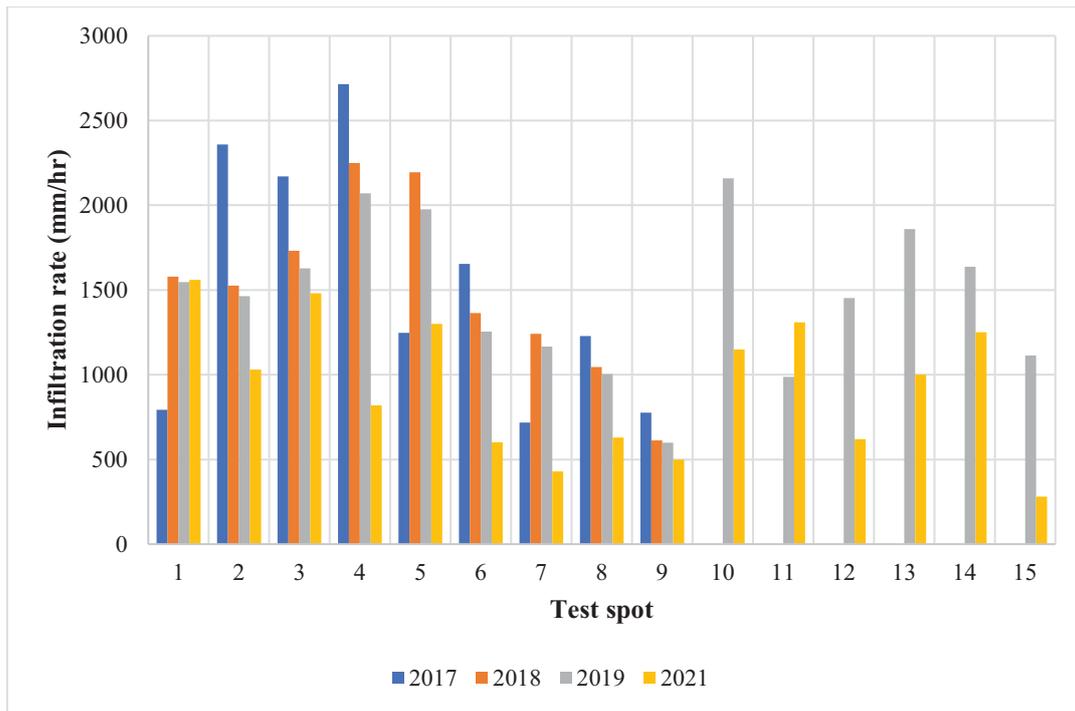
Figure 4-9: 2017-2021 BRM ASTM infiltration rates
 (After Artus, 2017; Vella, 2018; Barnard, 2019; Matolengwe, 2021)

Figure 4-9 presents the measured infiltration rates. The infiltration capacity of the PICP site had decreased with age from 2017 to 2021 at Test spots 2 to 9. Test spots 10 and 12 to 15 illustrate the same pattern of infiltration capacity drop with the age of PICP from 2019 to 2021. The outliers were test spots 1 and 11 both of which were both located within parking bays. Most of the infiltration capacities were below 2000 mm/hr in 2017 except for Test spots 2, 3, and 4. By 2018, the infiltration rates for Test spots 2 and 3 had also decreased to below 2000 mm/hr. Generally, the test spots located along the vehicle roadways had lower infiltration rates than those located within the parking bays. By 2021, all infiltration rates had dropped although none were less than 250 mm/hr – the benchmark used to indicate total blocking (measured infiltration rates likely to be more leakage than infiltration). The lowest infiltration rate recorded in 2021 was 280 mm/hr for Test spot 15, while the highest was only 1600 mm/hr for Test spot 1. For Test spots 1 to 5, the infiltration capacities had dropped despite the maintenance that was performed in 2021 indicating that maintenance only temporarily improves PICP infiltration rate, it does not fully restore it. Over the period 2017 to 2021, the BRM PICP maintenance was being performed on a three-year cycle.

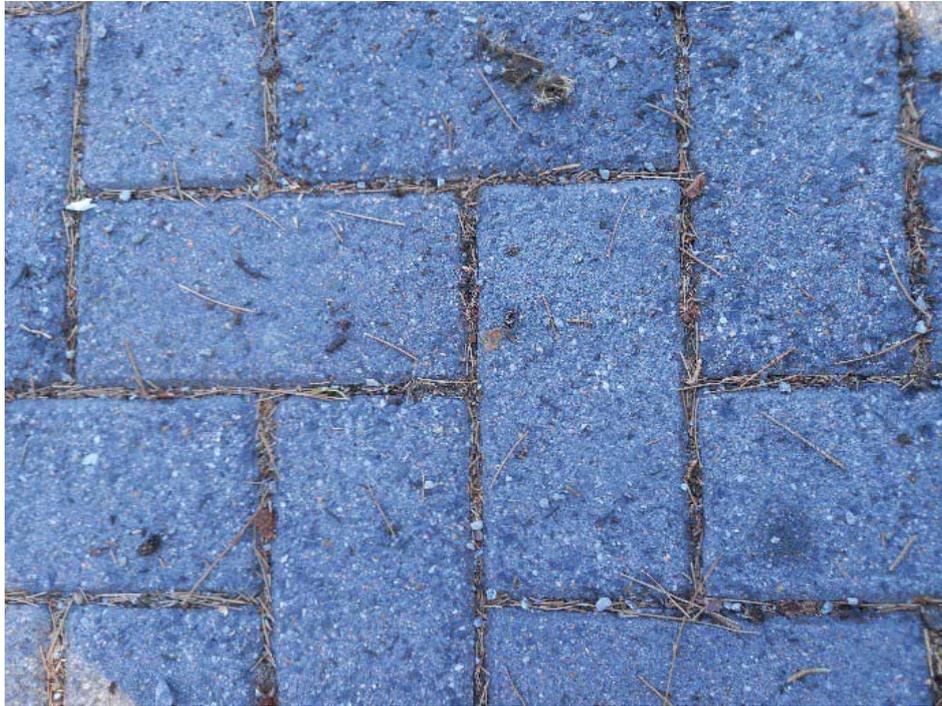
Figure 4-12: Typical PICP section with needle-shaped leaves wedged in the joints

– probably at the base of the joints (Type II). This is likely to increase with the age of the pavement.

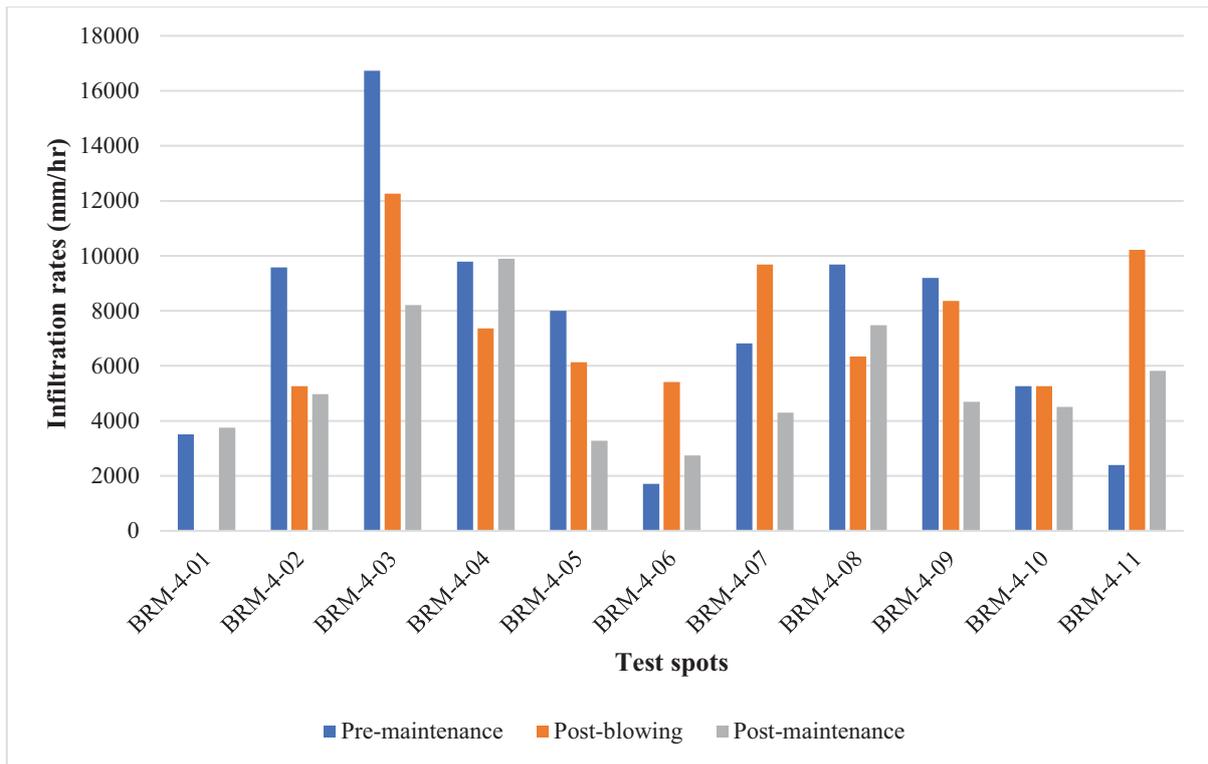
Figure 4-13: BRM Area 4 test infiltration rates

Overall, air blowing had a variable impact – with an improvement of 144% observed in one case, but a drop of 59% in another. On the whole, however, the post-maintenance infiltration rates were mainly above 2000 mm/hr which is considerably above the nominal clogged rate of anything below 250 mm/hr.

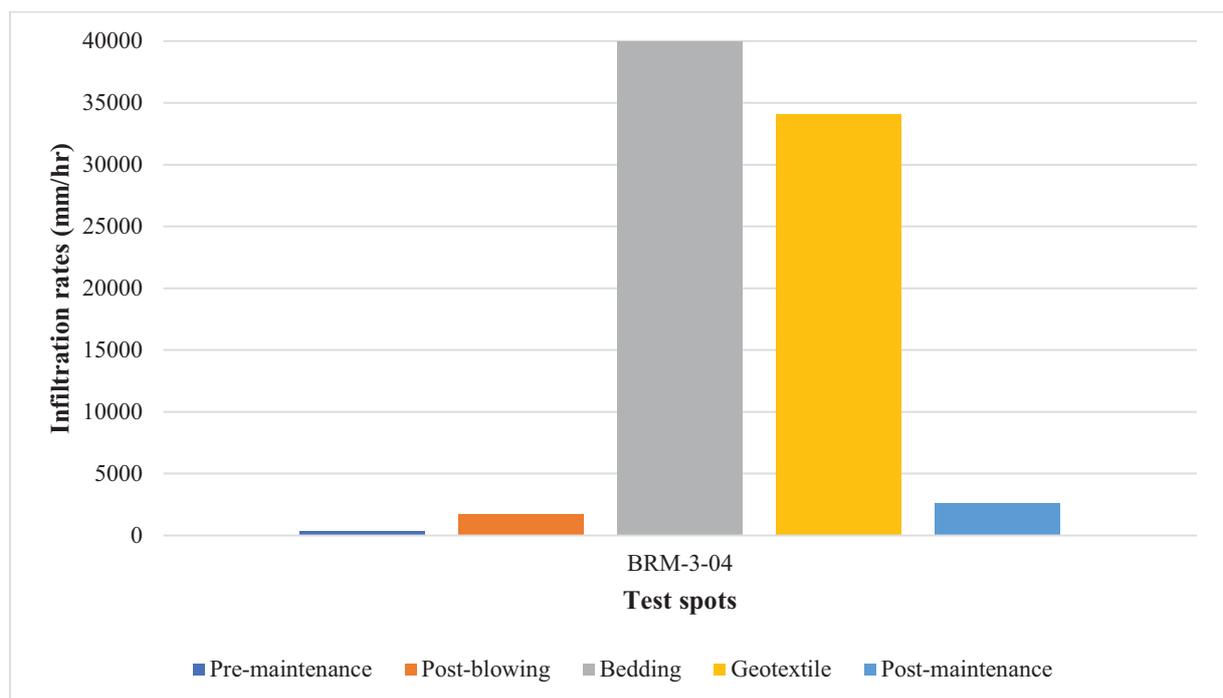
Figure 4-15: BRM Area 3 PICP diagnostic assessment infiltration rates

A diagnostic assessment was performed on Test spot BRM-3-04 with the measured infiltration rates given in Figure 4-15. The sediment in the joints was intermixed with the joint material (Figure 4-16 (a)) for the top 25 mm (Type I clogging). However, the sediment outlining the paver pattern on the bedding (Figure 4-16 (b)) suggested that Type II clogging was also taking place. On the other hand, the geotextile was intact with only small quantities of trapped sediment. When cut, it was evident that the underlying aggregate layers were clean (Figure 4-16 (c)).

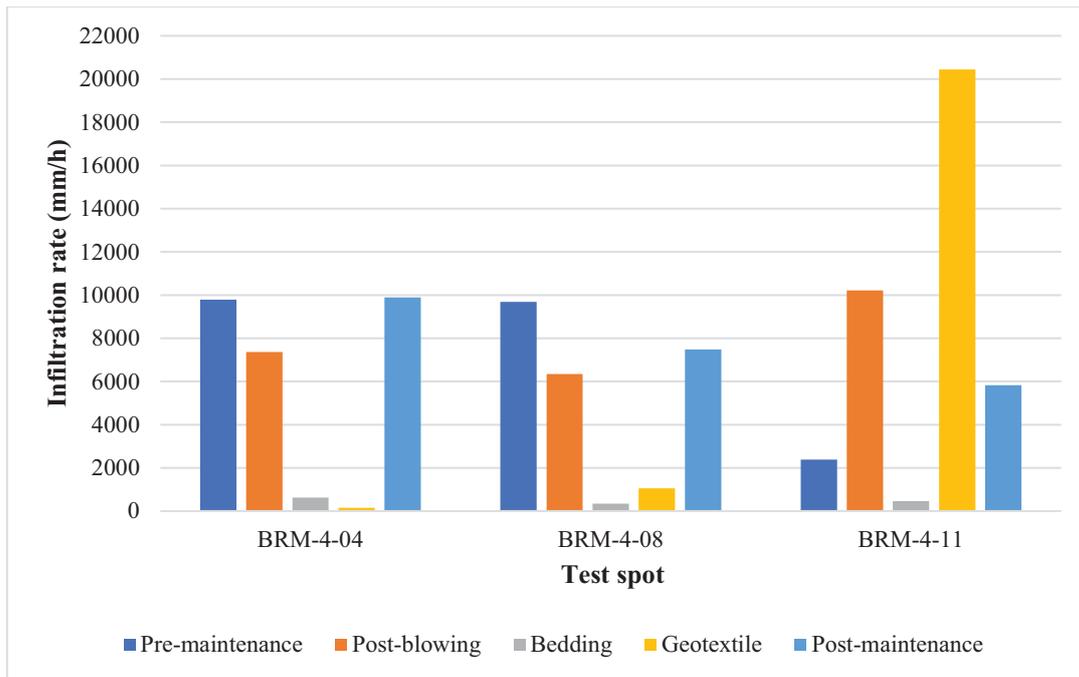
Figure 4-17: BRM Area 4 PICP diagnostic assessment infiltration rates

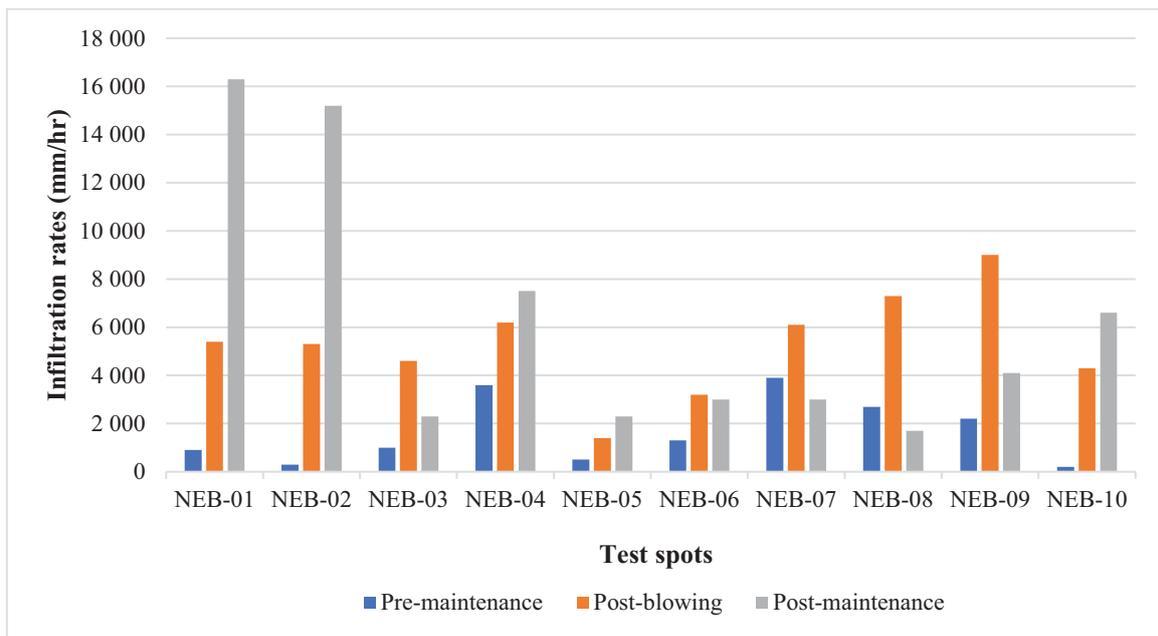
Figure 4-27: NEB Mod-ASTM maintenance infiltration tests

Test spots NEB-01 and NEB-02, and NEB-03, NEB-04, and NEB-05 were adjacent to each other and thus relatively exposed to the same environmental conditions but differed in the use of a geotextile under the bedding layer. Infiltration testing was carried out: pre-maintenance, post-blowing, and post-maintenance (Figure 4-27).

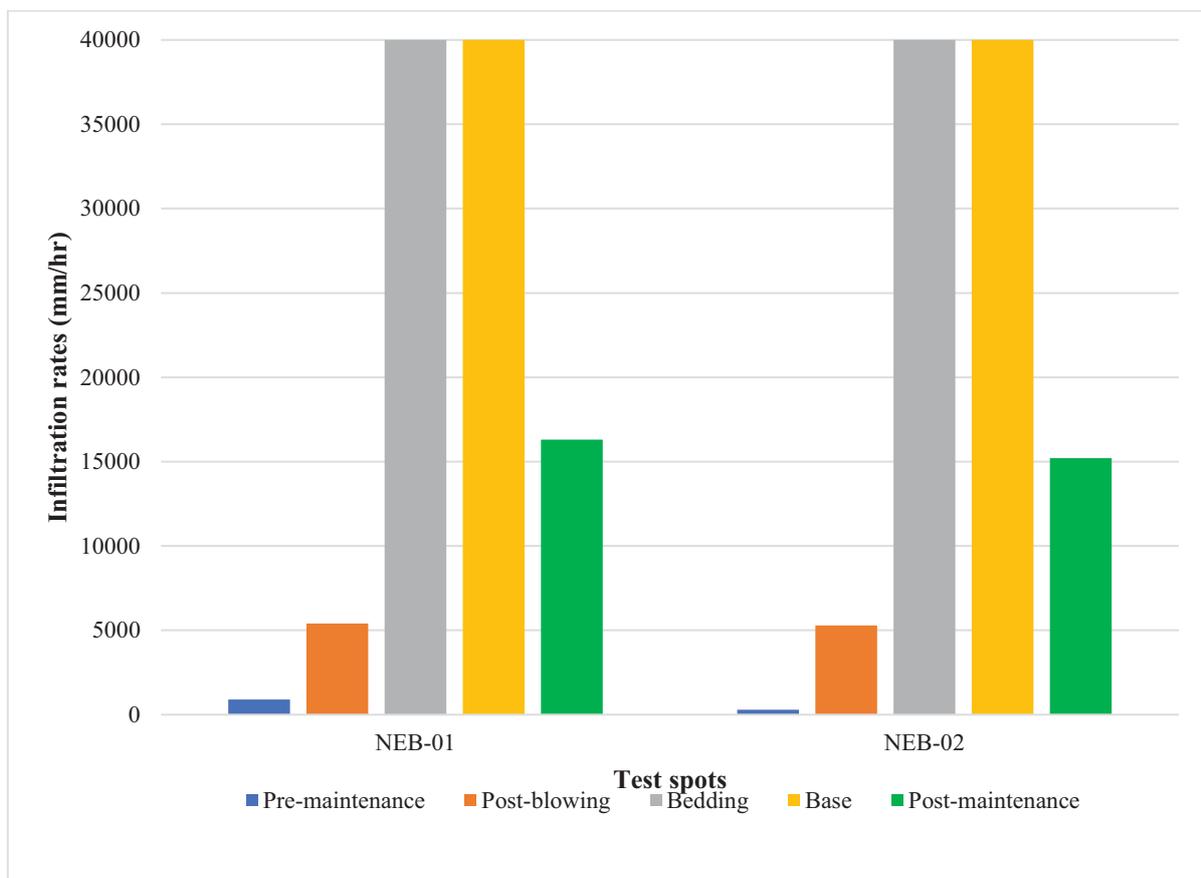
Figure 4-29: NEB no-geotextile design diagnostic assessment infiltration rates

Test spots NEB-01 (parking bay) and NEB-02 (roadway) were located in the area of PICP without a geotextile under the bedding layer. The measured infiltration rates presented in Figure 4-29 displayed similar performance. The bedding and base infiltration rates of the two test spots were both recorded as 40,000 mm/hr because the infiltration rates were so high that they could not be measured and thus it was assumed that they were probably in the order of clean coarse-grained aggregates or greater than 36,000 mm/hr. Both test spots showed a good response to maintenance (air-blowing); the measured infiltration rates for NEB-01 increased from 900 to 16,300 mm/hr, while those for NEB-02 increased from 300 to 15,200 mm/hr.

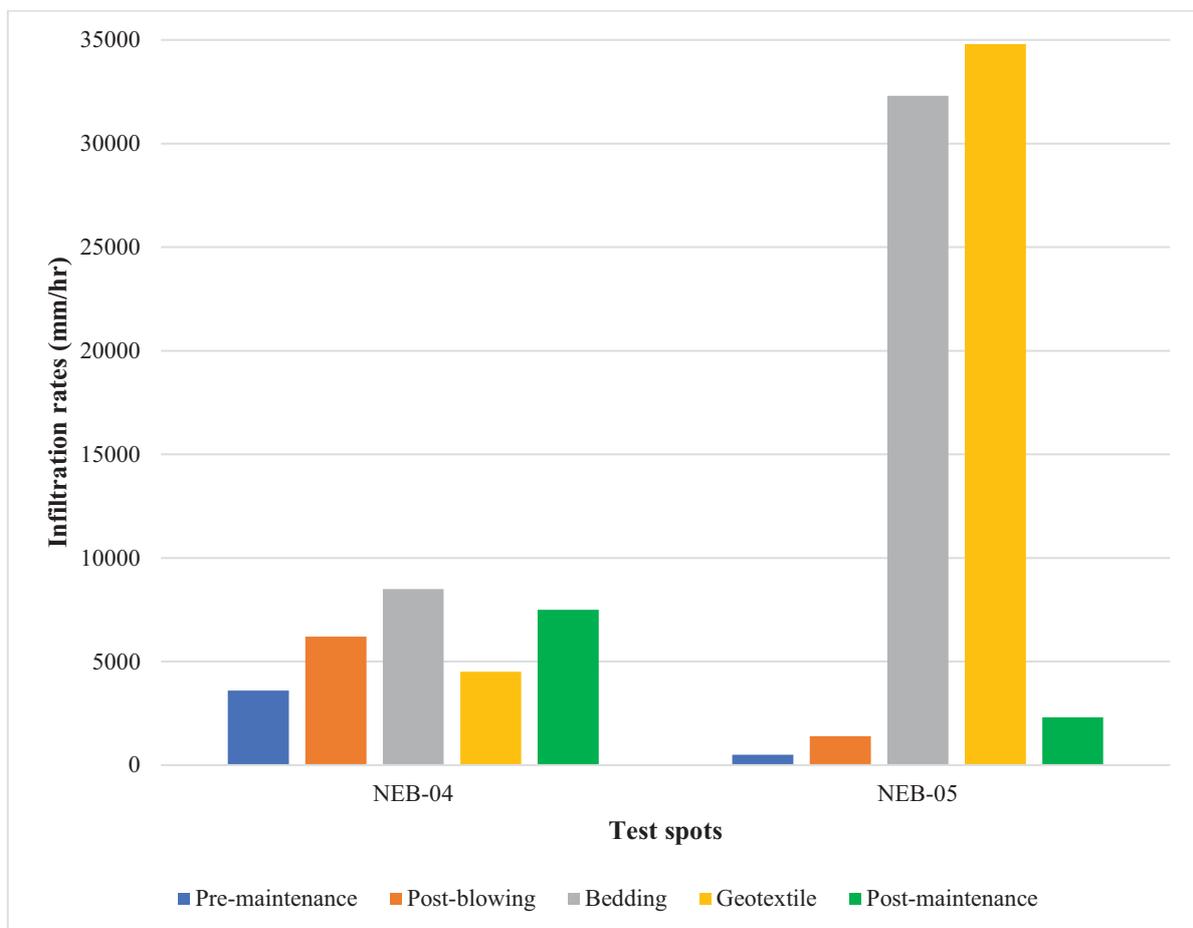
Figure 4-31: NEB geotextile design diagnostic assessment infiltration rates

Diagnostic assessments on the PICP area with an underlying geotextile were performed on Test spots NEB-04 (roadway) and NEB-05 (parking bay) (Figure 4-31). There was a significant difference between the test spots infiltration rates. NEB-04 showed a higher pre-maintenance infiltration rate than NEB-05 but this did not extend to the bedding and geotextile infiltration capacities. This could have been because the site chosen happened to be where the geotextiles overlapped (NEB-04) thus reducing the geotextile infiltration capacity (Rowe *et al.*, 2009). The infiltration capacities after the maintenance trials of the two test spots improved by 108% and 360% for NEB-04 and NEB-05 respectively.

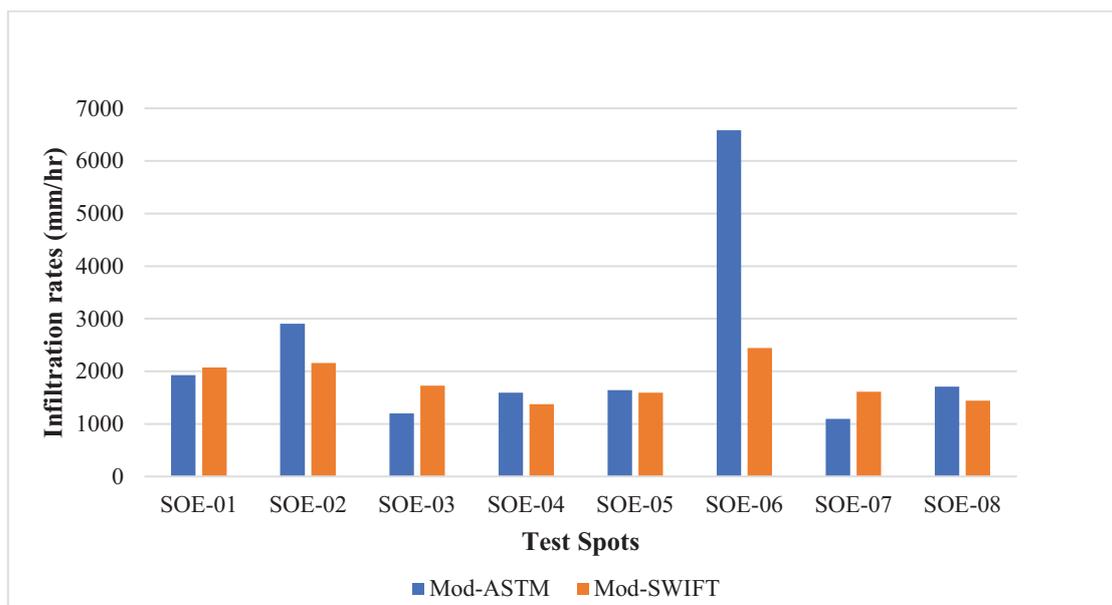
Figure 4-39: SOE surface infiltration rates

Figure 4-38 shows the position of the infiltration test spots at the SOE. The choice of the test spots was based on the desire to provide some variation in the proximity to vegetation and include both the parking area and vehicle roadway. The infiltration test results are shown in Figure 4-39.

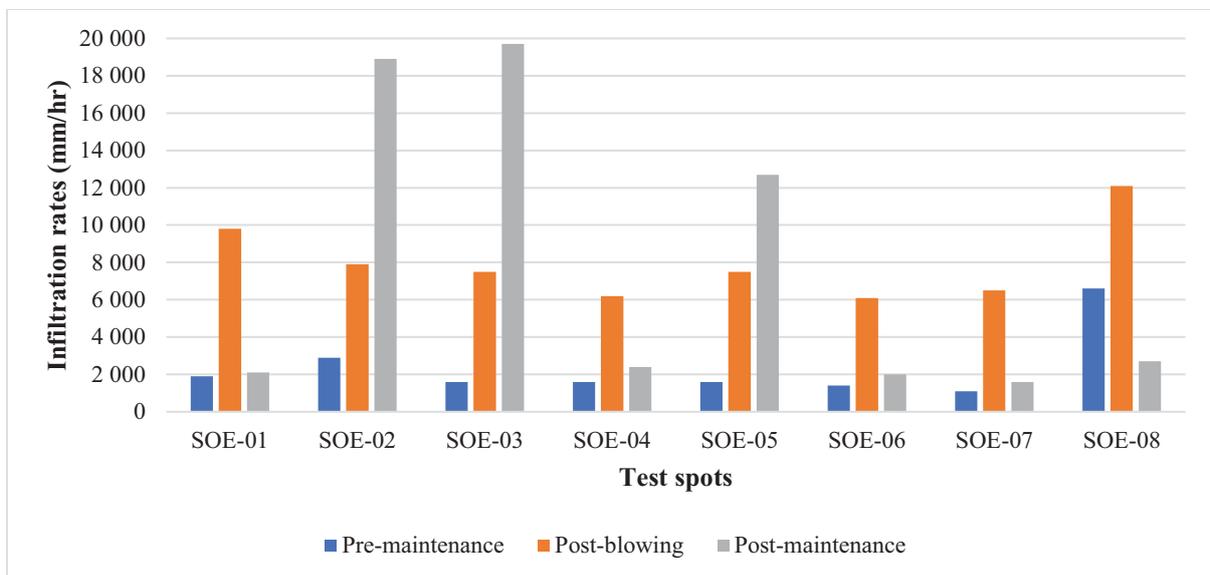
Figure 4-41: SOE infiltration measurements

Figure 4-41 presents the Mod-ASTM pavement maintenance infiltration rates for the test spots shown in Figure 4-38.
