GUIDELINES FOR PERMEABLE INTERLOCKING CONCRETE PAVEMENTS (PICP) IN SOUTH AFRICA

Volume 1: Clogging in Permeable Interlocking Concrete Pavement (PICP)

Report to the
WATER RESEARCH COMMISSION

WRC Report No. TT 913/1/23
ISBN 978-0-6392-0403-1

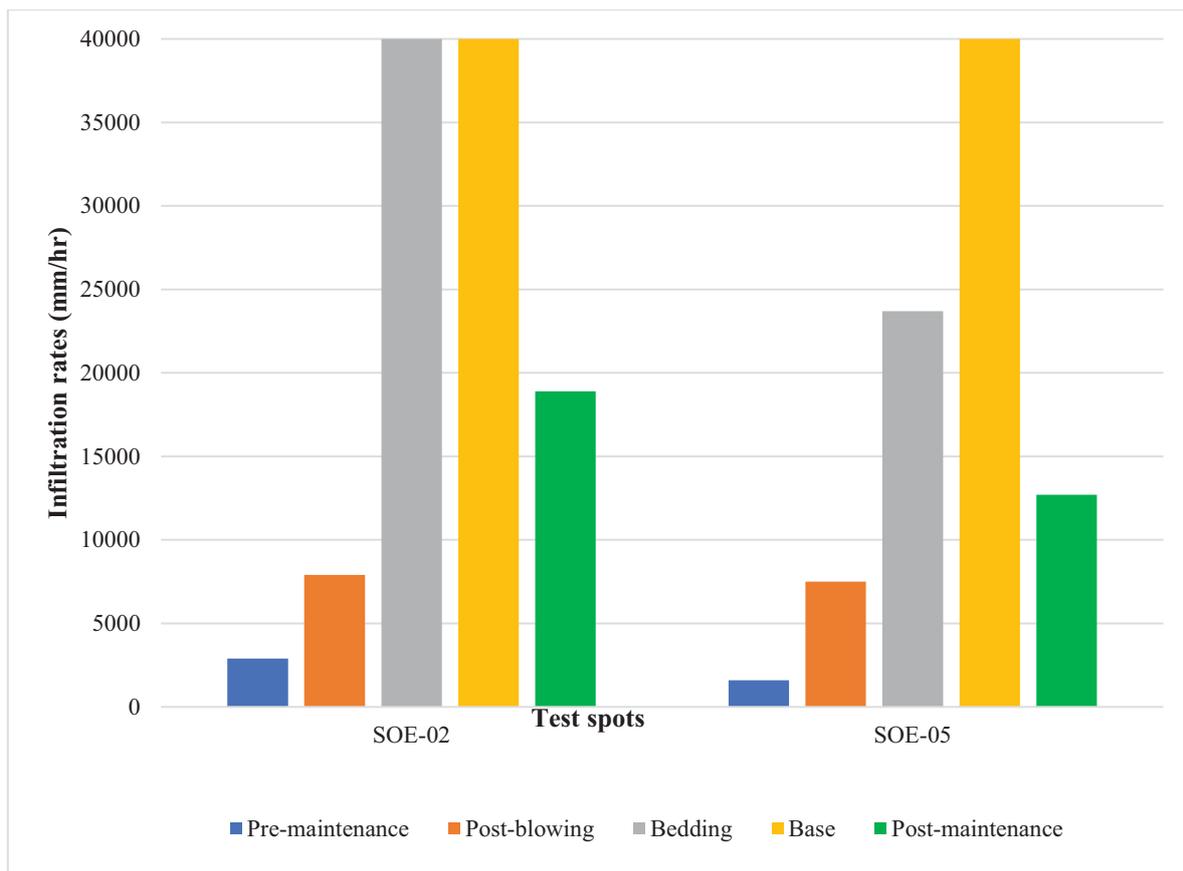
Figure 4-42: SOE diagnostic assessments infiltration rates

The infiltration rates for the bedding for Test spots SOE-02 and SOE-05 were significantly greater than 40,000 mm/hr and 23,700 mm/hr indicating negligible clogging (Figure 4-42). The basecourse infiltration rates were beyond the measuring rate and thus reported as 40,000 mm/hr. Both the bedding and base layer were however covered in a muddy film of the fine material that had worked its way into the structure of the PICP presumably by the vibratory movement of vehicular traffic combined with runoff and the absence of any geofabric to block migration into the base layer (Figure 4-43). Although the sediment pattern on the bedding is similar for the two test spots, the different colours – with SOE-02 lighter than SOE-05 – suggest different sediment sources, however both test spots demonstrated Type II clogging.

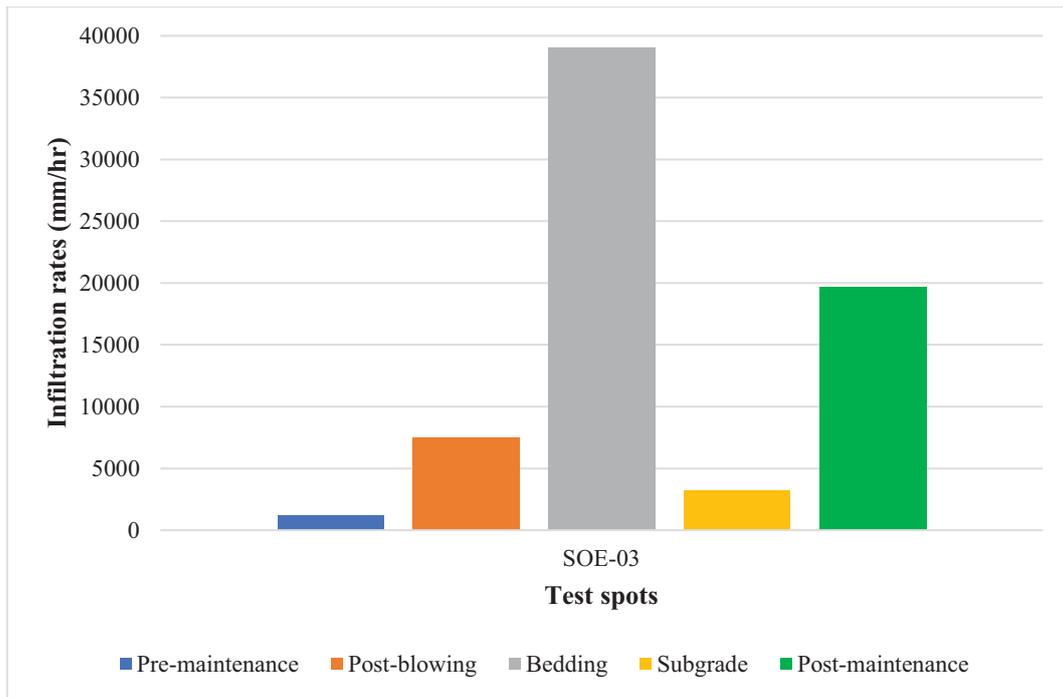
Figure 4-44: SOE-03 measured infiltration rates

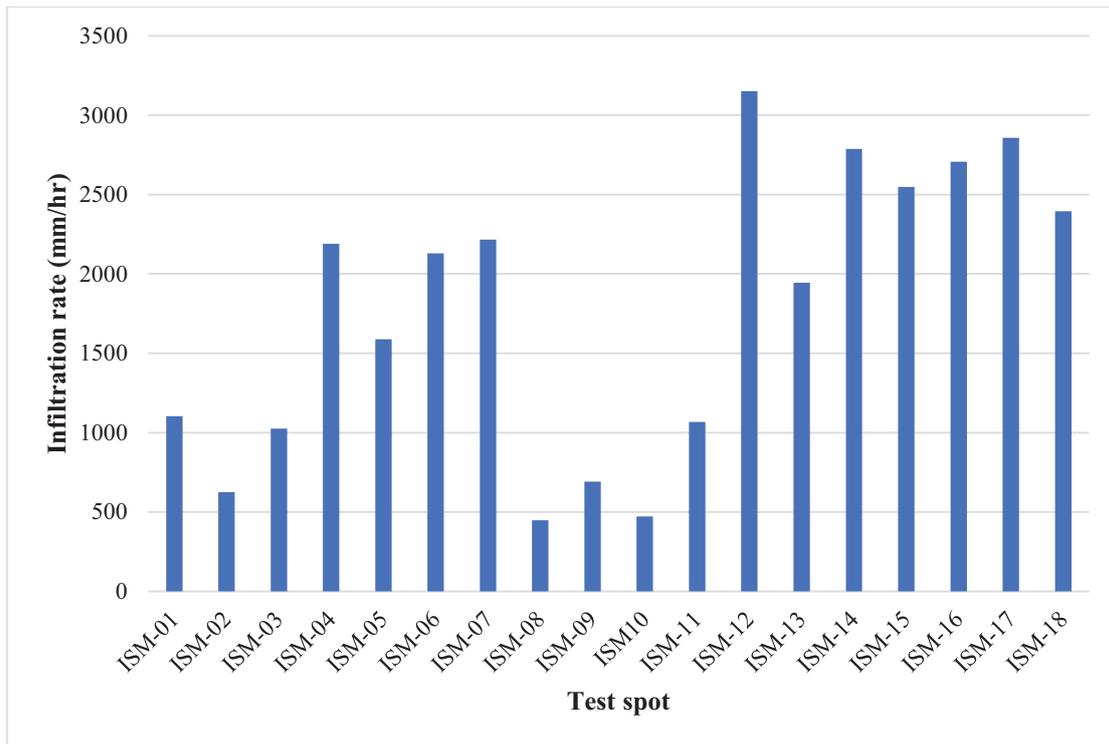
Figure 4-49: ISM surface infiltration rates (After Matolengwe, 2021)

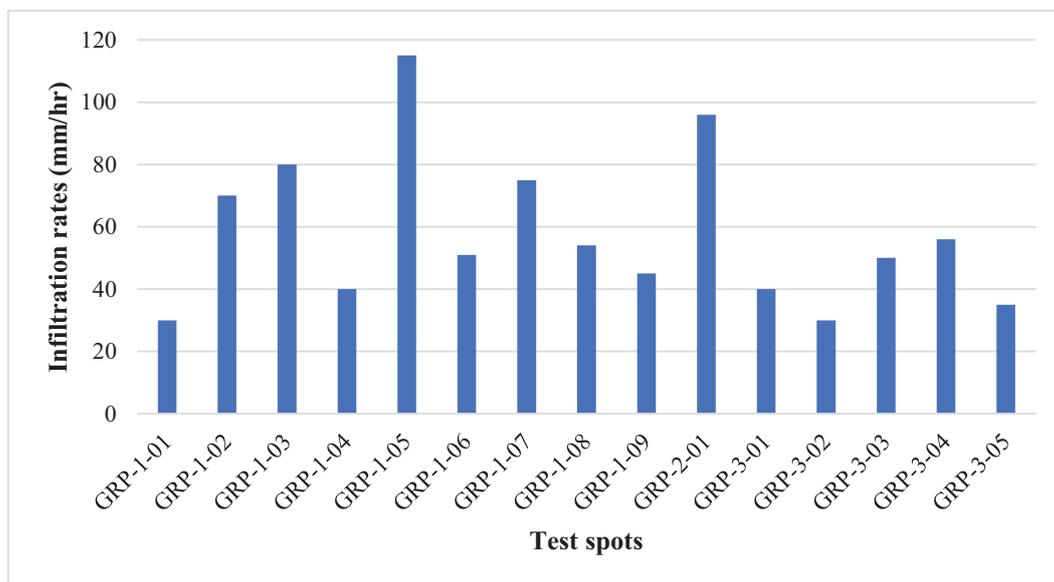
Figure 4-55: Grand Parade surface infiltration rates

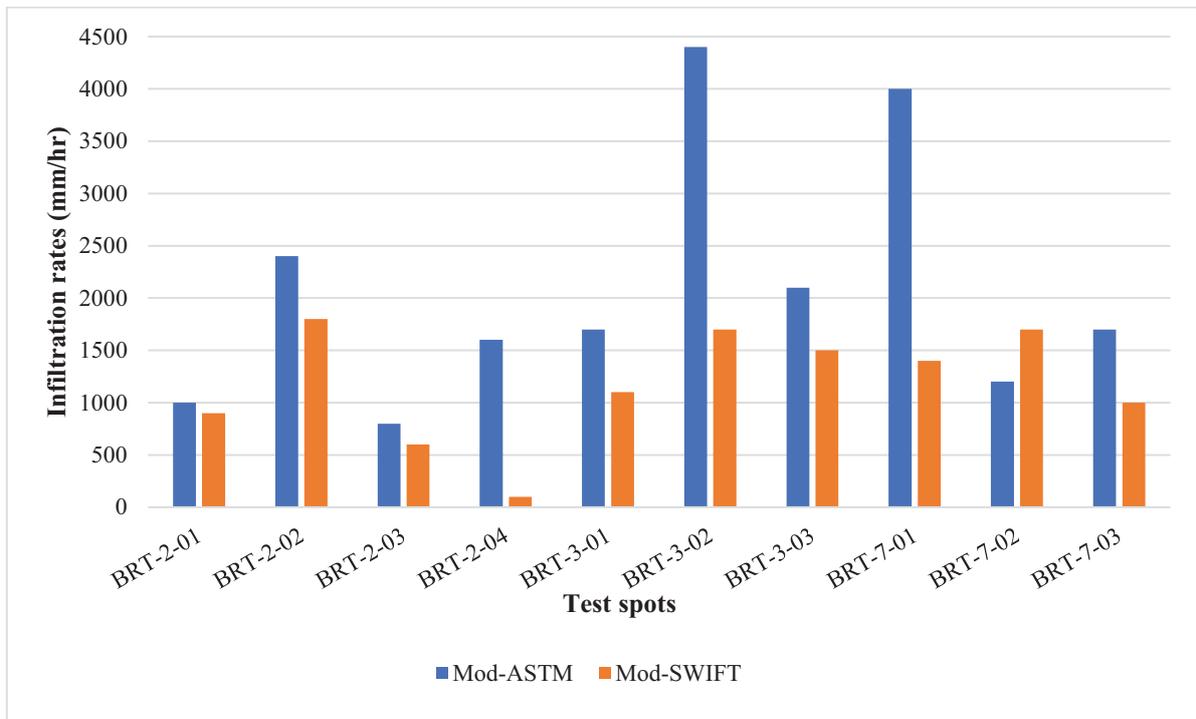
Figure 4-63: BRT surface infiltration rates

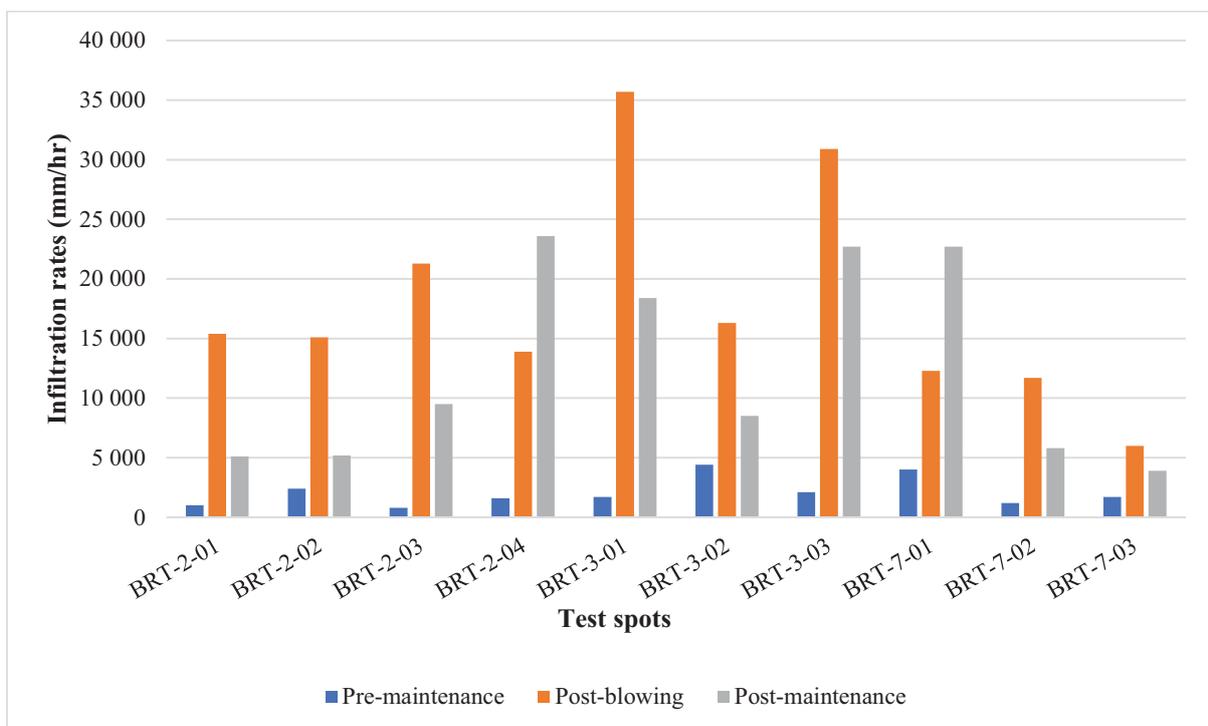
Figure 4-65: BRT maintenance trials infiltration rates

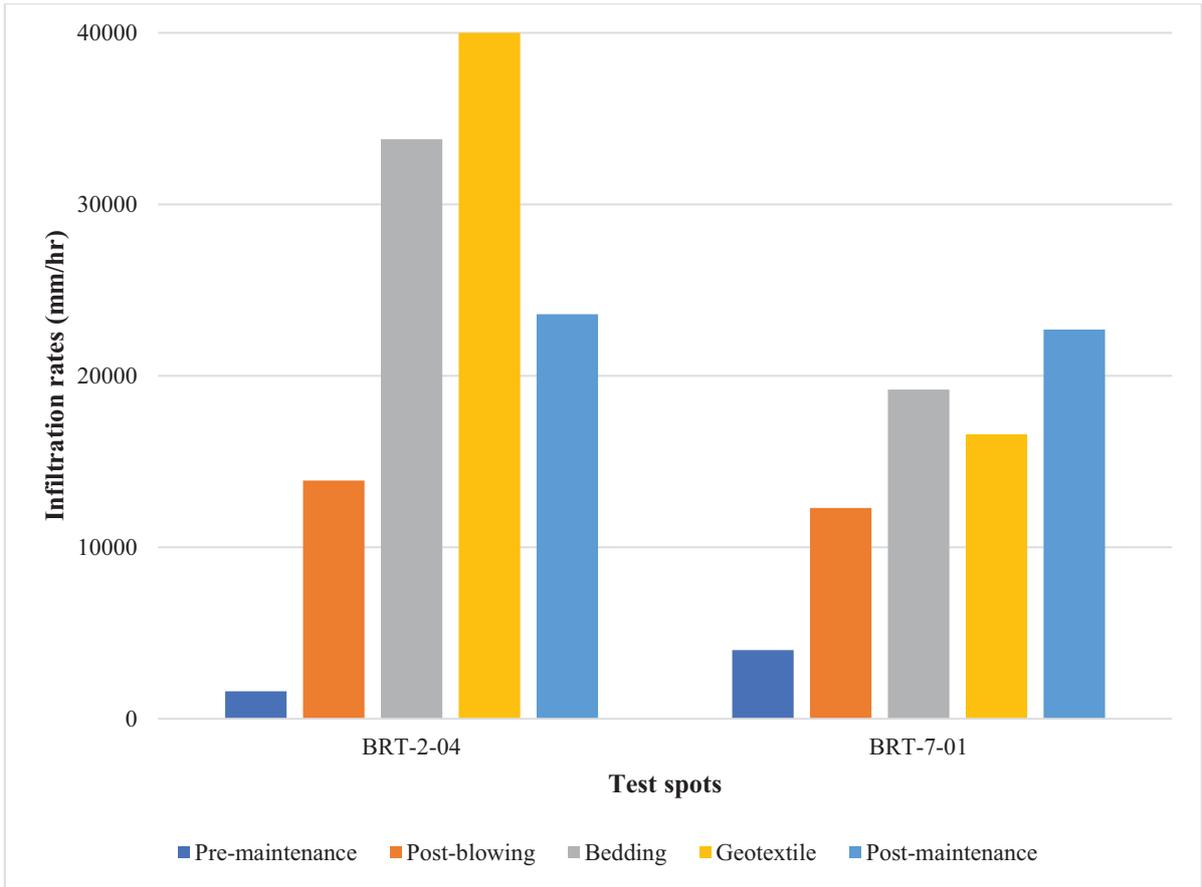
Figure 4-67: BRT diagnostic assessment infiltration rates

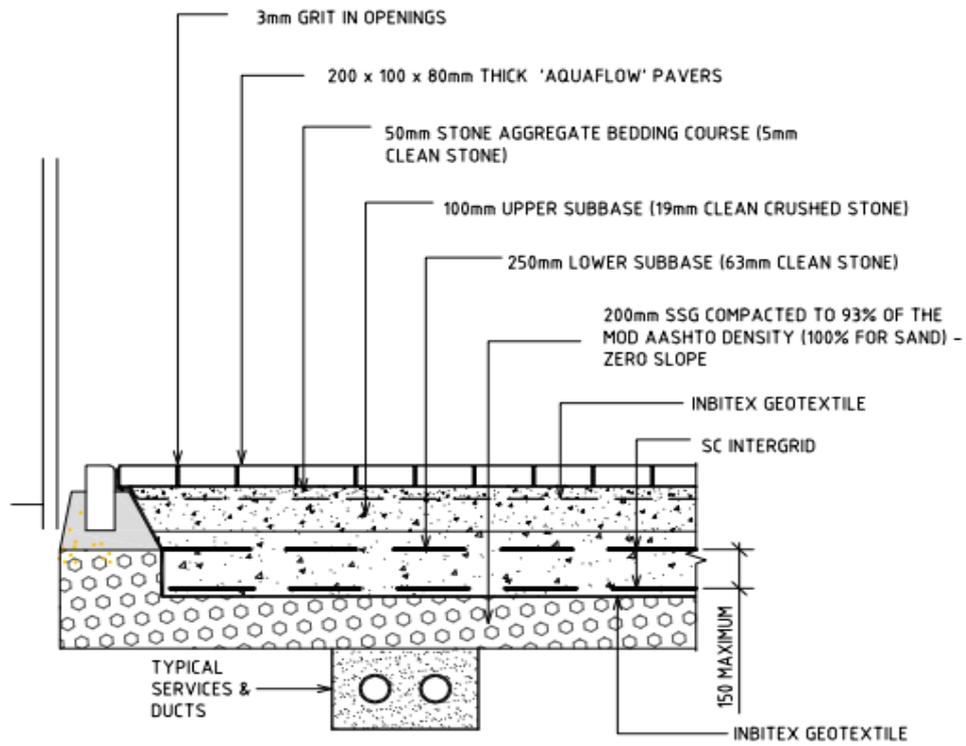
Figure 4-75: SAF PICP design layers (Matolengwe, 2021)

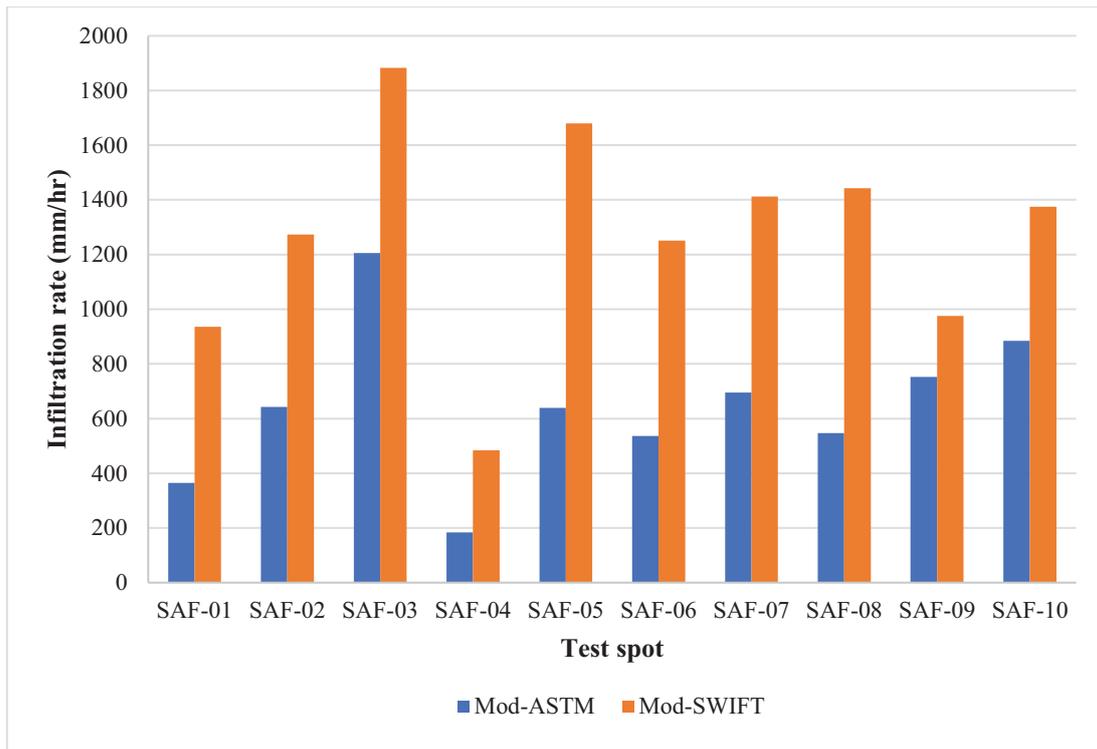
Figure 4-77: Mod-ASTM and Mod-SWIFT infiltration rates (After Matolengwe, 2021)

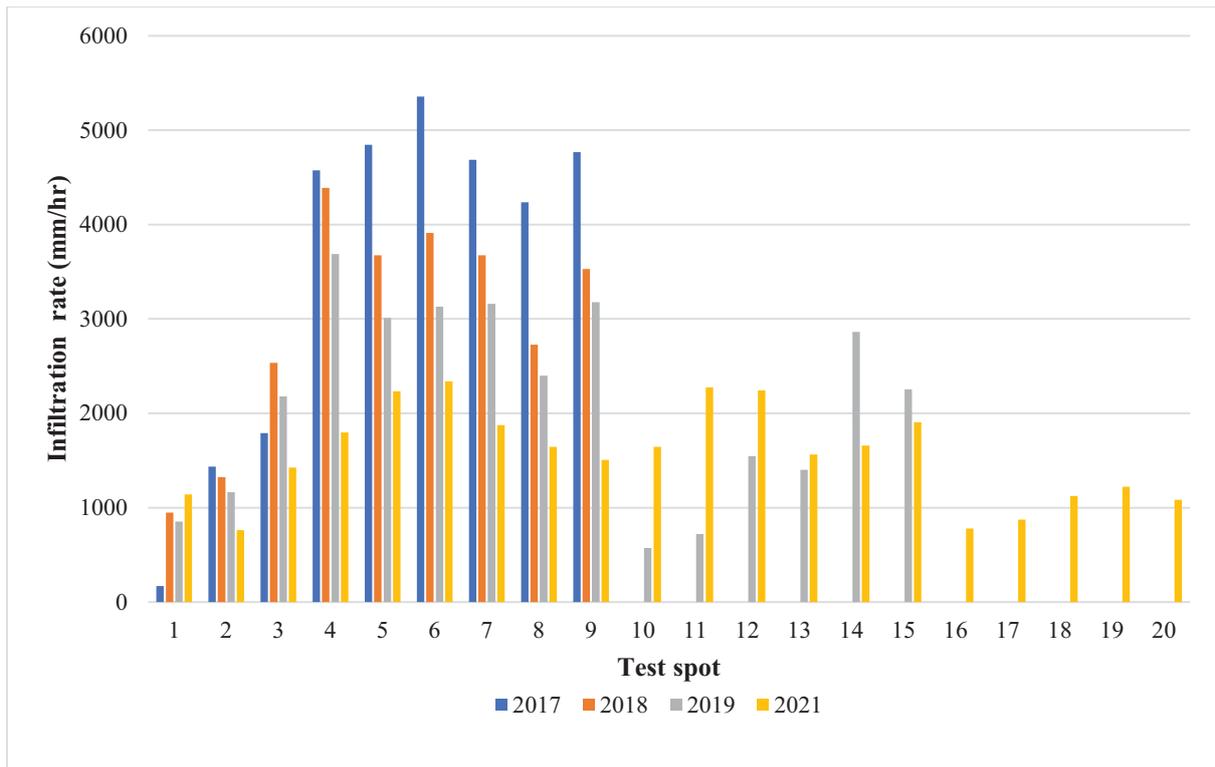
Figure 4-82: 2017-2021 HAM infiltration rates
 (Adapted from Artus, 2017; Vella, 2018; Barnard, 2019; Matolengwe, 2021;)

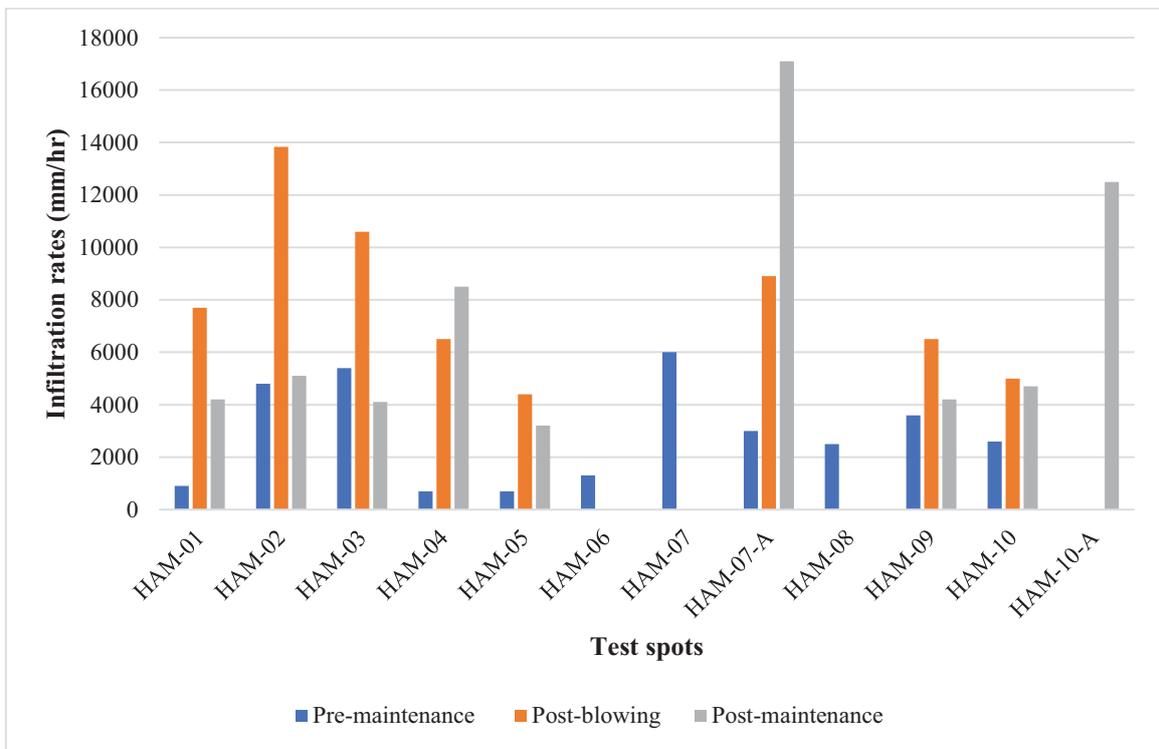
Figure 4-84: HAM maintenance trials infiltration rates

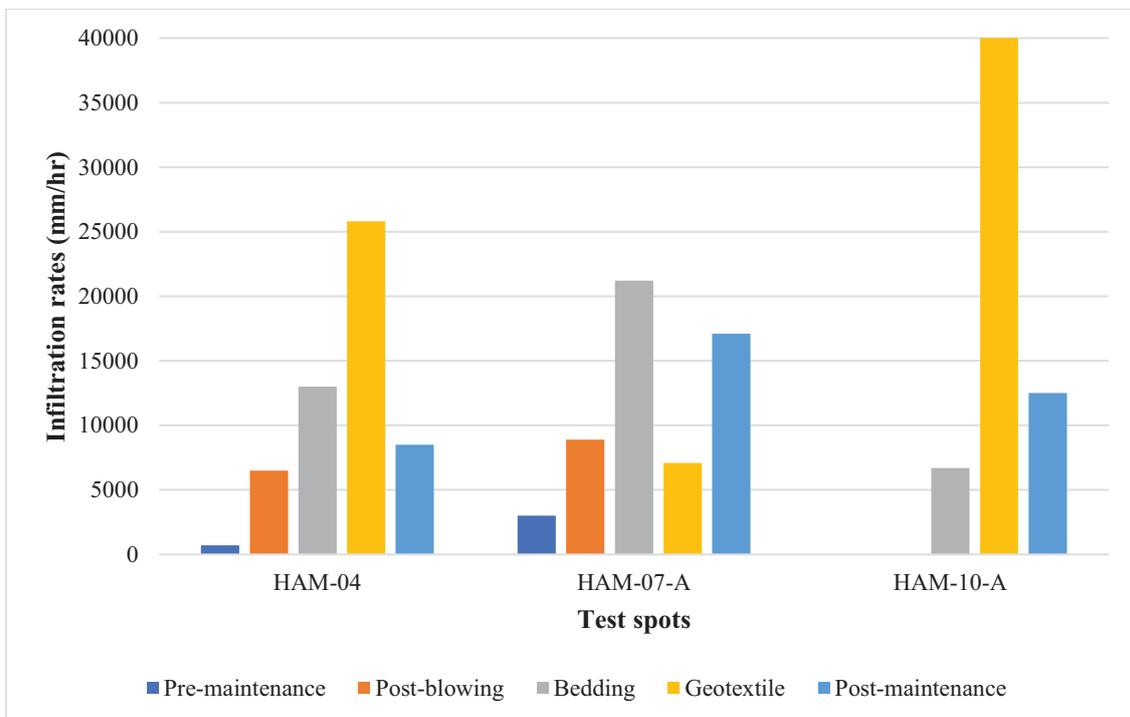
Figure 4-86: HAM diagnostic assessment infiltration test results

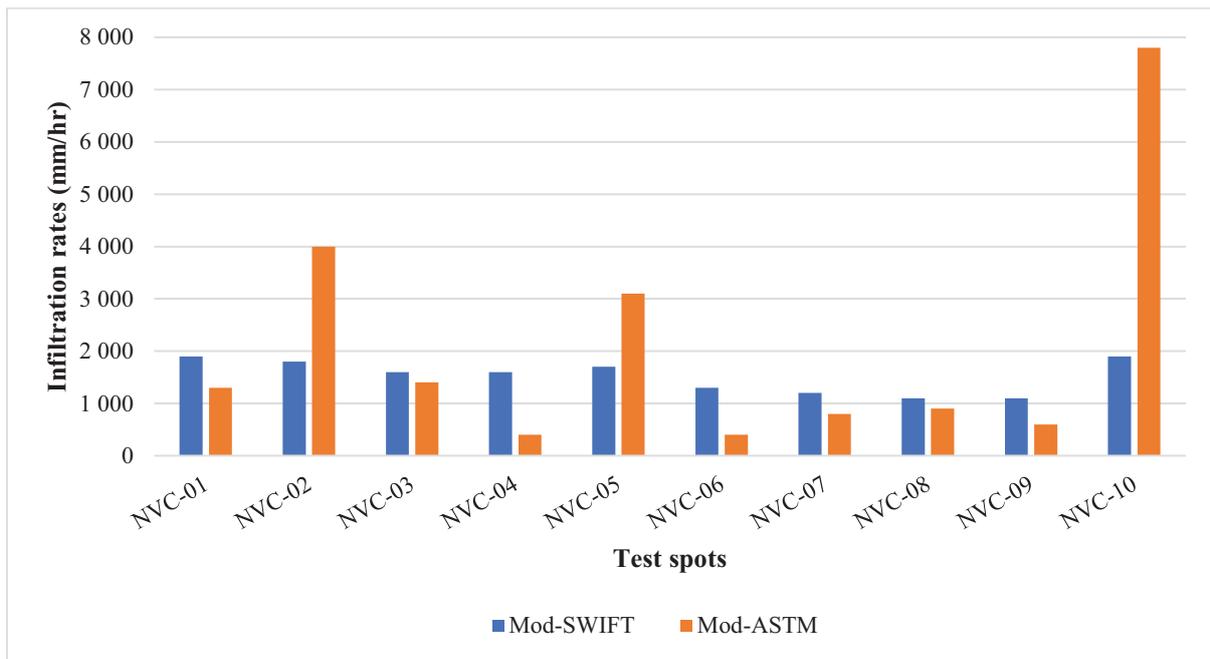
Figure 4-94: The NVC infiltration rates

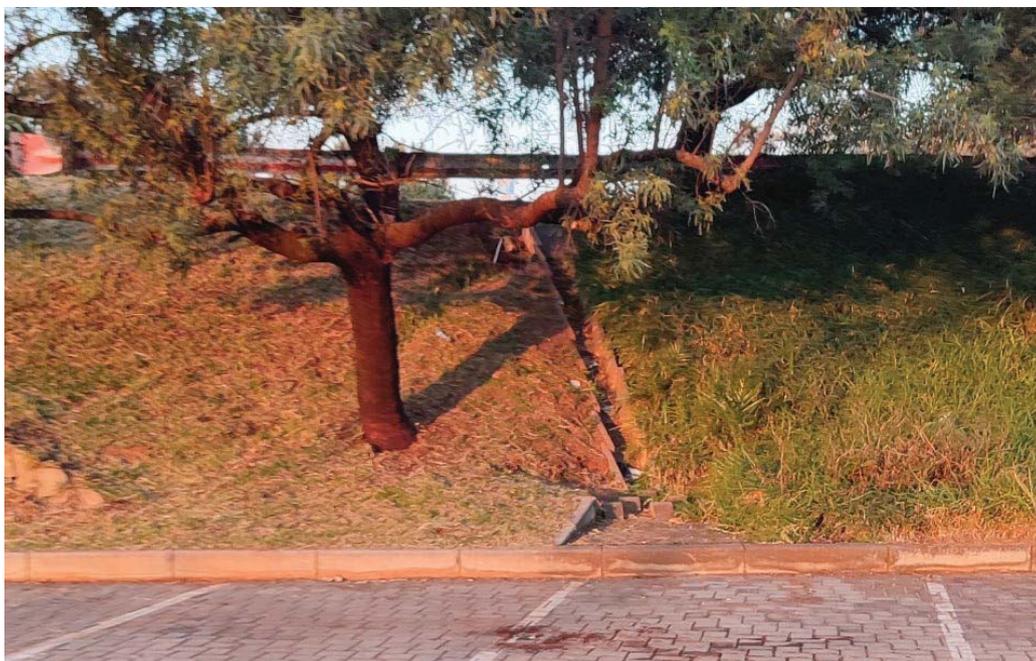
Figure 4-101: Typical concrete-lined chute between WITS-U and WITS-L

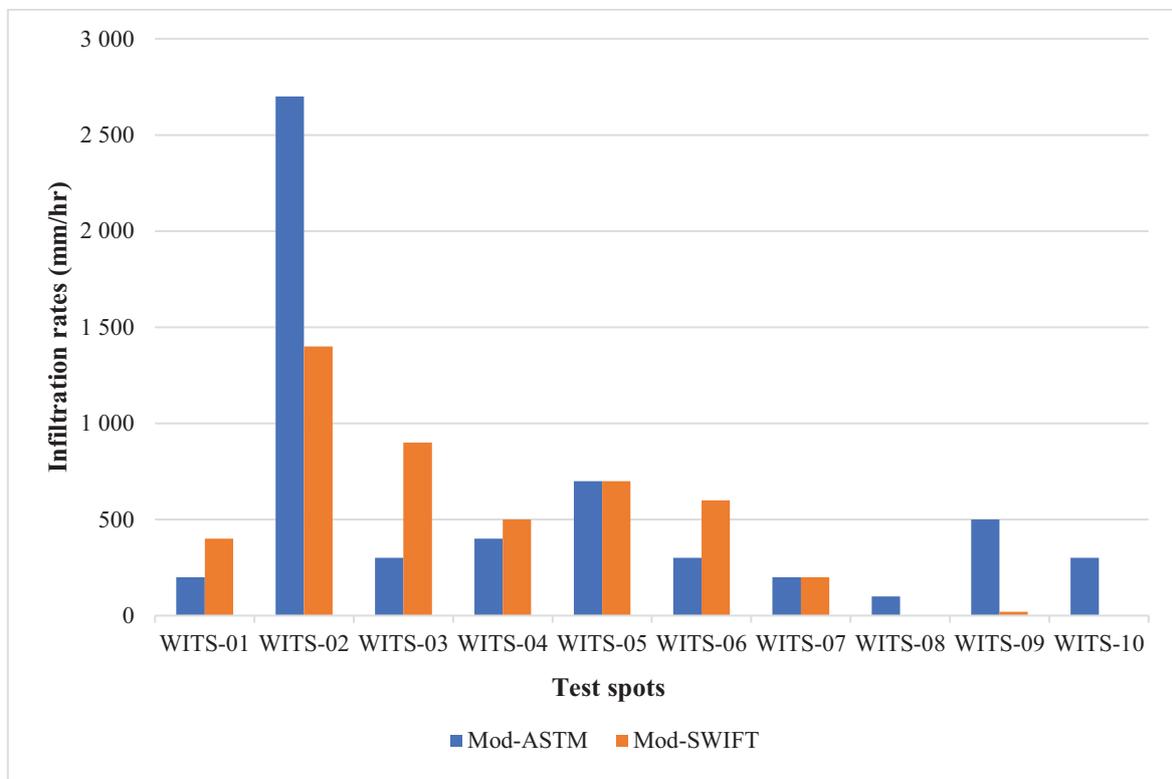
Figure 4-103: WITS infiltration rates

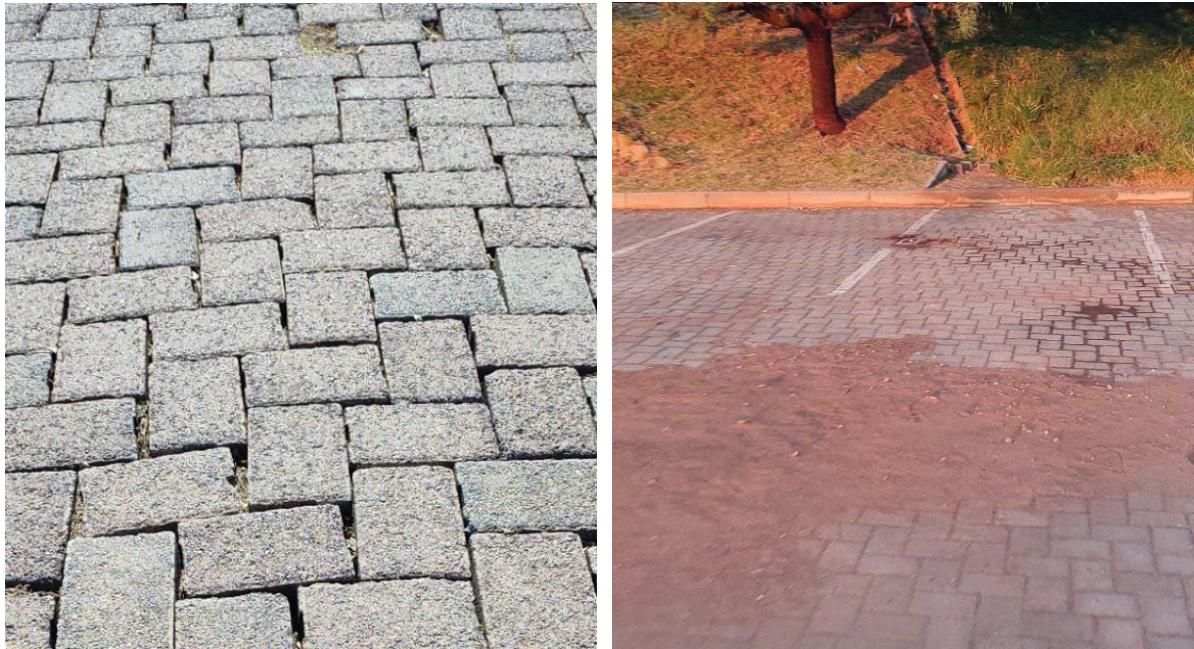
(a) Dislocated pavers adjacent to WITS-05

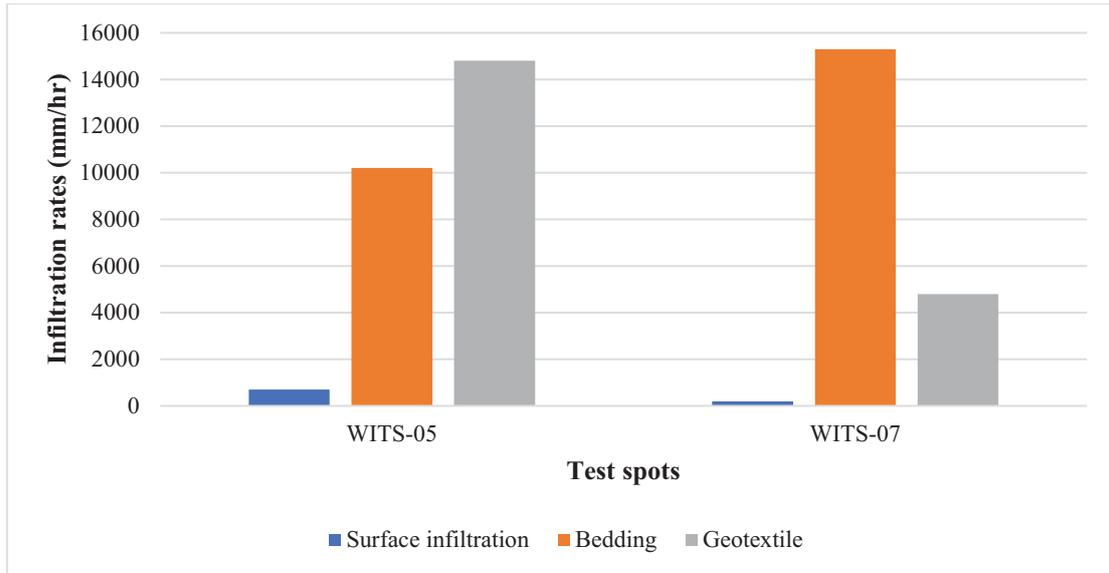
Figure 4-105: Mod-ASTM infiltration diagnostic tests

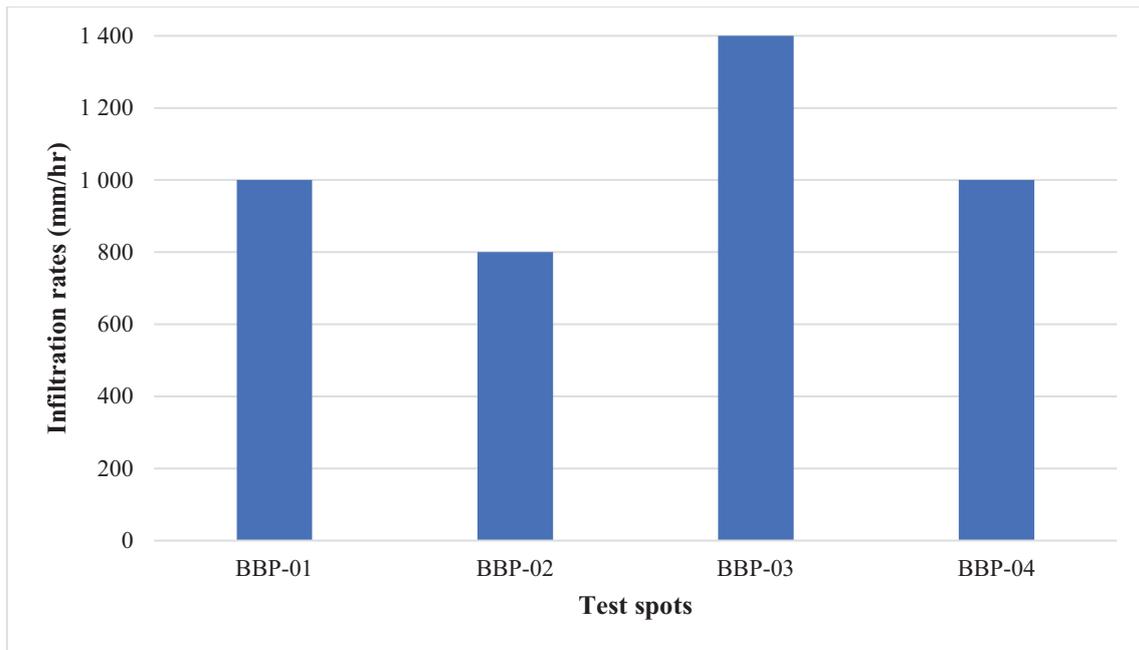
Figure 4-112: BBP Mod-SWIFT infiltration tests

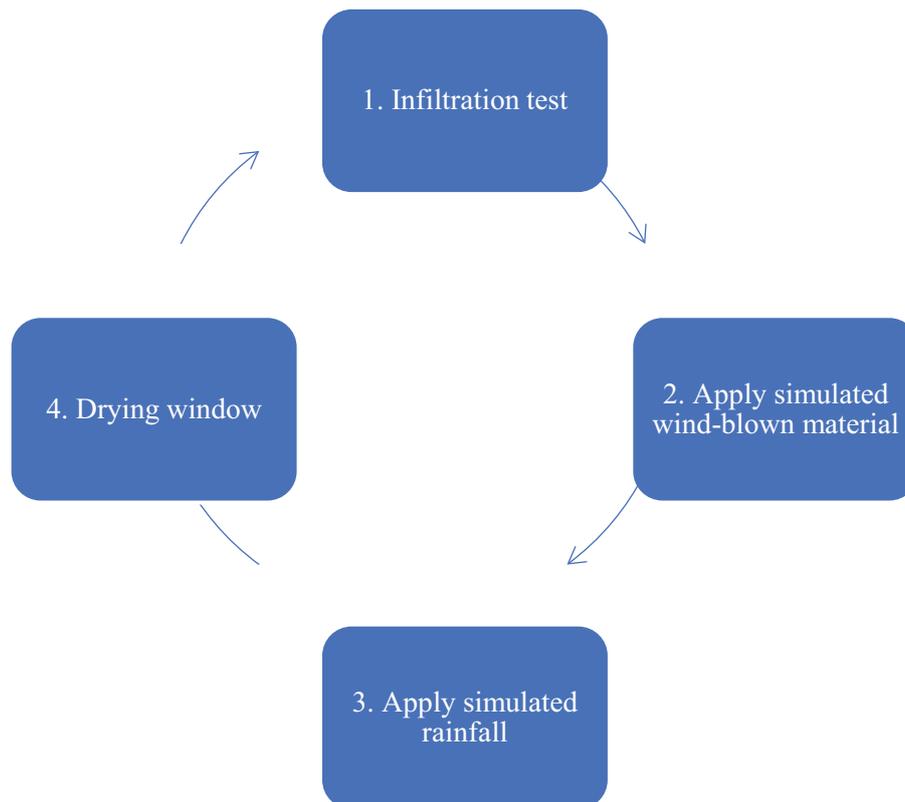
Figure 5-7: Schematic of the experimental method for the Permaflow® paver test

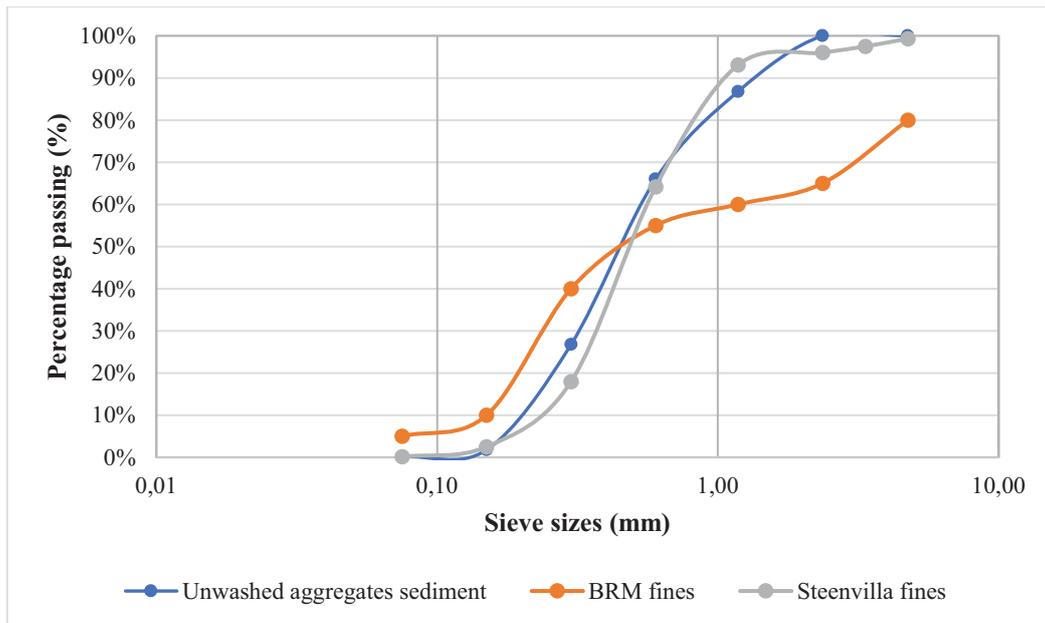
Figure 5-8: Test fines grading curves

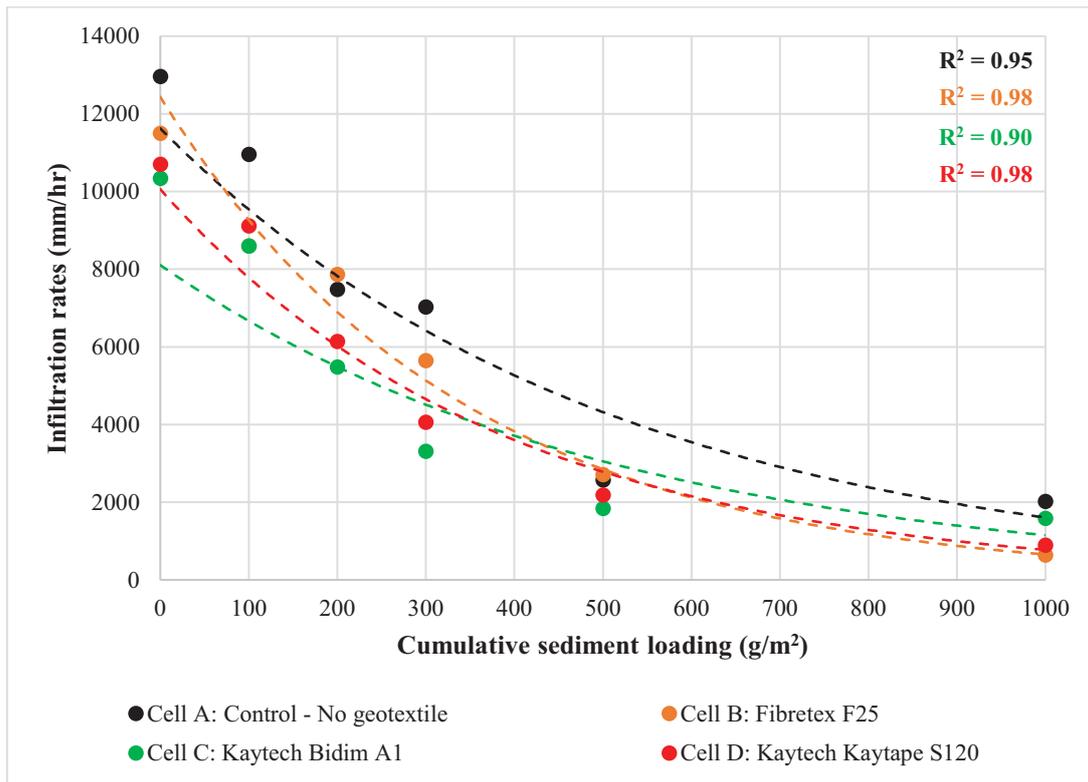
Figure 5-11: Permaflow ® sediment cumulative loading versus infiltration rates
(After Blackshaw, 2021)

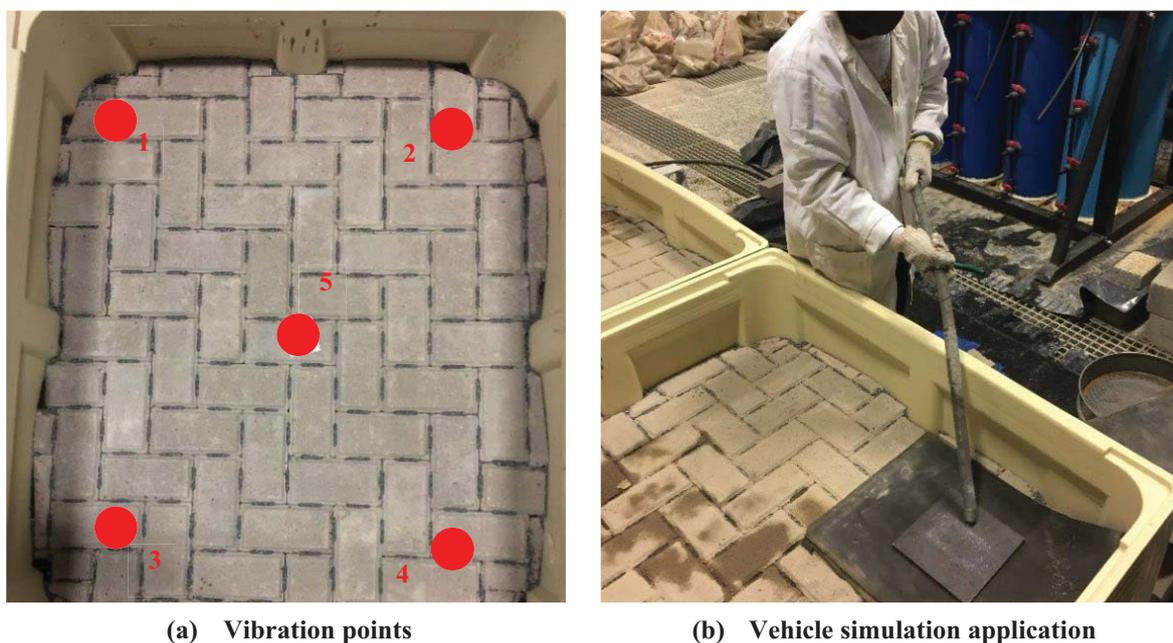
Figure 5-13: Simulated vehicle loading application (After Peyi, 2021)

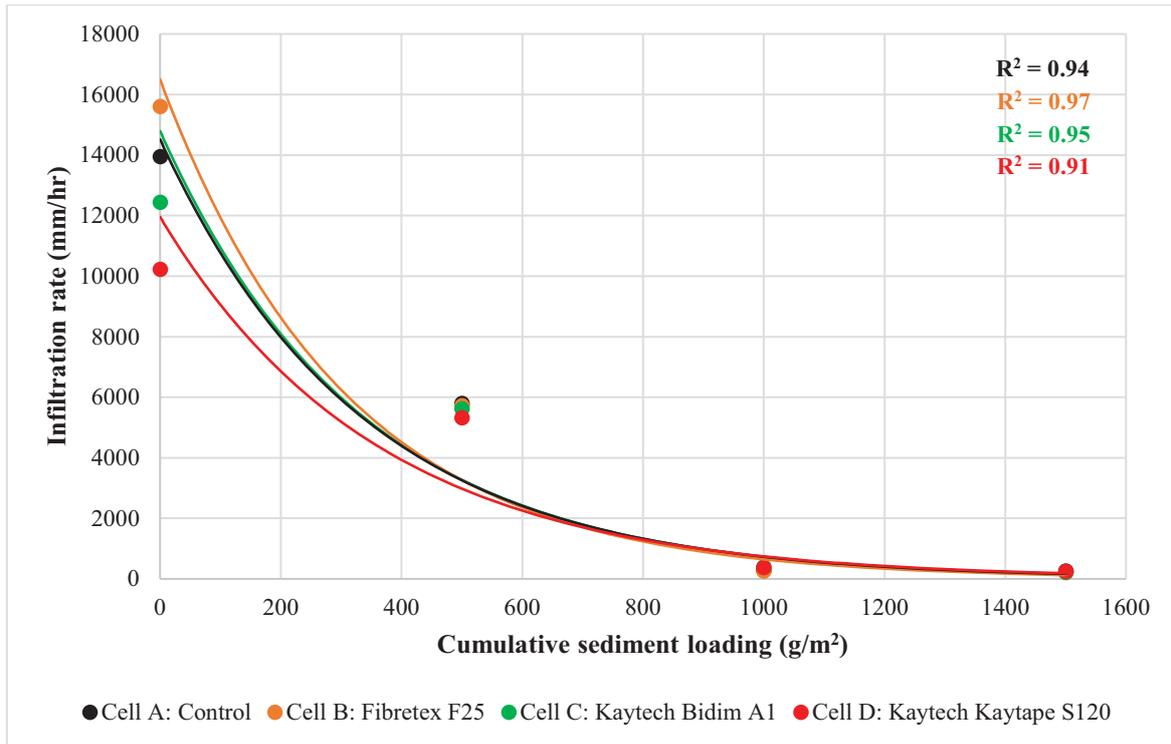
Figure 5-14: Drop in infiltration rate for the Aquaflow ® paver experiment (After Peyi, 2021)

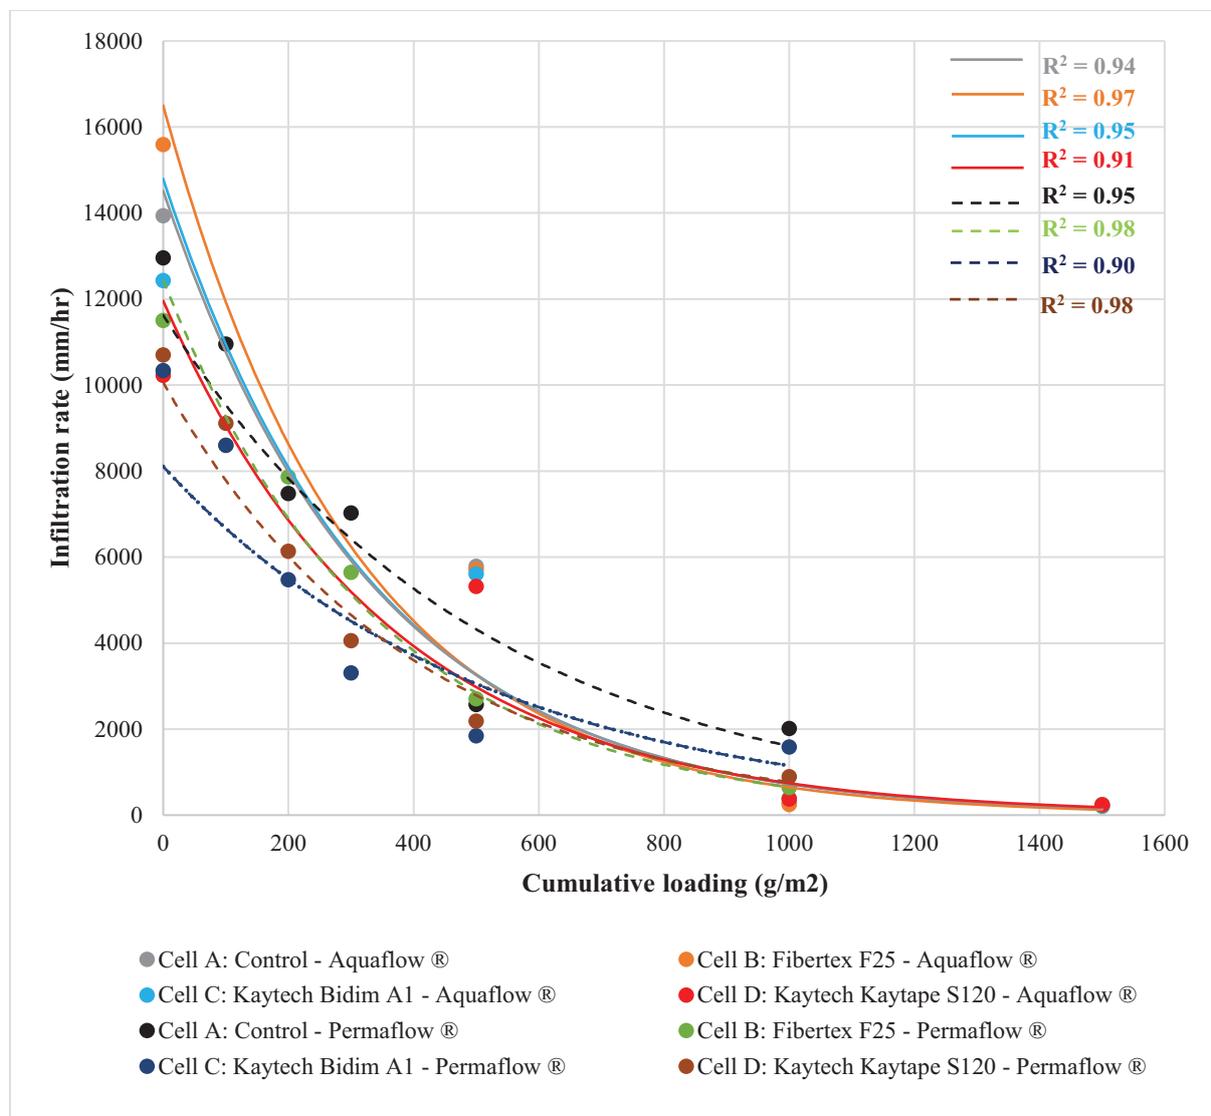
Figure 5-17: Infiltration rate versus Cumulative sediment loading for Permaflow[®] and Aquaflow[®] pavers (Blackshaw, 2021; Peyi, 2021)

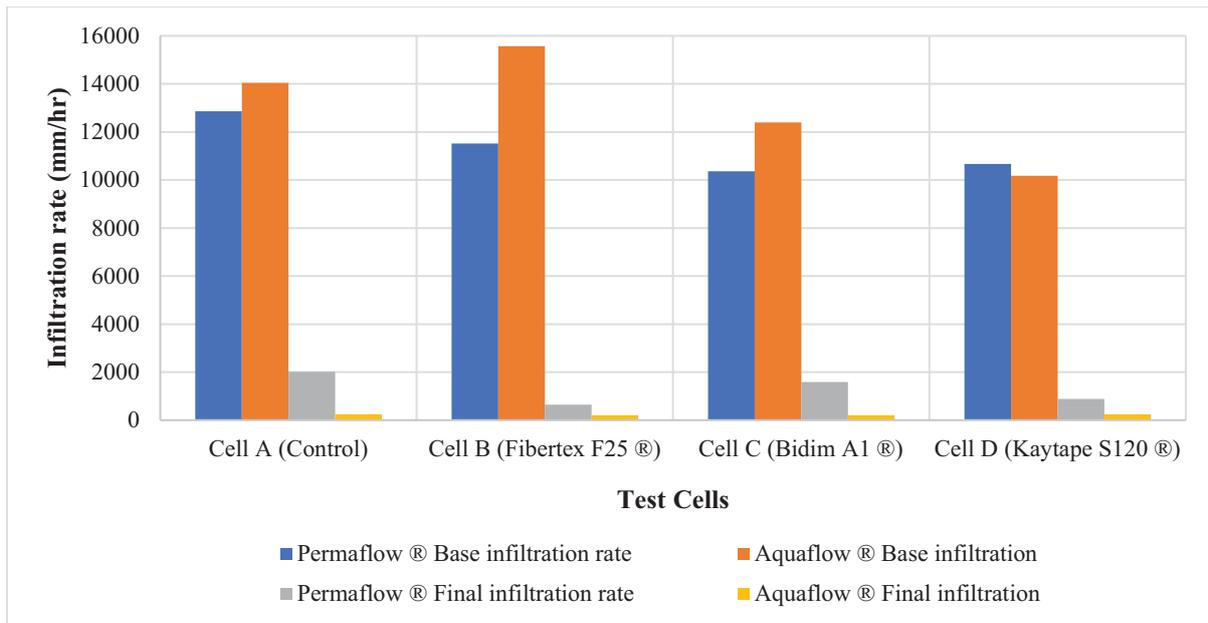
Figure 5-18: Comparison of Permaflow® and Aquaflo® base and final infiltration rates (Blackshaw, 2021; Peyi, 2021)

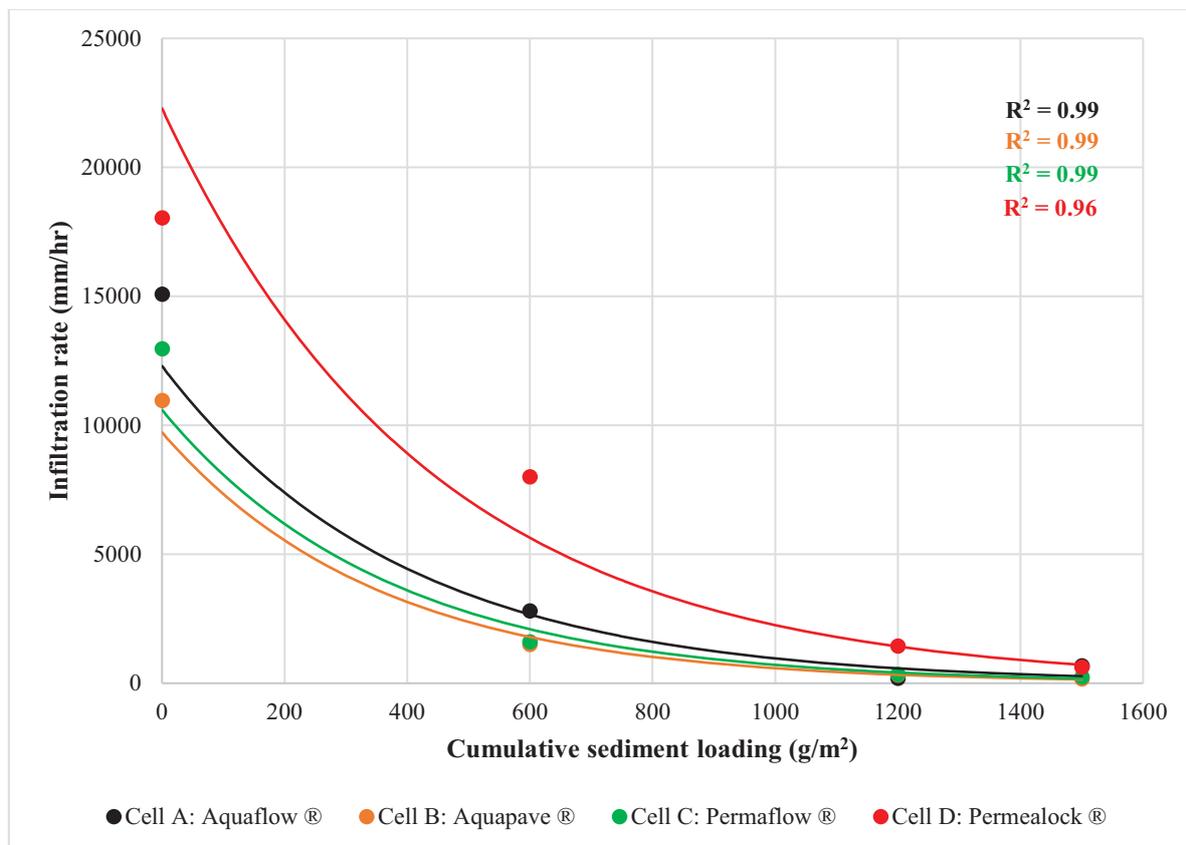
Figure 5-23: Infiltration rate versus Cumulative sediment loading for the different pavers (After Mqadi, 2022)

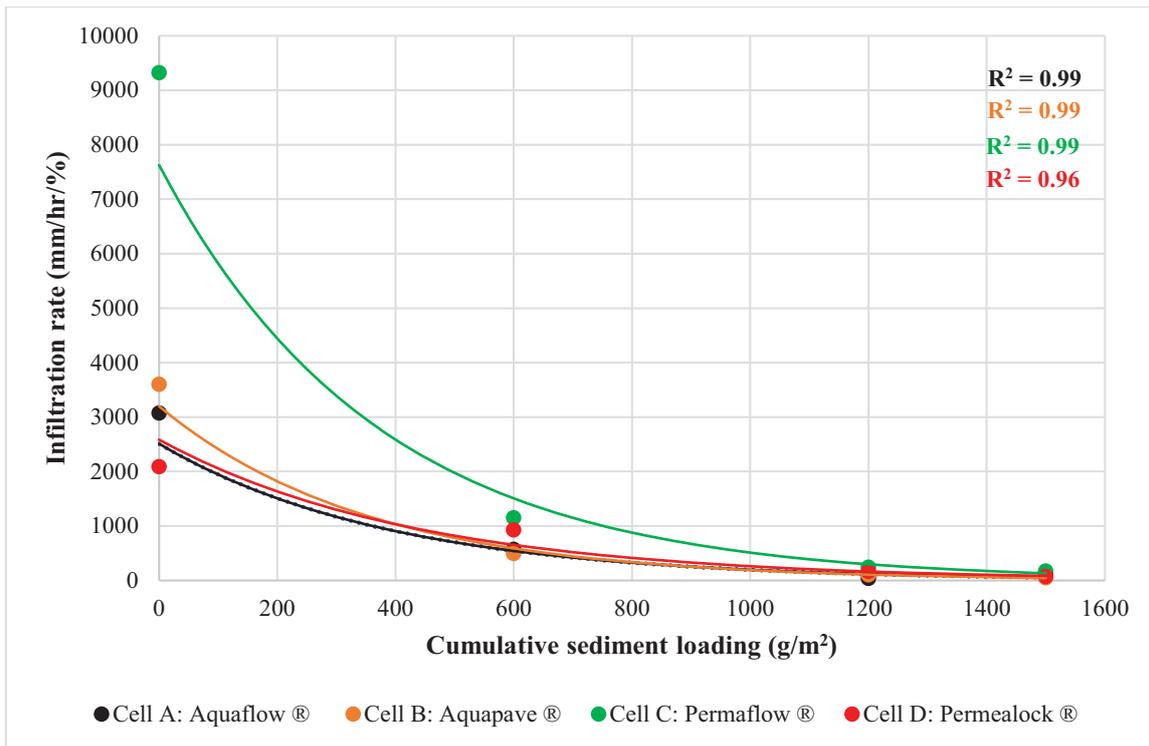
Figure 5-24: Cumulative sediment loading versus infiltration rates expressed in percentage void ratio (After Mqadi, 2022)
