GUIDELINES FOR PERMEABLE INTERLOCKING CONCRETE PAVEMENTS (PICP) IN SOUTH AFRICA

Volume 1: Clogging in Permeable Interlocking Concrete Pavement (PICP)

Report to the
WATER RESEARCH COMMISSION

WRC Report No. TT 913/1/23
ISBN 978-0-6392-0403-1

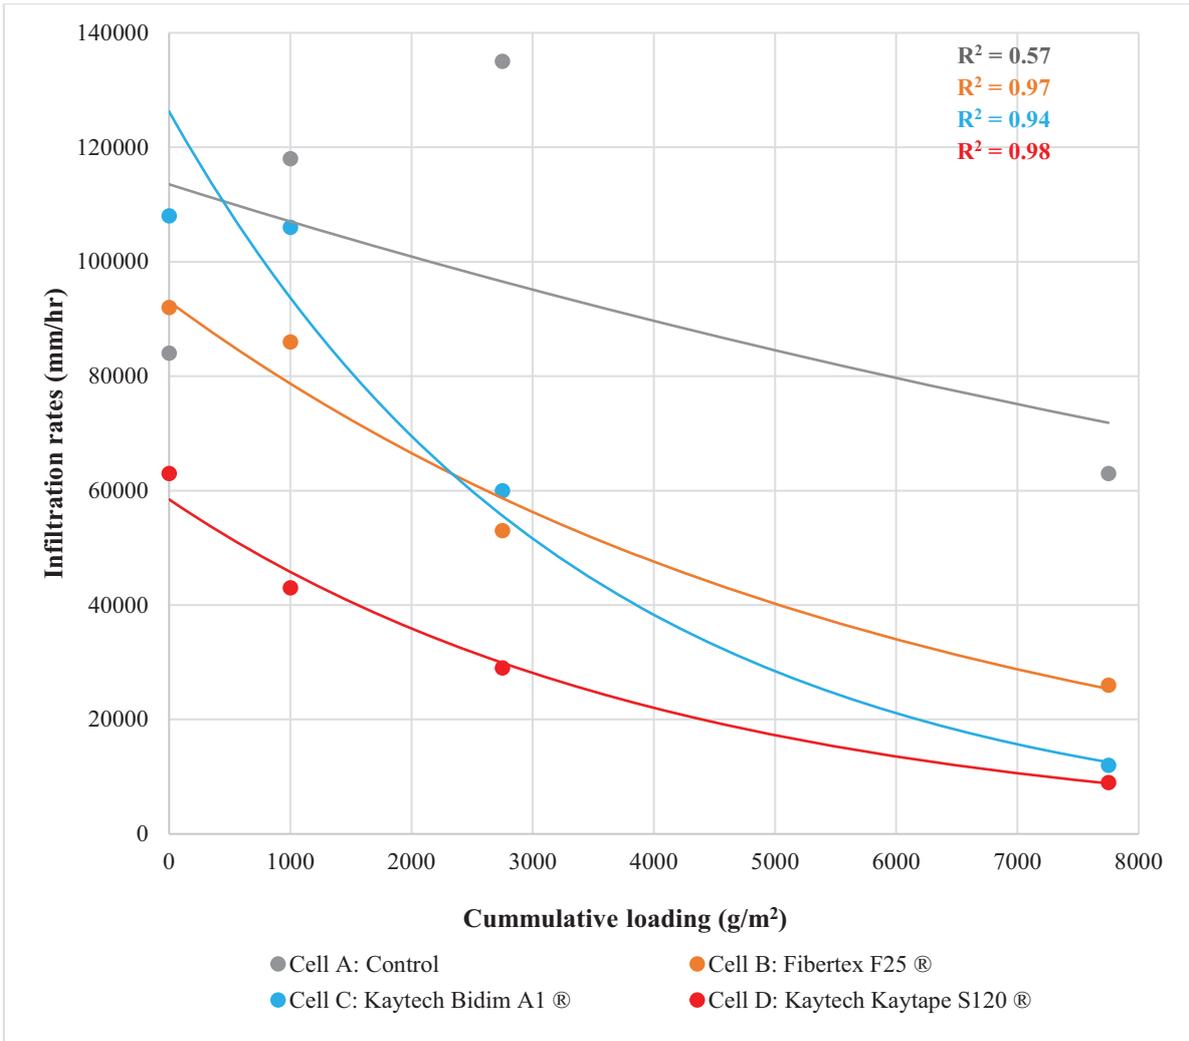
Figure 5-28: Infiltration rate versus Cumulative sediment loading for the different geotextiles (Morritt-Smith, 2022)

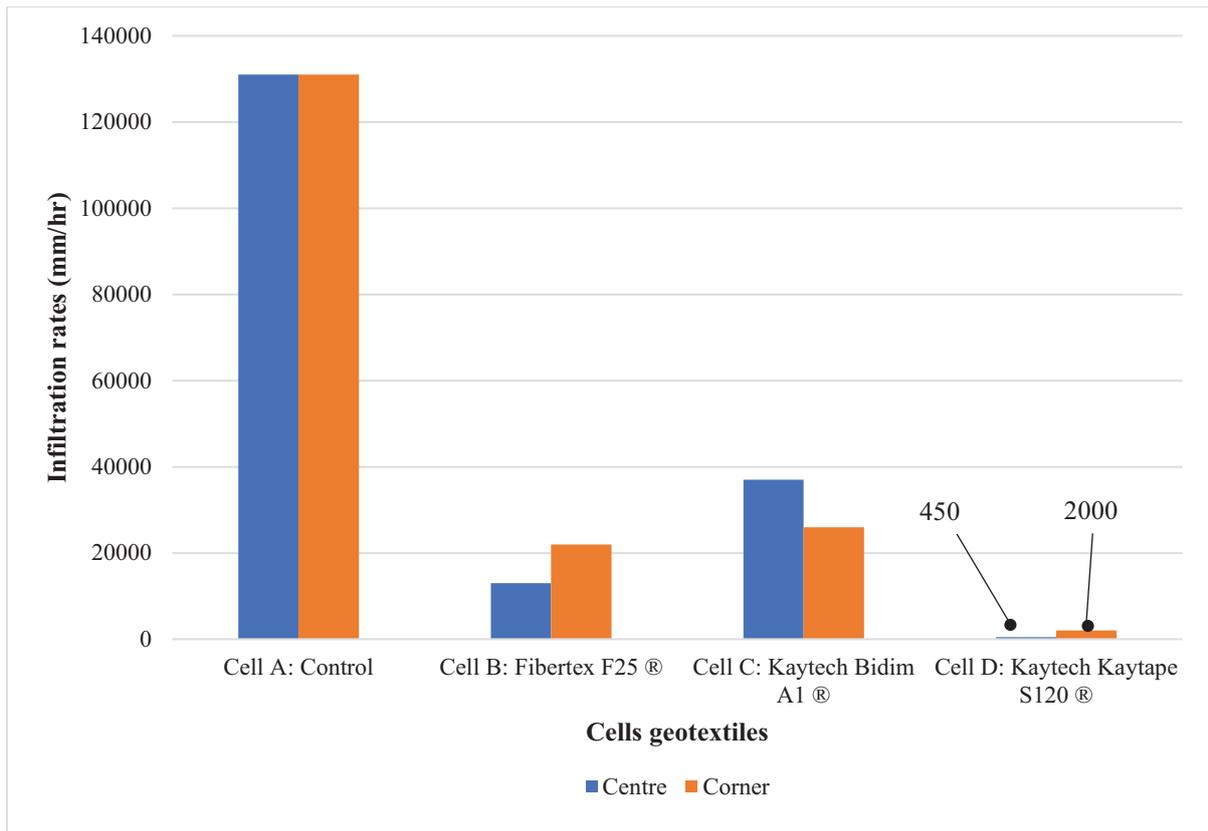
Figure 5-33: Different geotextiles infiltration rates (Morritt-Smith, 2022)

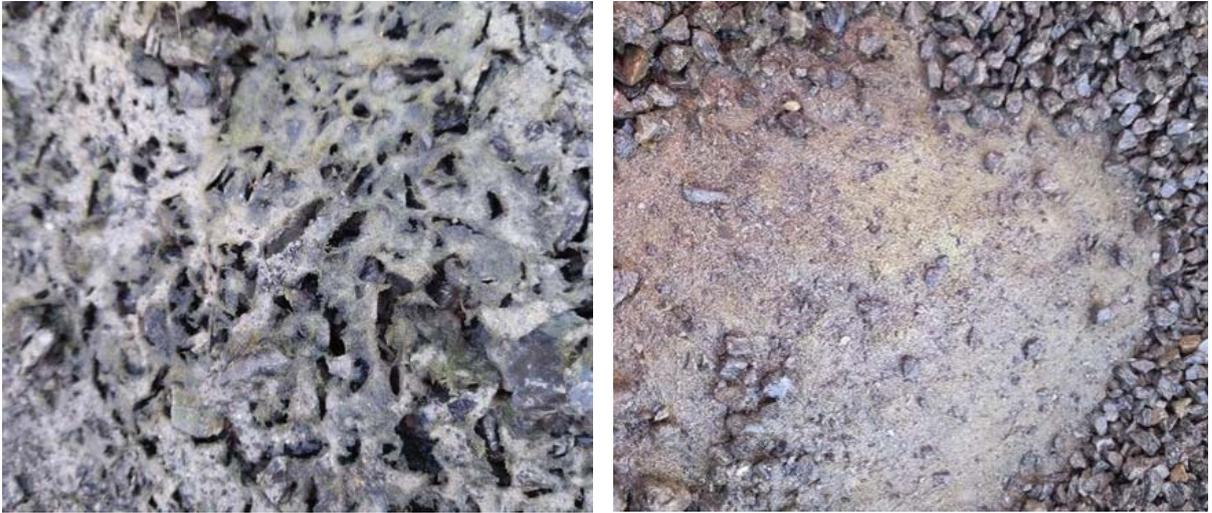
Figure E-4: Top geotextile failure

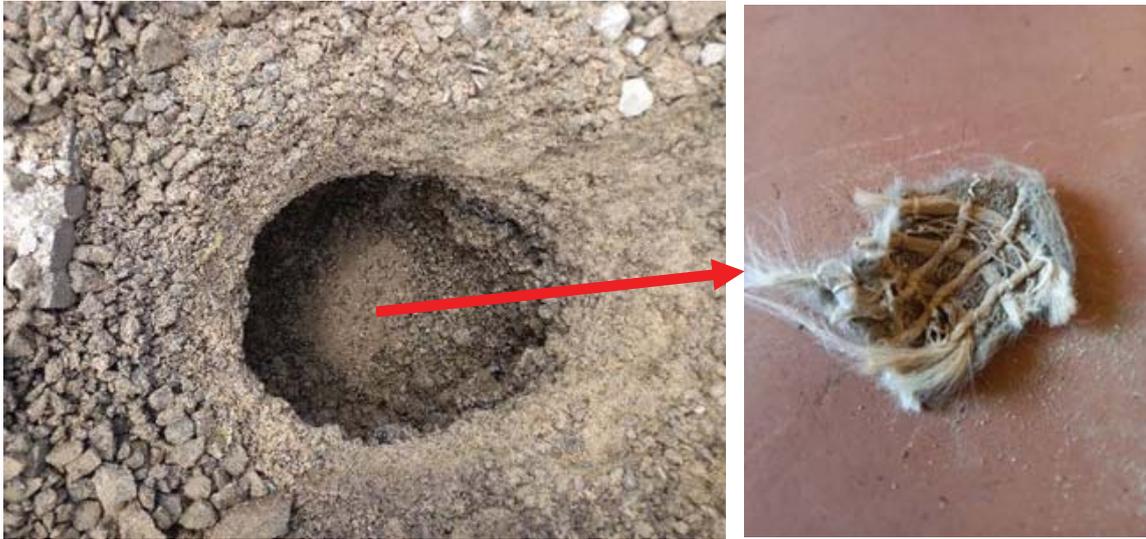
Figure E-6: Damaged bottom geotextile
