FRAMEWORK FOR NATURAL AND ANTHROPOGENIC CHANGES TO THE URBAN VADOSE ZONE: CASE STUDIES

Report
to the Water Research Commission

WRC report no. TT 954/2/26

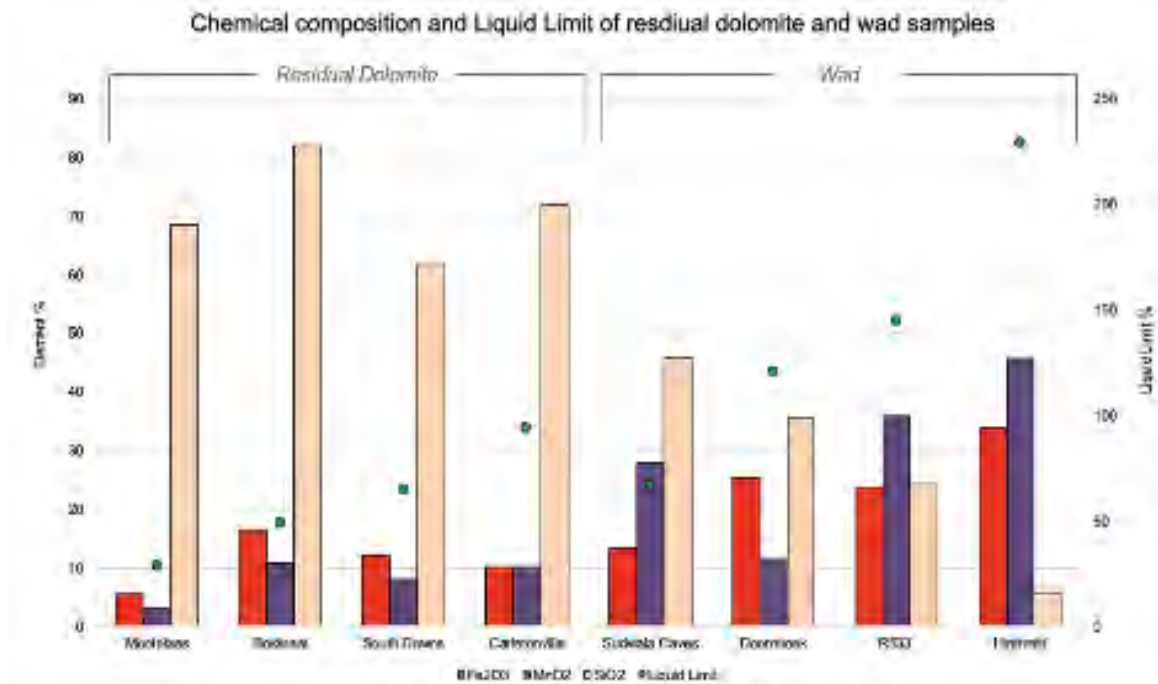
Figure 3-2 Major chemical components and liquid limits of residual dolomite and wad samples (Swart 2019).

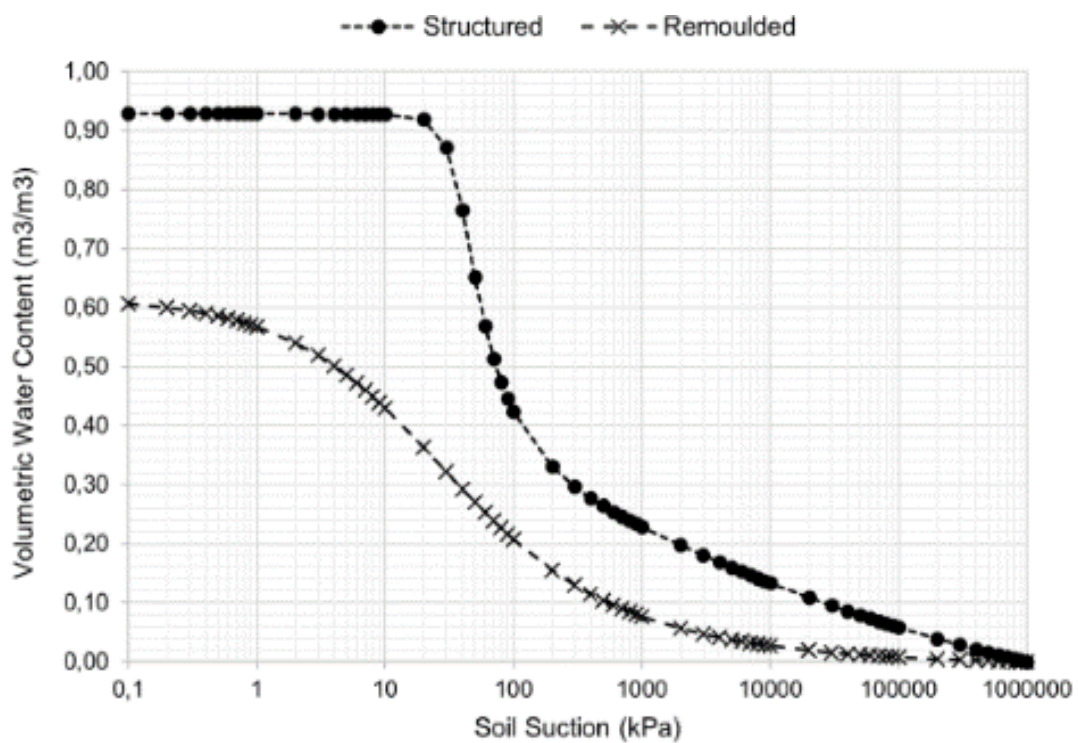
Figure 3-6 SWRCs for an undisturbed Highveld sample (structured) and remoulded Highveld sample.

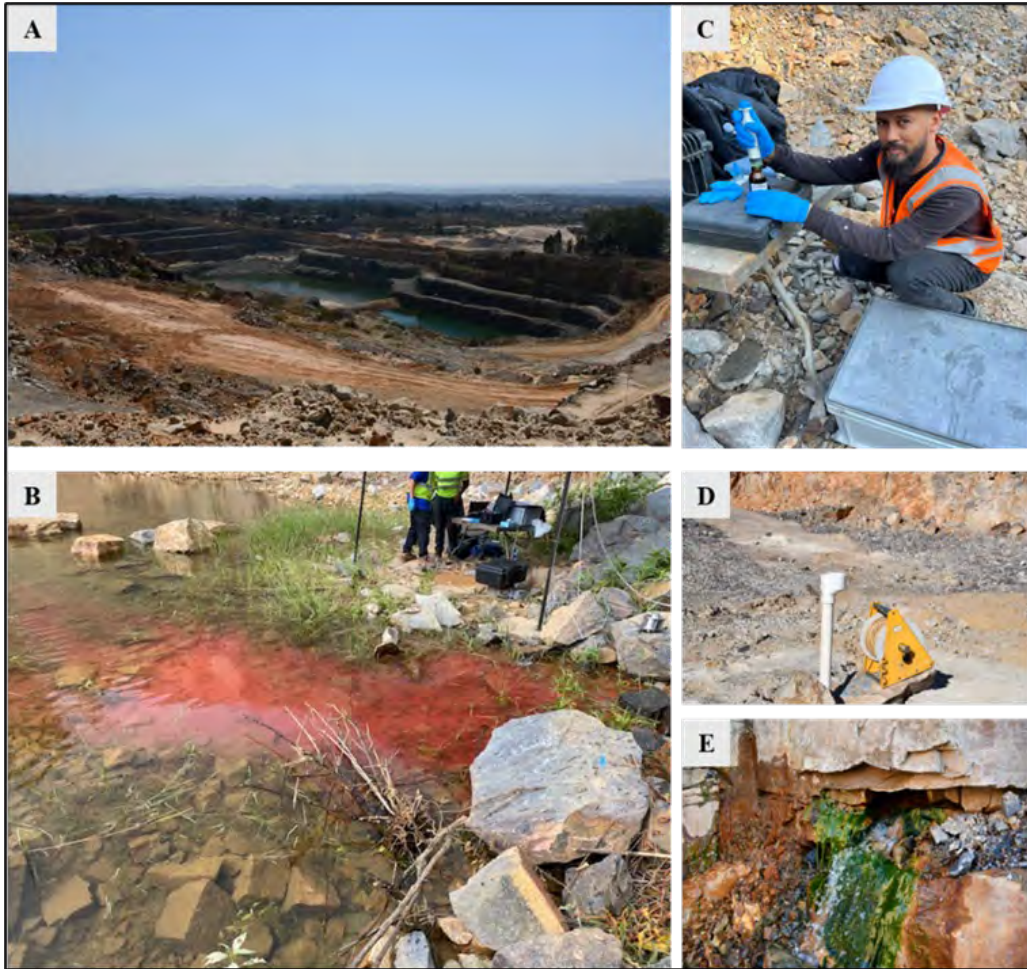
Figure 4-15 Experimental set-up for tracer monitoring using the GGUN-FL30 fluorometer (photographs by van Wyk, 2023).

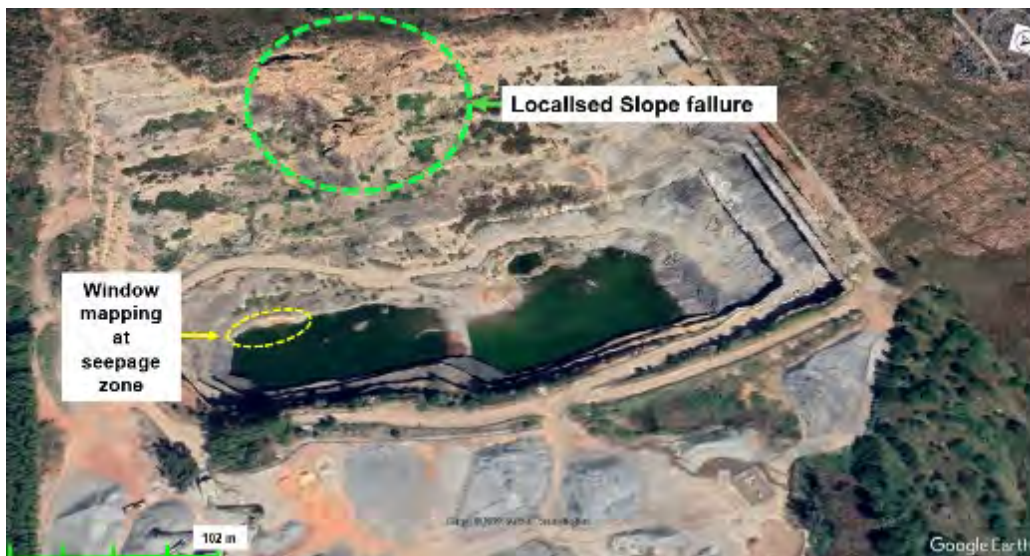
Figure 5-1 Google Earth image showing localised planar slope failure and geotechnical window mapping location in the quarry pit.

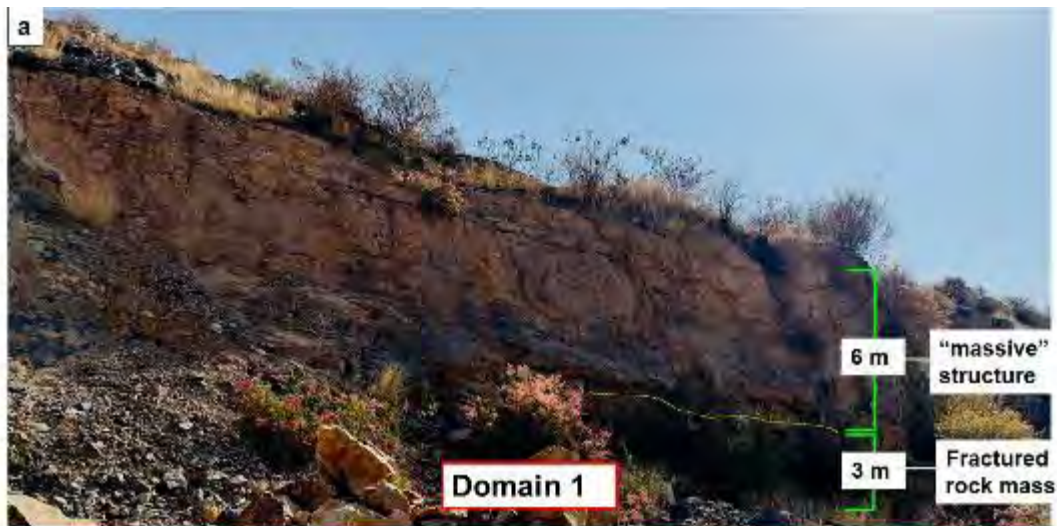
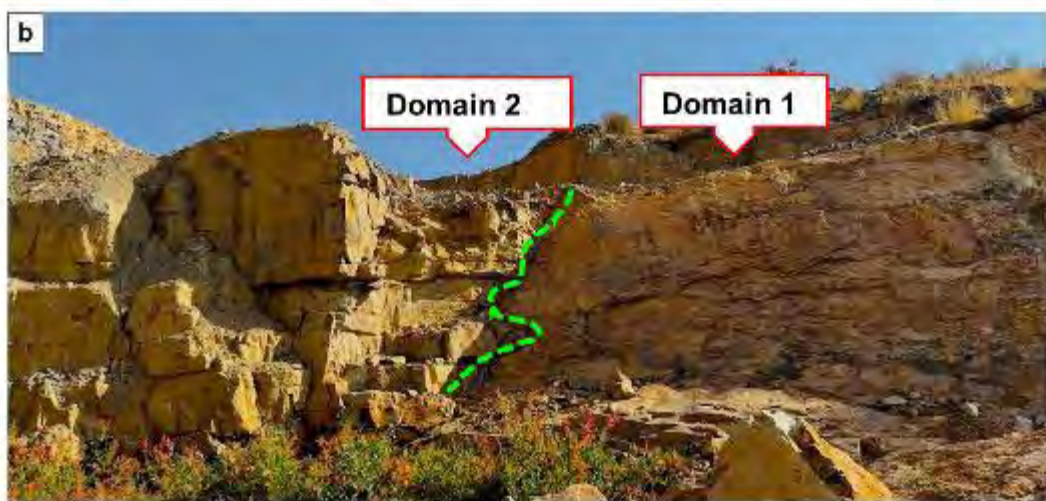
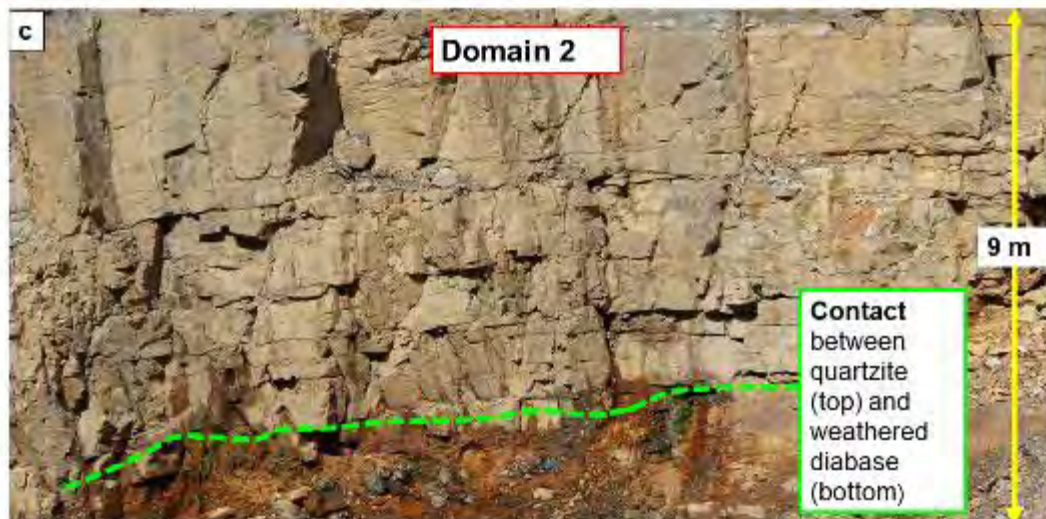
Figure 5-5 Geotechnical domains window mapped in the high wall (a) domain 1 (b) Highly weathered (b) transition between domain 2 and 3 (c) domain 3 with seepage zone between quartzite and diabase (photographed by Maoyi 2024).
