RIVER ECOCLASSIFICATION: MANUAL FOR ECOSTATUS DETERMINATION (Version 2)

Module G: Index of Habitat Integrity Section 2: Model Photo Guide

TT 378/09

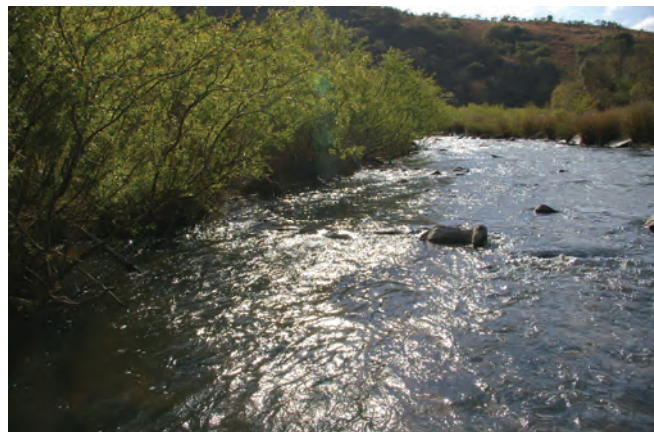
Assegaai River (Mpumalanga)

Base flow dry season

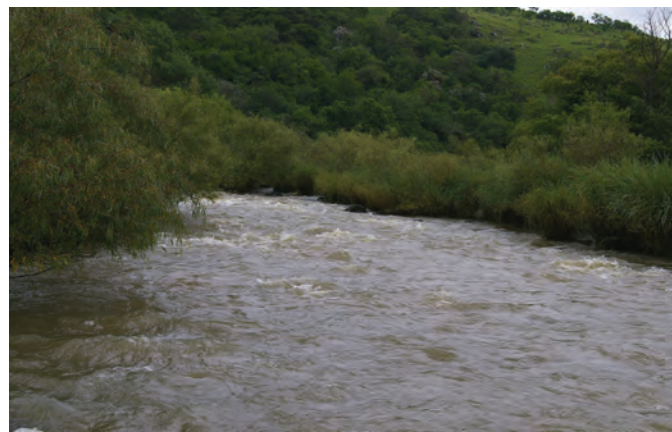
Base flow wet season

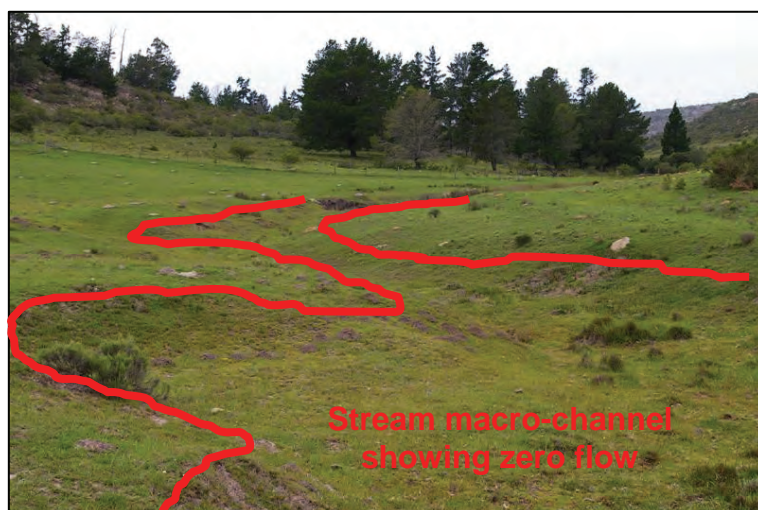
Bushmans River downstream of the
Jameson Dam (Eastern Cape)

The picture shows a dry river channel due to afforestation and an upstream dam. There is now zero flow and the channel has become vegetated.

Stream macro-channel
showing zero flow

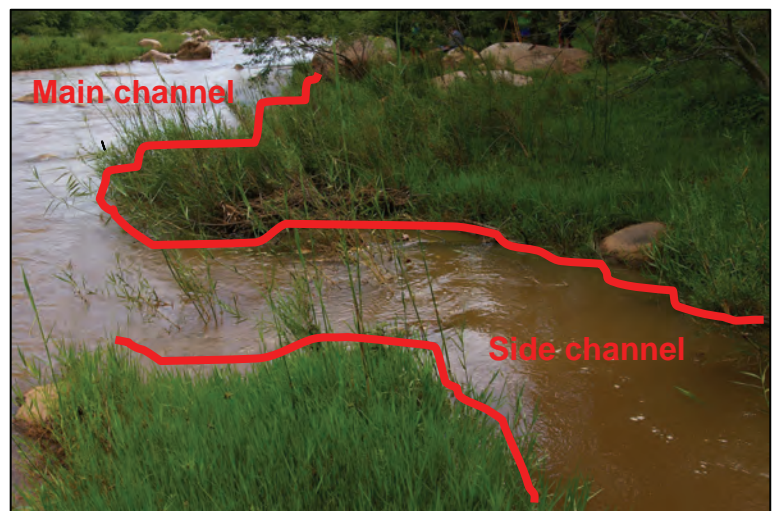
Mkhondvo River (Swaziland)

The picture illustrates how side channels are activated during a moderate flood.

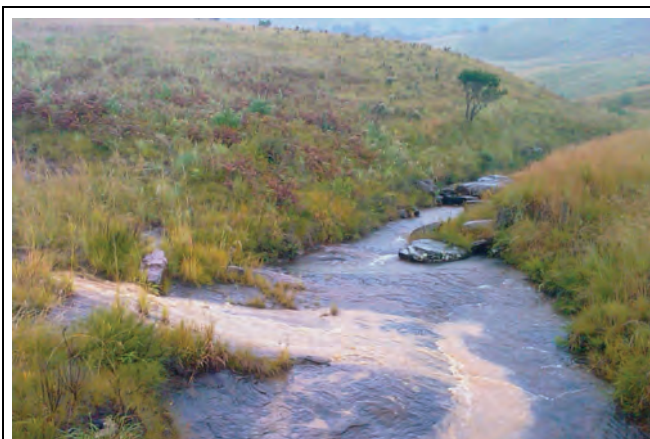
Clear Drakensberg stream with high turbidity coming in from the left illustrating overgrazed rural sub-catchment with high turbidity.

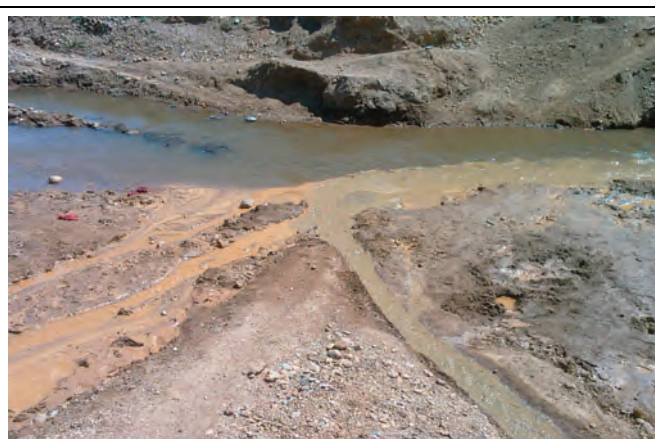
Confluence of Tangwiza and Mwana rivers showing high turbidity water and sediments from artisanal gold mining.

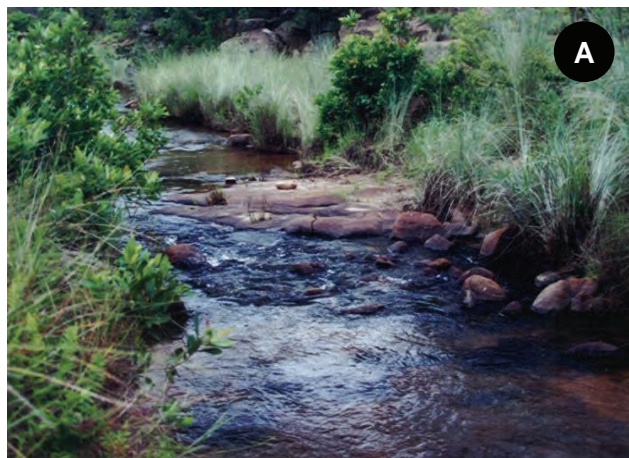
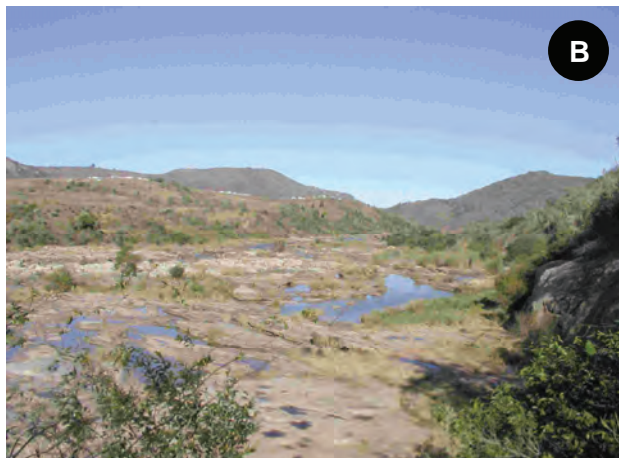
Frikkie-se-Loop

Geomorph Zone: Lower foothills

No upstream development. Site in excellent condition with no indication of extra sedimentation.

Bedrock dominated channel with low sediment loads, clear pools and clean bedrock. Few sand or gravel bars, silt drapes or silt in pools.

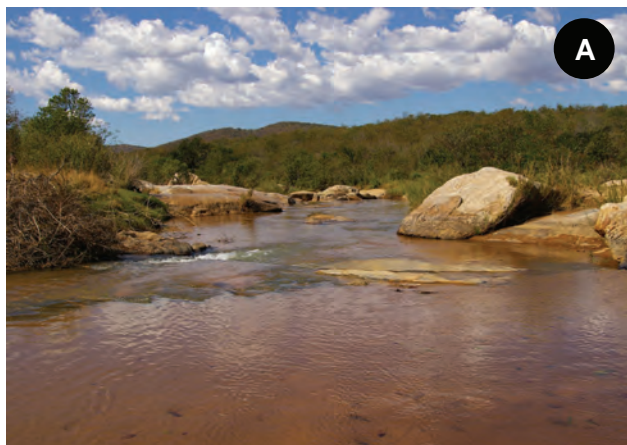
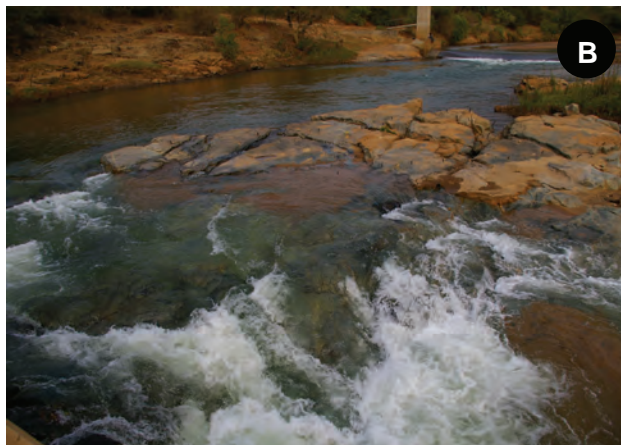
Ngwempisi (EFR1)

Geomorph Zone: Lower foothills

Upstream subsistence farming, irrigated sugar cane and an upstream gauging weir (with its stilling basin full of sediments) has led to a moderate increase in sedimentation across the bedrock areas.

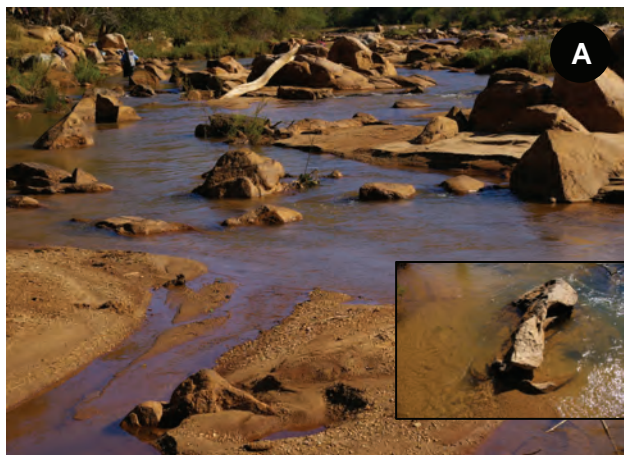
Mkhondvo

Geomorph Zone: Lower foothills

Extreme sedimentation of a largely bedrock type river has caused most of the habitat to be lost in this reach of river. Picture and inset illustrate the sediments accumulating around the large bedrock elements in this river.

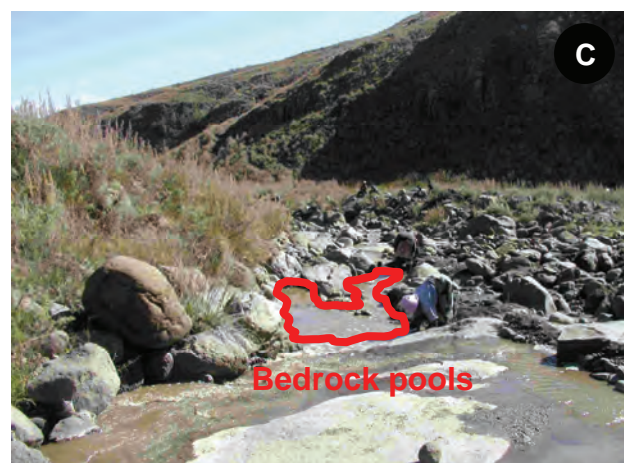
Kao

Extreme sedimentation of a largely bedrock type river has caused most of the bedrock habitat to be lost in this reach of river. Picture illustrates the sediments accumulating around the large bedrock elements in this river.

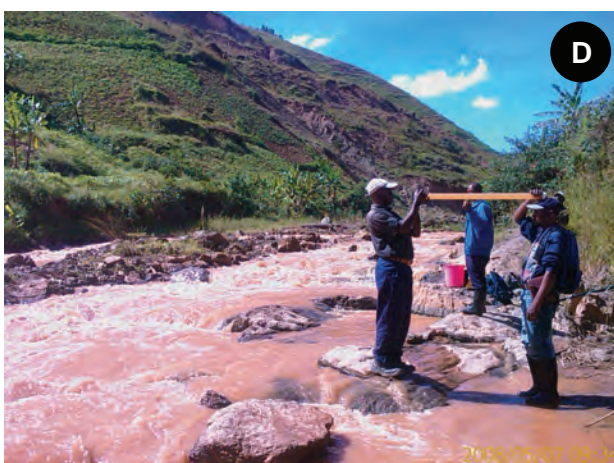
Kudobo

Geomorph Zone: Mountain stream

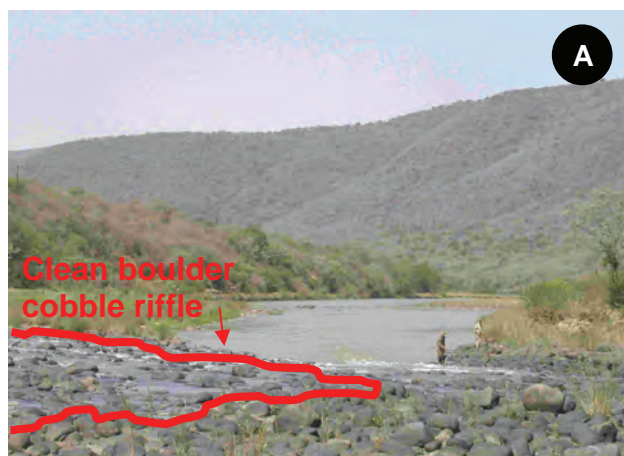
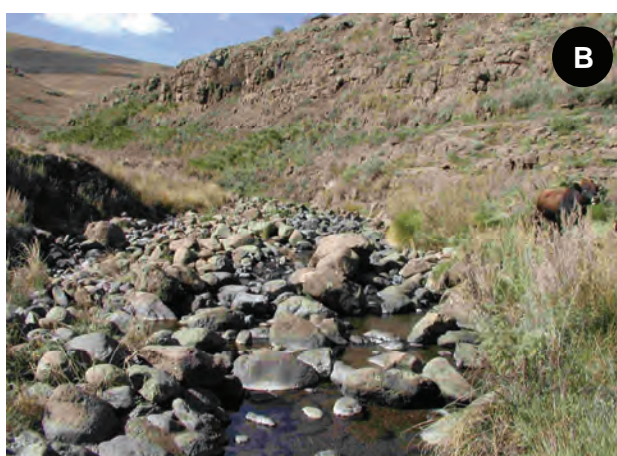
Umkomaas (at Umko Lodge below Staebas Farm)
Geomorph Zone: Upper foothills

Clean boulder cobble riffle with very little sediment accumulation amongst cobbles.

Kao
Geomorph Zone: Mountain stream

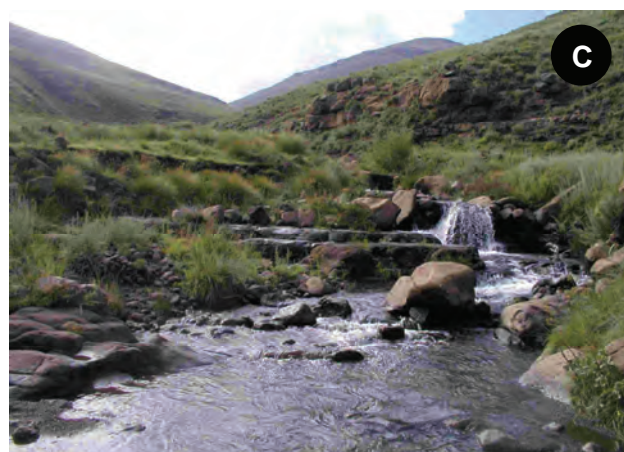
Kao
Geomorph Zone: Mountain stream

Clean boulder cobble riffle with very little sediment accumulation amongst cobbles.

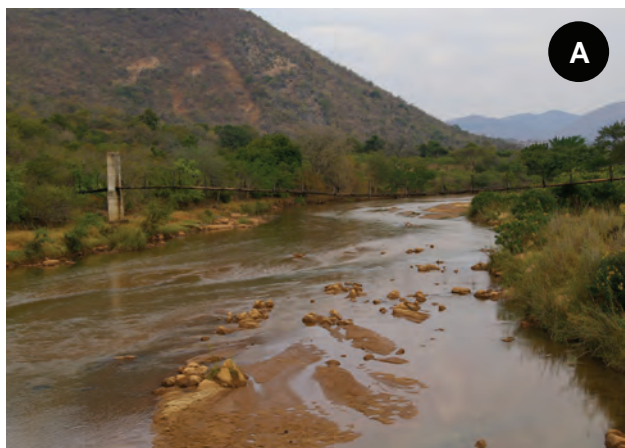
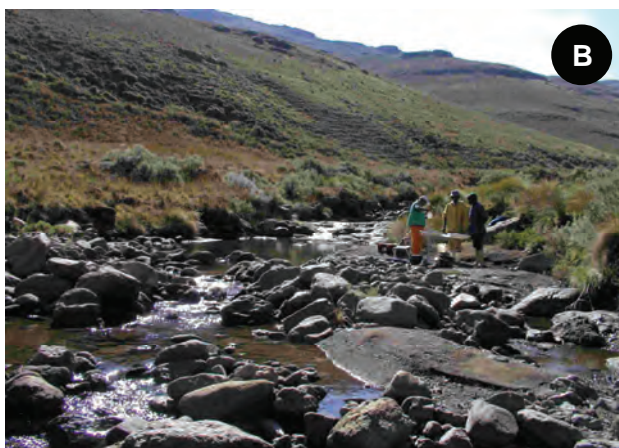
Mkhondvo

Geomorph Zone: Lower foothills

Extensive upstream sugar cane farming and subsistence agriculture as well as decreased sediment transport capacity are the cause for this rating. Boulder and cobble habitat occluded by sandy sediments. Considerable loss of cobble and boulder habitat.

Extensive gravel sediments filling pools and spaces between cobbles and boulders. Loss of boulder habitat and infilling of pools.

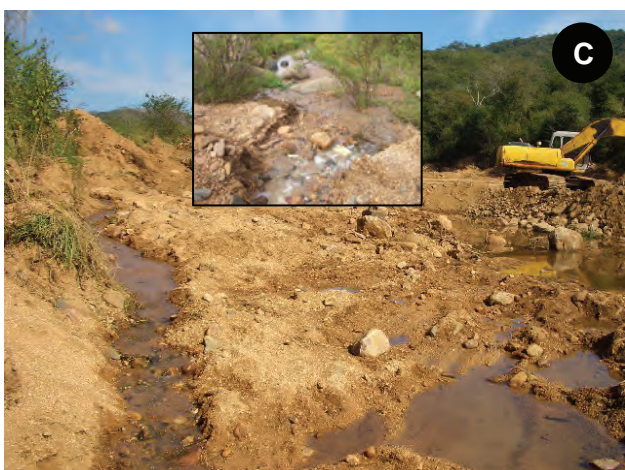
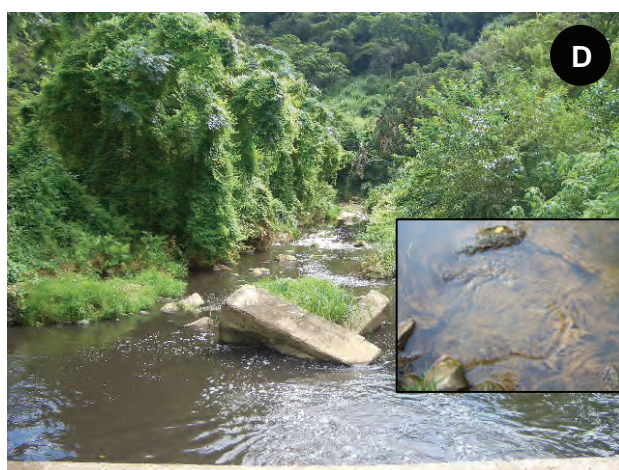
Sikelekehleni (upstream from uMgeni confluence)

Geomorph Zone: Lower foothills

Insert shows how sediment has covered the boulder cobbles resulting in loss of habitat. The entire boulder/cobble nature of the river has been transformed to a sediment dominated system. Destabilisation of riparian and instream zones due to sand mining is the primary cause of this decline.

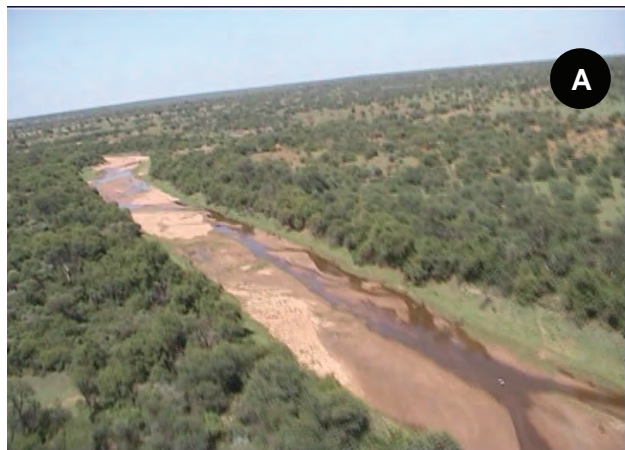
Crocodile

Geomorph Zone: Lower foothills

Extensive upstream abstraction and agricultural activities are evident, but because this is an alluvial bed, it is resilient to changes. There is also a good riparian buffer moderating the upstream impacts.

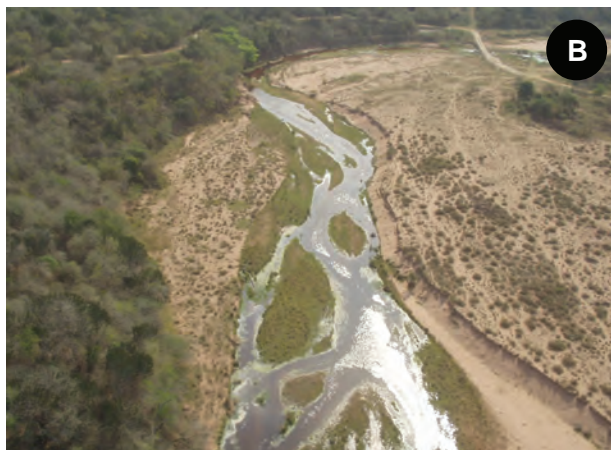
Sterkspruit (at Shongweni inflow)

Geomorph Zone: Lower foothills

Braided alluvial stream in good condition with vegetation in channel bars. Good recovery from 1987 floods.

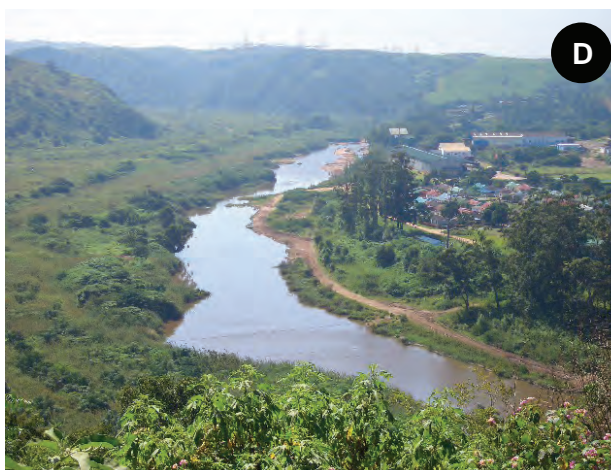
Lovu

Broad alluvial flood plain in good condition with natural sedimentation.

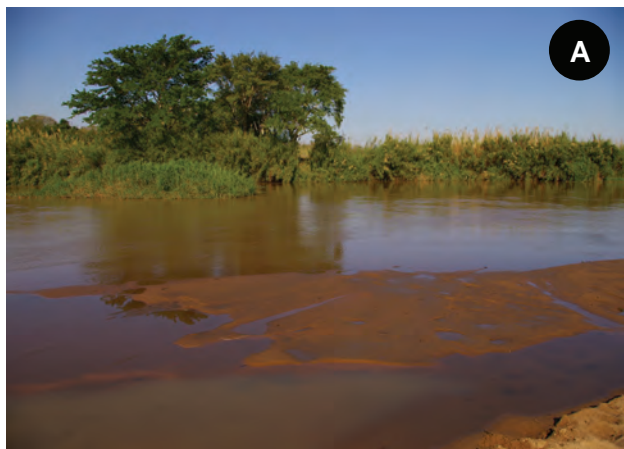
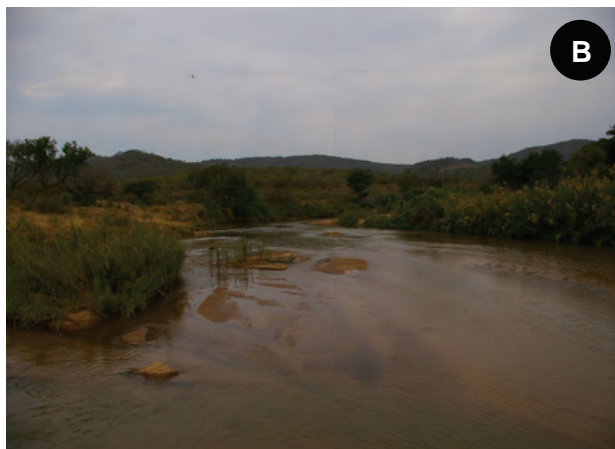
Maputo (EFR 4)

Geomorph Zone: Lowland river

This river has been affected by the Phongolapoort dam, sugar irrigation from the Usuthu River and fairly extensive flood plain utilisation. Decreased flooding within this reach and the above-mentioned activities have had an impact on sediment accumulation and sediment mobility. However, this is a very large river, well buffered by good riparian zone integrity and hence is still in reasonable condition.

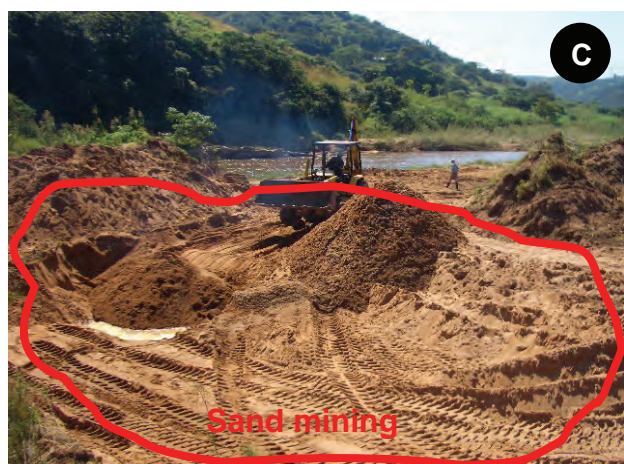
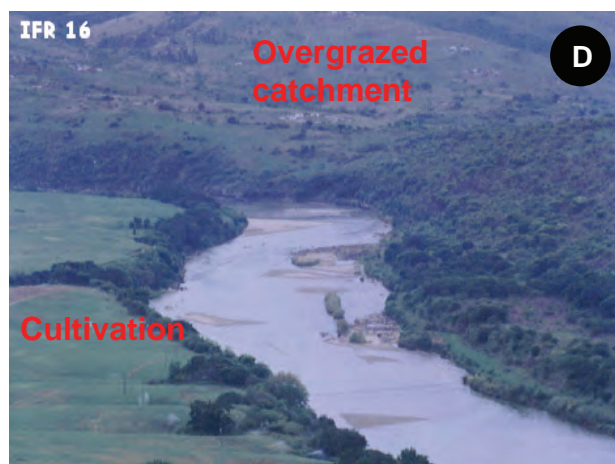
Lovu

Excessive sedimentation due to overgrazing within the catchment, numerous dams on the system, and the associated low flows have caused increased reed growth.

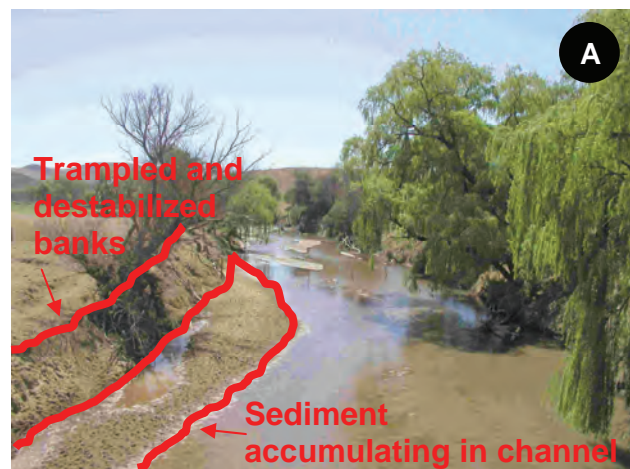
Mzimvubu (at Jones Bridge)
Geomorph Zone: Lower foothills

Extensive alien willows along bank resulting in bank destabilisation combined with chronic trampling of banks by livestock. Lack of bank stability and increased sedimentation negatively impact on the instream channel.

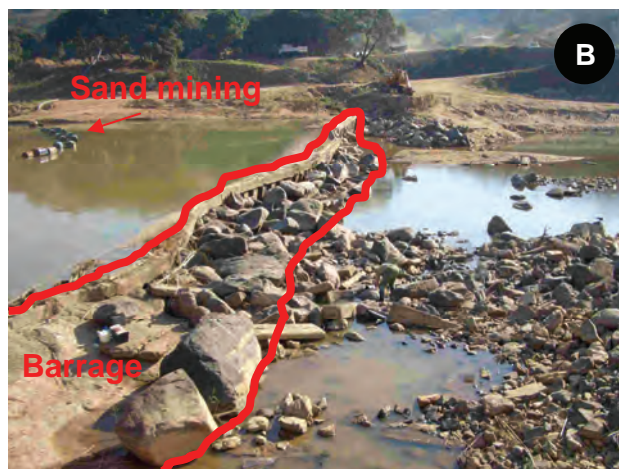
Umkomaas (at Sappi Saicor barrage)
Geomorph Zone: Lowland river

Construction of barrage and sand mining by dredging is interfering with the movement and distribution of natural alluvial sediments.

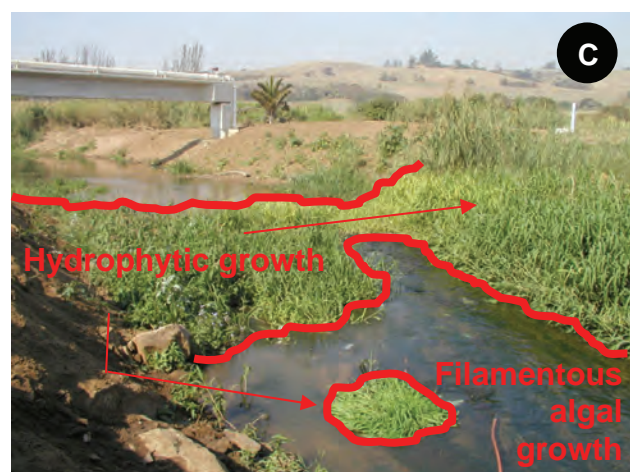
Ohlangua (downstream from N2 road bridge)
Geomorph Zone: Lowland river

Canalisation of river for bridge has resulted in a change of flow regime. High nutrient content from sewage return flows results in extensive instream hydrophytic growth. Filamentous algal growth is also evident in the stream bed resulting in changed instream habitat.

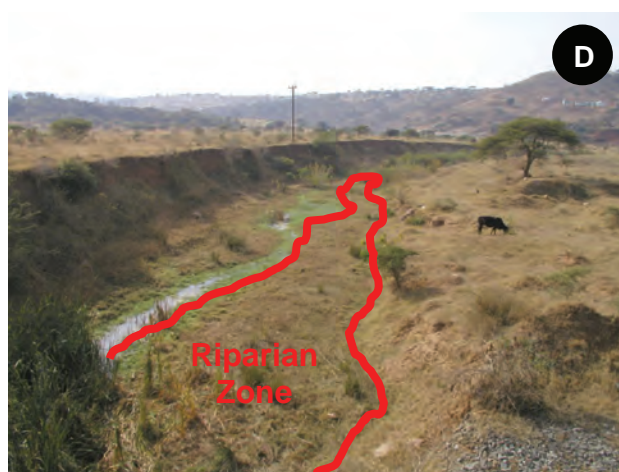
Mshwati (upstream from confluence with Duzi)
Geomorph Zone: Lower foothills

Extensive livestock utilisation of riparian zone and trampling of banks and channel. Loss of natural riparian vegetation. Unstable instream sediments and loss of diversity of instream habitats.

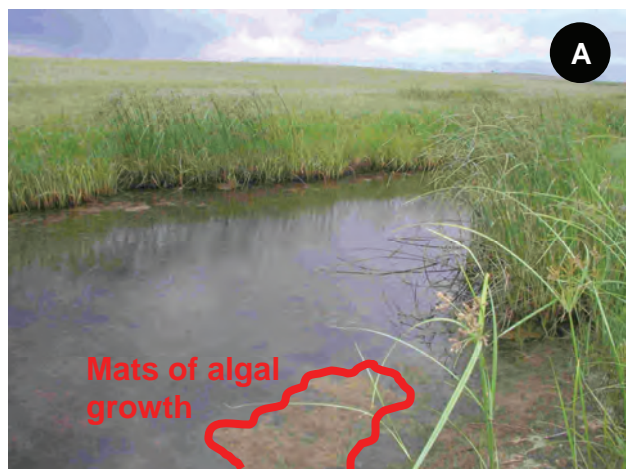
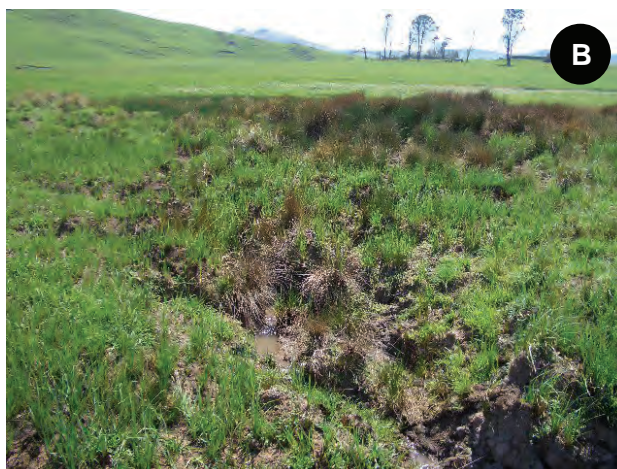
Unnamed stream (Bergville)
Geomorph Zone: Upland flood plain

Extensive mats of algal growth on bottom sediments, otherwise in good condition.

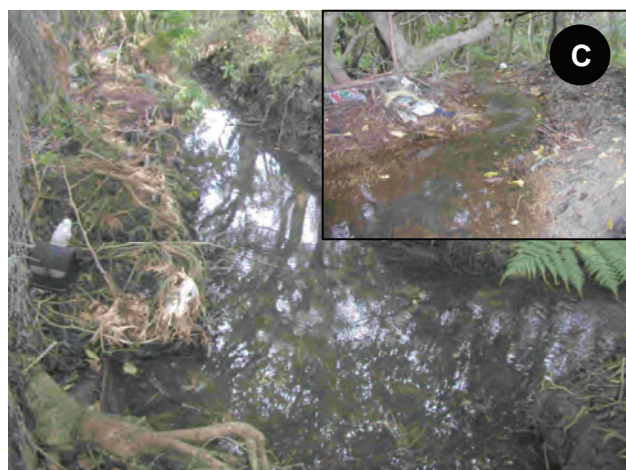
Unnamed stream (swamp forest, KwaZulu-Natal South Coast)
Geomorph Zone: Lowland river

Light channel incision and physical litter accumulation from stormwater runoff.

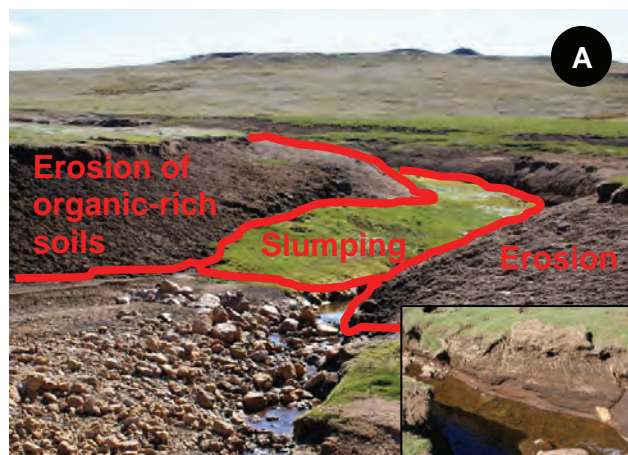
Unknown

Geomorph Zone: Upland flood plain

Deep organic wetland soils on either side of river channel are being severely eroded with slumping of the river bank into the channel. Insert illustrates erosion of organic-rich wetland type soils.

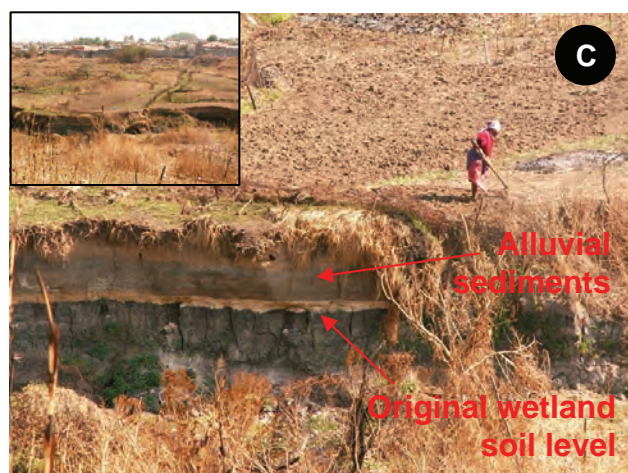
Unknown Gauteng

Erosion due to overgrazing has removed organic wetland soils down to subsoil and bedrock. There is also a localised lowering of the water table due to channel incision.

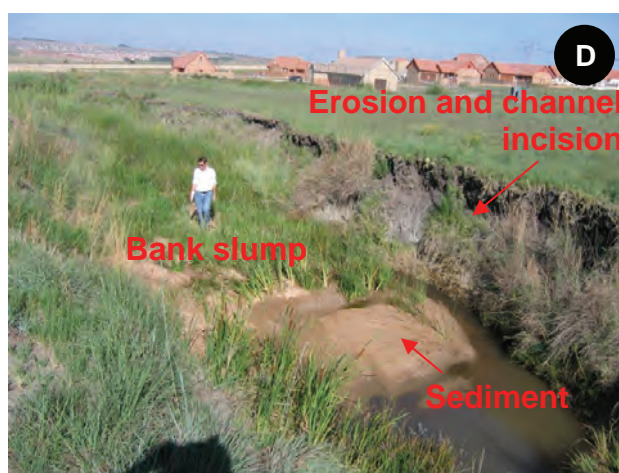
Unknown (Gauteng)

Geomorph Zone: Upland flood plain

Accelerated urban runoff and increased flood peaks cause erosion through the wetland. Picture also illustrates bank slumping, channel incision and bed modification and sedimentation.

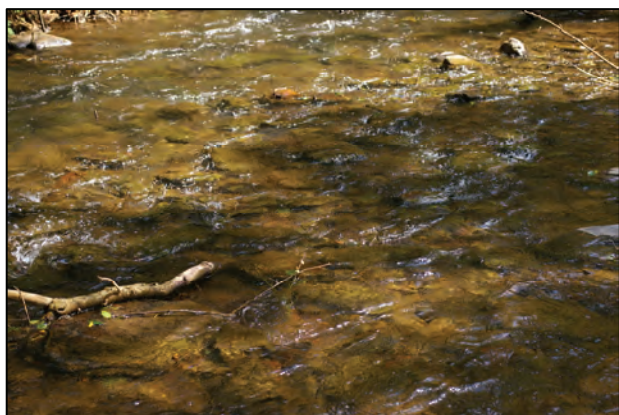
Mats of benthic algal growth covering stream bed and reducing available habitat.

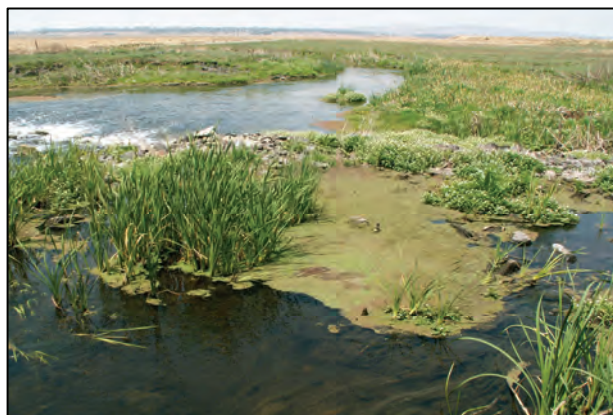
Instream filamentous algae visible in the foreground of the above photo.

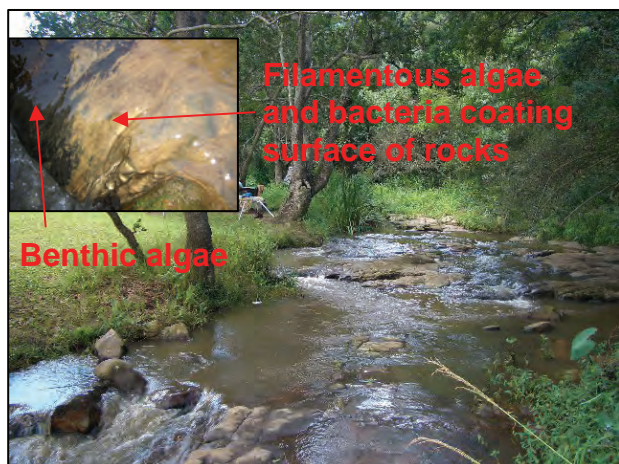
Nqutu (at Kranskloof Nature Reserve)
Extensive benthic algal and bacterial growth covering surface of bedrock and cobble biotopes (see insert) in response to nutrient enriched water.

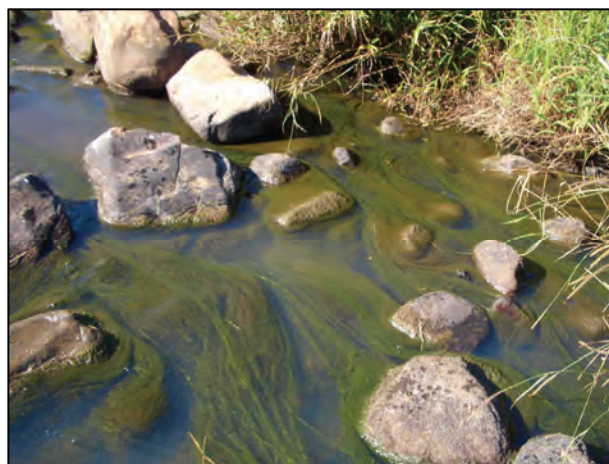
Mlazi
Intensive market gardening and crop production upstream with nutrient runoff into the streams causing extensive filamentous algal growth.

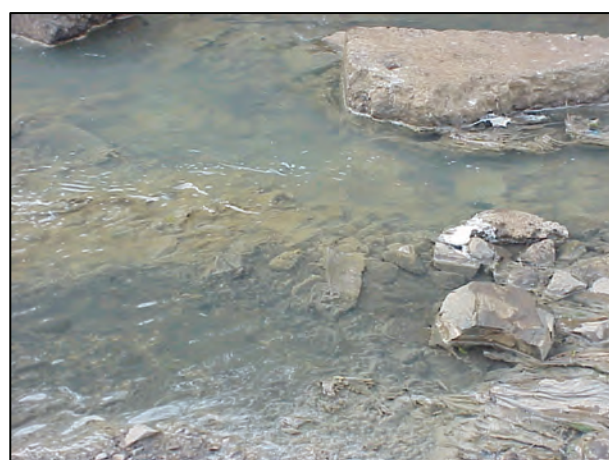
Sewage fungus coating the instream stones habitat of the Baynespruit, Pietermaritzburg.

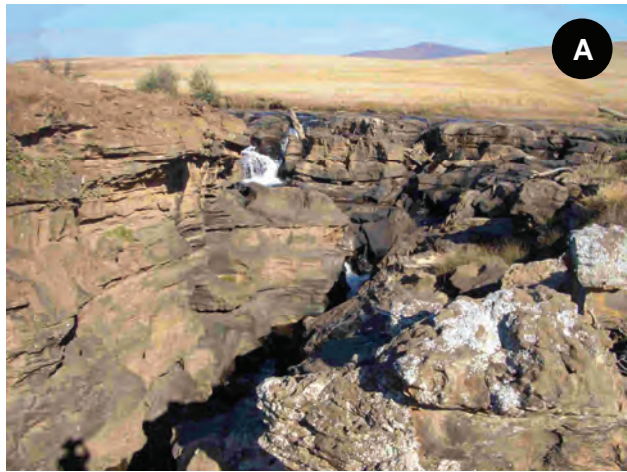
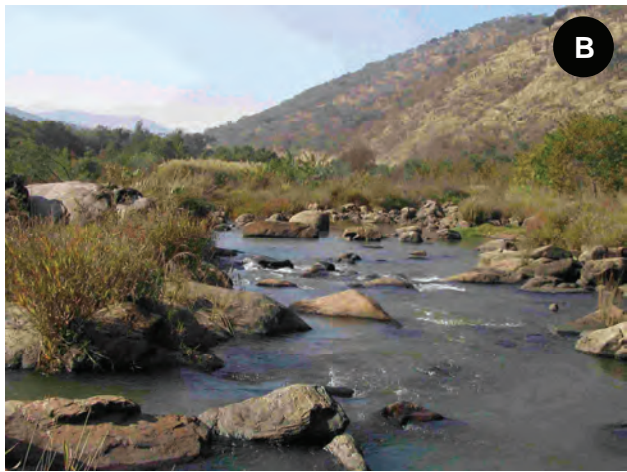
<p>Tsitsa (at Niagra Falls) Geomorph Zone: Transitional</p> <p>Bedrock intact with healthy riparian vegetation.</p>	<p>uMgeni Geomorph Zone: Upper foothills</p> <p>Bedrock and large boulder banks intact with healthy riparian vegetation.</p>

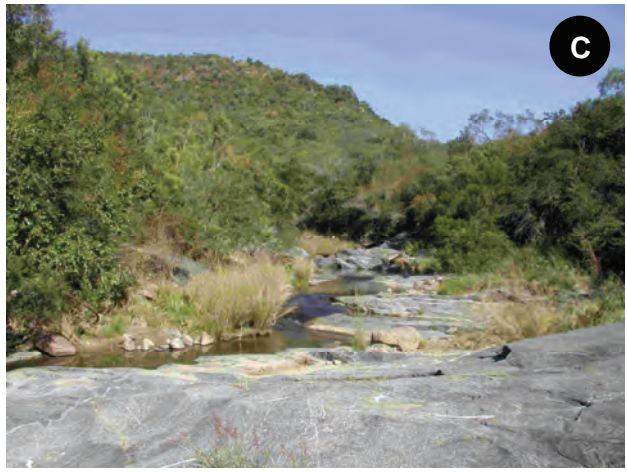
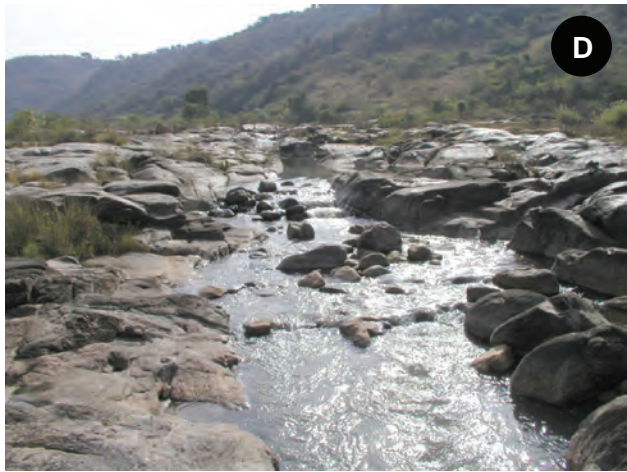
<p>Mandleni (at Overshot Farm) Geomorph Zone: Mountain stream</p> <p>Bedrock intact with healthy riparian vegetation. Bedrock dominated riparian zone which is very stable and intact.</p>	<p>uMgeni (downstream from Nagle Dam) Geomorph Zone: Lower foothills</p> <p>Bedrock dominated riparian zone which is very stable and intact, although there has been some armouring of this river.</p>

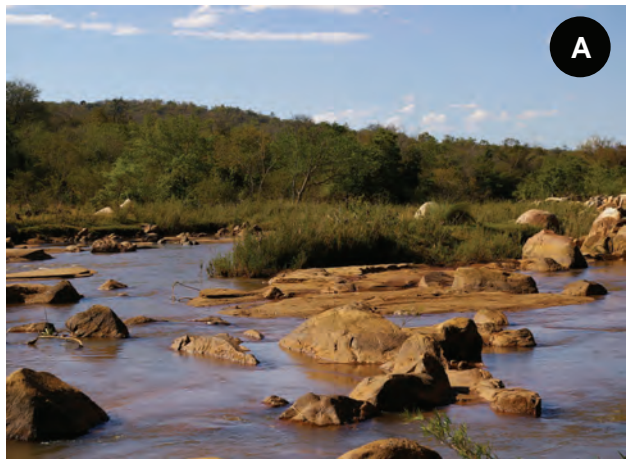
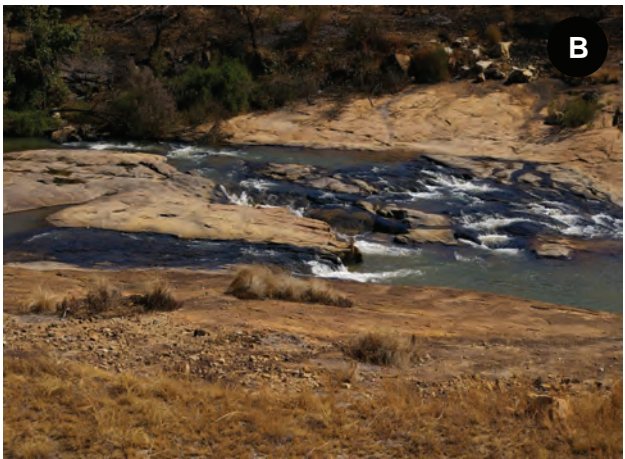
<p>Mkhondvo Geomorph Zone: Lower foothills</p> <p>Large boulder/bedrock bank with slightly elevated gravels and sand. Marginal vegetation is in moderate condition.</p>	<p>Lushushwane Geomorph Zone: Transitional</p> <p>Relatively stable bedrock banks with localised overgrazing of grassy riparian vegetation. River banks still in moderate condition.</p>

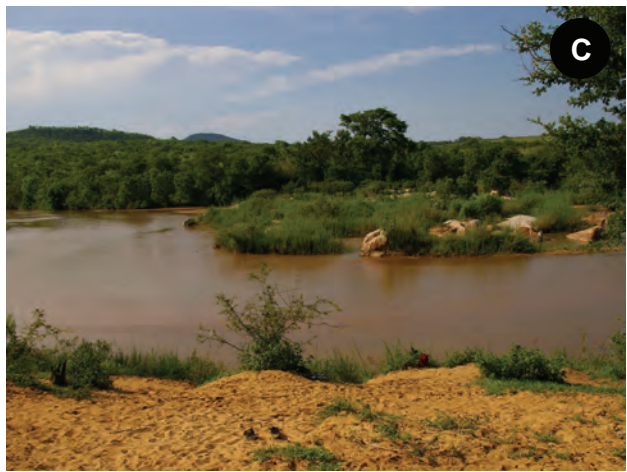
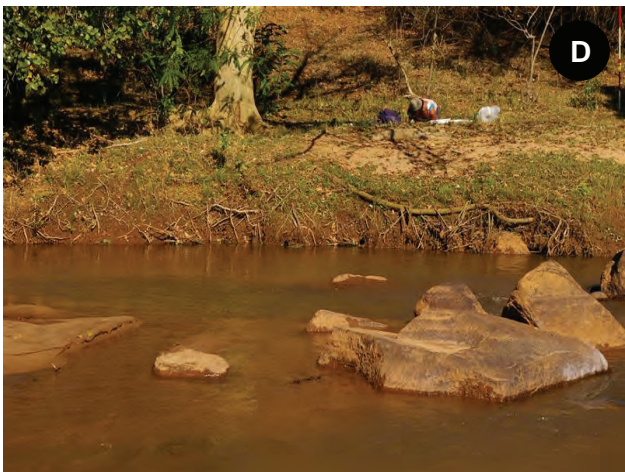
<p>Ngwempisi (EFR 1) Geomorph Zone: Lower foothills</p> <p>The far bank is relatively undisturbed (rating probably 1). The near bank is highly disturbed with localised vegetation removal and trampling by livestock. Hence the overall rating is moderate (2-3).</p>	<p>Mkhondvo Geomorph Zone: Lower foothills</p> <p>Modified sediment transport dynamics have resulted in undercutting and erosion of the exposed bank. As the river attempts to widen, vegetation root structure is exposed.</p>

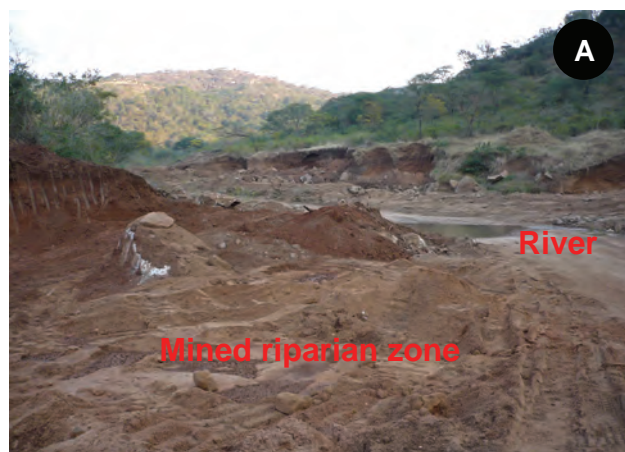
Sikelekehleni

Massively impacted riparian zone due to removal of gravel sediments for sand mining. Destruction of riparian zone is virtually complete.

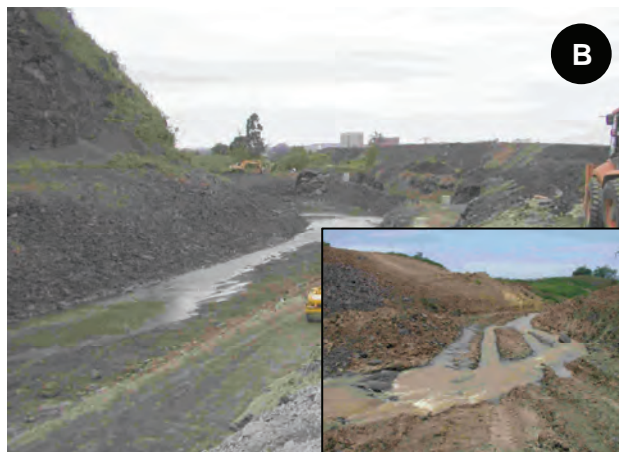
Town Bush Stream

Channel re-alignment and complete bank modification in both marginal and non-marginal zones. Complete loss of riparian zone functioning.

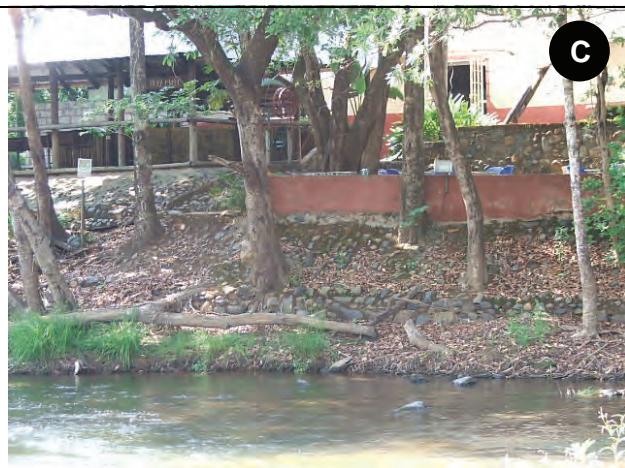
Sabie River (at Aan-de-Vliet Lodge)

Marginal zone has been highly modified to cater for recreational areas on the banks (including the lodge).

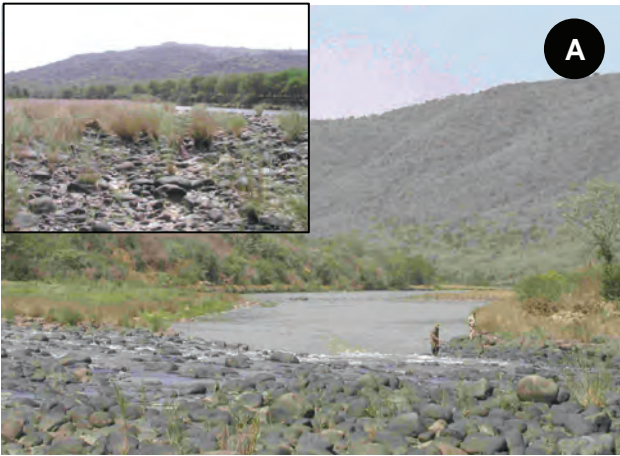
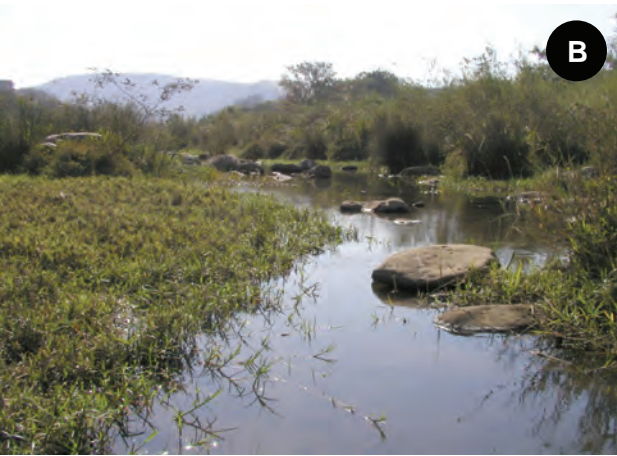
<p>Umkomaas (at Umko Lodge) Geomorph Zone: Lower foothills</p> <p>Good boulder/cobble substrate and vegetation along bank.</p>	<p>Tongaati (at Ngedleni Village) Geomorph Zone: Lower foothills</p> <p>Intact riparian vegetation (reeds) in both marginal and non-marginal zones.</p>

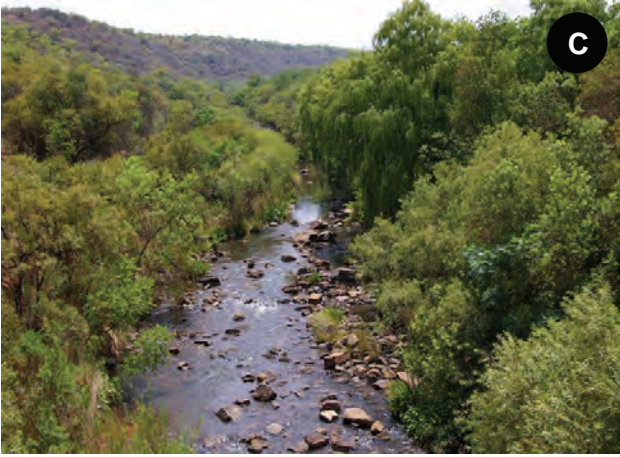
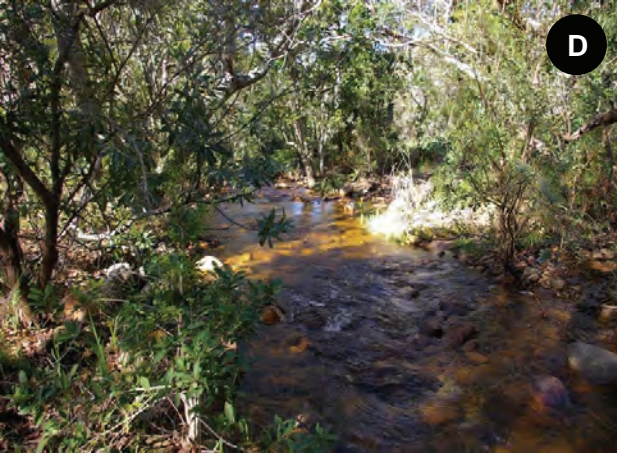
<p>Kaaloog-se-Loop Geomorph Zone: Upper foothills</p> <p>Intact riparian vegetation with little change to bank structure and integrity. Overhanging and good marginal vegetation provide excellent refugia for fish and invertebrates and hence good habitat integrity. The intact state prevents any erosion, sedimentation, bed modification and bank erosion.</p>	<p>Eerste (Western Cape) Geomorph Zone: Upper foothills</p> <p>Intact riparian vegetation with little change to bank structure. Overhanging and good marginal vegetation provides excellent refugia for fish and invertebrates and hence good habitat integrity. The intact state prevents any erosion, sedimentation, bed modification and bank erosion. There is also a clear lack of alien vegetation which adds to the integrity.</p>

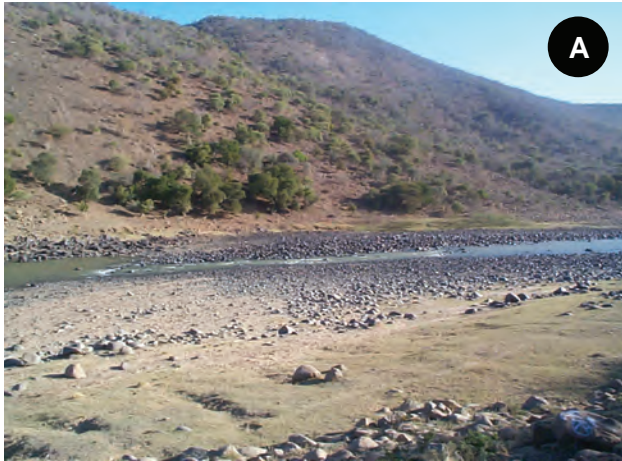
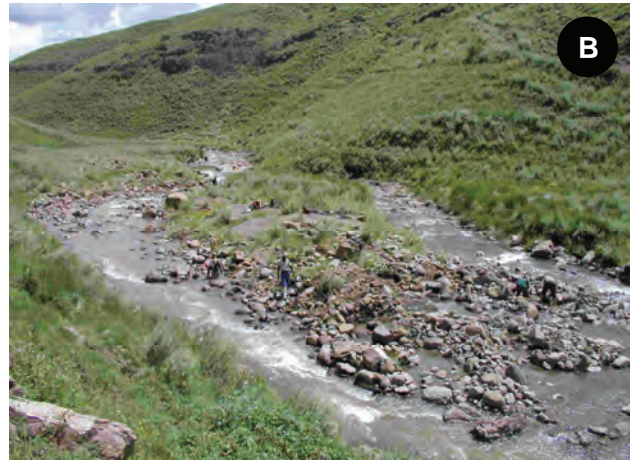
Thukela (at Tugela Ferry, IFR 9)
Geomorph Zone: Transitional

Marginal vegetation on banks cropped short and or removed by livestock grazing pressure. This provides very little marginal, instream and overhanging vegetation for this system. However this is localised and due to flooding, vegetation is removed and any regeneration of vegetation is repeatedly removed by grazing. Easy access amplifies this problem.

Kao (Lesotho)
Geomorph Zone: Mountain stream

Gravels and sediments accumulating in marginal zone. Reduction in integrity of marginal vegetation.

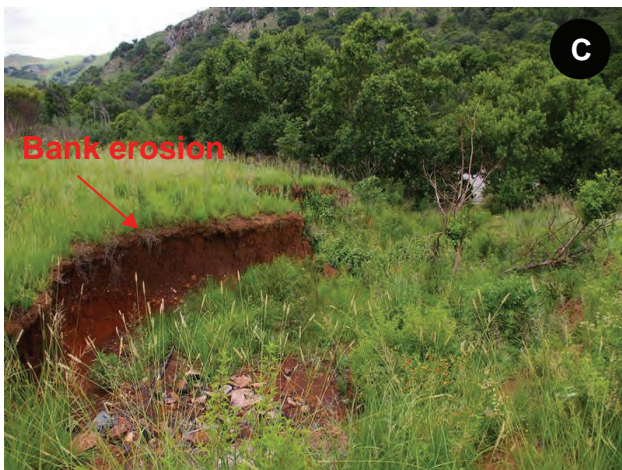
Assegaai
Geomorph Zone: Lower foothills

Overgrazing and associated pressures causing localised bank erosion and collapse.

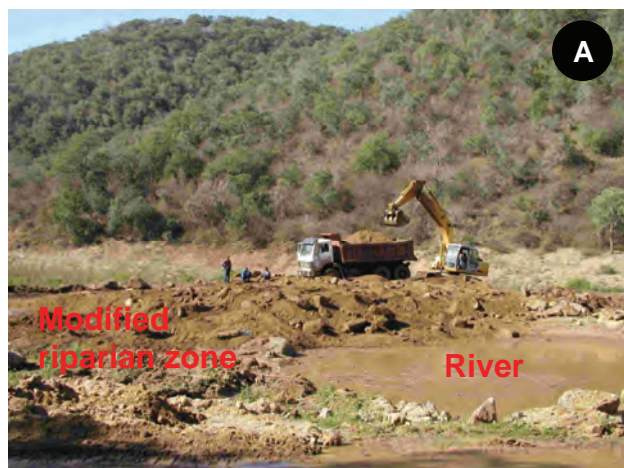
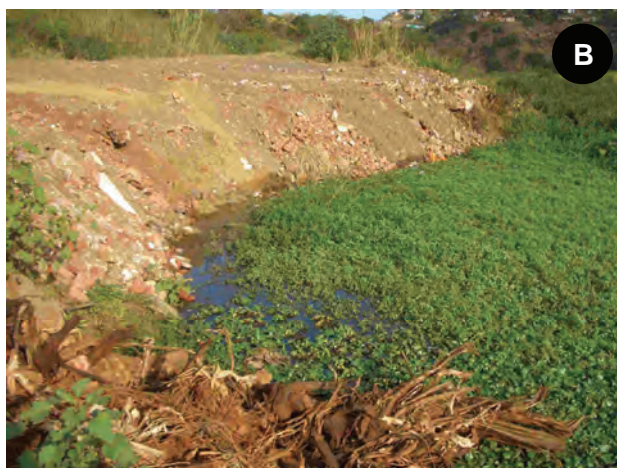
Extensive building rubble dumping into riparian zone and into stream channel. There is also nearly 100% exotic macrophyte cover (water hyacinth). These combined impacts have a major effect on the marginal and non-marginal zones of the bank.

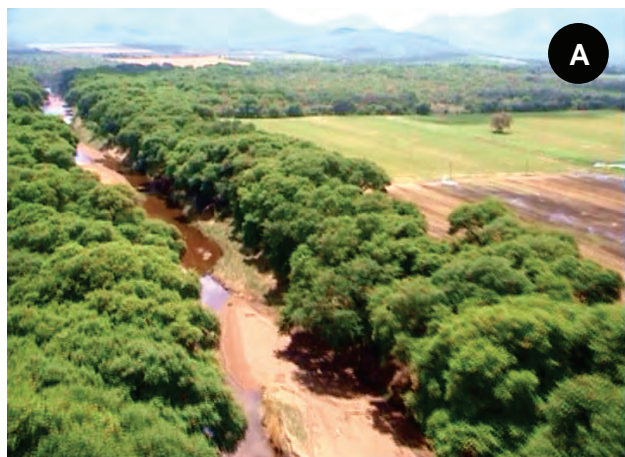
Crocodile

The encroachment by the agricultural lands within the upper riparian zones will have minor impacts on the bank integrity. Even though at present there does not appear to be a problem there is long term potential for impacts within this reach.

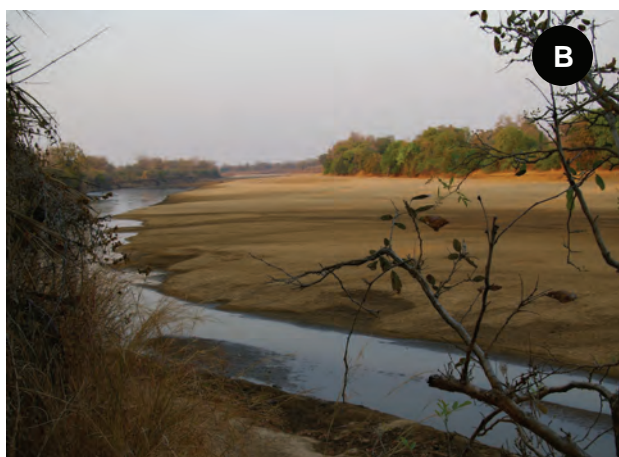
Broad alluvial banks, within a nature reserve (Southern Luangwa National Park), showing limited modification.

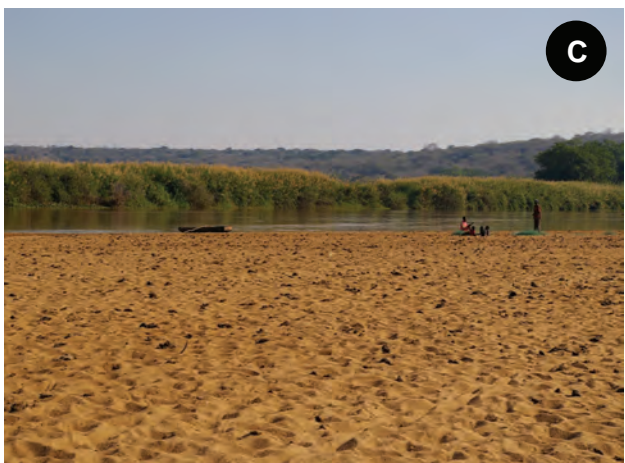
Maputo

There is some flood plain subsistence agriculture and due to limited human pressures, there is limited impact on the instream habitat. The flood plains in the lower reaches are regularly inundated and sand is deposited on the banks.

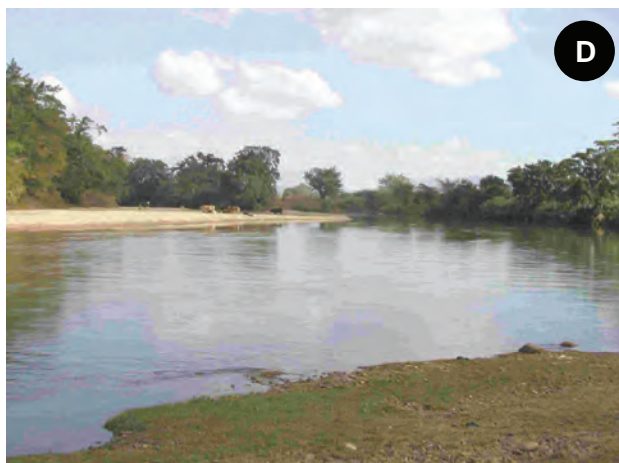
Phongola

Broad alluvial flood plain in good condition with natural sedimentation. Also illustrated are natural open patches within the riparian zone.

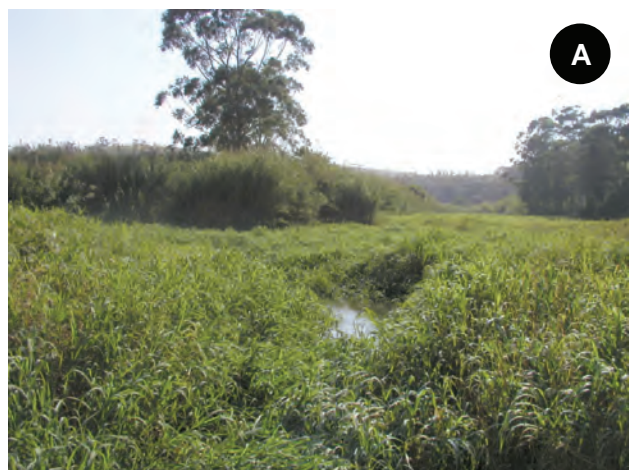
Tongaati (upstream from estuary)
Geomorph Zone: Lowland river

Marginal vegetation is intact with trees and shrubs except where informal and artisanal sandmining (see insert) is evident resulting in loss of marginal and non-marginal vegetation structure.

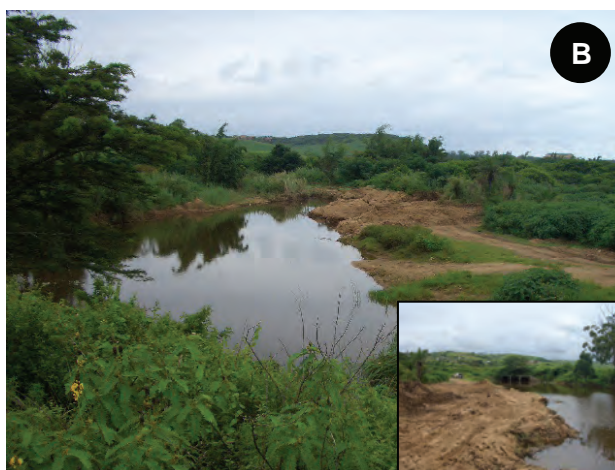
B

Msimbazi
Geomorph Zone: Lowland river
