RIVER ECOCLASSIFICATION: MANUAL FOR ECOSTATUS DETERMINATION (Version 2)

Module G: Index of Habitat Integrity Section 2: Model Photo Guide

TT 378/09

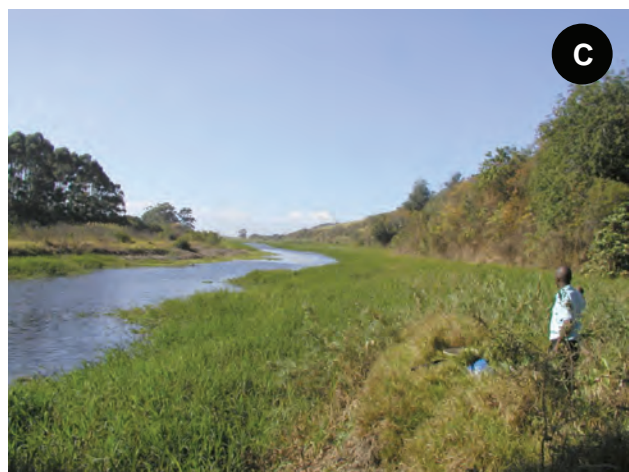
Mdloti (upstream from estuary at N2 bridge)
Geomorph Zone: Lowland river

Extensive sand mining operations along left bank. Almost complete destruction of marginal and non-marginal vegetation on one bank. Opposite bank is still in reasonable condition.

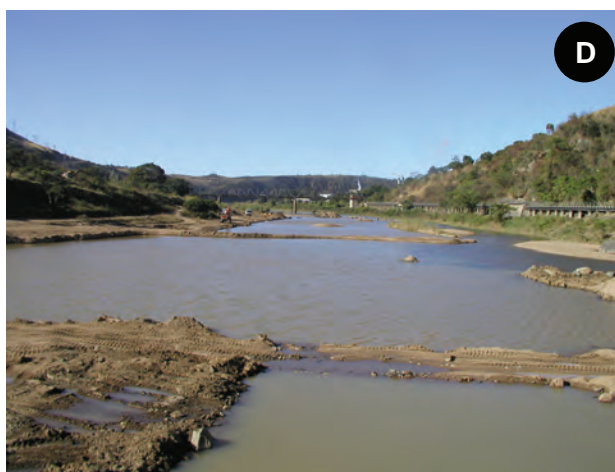
D

Umkomaas (at Sappi Saicor barrage)
Geomorph Zone: Lowland river

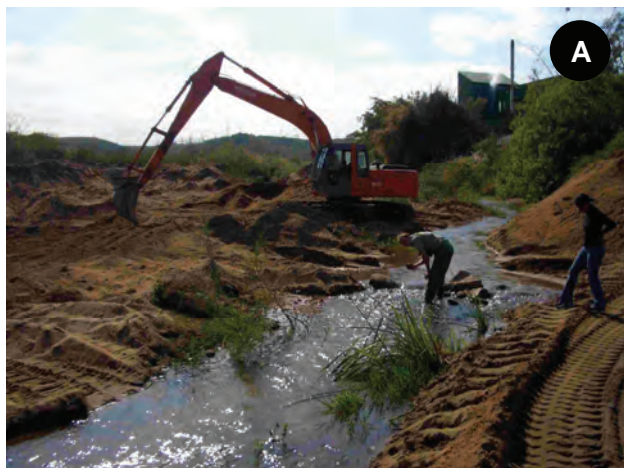
Lovu (at Illovo Sugar Mill)
Geomorph Zone: Lowland river

Total bank modification due to indiscriminate sand mining. Virtually 100% loss of marginal and non-marginal elements.

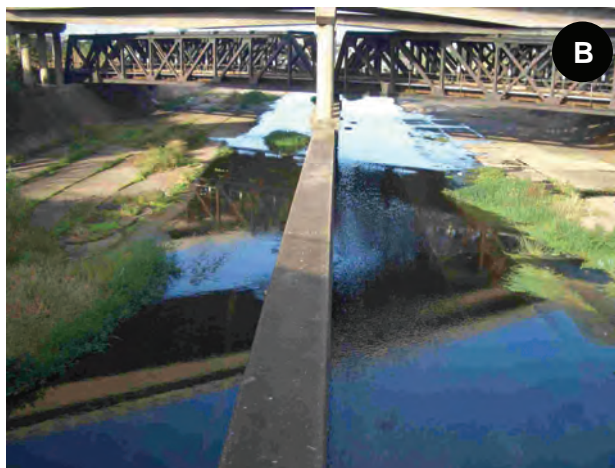
uMlaas canal (at N2 road bridge)
Geomorph Zone: Lowland river

Canalised section of river with 100% modification of natural marginal and non-marginal elements.

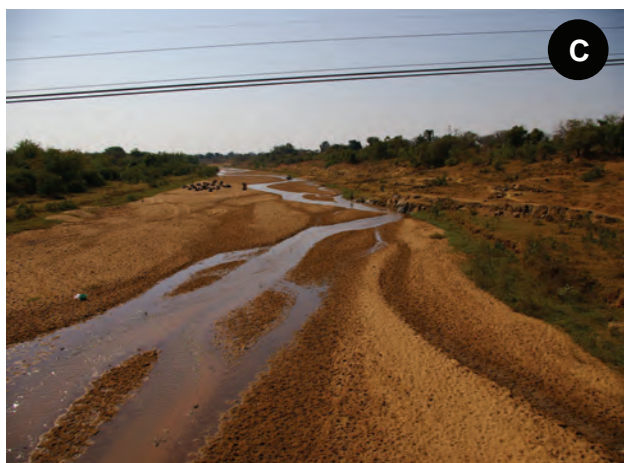
Mhlatuzane
Geomorph Zone: Lower foothills

Massive overgrazing and trampling by livestock with large-scale destruction of marginal and non-marginal elements.

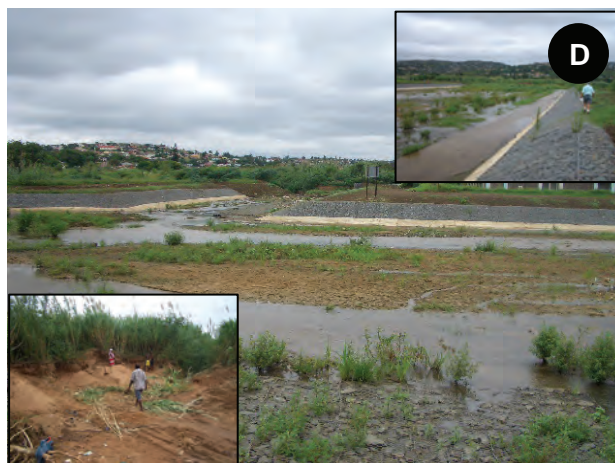
Piesang (at kwaMashu canal)
Geomorph Zone: Lowland river

Middle to lower reaches of the Piesang River canalised with extensive loss of functional riparian wetlands along marginal and non-marginal areas of the bank. Artisanal sand mining of non-marginal areas is now possible and is taking place (see lower insert).

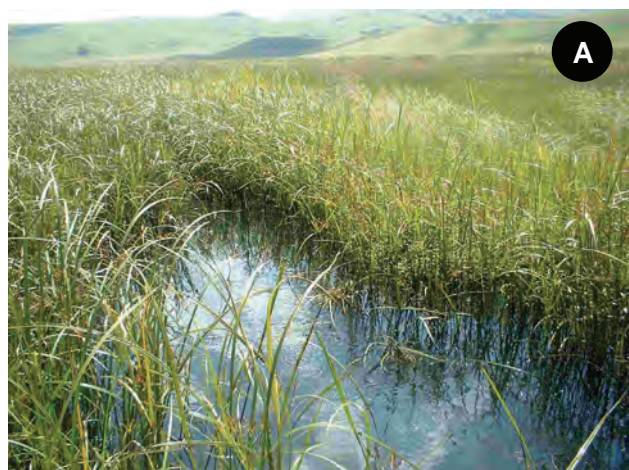
uMgeni headwaters (uMgeni Sponge)
Geomorph Zone: Source

Typical palustrine wetland/stream with intact marginal vegetation.

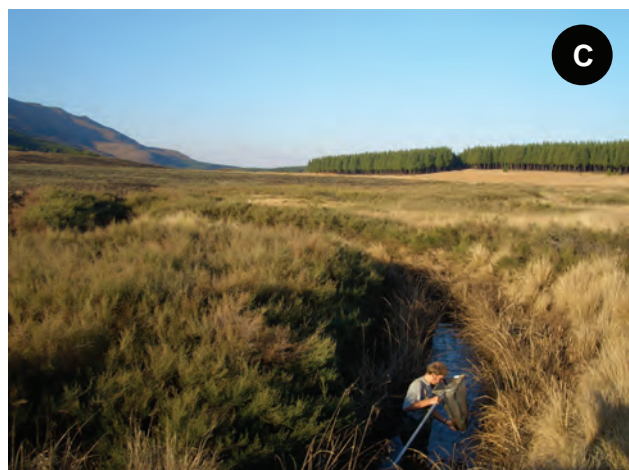
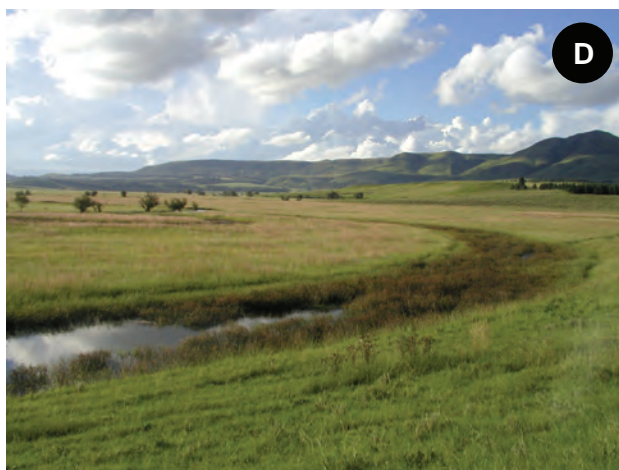
Gat
Geomorph Zone: Upland flood plain

Banks in very good condition with little or no impact.

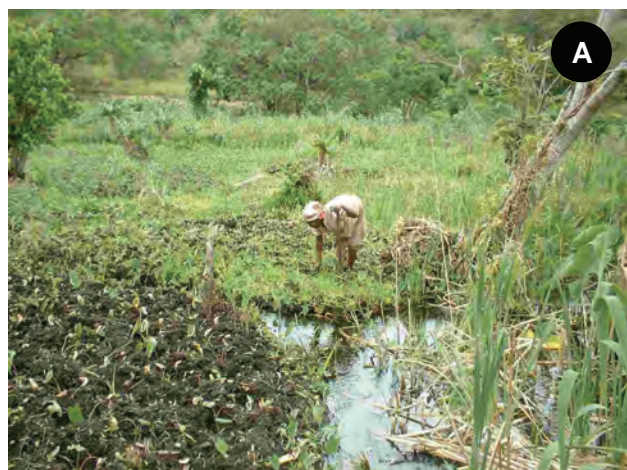
Tributary feeding into Kosi Bay Lake

Moderate cultivation of coastal swamp forest/wetland stream, but low impact on marginal and non-marginal zones.

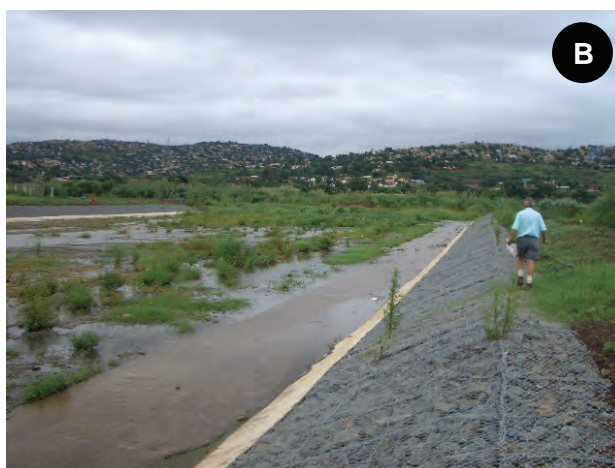
Umhlangane / Piesang

Naturally meandering river through coastal wetland has been straightened and canalised. There is significant loss of riparian wetland function.

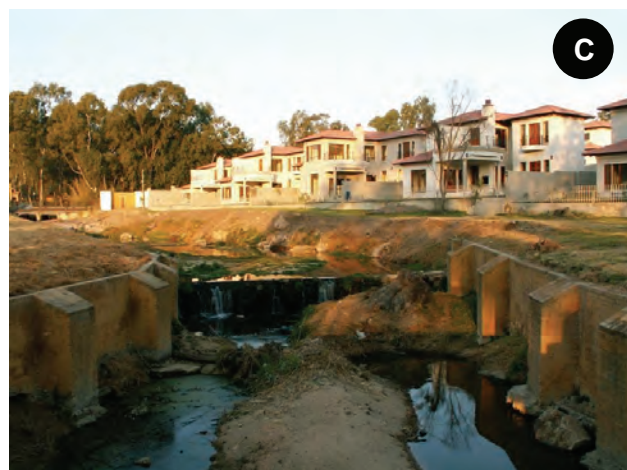
Unknown

Canalised and modified riparian wetland through urban setting – channel straightening, infill and hard engineered weirs have removed most wetland functioning. Increased flood peaks and accelerated stream flows also cause bank erosion and channel incision.

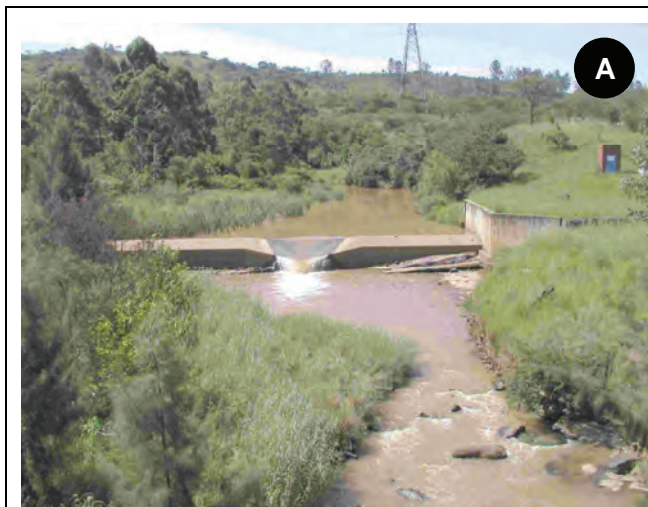
**Duzi at Edendale Weir**

The illustrated Krump weir is slightly more fish-friendly (as compared with photos C and D) but nonetheless interferes with connectivity.

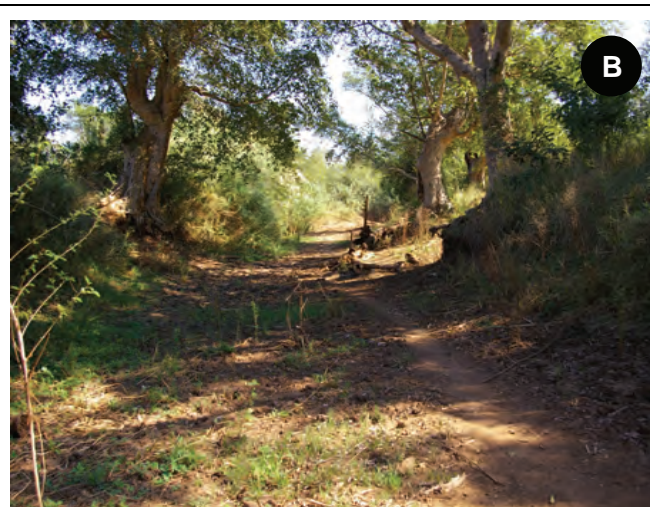
**Ingwavuma**

Extreme case of connectivity modification. The downstream section of this river hardly ever flows due to upstream abstractions.

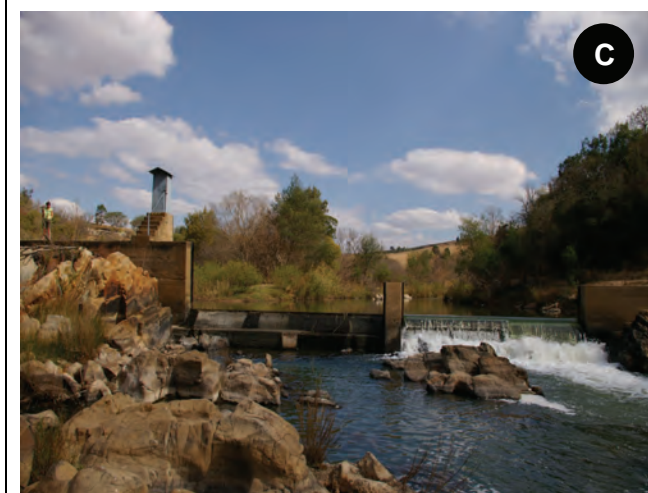
**Assegaai**

Typical gauging weir forming a natural migration barrier and interfering with lateral connectivity.

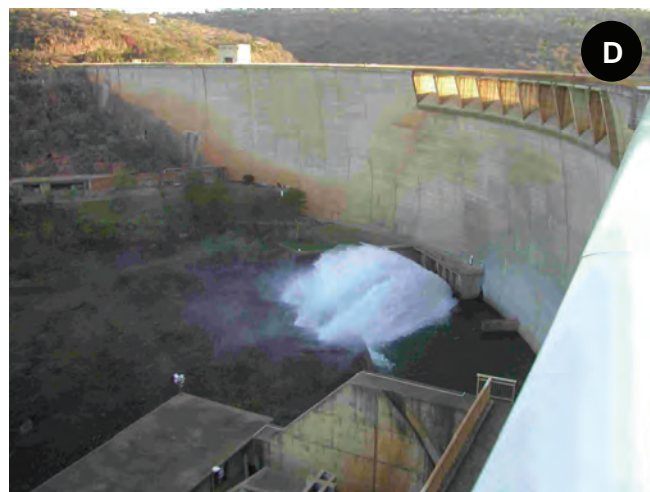
**Phongolapoort Dam**

Large dam wall forms a complete barrier to migration even during high flows.

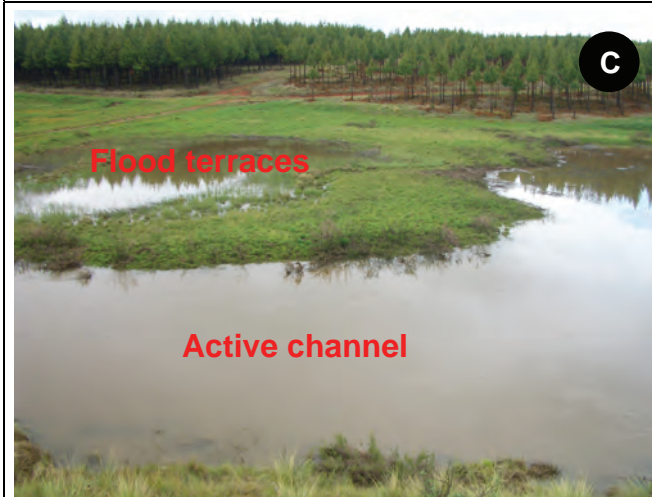
Gatberg
Flood terraces and flood plains recharged and connected to the main channel during flooding.

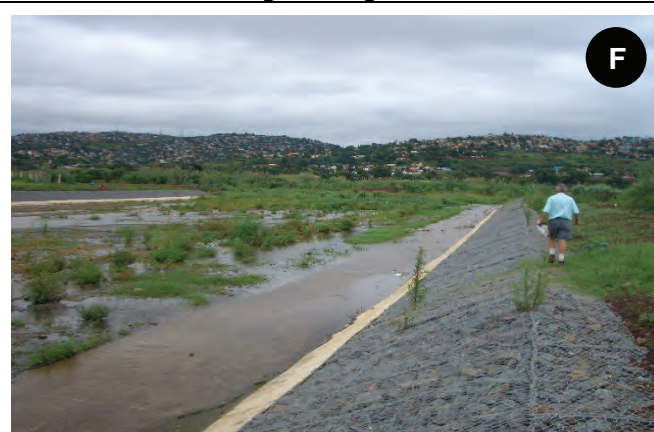
Lower Piesang / Umhlangane in KwaMashu showing extensive canalisation severely reducing lateral connectivity with adjacent riparian wetlands.

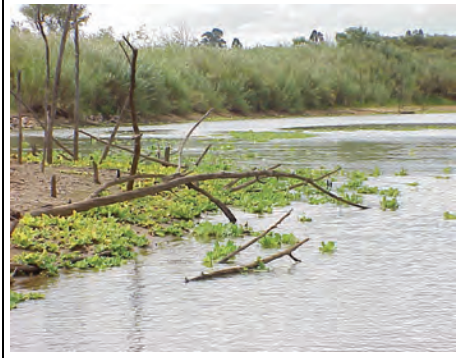
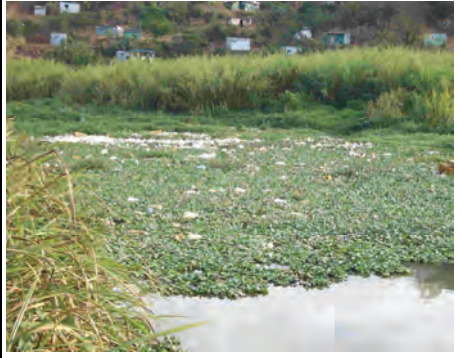
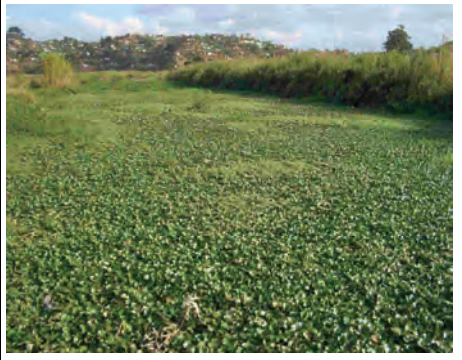
Rating is determined by the percentage coverage of water surface by macrophytes

0-1 (0-30%)	2-3 (30-60%)	4-5 (60-90%)

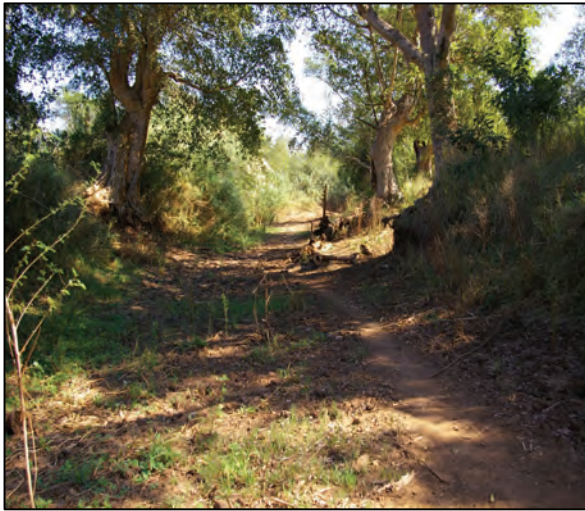
Ingwavuma

Photo shows complete encroachment and terrestrialisation. Older trees are surviving but there is little replacement of vegetation by younger riparian species.

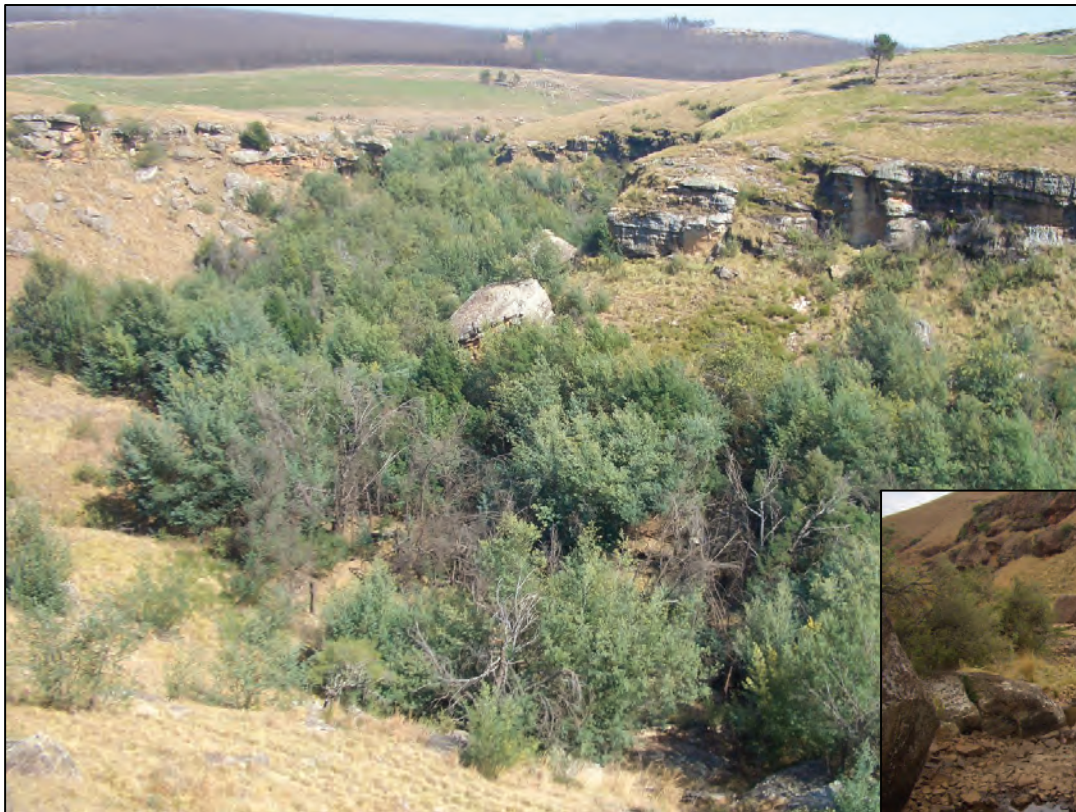
NECF Funeray Plantation

Afforestation in upper catchment and trees within the riparian zone have dramatically reduced base flows. Photo inset shows normally perennial river reduced to seasonal pools.

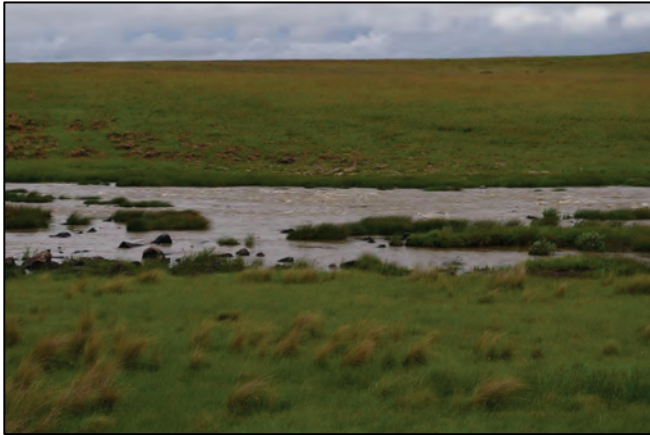
Vaal River Prior to flooding

Prior to moderate flooding and freshes, the riparian vegetation in the Vaal and Mzintlava rivers in the photographs below, is clearly obvious. During flooding this riparian vegetation is inundated temporarily.

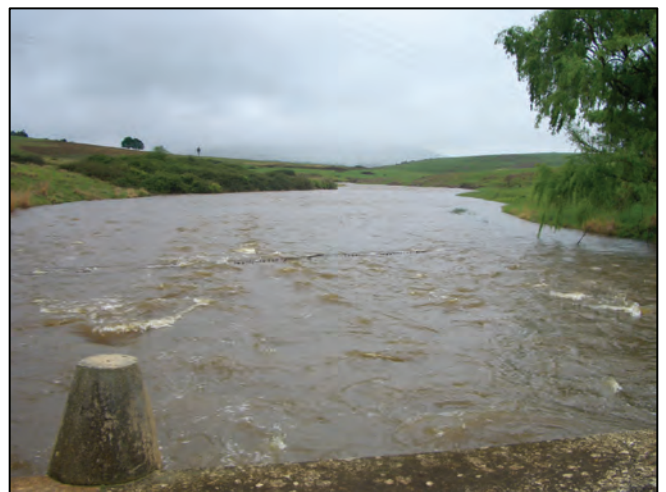
Mzintlava River Prior to flooding

During flood

The 1937 aerial photograph below shows the uMgeni river before the construction of Albert Falls dam. Note the lack of encroachment of vegetation within the riparian zone. Compare this with the same area in 2003. Vegetation has progressively thickened, due to a reduction in large and moderate floods and their frequency.

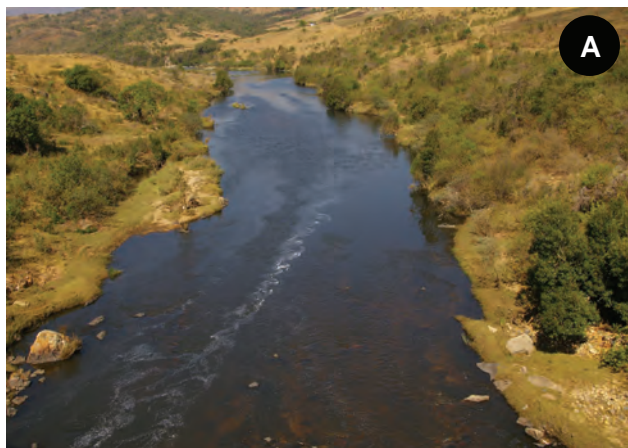
Usuthu

Geomorph Zone: Upper foothills

Left and right banks are well covered by a combination of grass, trees and shrubs. Very little substrate is exposed.

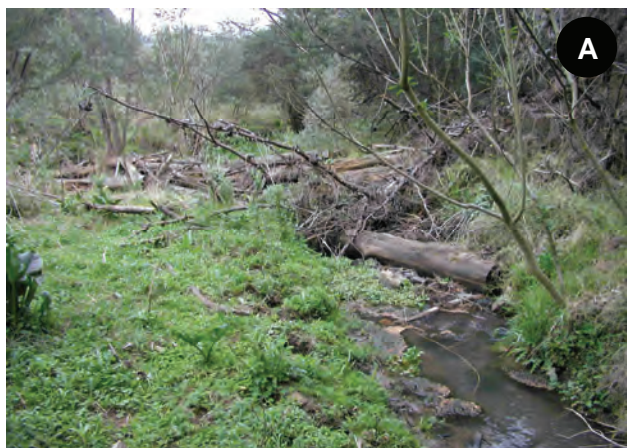
Snake

Geomorph Zone: Upper foothills

Forestry harvest debris in channel with localised bank erosion and exposure. Also evidence of cattle grazing within the riparian zone. Cattle hoof action is destabilising riparian zone banks.

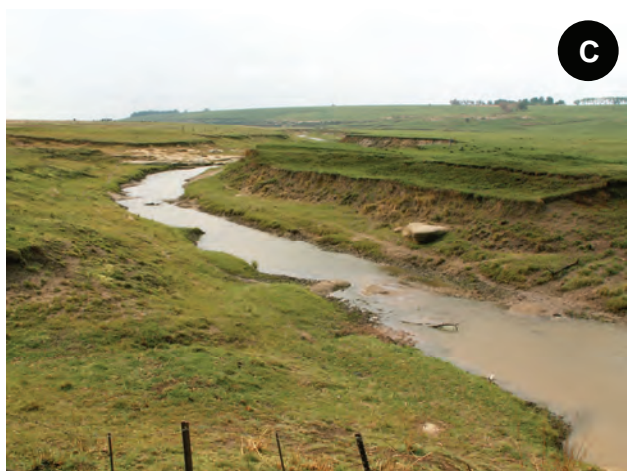
Unknown

Riparian vegetation removal by livestock grazing and trampling particularly on near bank. Insert shows sparse cover in areas. Far bank is well covered.

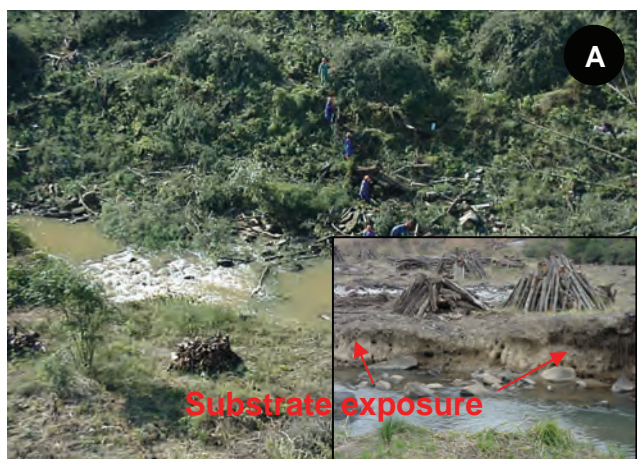
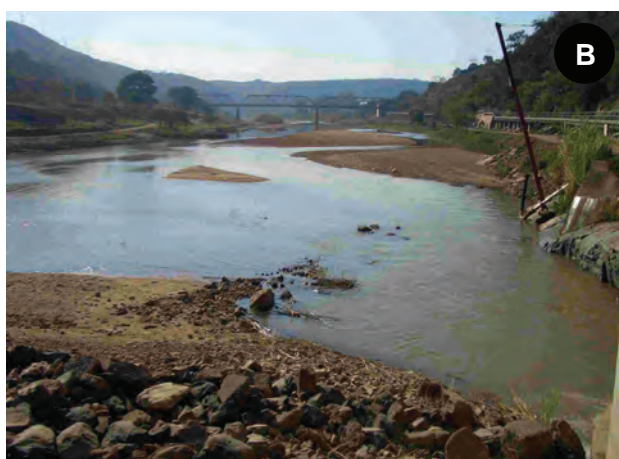
Lion

Geomorph Zone: Upper foothills

Alien weed control, removal, stacking and burning of aliens has led to severe substrate exposure along banks.

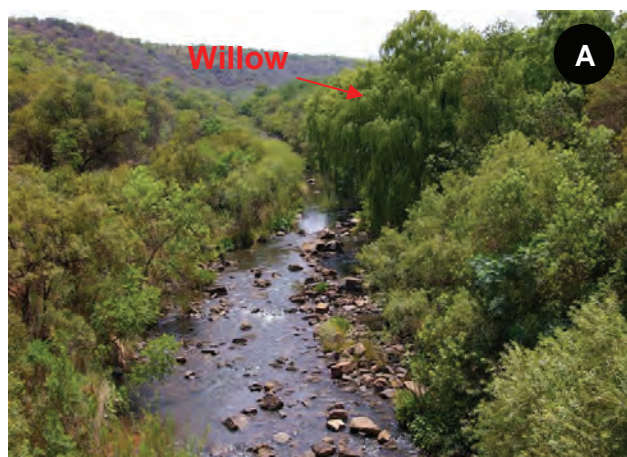
Kaaloog-se-Loop

Geomorph Zone: Upper foothills

Minimal alien invasion along riparian bank – one willow tree can be seen but few other aliens are evident. There is also minimal upstream impact that can affect vegetation.

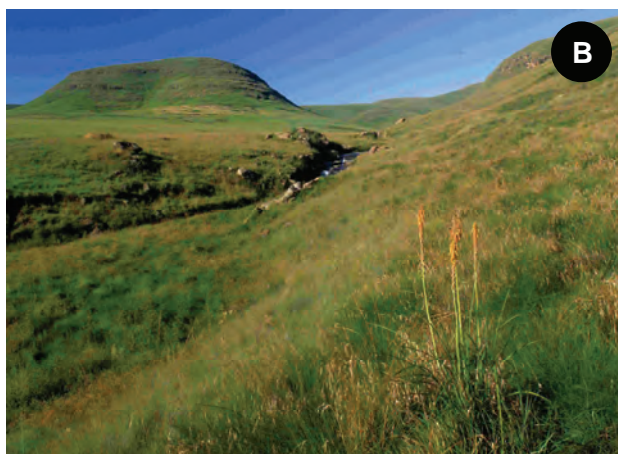
Coleford Stream

Geomorph Zone: Mountain stream

No aliens along riparian zone. Healthy and intact banks.

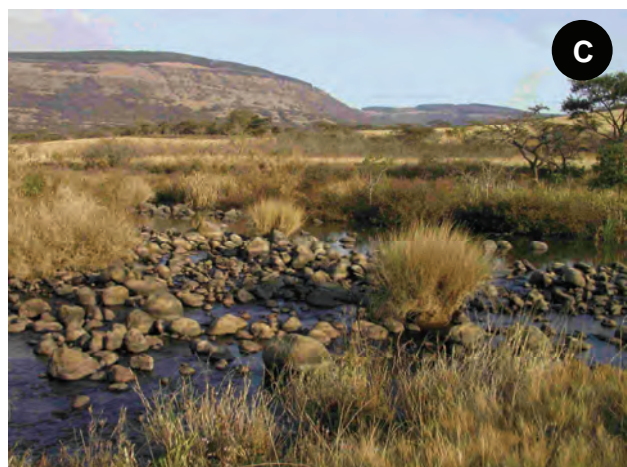
Karkloof River (at Game Valley)

Geomorph Zone: Upper foothills

No alien infestation of riparian zone. Healthy and intact banks.

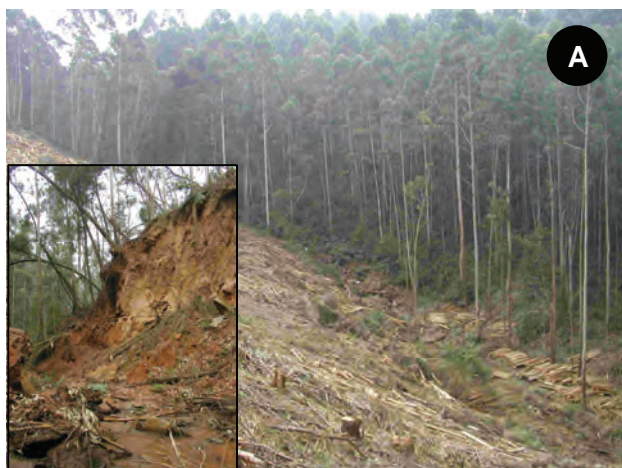
Town Bush Stream

Geomorph Zone: Upper foothills

Gums planted through riparian zone. Insert shows destabilisation of bank due to adjacent plantation and shading out of natural riparian zone species. Loss of these riparian zone species results in bank erosion and collapse.

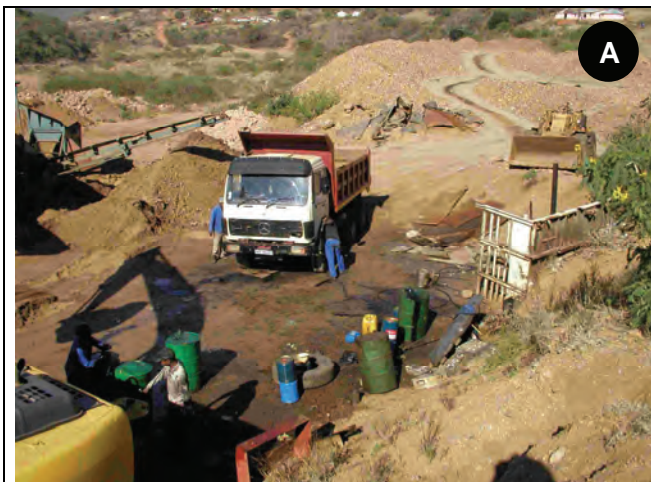
Sikelekehleni

Photo illustrates diesel and oil spillage in riparian zone associated with illegal sand mining operations.

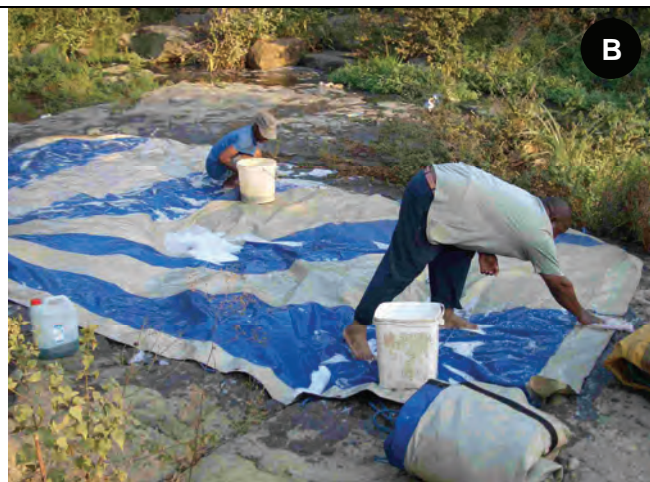
Little Amanzimtoti

Tent washing is a common sight in riparian zones following weekend funerals and weddings.

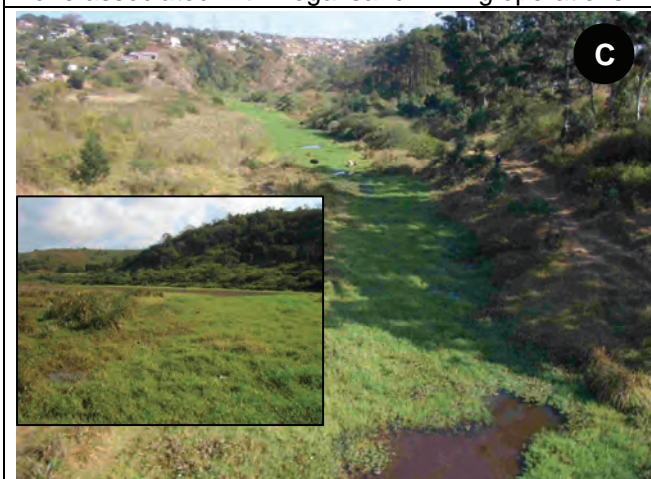
Mbokodweni

Hippo grass infested riparian and instream zones due to nutrient enriched water.

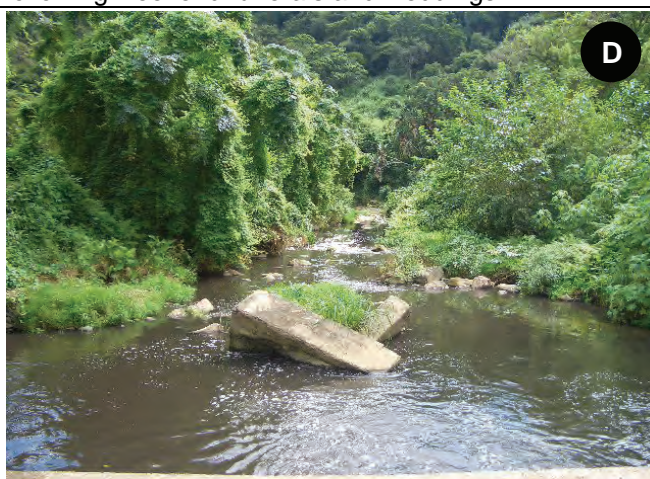
Umbilo

Sewage works discharge has resulted in abundant nutrients and a flourishing alien weed community.

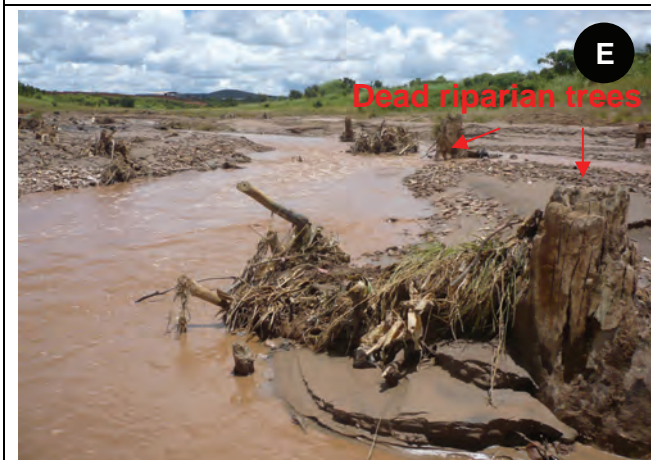
Likasi

Acid mine drainage and excessive sedimentation have killed riparian tree species.

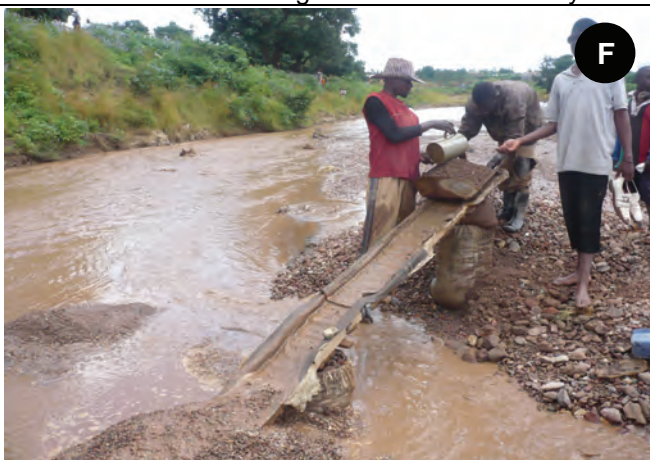
Likasi

Artisanal mining and working of riparian sediments have changed the physical structure of the bank.

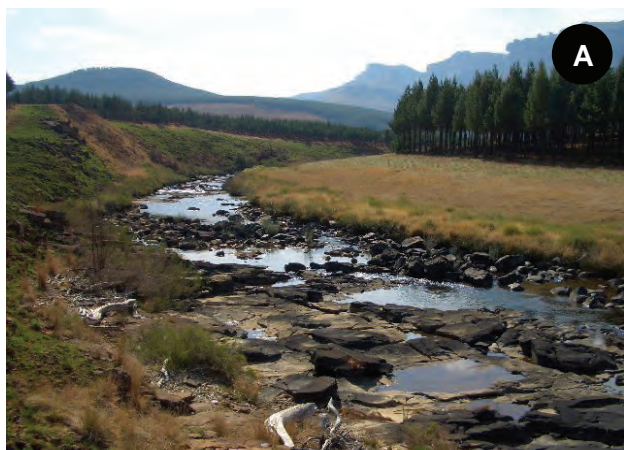
Wildebees

Geomorph Zone: Upper foothills

Bedrock and boulder dominated riparian zone with very little erosion. Forestry is not in the riparian zone and does not impact on the instream habitat.

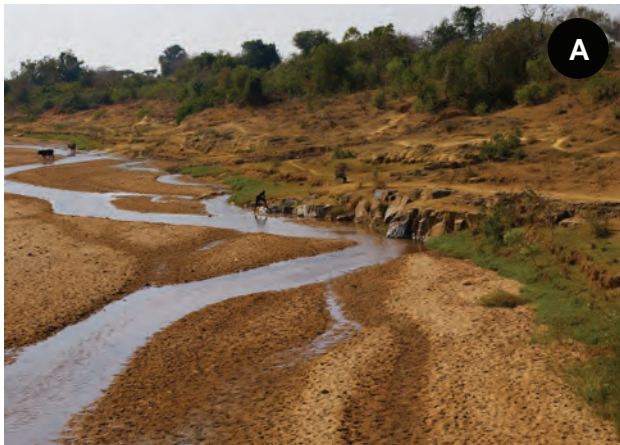
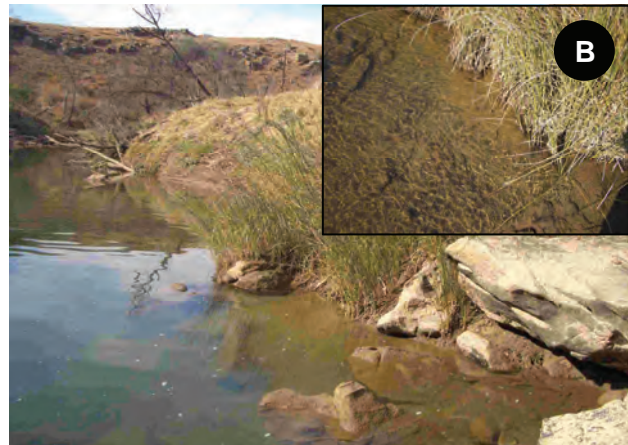
Mhlatuzi

Geomorph Zone: Lower foothills

Extensive erosion of both left and right bank along long reaches of river. Livestock pressure has caused instream and riparian modification.

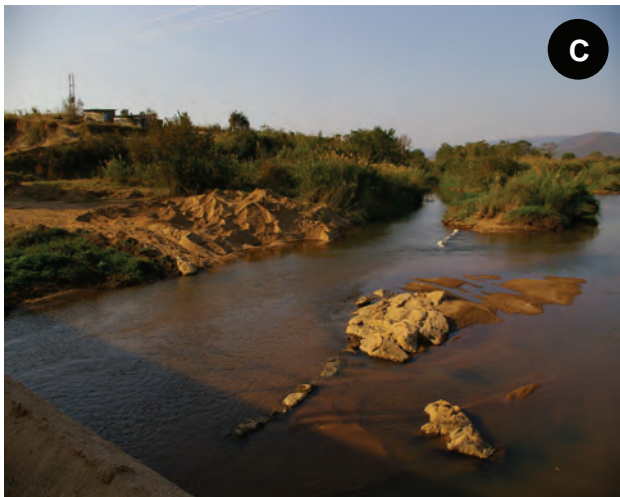
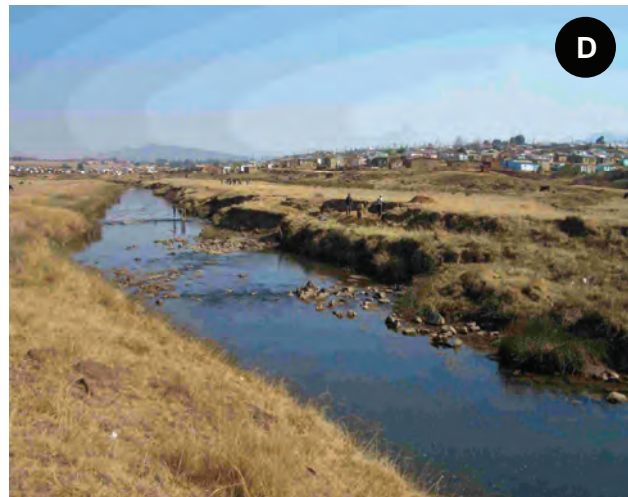
Usutu

Moderate erosion of banks with sedges stabilising areas.

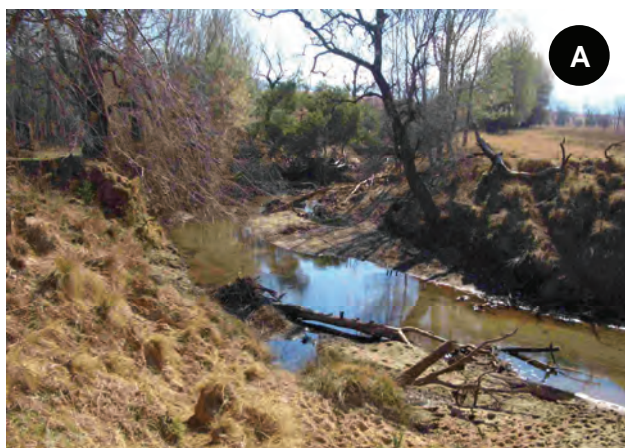
Unknown

Geomorph Zone: Lower foothills

Alien trees and livestock hoof impact have caused large-scale bank erosion and sedimentation of channel.

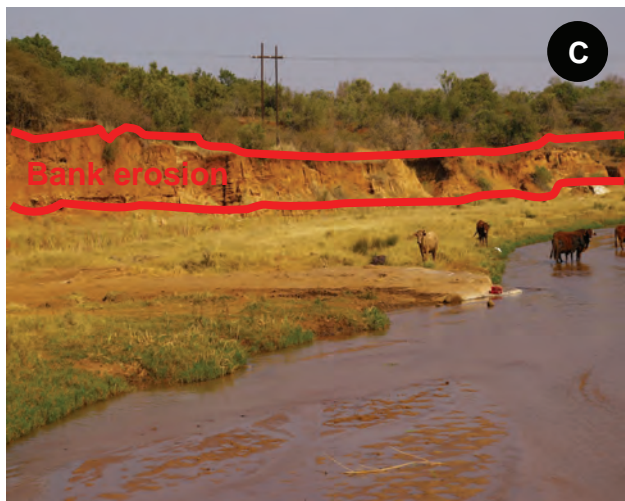
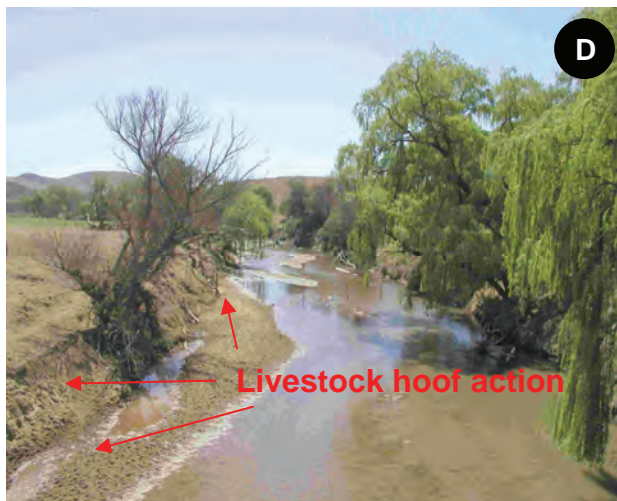
Ingwavuma

Extensive erosion of both left and right banks.

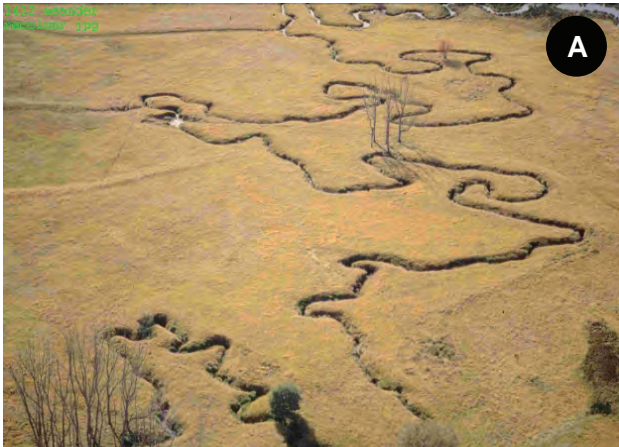
Unknown

Geomorph Zone: Upland flood plain

Naturally meandering section of river with no channel modification.

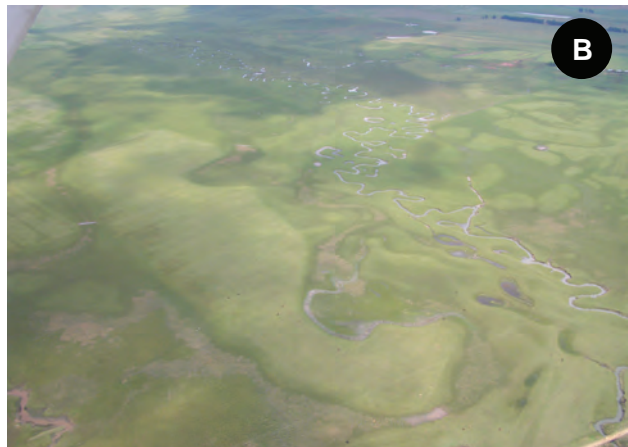
NECF Sephton Wetland

Geomorph Zone: Upland flood plain

Naturally meandering stream through Sephton wetland showing little channel modification.

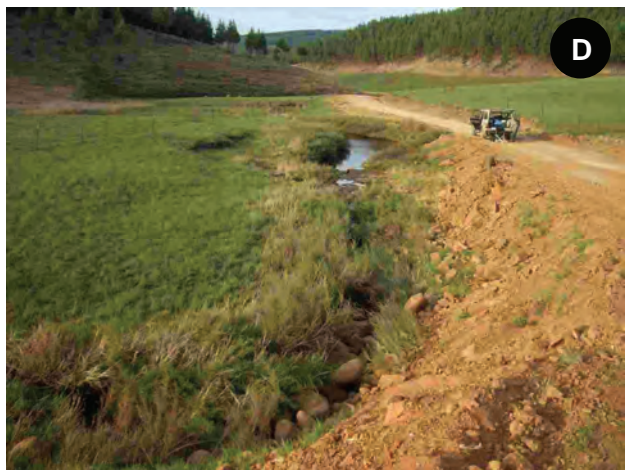
Tributary of Mooi River (N.E. Cape)

Natural sinuosity of this river has been modified to accommodate cultivation along river flood plains. Encroachment by orchards is evident.

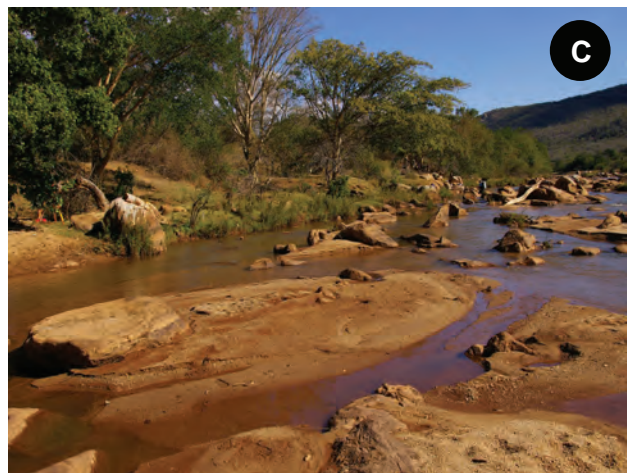
Mkhondvo

Canalisation of this river has reduced natural sinuosity of this river. This is localised to accommodate local industrial development, hence the moderate rating.

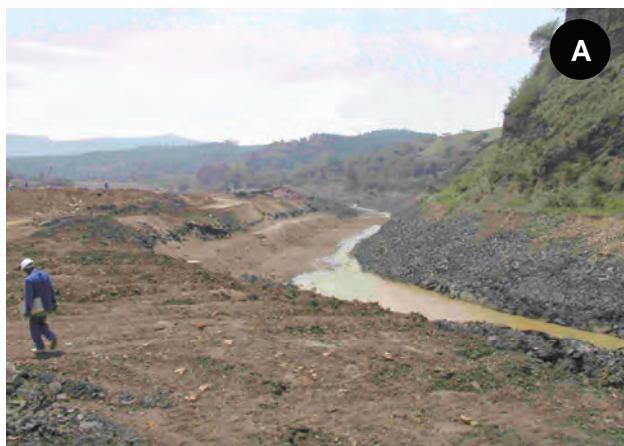
Town Bush Stream

Geomorph Zone: Lower foothills

Extensive channel realignment to accommodate new shopping complex.

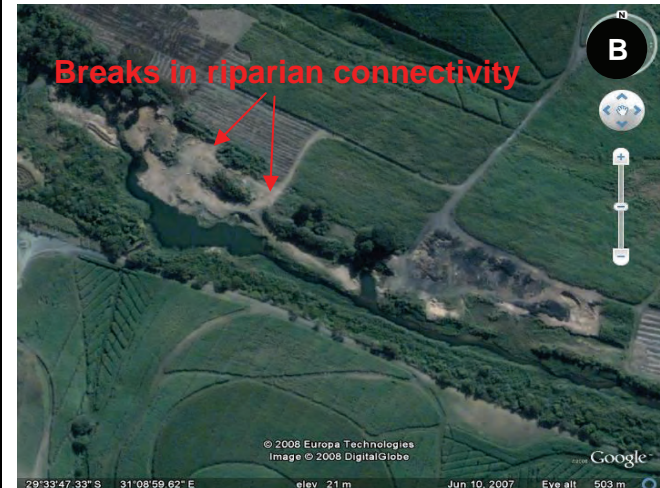
<p>B</p> <p>Breaks in riparian connectivity</p> <p>© 2008 Europa Technologies Image © 2008 DigitalGlobe</p>
<p>Berg</p> <p>Cultivation in riparian zone has interfered with longitudinal connectivity.</p>	<p>Tongaat</p> <p>South bank shows good connectivity of the riparian zone. The north bank connectivity has been broken by agriculture in the riparian zone.</p>

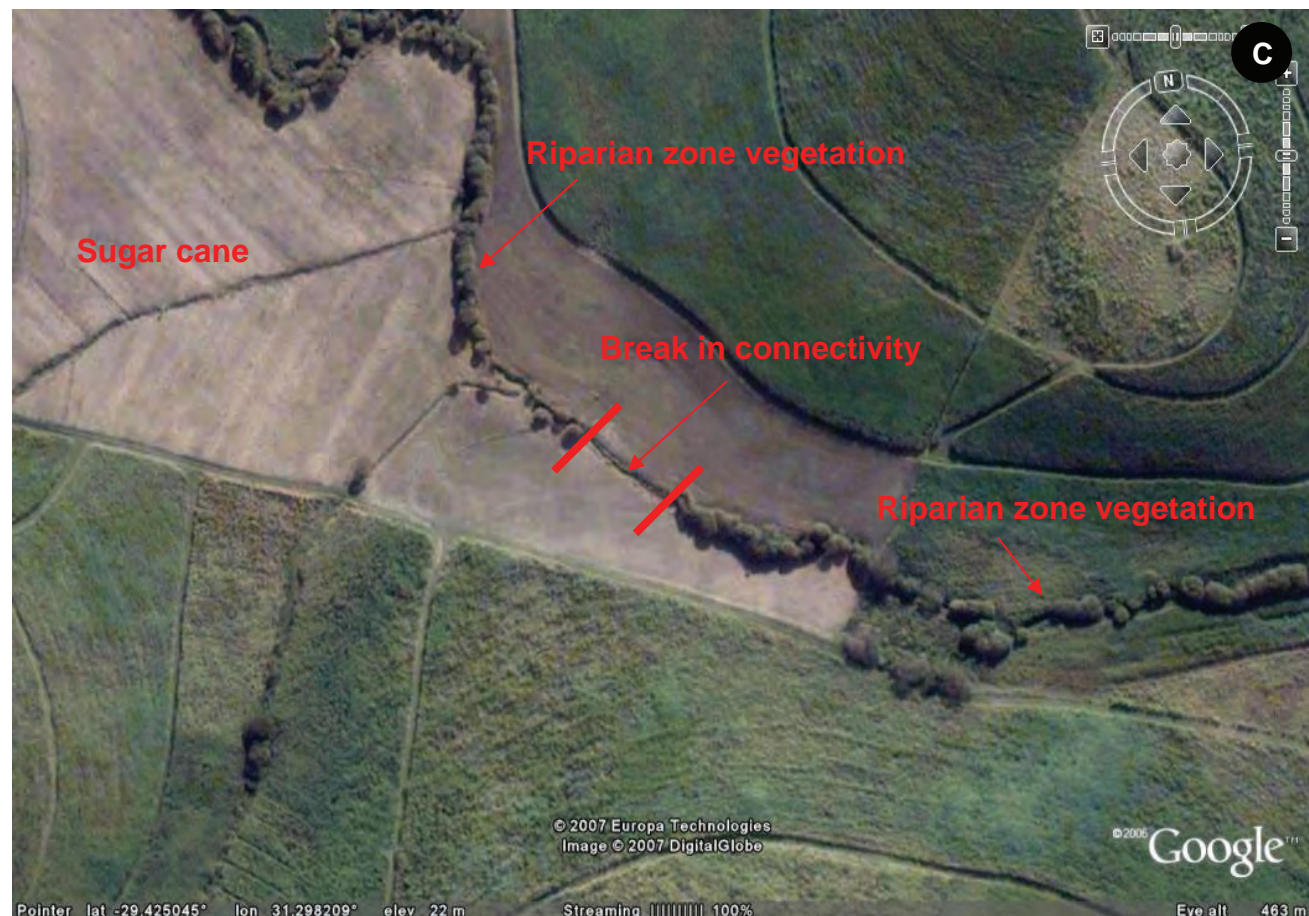
<p>C</p> <p>Sugar cane</p> <p>Riparian zone vegetation</p> <p>Break in connectivity</p> <p>Riparian zone vegetation</p> <p>© 2007 Europa Technologies Image © 2007 DigitalGlobe</p> <p>Pointer lat -29.425045° lon 31.298209° elev 22 m Streaming 100% Eye alt 463 m</p>	
<p>KwaZulu-Natal coastal river through sugar cane fields showing breaks in riparian zone connectivity due to cultivation to the edge of the stream.</p>

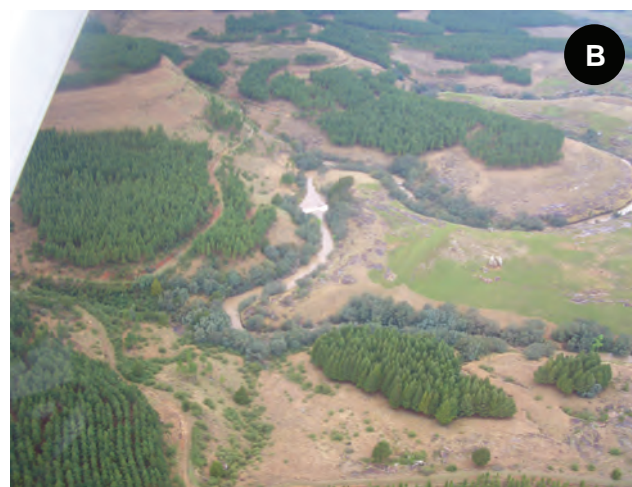
NECF Sephton wetland

Extensive connectivity modification by wattle invasion in this lower area of the NECF Sephton wetland.

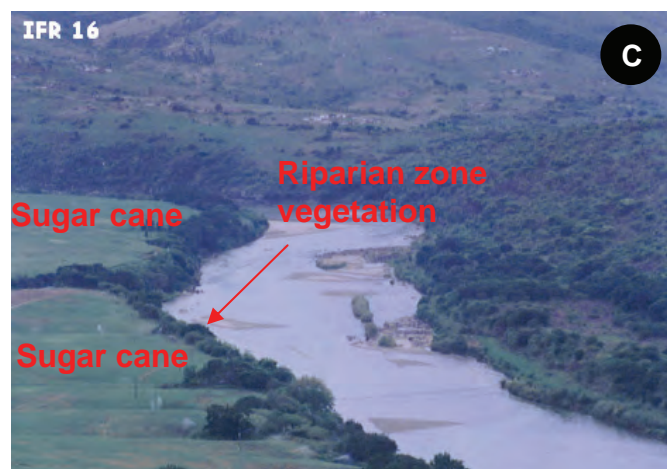
Thukela

Cultivation along the riparian zone has significantly altered the lateral connectivity between the river and the riparian zone. Sugar cane on the flood plains and left bank have reduced the width of this riparian zone and isolated it from the natural flood plains.

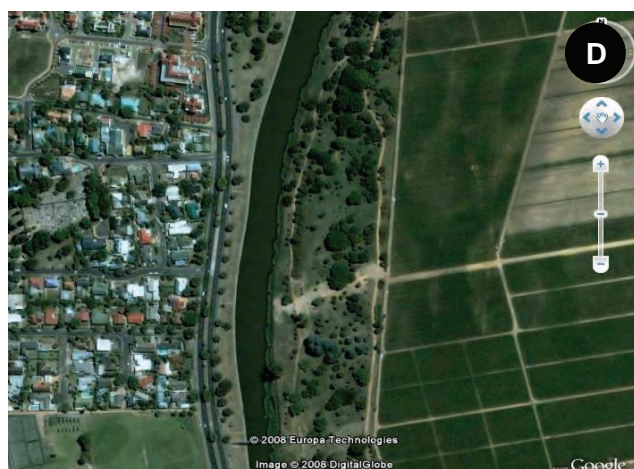
Berg

Parklands have been established on the west bank with grass planted to the water's edge, as opposed to the more natural riparian zone vegetation on the east bank.
