# DEVELOPMENT OF MANAGEMENT AND REHABILITATION PROTOCOLS FOR PEATLANDS IN SOUTH AFRICA: CASE STUDIES OF PEAT FIRES

Report to the  
**Water Research Commission**

**WRC Report No. TT 907/22**

The publication of this report emanates from a project entitled “*Determine peat loss and develop management and rehabilitation protocols for peatlands in South Africa*” (WRC Project No. 2019/2020-00098)

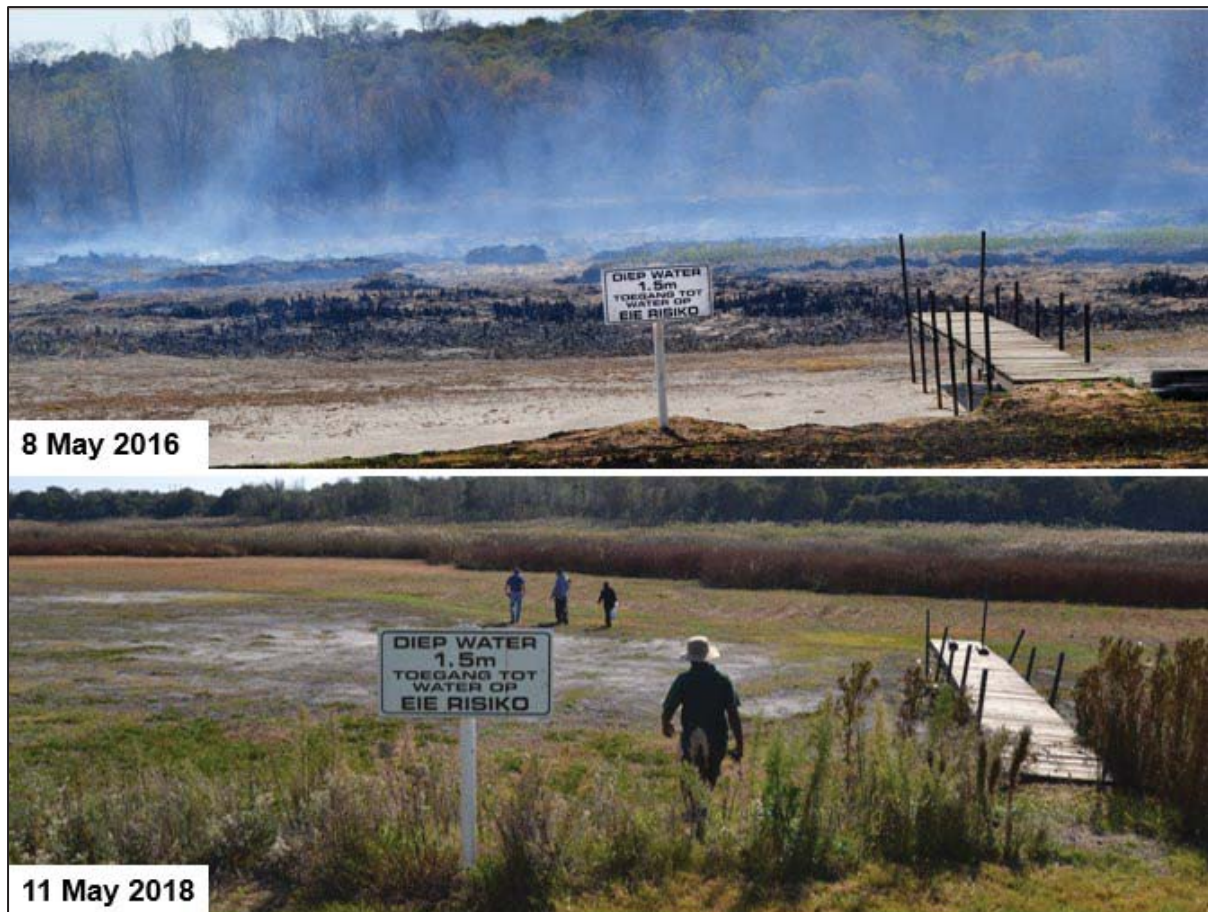
**Figure 2.6** The Molopo Peatland burning in 2016 (Photo: Piet-Louis Grundling), and visited again in 2018 (Photo: Althea Grundling). The sign to the left of the bridge states "Deep water 1.5 m", warning people to be cautious. The sign was later covered by "Peat fire warning".

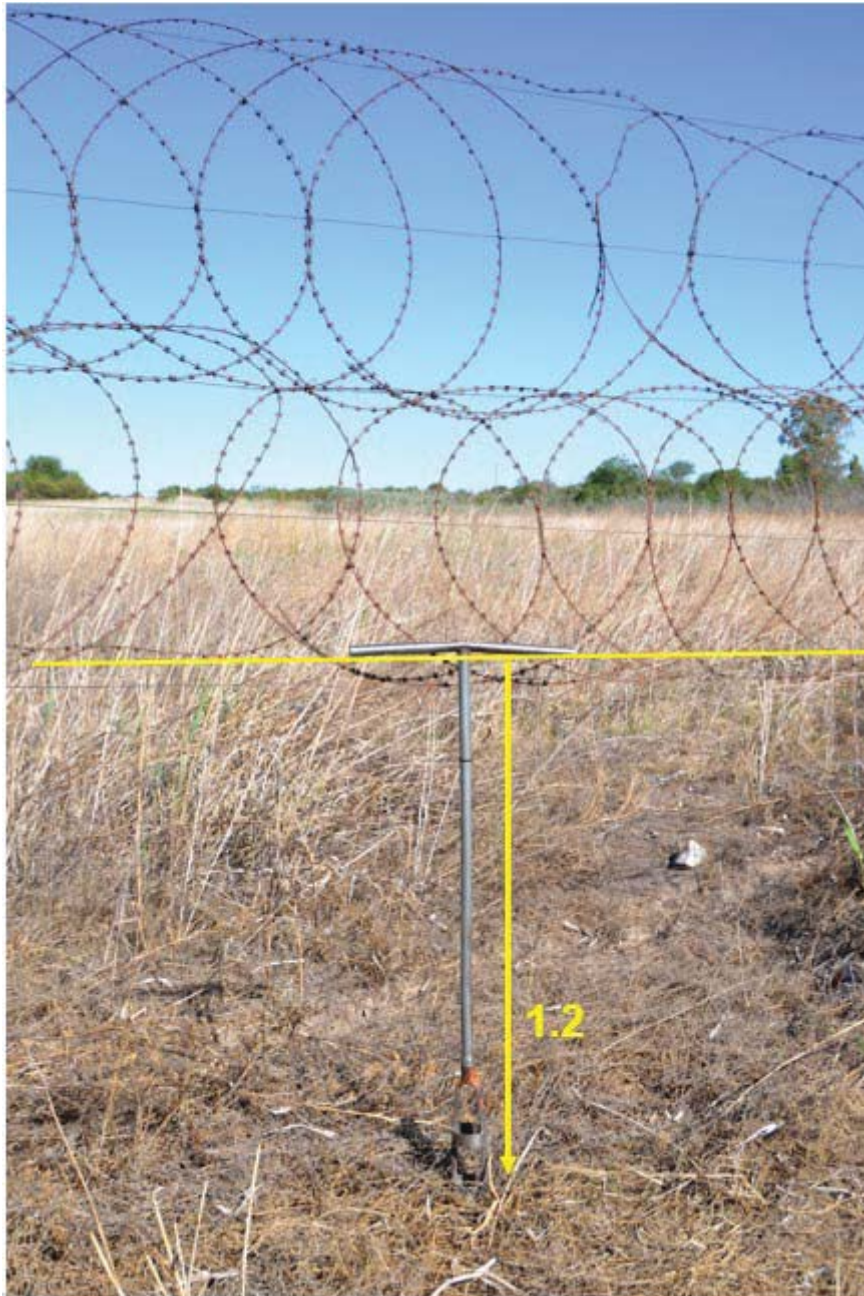
A dumpy level was used to measure the peat lost due to fire and erosion in the respective peatlands. A handheld GPS was used to capture the coordinates of survey points, where the elevation of each point was recorded using a measuring staff and thereafter correlated to the relative height of the dumpy station. In order to correlate the survey points to sea level, a GPS point was taken at the eye level of the dumpy station. The first and last point in each transect which had evidence of peat (i.e. presence of peat ash or degraded peat) at notable elevation changes aligned with the edge of the respective watercourse, was assumed to be the previous peat edge before the onset of degradation (**Figure 2.15**). Other indicators such as the bottom of fences were also used. An inspection profile of the soil/peat was also performed at the survey points using a soil or Russian peat auger.

**Figure 2.15** A soil auger indicating the 1.2 m of peat loss using the bottom of the fence line as an indicator of the former level of the peatland surface.

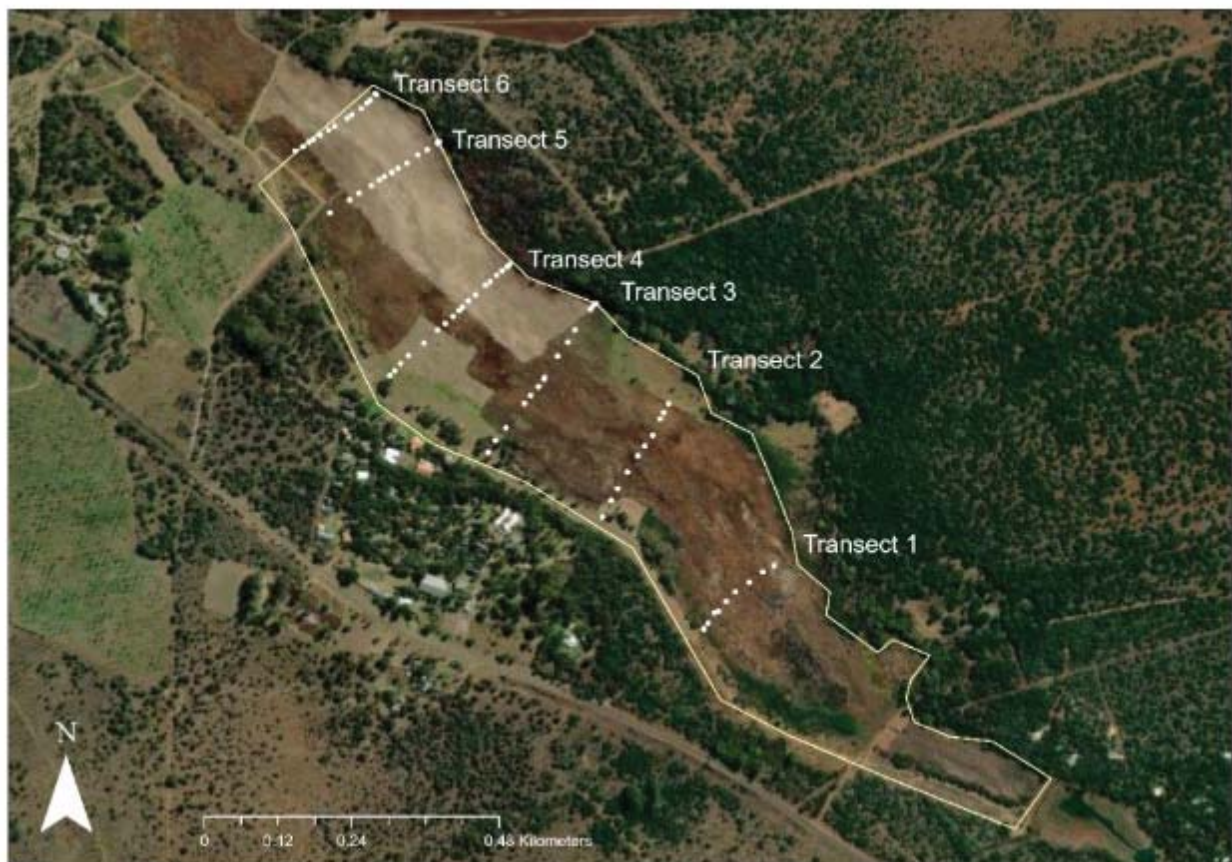
**Figure 2.16** Surface elevation sampling transects in the Molopo Peatland, North West Province.

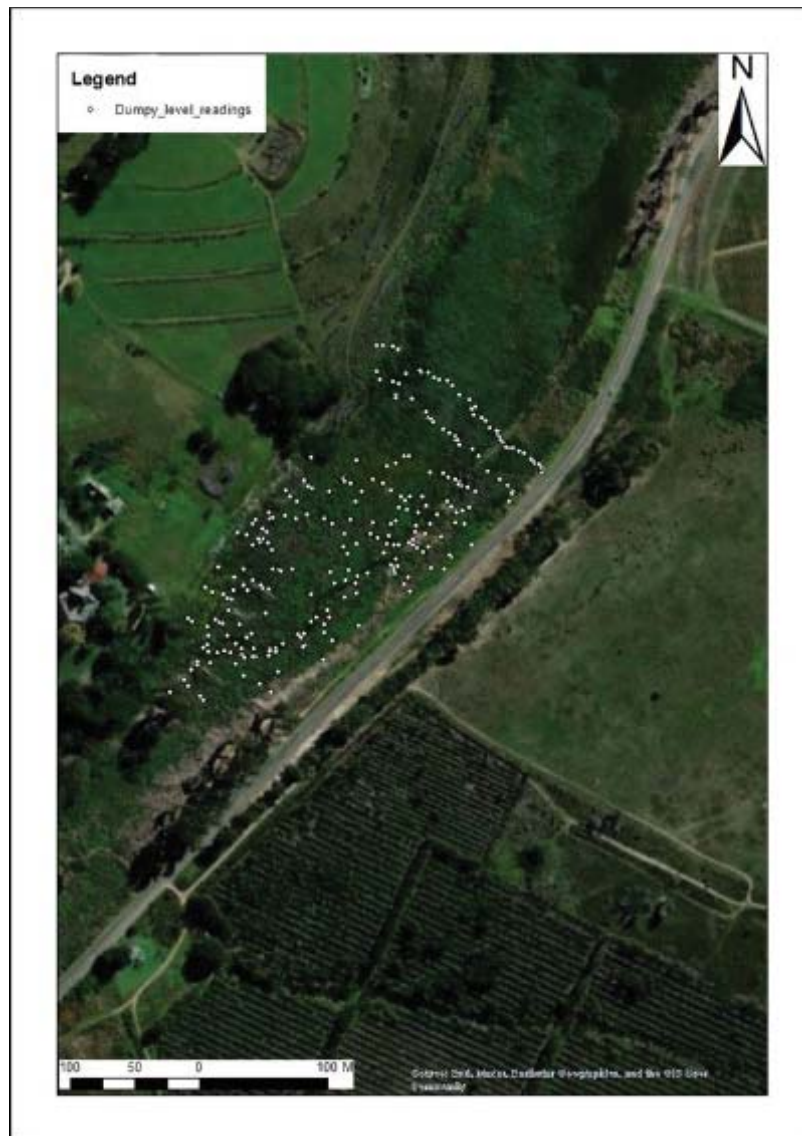
**Figure 2.17** Surface elevation survey points along the Onrus Peatland, Western Cape.

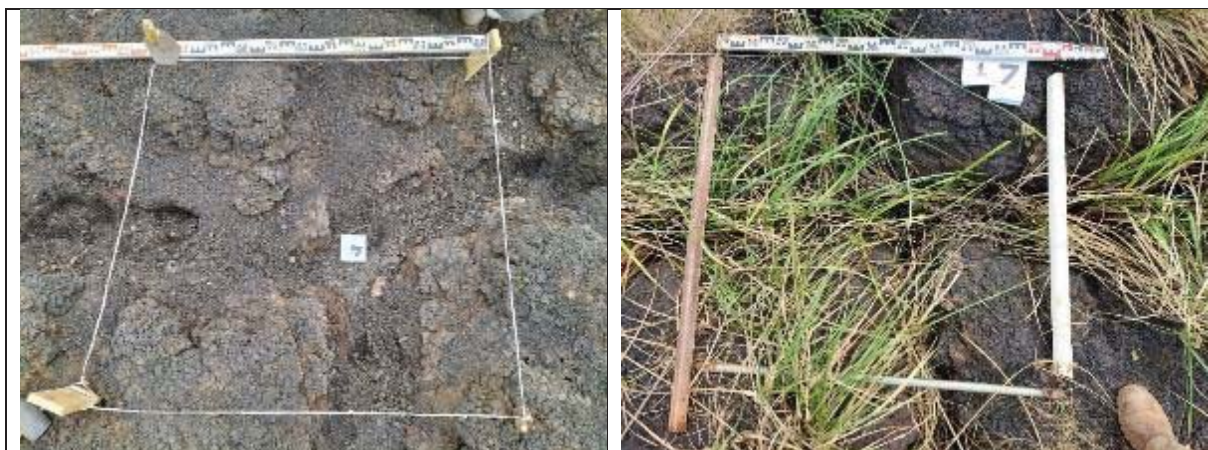
**Figure 2.19** Examples of two different crack size units used to determine the amount of peat lost in the Vasi Peatland.

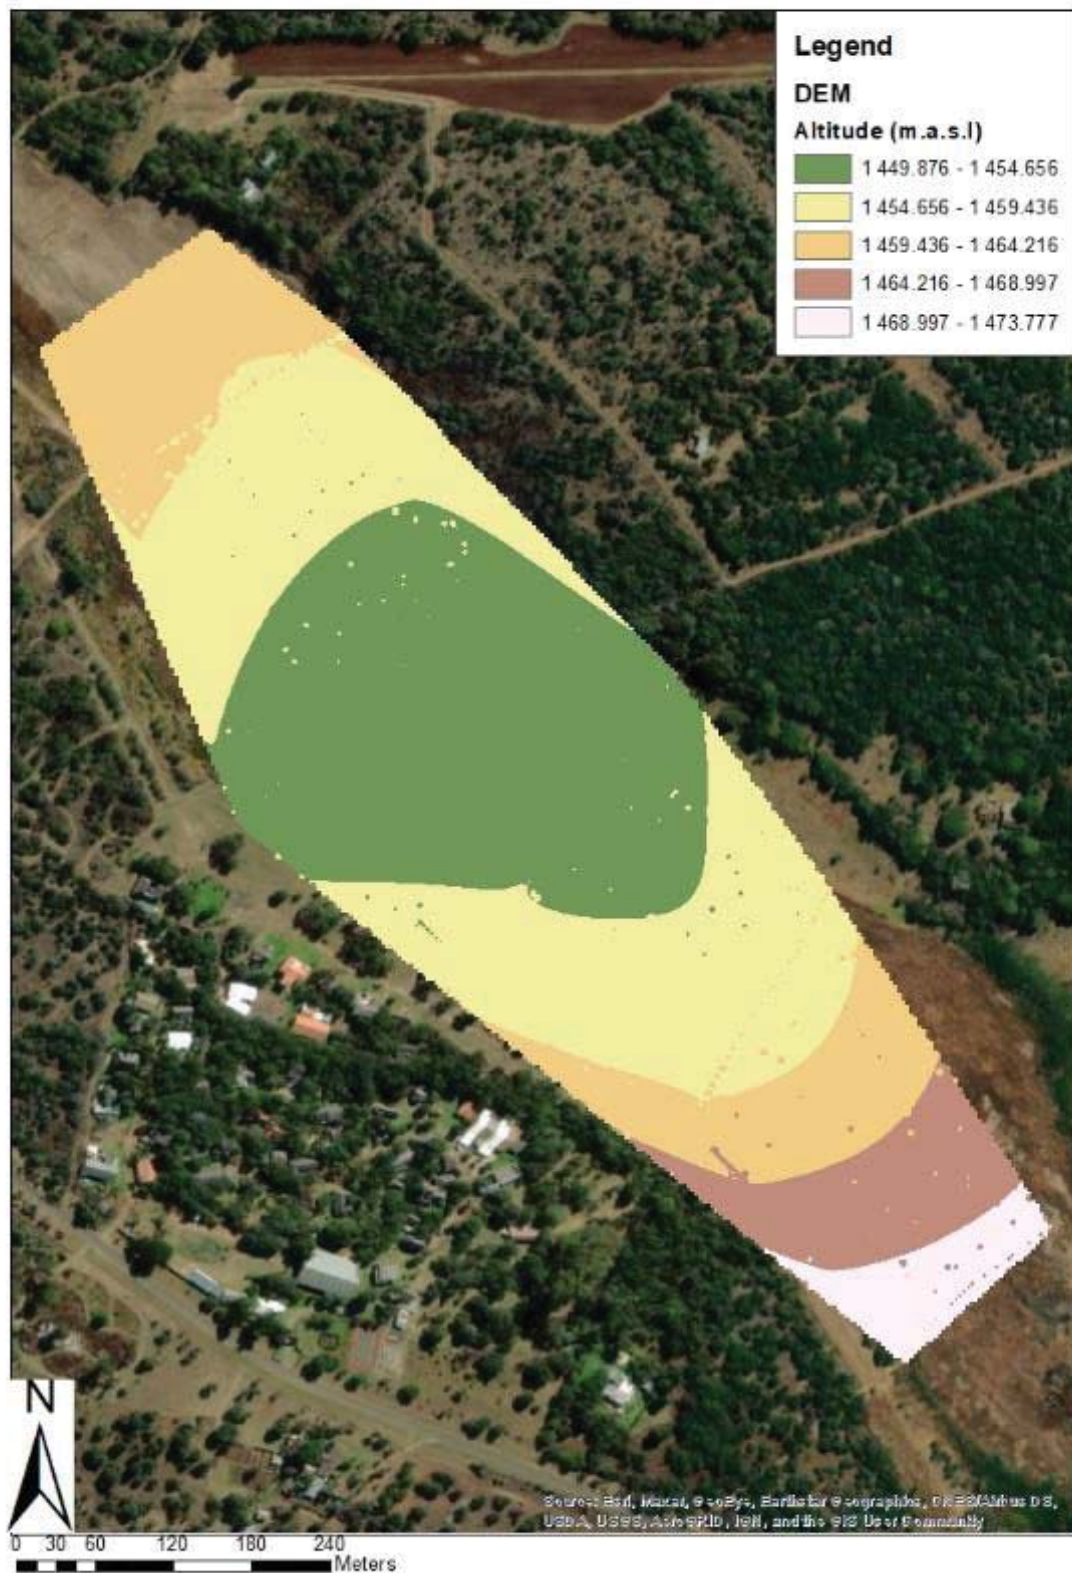
**Figure 2.33** A map estimating the surface elevation of the Molopo Peatland, North West Province.

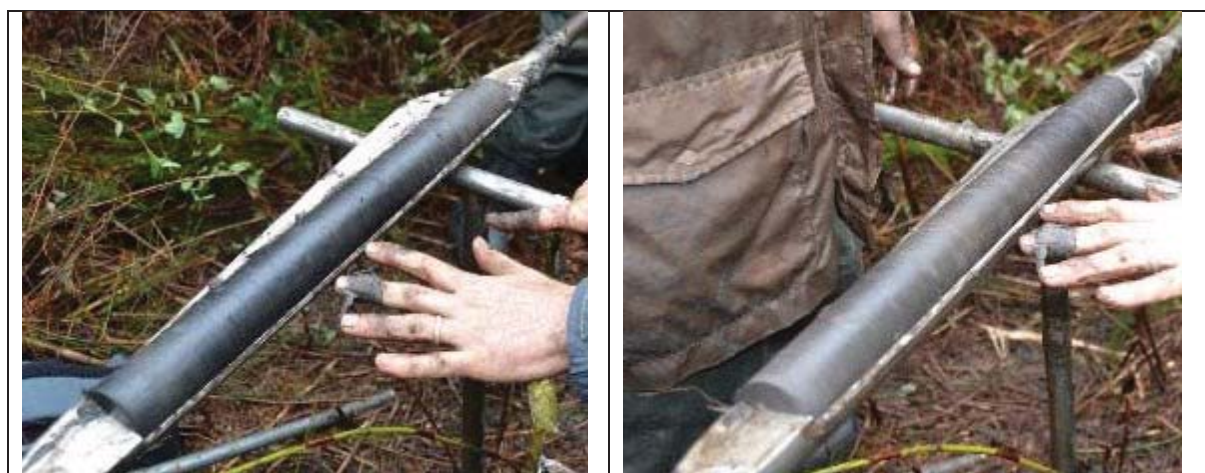
**Figure 3.2** Spatial variation of peat/organic material. The peat/organic sediment layers were interrupted by mineral sediments (predominantly fine grained but with some sandy layers) suggesting a “punctuated/interrupted” aggradation of the peat/organic sediments.

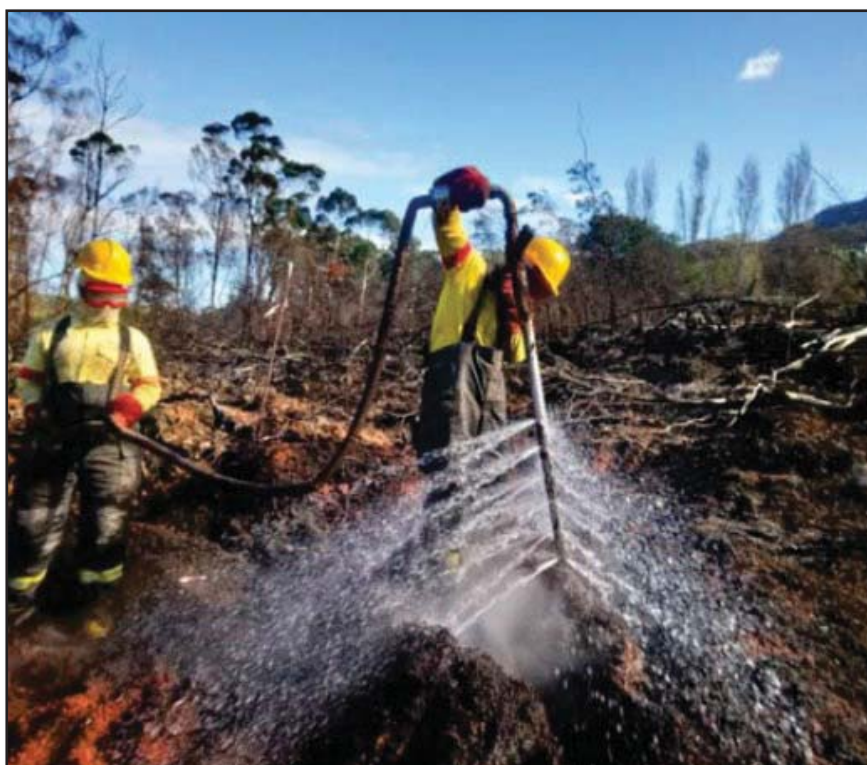
**Figure 4.2** The spike tool designed to extinguish peat fires (Grundling et al., 2019).

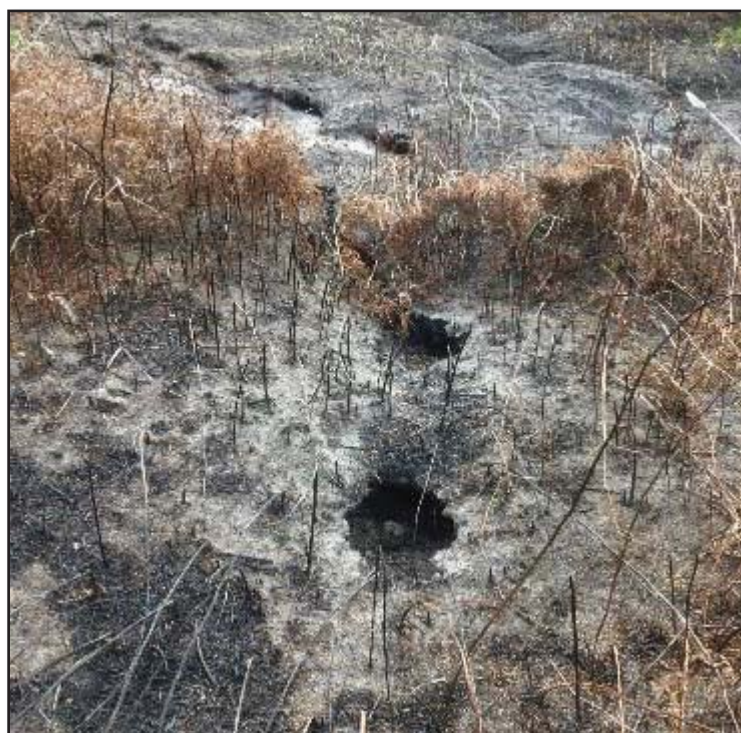
**Figure 4.3** Cavities formed due to subsurface burning at the Bergfontein Peatland in the Western Cape (*Photo: Jason le Roux*). Burning was commonly active in the bottom of the cavities.
