# AN INVESTIGATION OF THE REHABILITATION POTENTIAL OF THE BAAKENS RIVER, GQEBERHA

## PART 5: REHABILITATION POTENTIAL OF THE BAAKENS RIVER, GQEBERHA. SUMMARY REPORT.

**WRC Report No. TT 910/5/23  
ISBN 978-0-6392-0354-6**

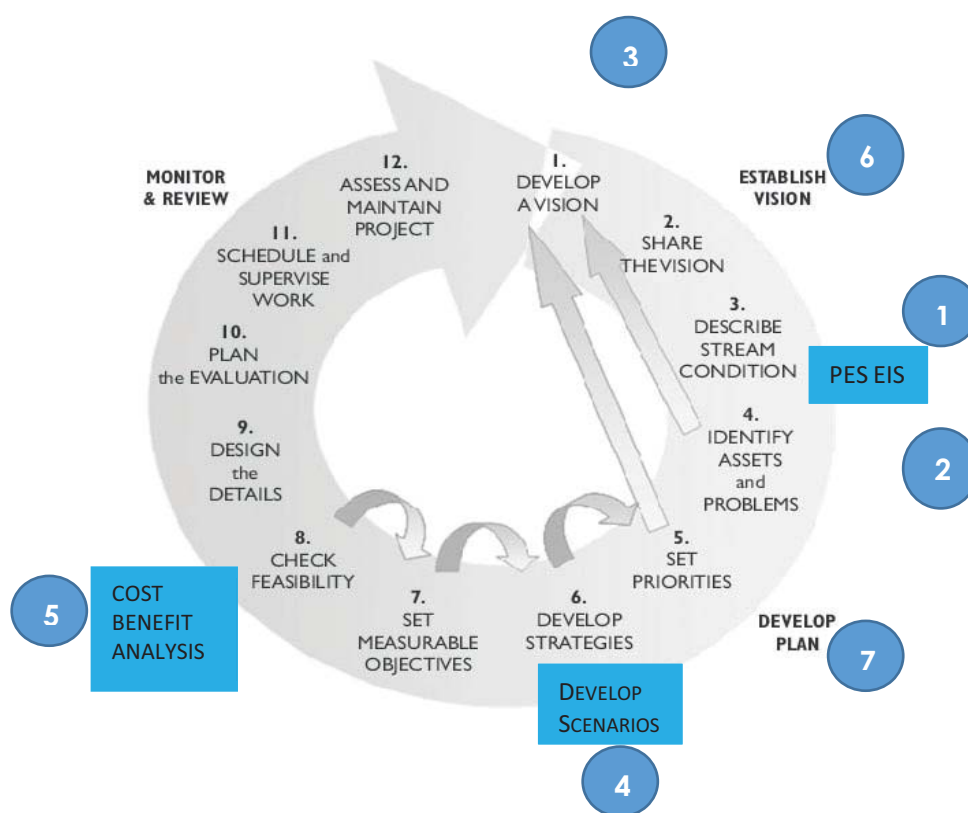
Figure 1.2 A graphic summary of the 12-step river rehabilitation process of Rutherford et al. 2000. Numbers in blue circles represent the altered sequence of steps in this study, and blue text boxes indicate the slightly different approach taken.

Local and international river rehabilitation guidelines informed the approach and methodology of this study. The main method applied the 12-step Australian Stream Rehabilitation method, with which the Project Leader was most familiar. Only a few of the 12 steps were possible within the Scope and duration of the study, and the method was adapted accordingly, as shown in the graphic below.

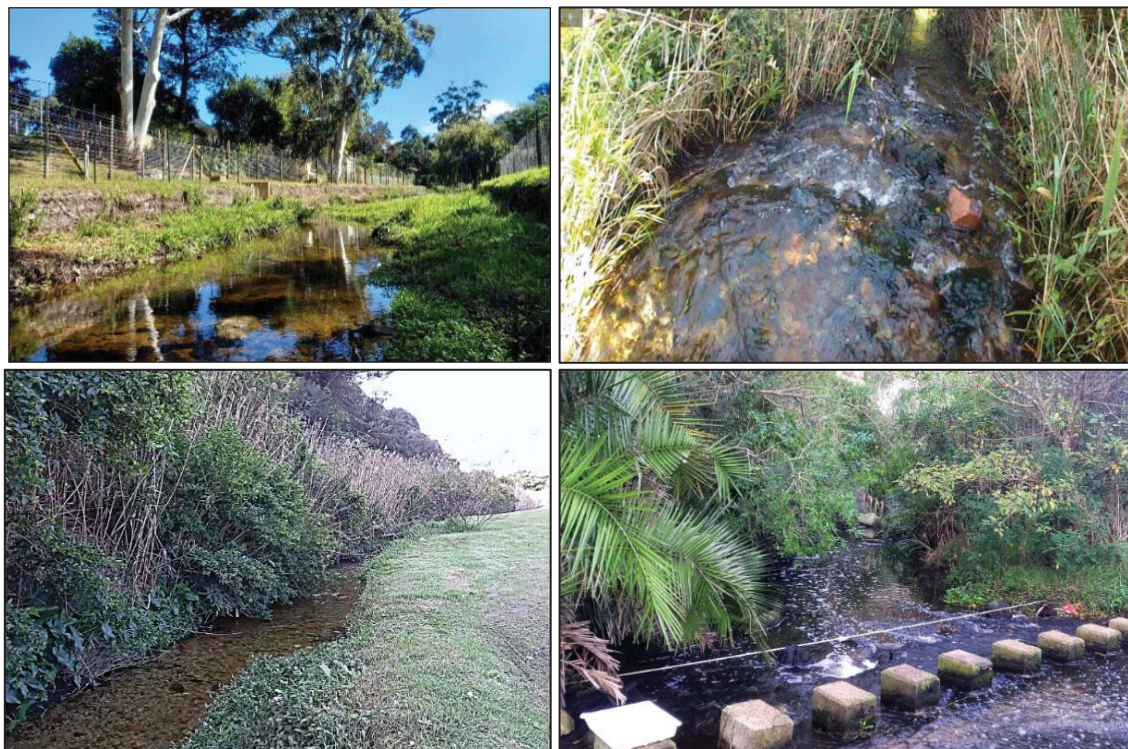
Figure 1.4 Photographs of each of the four sampling sites (Clockwise from Left Top: Sites 1-4)
