# WATER RESOURCE MANAGEMENT

## Rehabilitation of eroded watercourses at Vergelegen

*Vergelegen wine estate in Somerset West, which is renowned for its biodiversity and commitment to environmental sustainability, has just completed an extensive programme to rehabilitate eroded watercourses. This complex environmental undertaking on five sites has seen the removal, storage and replanting of some 15 000 indigenous plants that were housed temporarily while the programme was underway.*

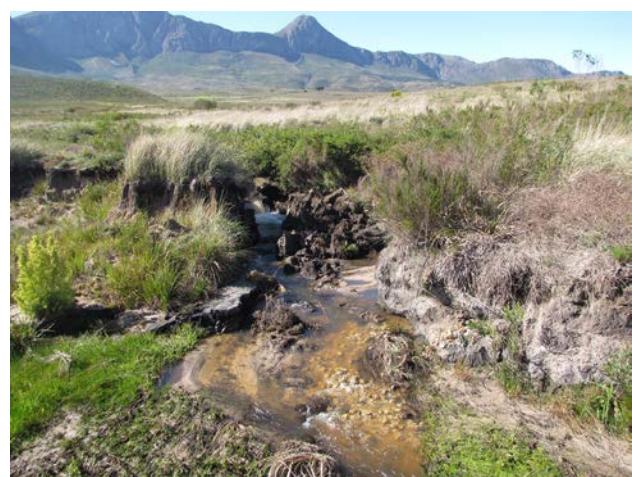
*Site four before treatment.*

In a massive undertaking, 30 erosion control weirs were constructed, sediment was removed, and rocks and other materials were placed in the watercourses.

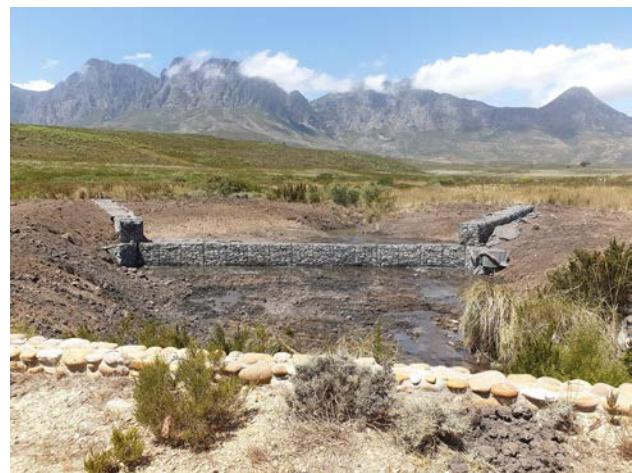
*Site four after treatment.*

In addition, green, well-rooted palmiet was gathered from a dam spillway stockpile and placed vertically in the weirs. Palmiet initially requires flowing water over the rhizome and stem until the roots re-establish in the soil. Water was pumped in using the Vergelegen firetruck.
