Heidi Shyman

Blue-green Algae – Making Water Dangerous

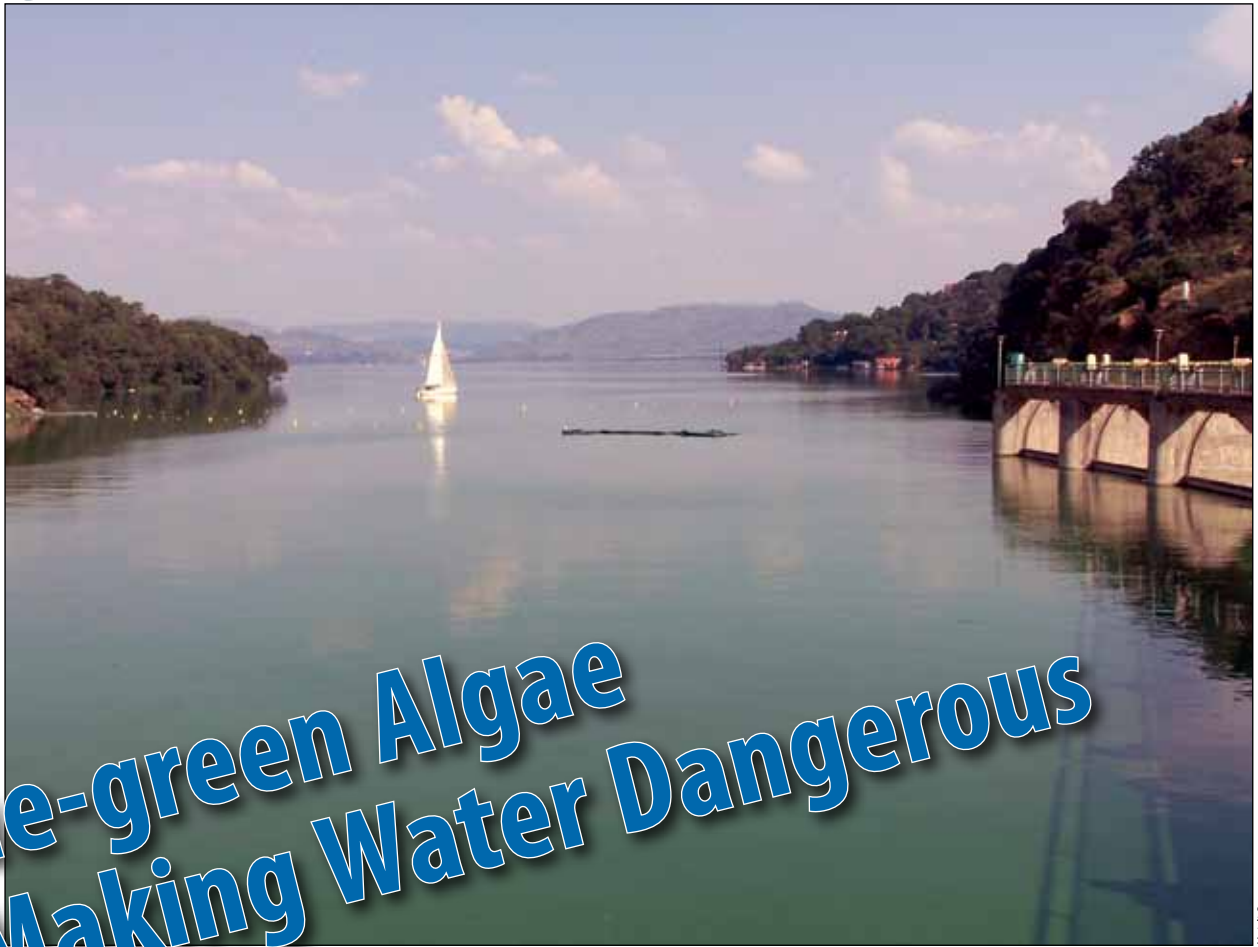
Hartbeespoort Dam, perhaps South Africa's most well documented case of a eutrophied water body.

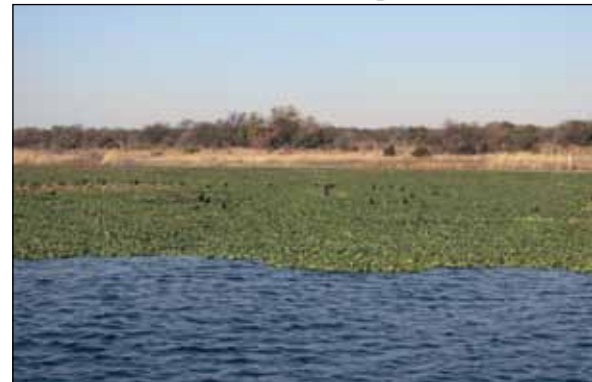
Hyacinth, a water weed, is also associated with eutrophication.

Known as *Harties Metse A Me*, the remediation programme includes a range of activities to improve the state of the Hartbeespoort Dam. These activities include, among others, a resource management plan, which will determine the use of the dam; a monitoring programme to ensure water quality issues are addressed; restoring shoreline vegetation and placing booms in the dam to assist with physical removal of algae and hyacinth, a water weed.

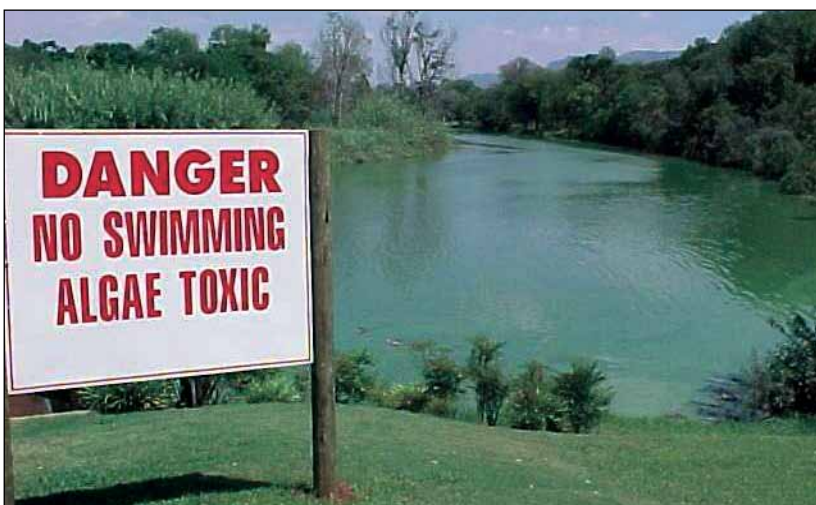
Eutrophication not only spoils the aesthetic appearance of a dam but negatively affects recreational activities such as water-sports and angling.
