Traditional water sources – Lifeline in a time of need

Traditional water resources are proving the only lifeline to poor rural communities in the scenic coastal region of north-eastern KwaZulu-Natal amidst failed local service delivery and drought conditions. Althea Grundling investigates the importance of traditional sources of water to a community in the grip of a nine-year drought.

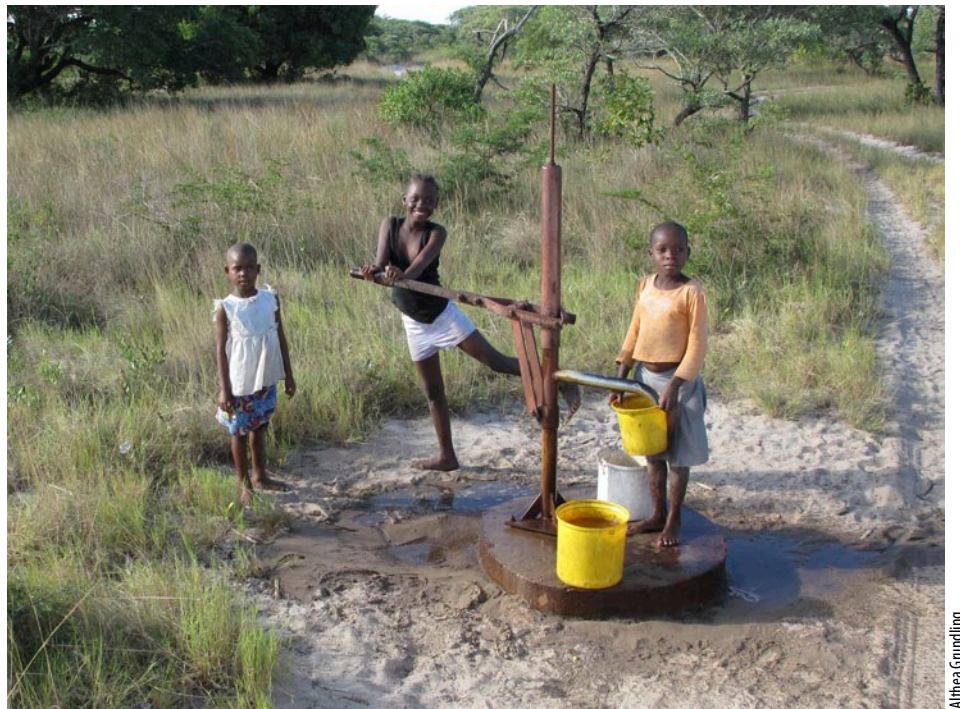
Above: Children collecting water from a well fitted with a hand pump. A broken rubber washer (although relatively easy and cheap to replace) has rendered many of these wells in the area useless.

Maintenance on wells, boreholes and pumps is a high priority. There is a continual need for nylon rope, buckets and water containers as well as spare parts and tools to maintain hand pumps. The following practical measures could greatly enhance access to and sustainable use of these natural water sources:

- Erect notice boards indicating well sites.
- Stabilise walls and edges of the wells and line deep wells.
- Fence off wells with a gate that can be closed.
- Address the problem of littering in wells and boreholes.

- Train local community members so that they can maintain their own hand pumps.

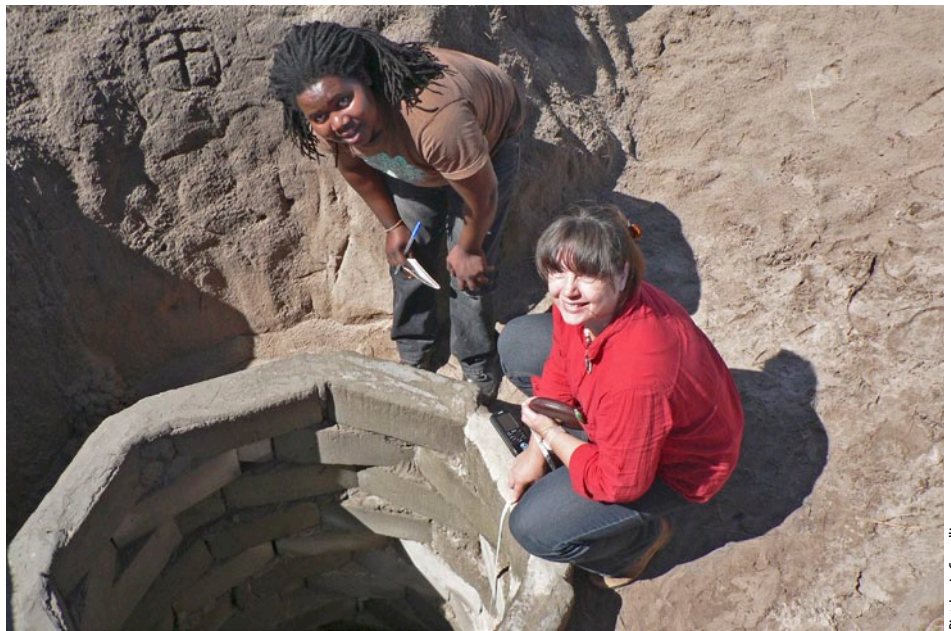
Above: Althea Grundling (right) and research assistant Siphwe Mfeka measuring groundwater levels in wells.

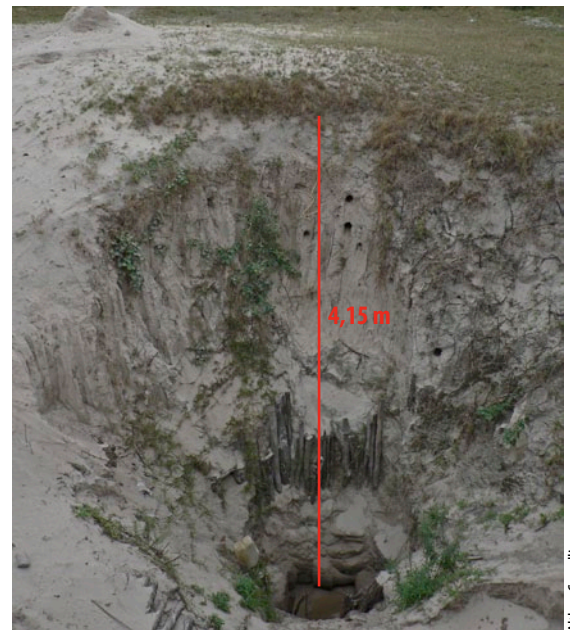
Right: The project team came across various precarious traditional water sources. As the water table drops the community is forced to dig deeper after water.

their wells deeper each year. Areas surrounding deepened wells can be very dangerous due to collapsing walls and edges of the wells. Unlined wells are also collapsing, not only blocking access to the water but rendering these wells potentially life threatening. Well sites are not always clearly marked or fenced-off and misbehaviour leads to wells and boreholes being polluted by litter. In some cases homemade ropes from Lala Palm (*Hyphaene coriacea*) leaves are used to draw water and hand pumps are not in use due to poor maintenance.
