An assessment of the channel morphological changes in the Lourens River, Western Cape

LB Smith-Adao^{1*} and ACT Scheepers²

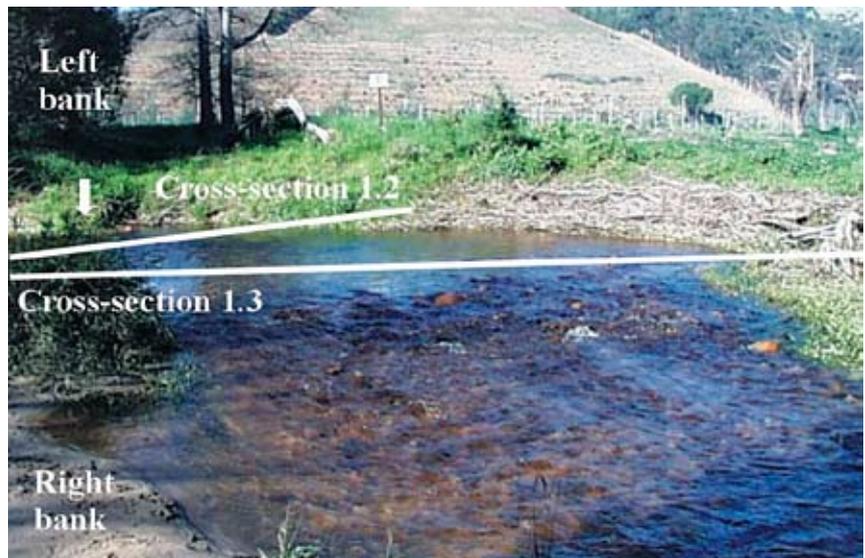
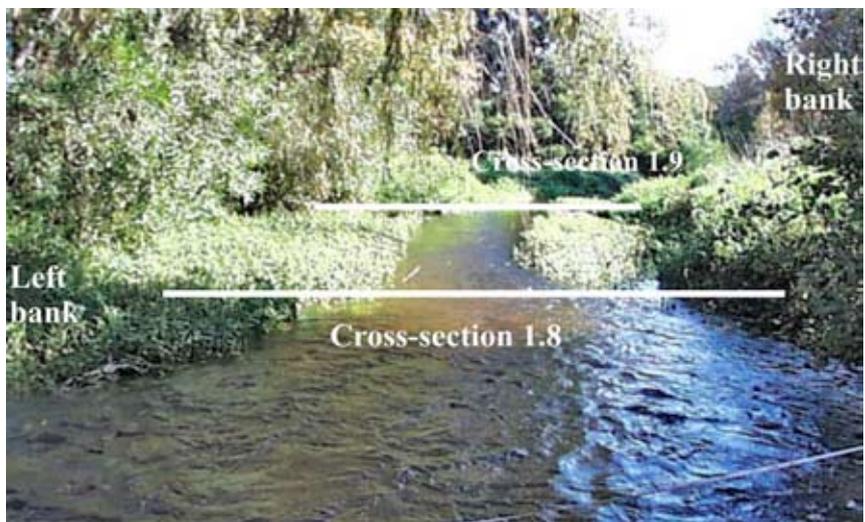
Plate 1

Photographic comparison between the (a) upper section and (b) lower section of the study reach at the beginning of the study period (May 2001). (a) Note the wide channel, the natural predominance of smaller cobbles in a foothill river, the gravel/cobble lateral bar at the foreground bottom left and the presence of cobble gabions (white arrow indicates the end of gabions). (b) Note the narrow channel and alien-infested river banks.

The study reach is located in the foothill zone and comprised 90 m of the Lourens River (Fig. 3). Salient features of the study area in this zone include a stony substratum, small to medium-sized gravels/cobbles with a few large cobbles and small boulders. Reach morphology could be classified as short riffle/pool/run transitional hydraulic biotopes. The study reach was chosen due to its accessibility, diverse array of geomorphological and physical characteristics and degree of disturbance (King et al., 2003). It lacked major channel modifications such as canalisation or impoundments. However, gabion mattresses did form part of the right bank while at the most downstream section of the reach, the river was constrained by a concrete wall on the left bank, designed as a flood protection measure (Plate 1a) (King et al., 2003).

Likewise, species such as *Salix babylonica* (Plate 1b) located on the left bank, which has a shallow rooting system, was unable to withstand flood flows (Rowntree, 1991; Rowntree and Dollar, 1996a, 1999). Roots will reinforce the bank against failure if the bank height is less or equal to the rooting depth hence, the roots need to extend to at least the average low water plane, if not, the flow will undercut the root zone during flood flows (Thorne, 1990; Rowntree, 1991). A detailed account of the benefits of vegetation cover is presented by various studies (Hickin, 1984; Gray and MacDonard, 1989; Thorne, 1990; Friedman and Auble, 2000). Observations in the field confirmed that these trees resulted in bank collapse through slumping of blocks of bank material due to surcharging, especially in areas of undercutting of the saturated left bank.

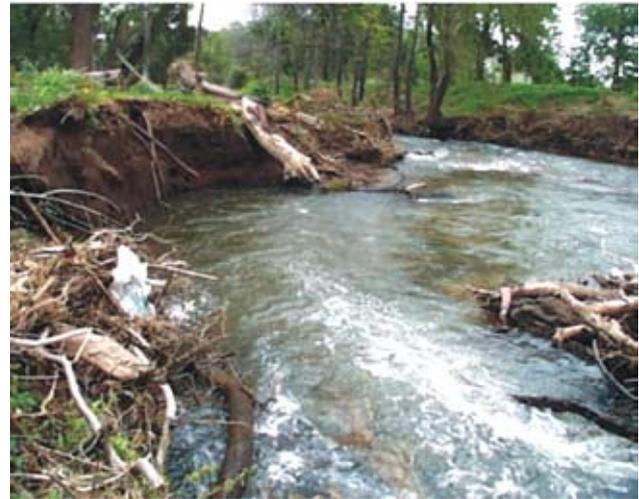
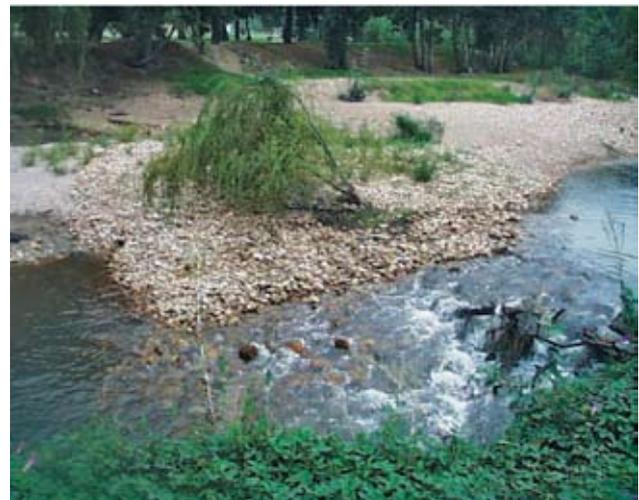
Plate 2

Extensive localised erosion and deposition caused by the 2001 winter flooding events at the upper section of Study reach, Lourens River. (a) View of channel scour and widening on the left bank channel looking downstream (Photograph taken on 18 September 2001). Note the active left bank retreat on the outside bend (lateral migration) and the removal of the established vegetation cover. (b) View of mixed gravel and fines deposited in the form of a lateral bar on the right channel bank. Note the pioneer herbs, grasses and tree seedlings which are sprouting from the deposited sediment and organic material, centre and background (Photograph taken on 28 January 2002).

Active undercutting led to enhanced instability of the left bank (Plate 2a). It would be reasonable to place the bank retreat along these cross-sections in the vicinity of between 5 m to 7 m. It is a matter of direct observation that at least a considerable part of the bank retreat was due to slumping that either occurred late in the flooding events of 2001 or after the individual flooding events had passed. The timing of bank collapse was demonstrated after the flood on 3 July 2001. During the first half of July 2001, blocks from the top of the left bank collapsed onto a bench created during the flood, partially burying the veneer of sand deposited there by floodwaters. Continued collapse was evident during successive field visits following July 3.

In-channel woody debris in the form of dead trees was also present in the vicinity of cross-profile 1.3, at the left bank water's edge (Plate 2a) and it appears as if they contributed to the bank erosion. Dead trees tend to result in instability due to the loss of root-associated soil strength and their relic roots providing pathways for rapid seepage which often leads to piping (Thorne, 1990; Rowntree, 1991). These dead trees were thrown into the path of flooding events and probably lifted sections of the bank into the channel when it fell over. Also, channel morphological changes such as bed degradation caused by floods can lead to water table alterations which, in turn, can result in plant mortality (Friedman and Auble, 2000). For example, *Populus* species and *Salix* species are obligate phreatophytes. Both the maximum depth and the rate of fall of the water table are thus critical to their survival. Phreatophytes track falling water tables rather than utilising soil moisture (Gurnell et al., 2001).
