Bridging Scour Knowledge Through Research

Mounting evidence suggests that South Africa should prepare itself for more extreme weather events, such as floods, in future due to global climate change. This could lead to increased erosion or scouring of riverbeds at engineering structures – a major cause of structural damage to bridges and fluvial structures in South Africa. Lani van Vuuren reports.

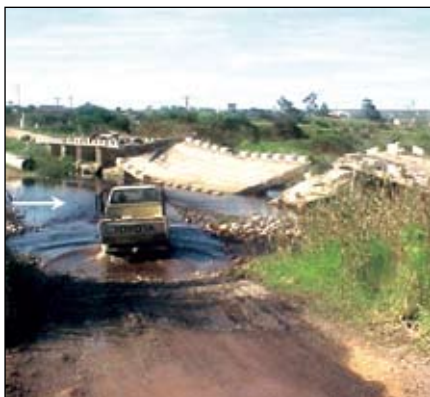
This bridge in the town of Heidelberg, Western Cape, failed as the foundations were undermined. The fact that piers on the upstream side failed suggests that local scour was responsible.

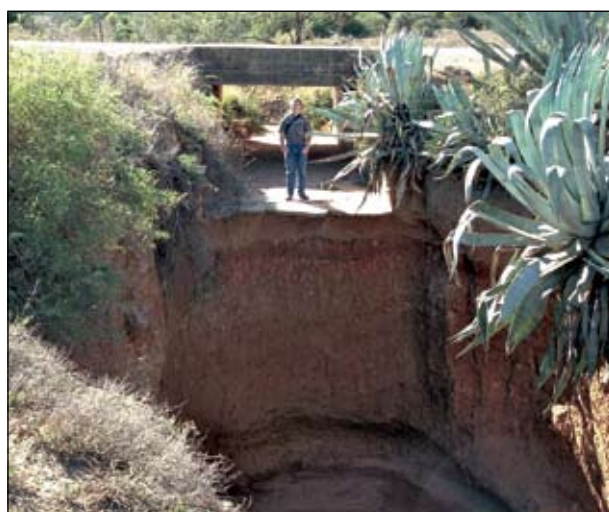
Constriction of the flow at this culvert near Riebeeck East, northwest of Grahamstown, in the Eastern Cape, has led to high velocity water exiting the downstream end. The riverbed has been severely scoured for a long distance downstream.

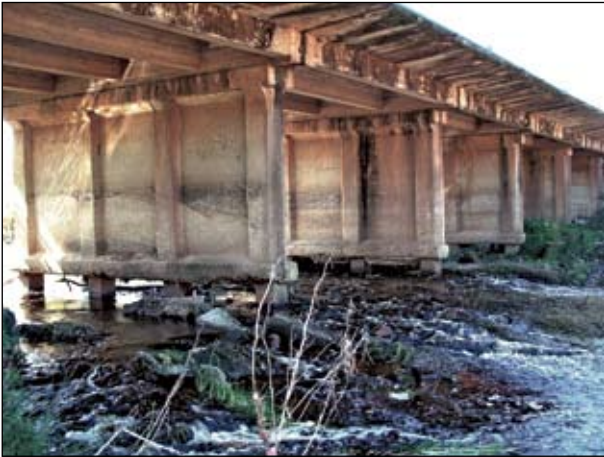
The Palmiet River in the main stream of Grabouw, in the Western Cape, no longer flows parallel to the bridge piers. This may have initiated scouring under the bridge and exposure of the piles.

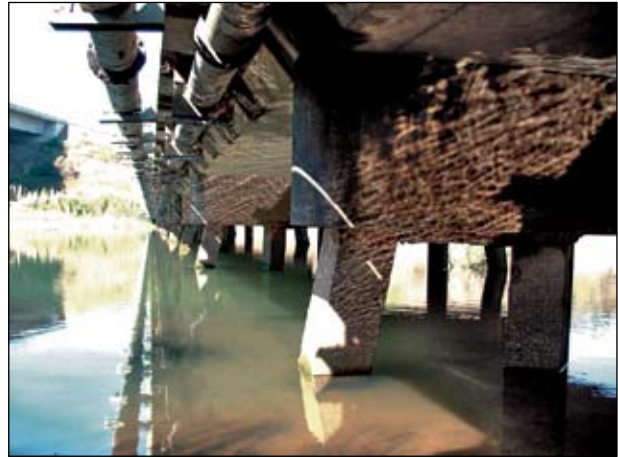
The piles of this bridge near the Mzimkulu River mouth have been exposed to a significant depth.
