# Kouga Catchment Enters Rehab

*A pilot project in the Eastern Cape is exploring ways of rehabilitating riparian zones after alien-clearing. Sue Matthews reports.*

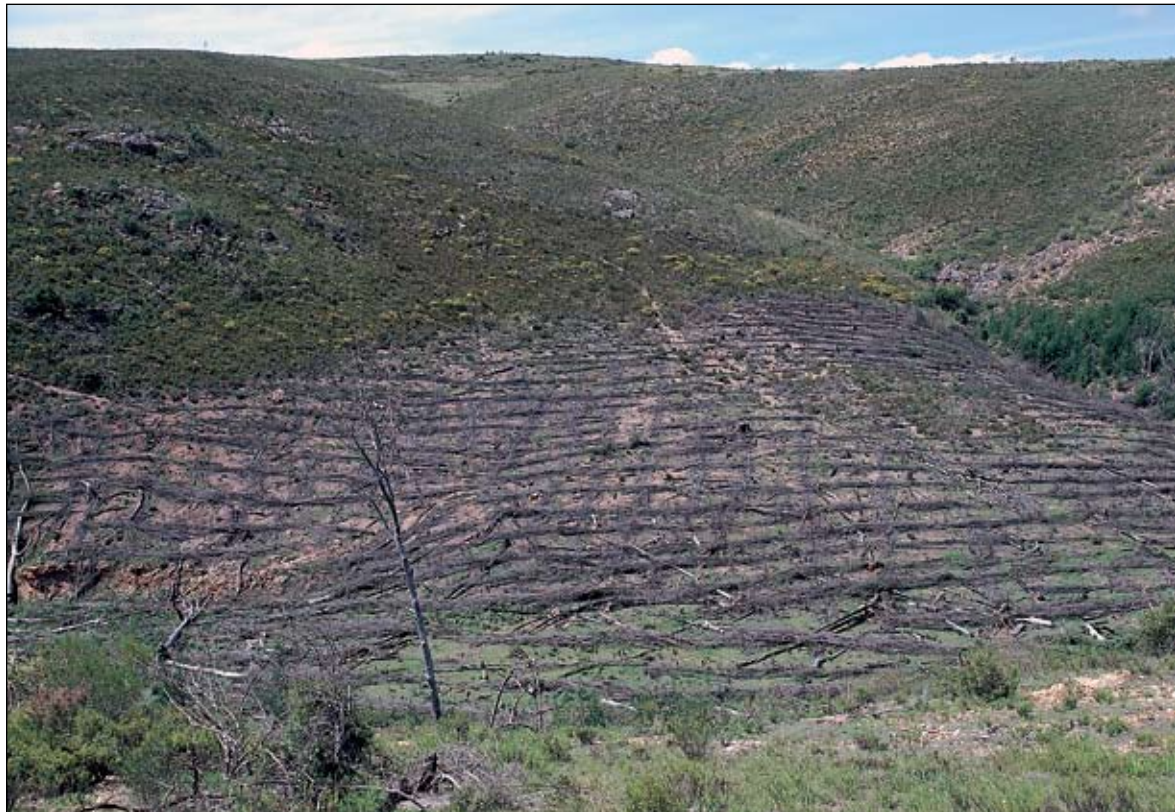
**Left:** A Working for Water team member finishes clearing a plot in the Baviaans River valley. Behind him, a stand of young black wattle trees await the same fate.

**Right:** Denuded slopes are testimony to the intensive alien-clearing work being conducted in the Kouga catchment.

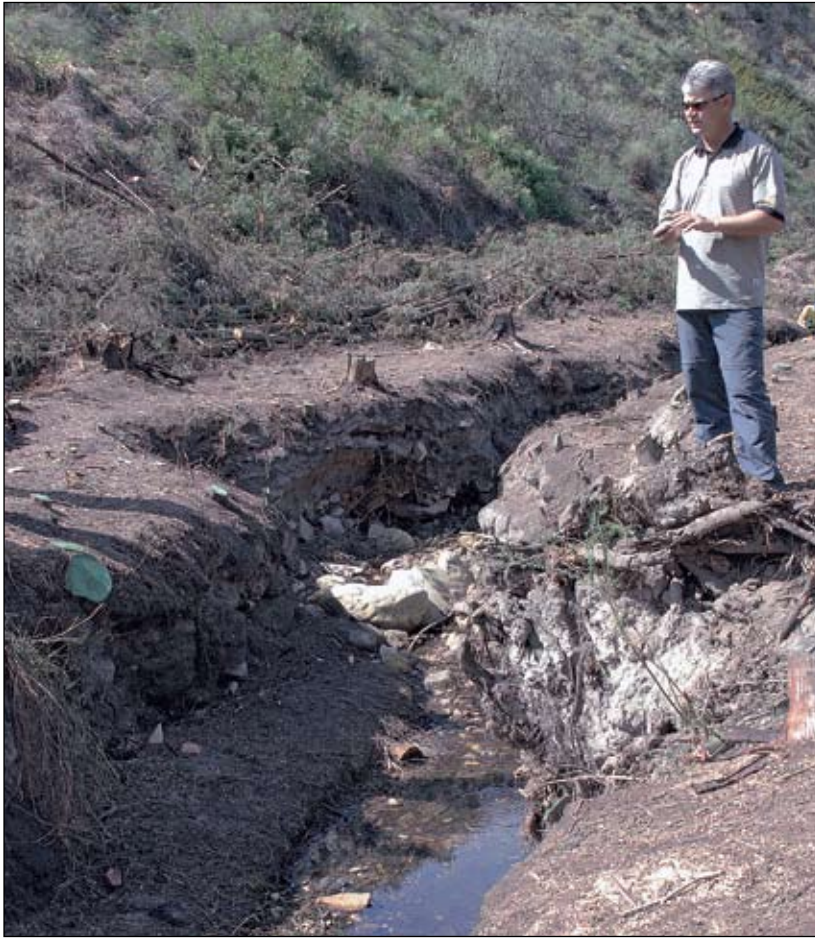
*Japie Buckle of Working for Wetlands explains how the black wattle invasion of the Baviaans River valley has caused headcut erosion and a deeply incised river channel. Subject to an EIA, a weir will be installed to raise the channel bed so that riparian vegetation can be planted.*
