# DEALING WITH TUNNEL AGEING

WRC Report No. 1088/1/03

Report to the  
Water Research Commission

Ninham Shand (Pty) Ltd  
In Association with the University of Stellenbosch and  
University of Pretoria

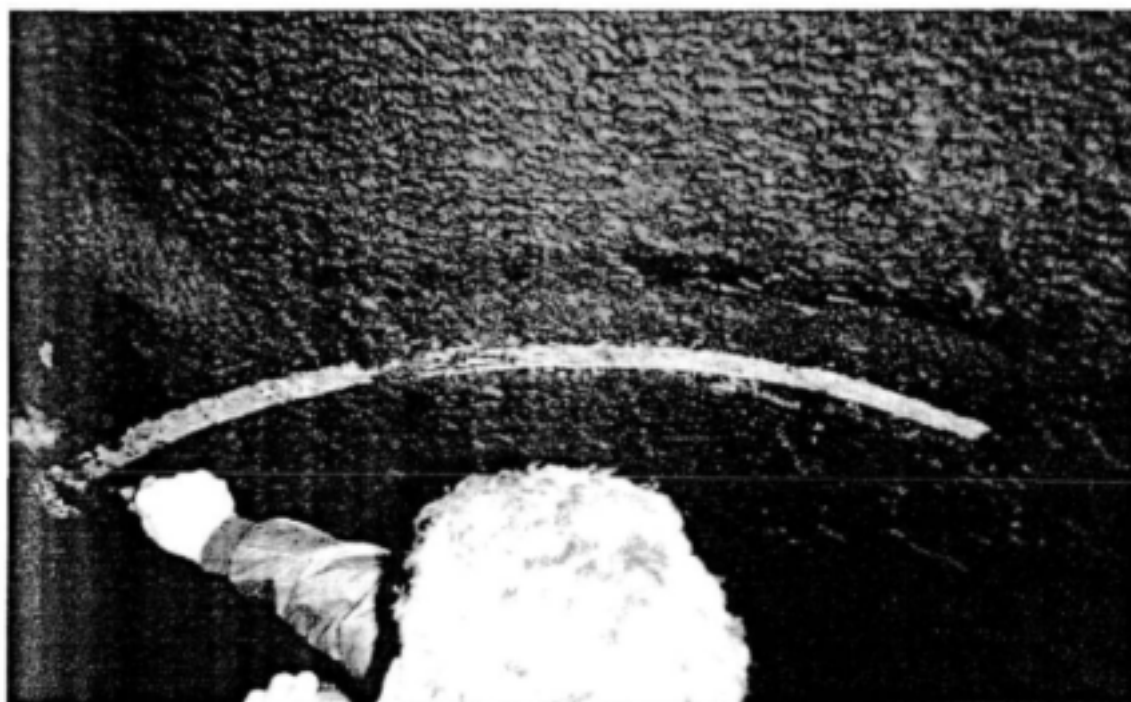
The Roode Elsberg Tunnel was constructed in the late 1960s and transfers irrigation water from the Roode Elsberg Dam to the Hex River valley (Figure 5.8.6-1). The insitu concrete lined tunnel is 5.2 km in length and 1.98 m in diameter. The tunnel has mostly been operated at flow velocities below 0.5 m/s and a 10 mm uniform layer of fine cohesive sediment deposited on the tunnel wall (Figure 5.8.6-2).

**Figure 5.8.6-2 Sediment deposition in Roode Elsberg Tunnel**

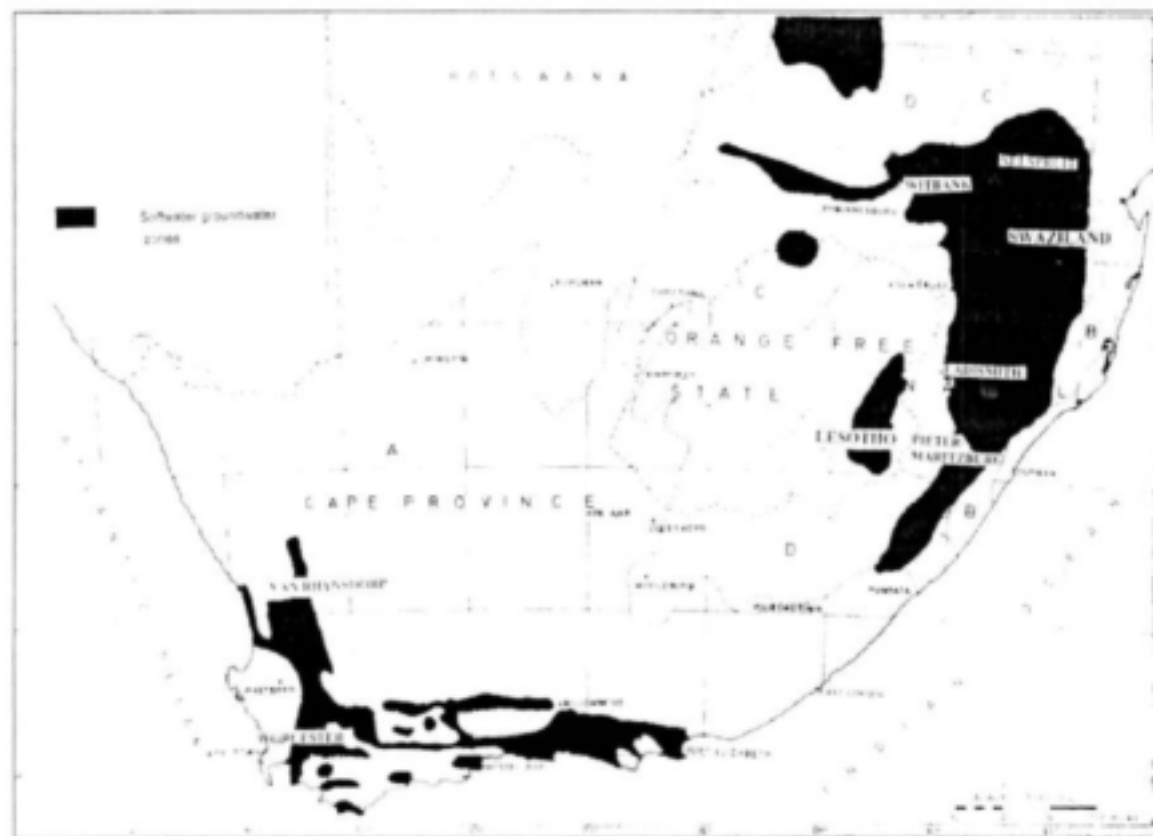
Aggressive ground water zones in South Africa are shown in Figure 6.1-1 and provides an indication of where soft water in surface water can be expected. The water quality of surface water at a specific tunnel should however be investigated to obtain site specific data.

Figure 6.1-1 Soft water zones in ground water in South Africa (DWAF, 1999)

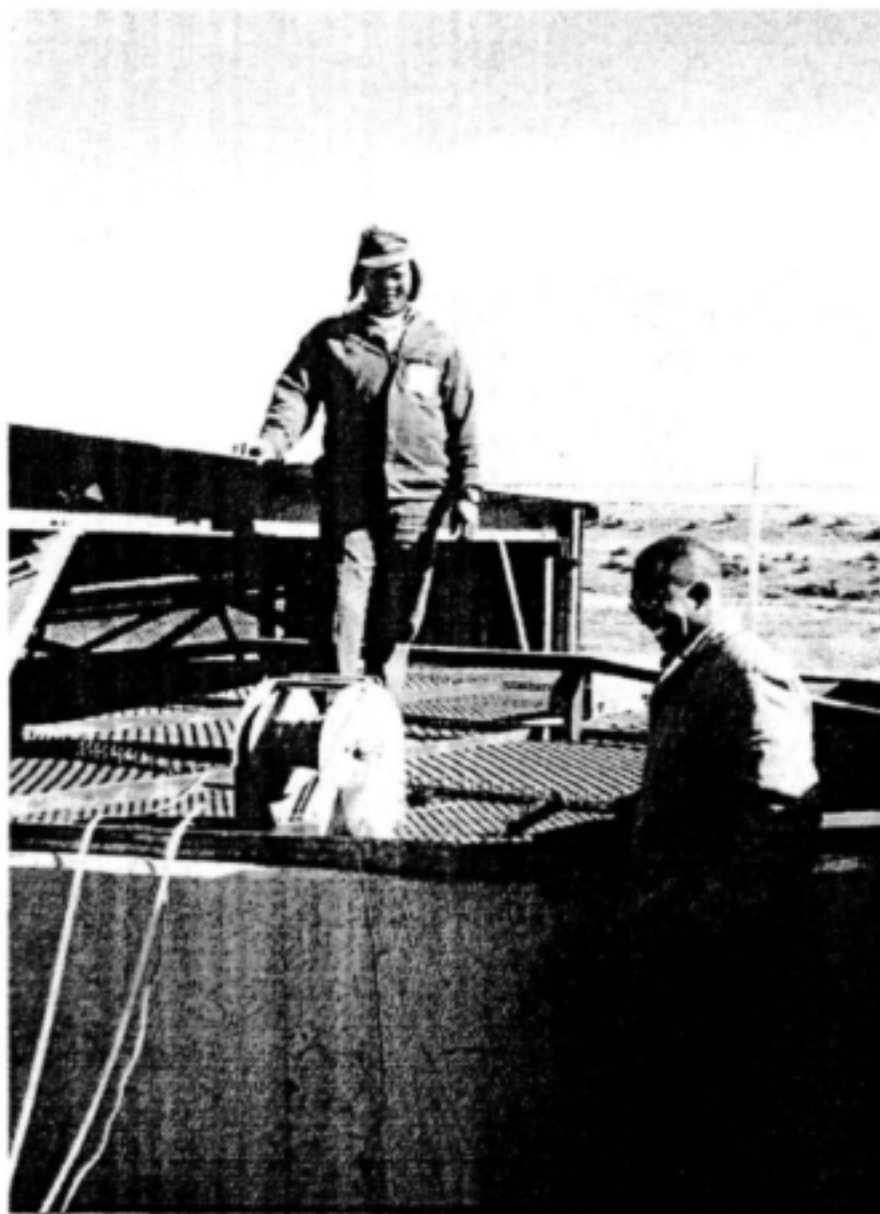
**Figure 8.1.2-8** Depth gauge at tunnel shaft operated by DWAF personnel

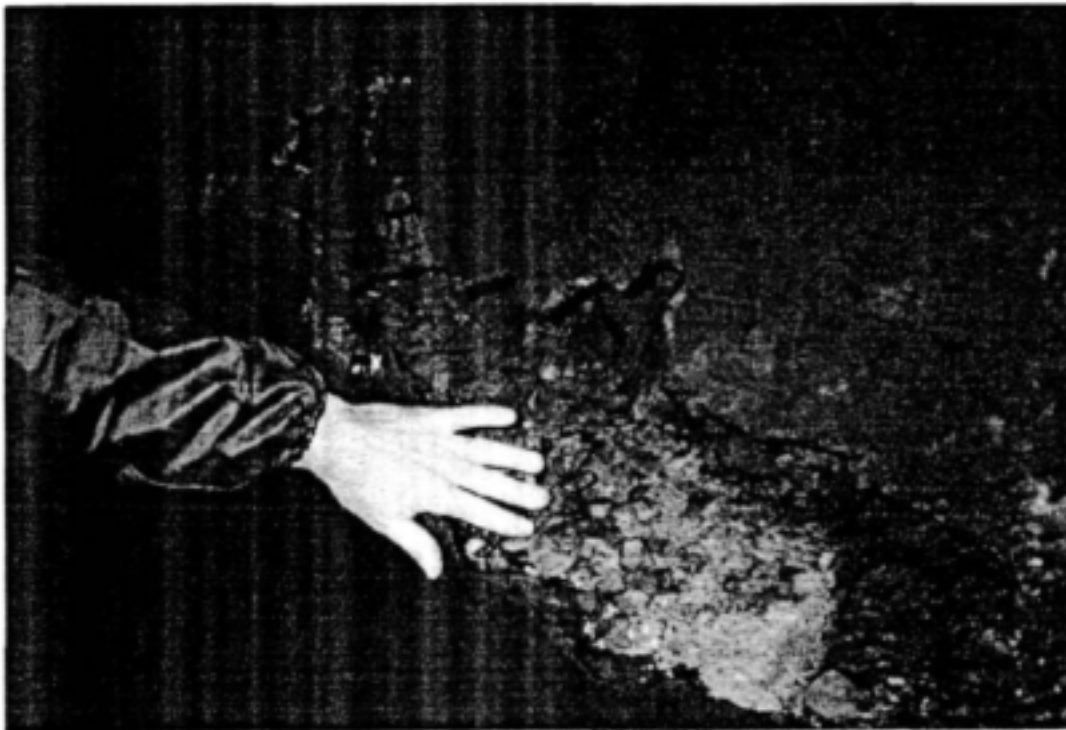
**Figure 8.1.3-5** Deep scour hole in soft water corroded concrete, intake to Berg River, Theewaterskloof Tunnel

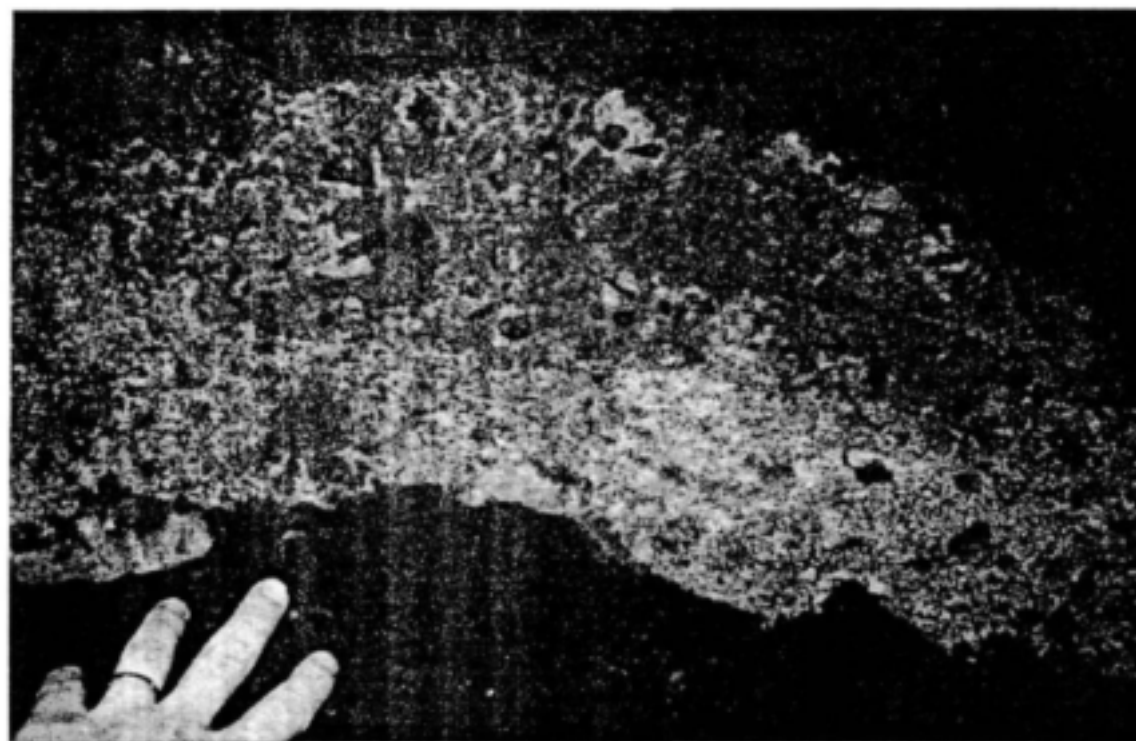
**Figure 8.1.3-7 Exposed coarse aggregate after sediment removal due to emptying, Banghoek to Jonkershoek, Theewaterskloof Tunnel**

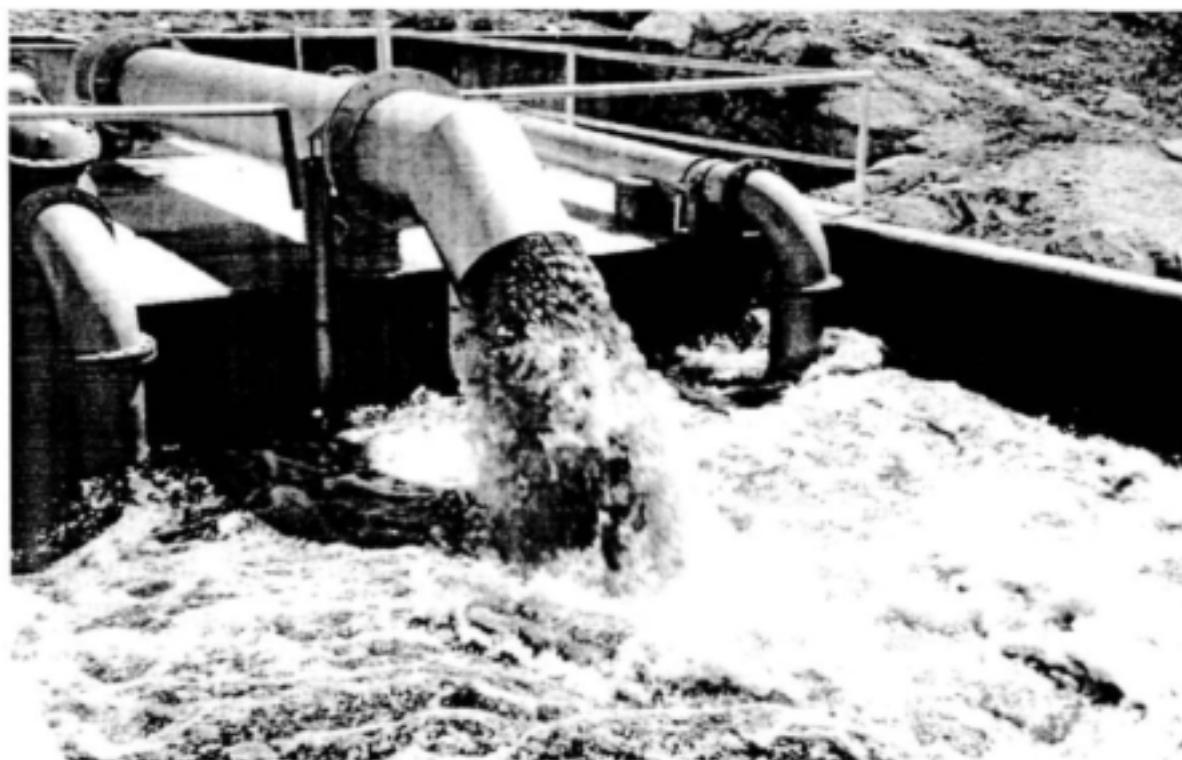
**Figure 8.1.4-8 Bypass pipe at Roode Elsberg Tunnel**

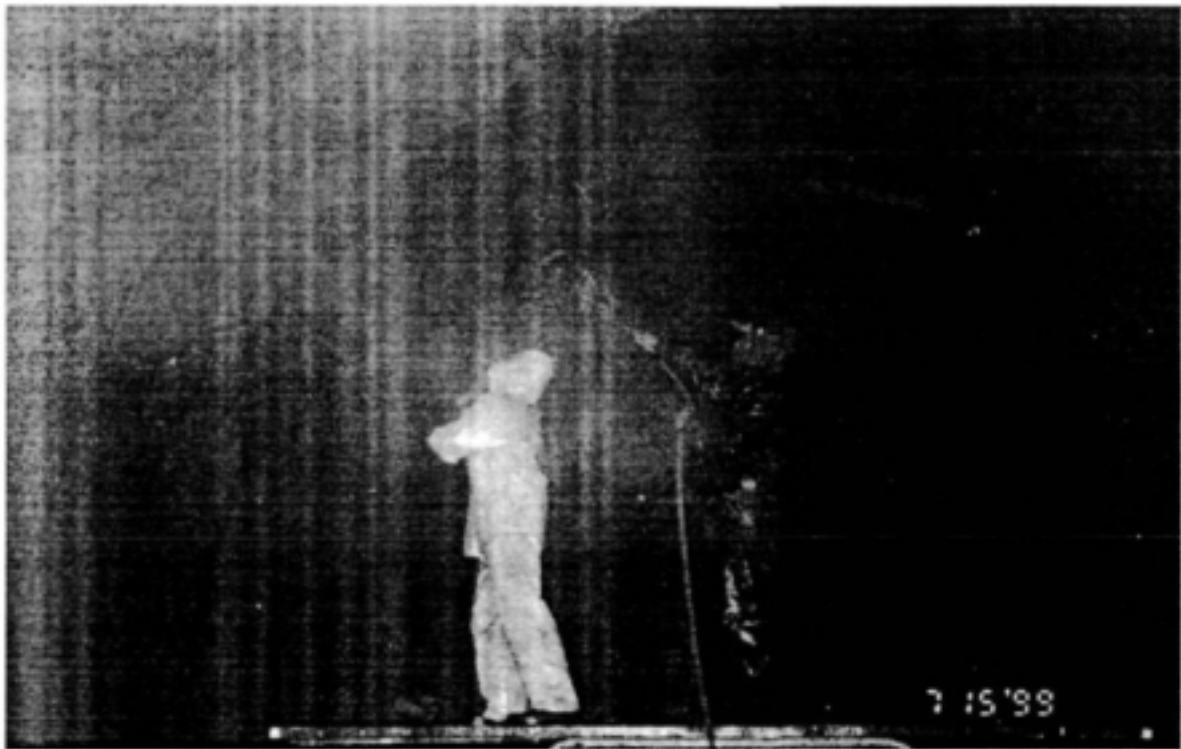
Figure 8.2.6-1 Theewaterskloof Tunnel cleaning during 1999

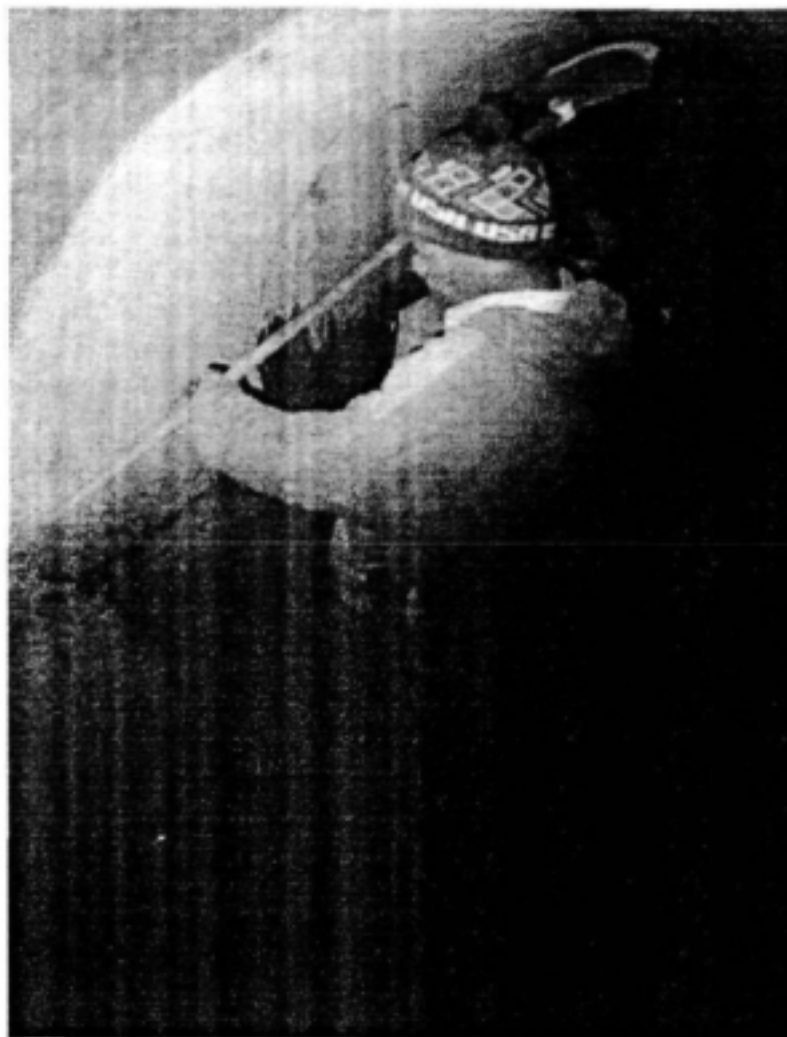
**Figure 8.2.7-1 Tunnel cleaning at Roode Elsberg Tunnel**

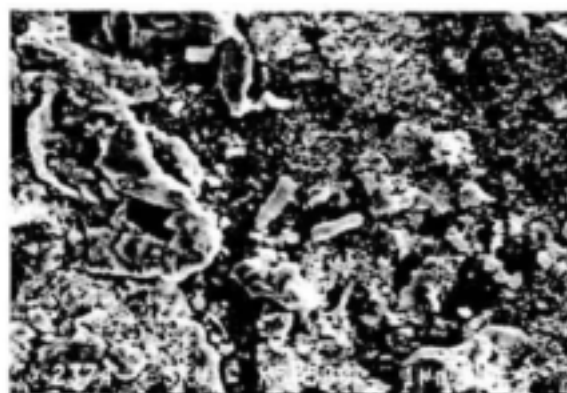
Figure 5: Rod-shaped bacterial cells
