# **AN INDEPENDENT INVESTIGATION AND ADVISORY ON THE ROLE OF WATER, SANITATION AND HYGIENE IN THE 2023 CHOLERA OUTBREAK IN HAMMANSKRAAL, SOUTH AFRICA**

### ***Part 2: Assessment of the Functionality and Compliance Status of the Temba Water Treatment Works***

Final Report to the  
**Water Research Commission**

**WRC Report No. 3167/2/24**

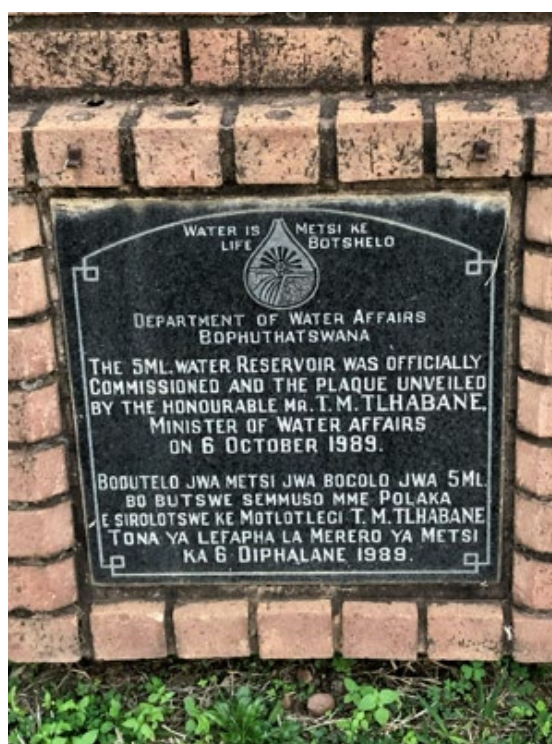
Figure 14: One of the 5 reservoirs

The treated water is stored in five reservoirs on-site. The estimated storage capacity is 25 Ml. The storage, if kept above one-quarter of the total capacity, would be sufficient to meet the 30-minute retention time for the chlorine.
