# **AN INDEPENDENT INVESTIGATION AND ADVISORY ON THE ROLE OF WATER, SANITATION AND HYGIENE IN THE 2023 CHOLERA OUTBREAK IN HAMMANSKRAAL, SOUTH AFRICA**

## **WORK PACKAGE 4: WATER AND SANITATION SAFETY ASSESSMENT AND ENVIRONMENTAL MONITORING**

### ***Part 1: Assessment of the Functionality and Compliance Status of Two Wastewater Treatment Works (Rooiwal and Temba) in the Outbreak Area***

**WRC Report No. 3167/1/24  
ISBN 978-0-6392-0652-3**

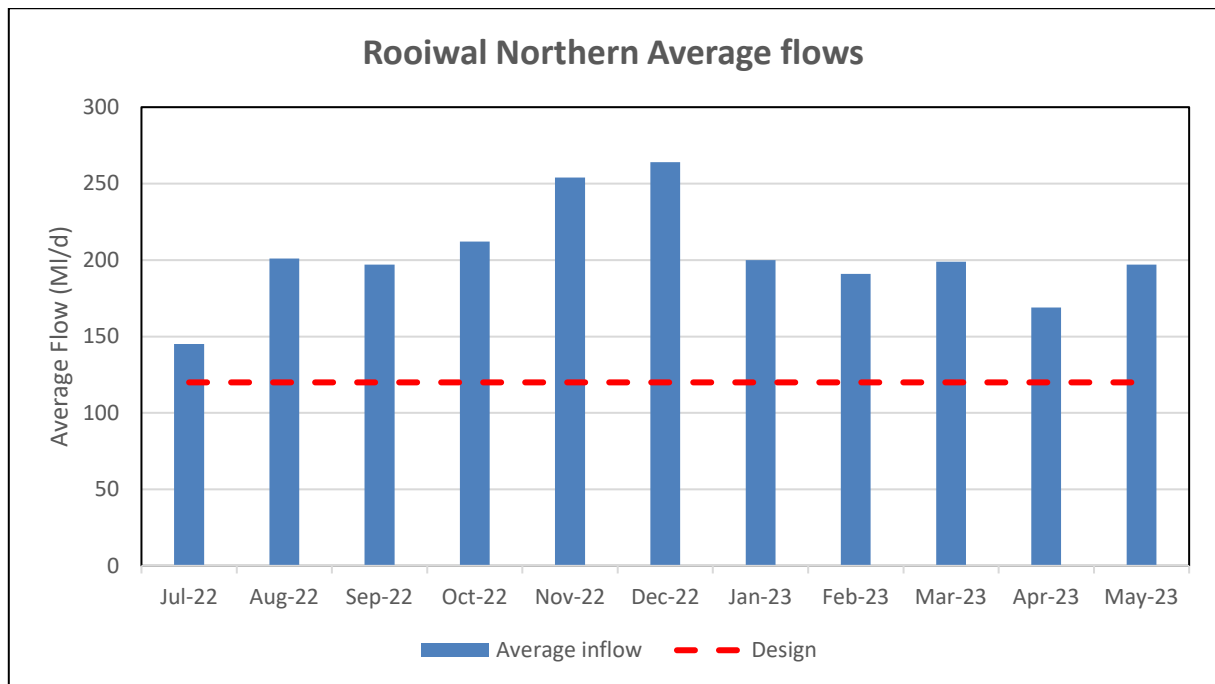
Figure 2 below shows that the plant consistently operates above the design capacity with some months recording an average daily flow of more than twice the design capacity. The out of commission BNRAS section

of Module 1 also means that the available capacity of the plant is further reduced, therefore the capacity exceedance impact is even greater.

**Figure 2: Average daily flows from July 2022 to May 2023**

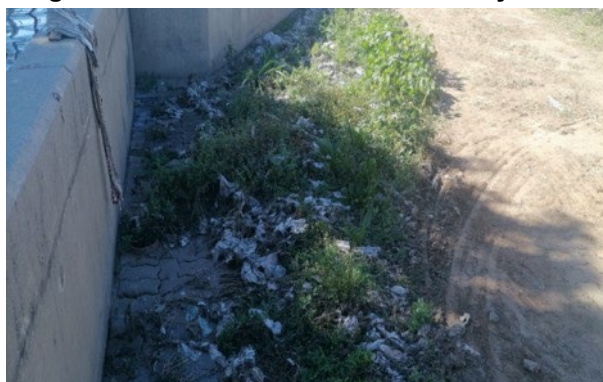
Provision is made for installation of three mechanical fine screens. However, the three fine screens have been removed for long periods resulting in raw wastewater only passing through manual coarse screens. Cleaning frequency of the manual coarse screen is also inadequate. Unavailability of fine screens results in carrying-over of debris to downstream processes. The screen conveyor is available and working but evidently, it requires serious maintenance, also, poor screenings disposal practices were observed as screenings are left lying around the plant without indication of when they would be removed.

**Figure 6: Screenings not safely stored**

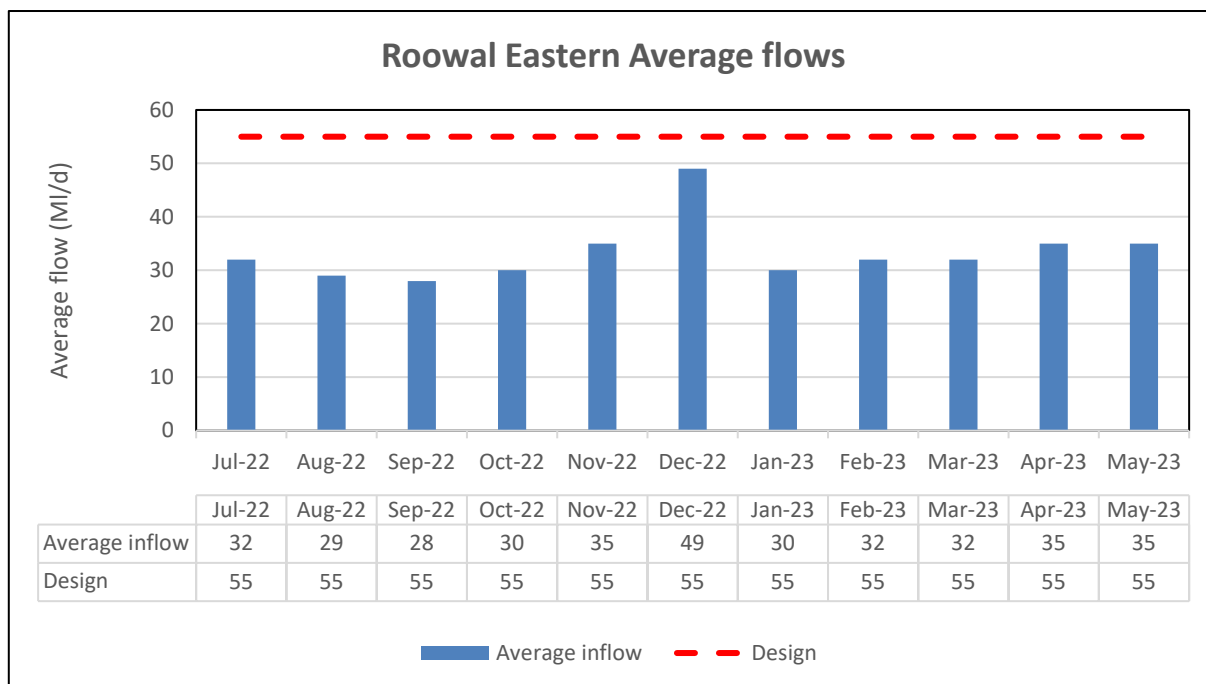
**Figure 19: Average daily flows from July 2022 to May 2023**

The average daily flow as presented in the figure above suggests that the plant operates below the design capacity. However, during inspection it was noted that most of the biofilters are out of commission and therefore available capacity is reduced. It is therefore highly likely that even at these flows, the plant was still hydraulically overloaded.

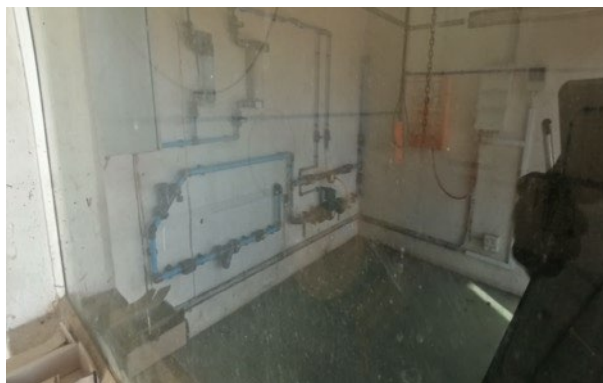
Disinfection is normally achieved using chlorine gas. There are two dosing banks installed. Each bank feeds 925 kg chlorine cylinders. At the time of inspection disinfection was not taking place since there was no chlorine stock. Therefore, the operational status of the disinfection system could not be verified. However, it was observed that there is lack of safety signage and equipment around the dosing area. One of the two carriage water booster pumps was out of commission. After chlorine dosing, effluent flows into the disinfection contact tank. Sludge settling was still observed in this tank, indicating that the upstream process is ineffective. Debris and some floating materials were also observed in this, further also confirming the inadequate screening at the head of works. Based on the quality of the effluent, high chlorine demand is guaranteed and introduction of chlorine to effluent of such quality may result in formation of chloramines. Serious spillage was also observed around the disinfection and contact tank area.

**Figure 35: Dosing room with provision for two banks, only one cylinder connected but not dosing due to lack of stock**

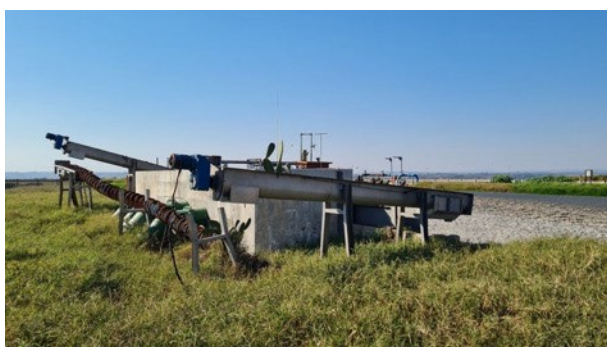
The sludge handling plant at the north of Rooiwal WWTW features a sump that receives sludge from the wastewater treatment plant. The inlet of the sump previously had mechanical screens, screw conveyors and skips that were used to further clean the incoming sludge. Currently, the sludge sump inlet works is not functioning as per the design, as shown on Figure 40. The dysfunction of the sump inlet screening equipment is evident at the composting plant where screenings and foreign objects are seen in compost, as shown on Figure 41.

**Figure 40: Northern sludge handling plant inlet  
works screens taken out and screw conveyor  
dysfunctional**

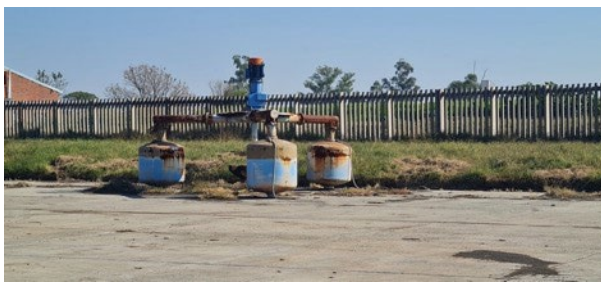
An accumulation of scum was seen at the top of the sump causing partial anaerobic conditions, as shown on Figure 42. This is exacerbated by the fact that two floating surface aerators at the sludge handling sump are dysfunctional and have been taken out of the sump, as shown on Figure 43.

**Figure 43: Floating surface aerators taken out**

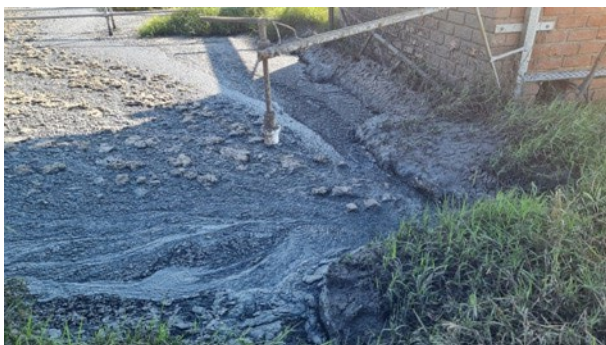
Since the sludge handling plant is not operated as it was designed, it was seen that the sludge overflows to the nearby fields, as shown on Figure 44. One of three pumps located near the sump is used to convey sludge to the main sludge handling building on manual mode, as shown on Figure 45. The other two pumps do not work and contribute to the overflowing of the pump.

**Figure 44: Northern sludge handling plant inlet sump overflows to nearby fields**

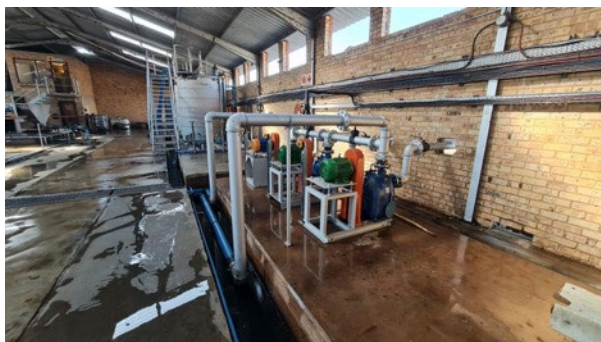
From the sludge handling sump, sludge is pumped into two storage tanks, as shown on Figure 46, which act as a buffer between the sump and belt presses for dewatering sludge. Both tanks are functional and in fair condition. Three pumps, shown on Figure 47, are installed to deliver sludge from the buffer storage tanks to the belt press. However, one of the three pumps is not working.

**Figure 47: Pump station for two out of four belt presses installed and correctly functioning**

The sludge handling plant, in its previous functioning state, had four belt presses installed in parallel with two sludge pump stations of three pumps at each pump station. Each pump station was designed and equipped with two belt presses at a time. Only one of the pump stations works and the other three pumps of pump station number two have been removed.

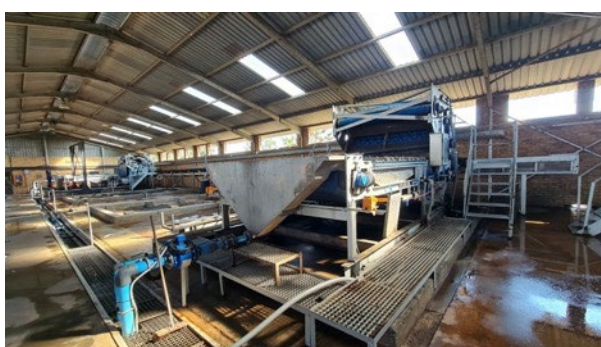
**Figure 49: Dewatering belt press No. 4 out of commission and two other belt presses removed**

Upon identifying the underperformance of the one belt press and querying the reason for operating at a lower capacity, it was revealed that the screw conveyors transferring the dry sludge to an elevated hopper are not capable of handling the 600 kg/h of dry sludge. This is evident when looking at the screw conveyor that was overflowing shown on Figure 50.

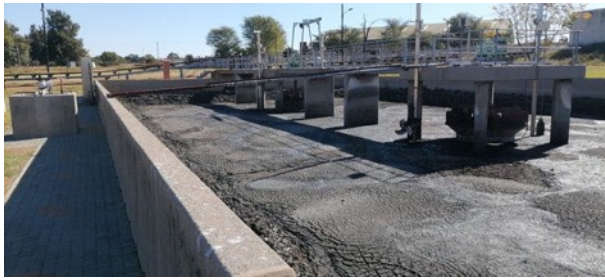
The sludge handling plant within the Rooiwal WWTW receives sludge that is stored in what is supposed to be an aerobic sump. The sump's inlet screening equipment does not function and allows screenings to enter the sludge handling plant. The sump has mixers and surface aerators that do not work, as shown on Figure 58. Consequently, the top of layer of scum can be seen. The second sump, located between the inlet sump and belt presses, also has a thick layer of scum and floating surface aerators that do not function, as shown Figure 59.

**Figure 58: Sludge handling sump one with mixers and aerators that do not work. A top layer of scum was seen**

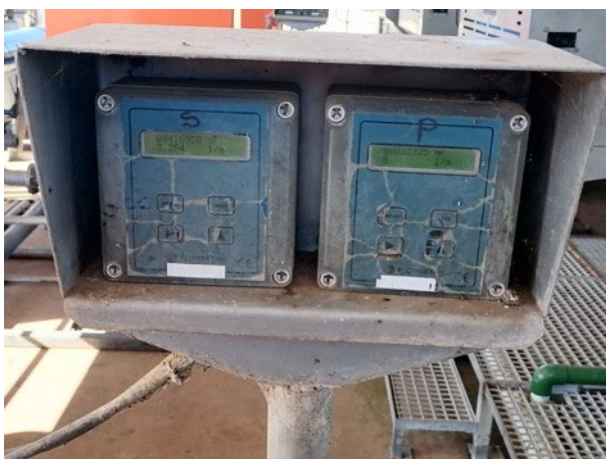
At the time of the inspection, the sludge sent to the dewatering belt presses was 3  $\ell/s$ , seen on Figure 62, higher than the sludge handling plant located at the north of Rooiwal WWTW. Between the Northern sludge handling plant and that seen inside the Rooiwal WWTW, there is a total of 6  $\ell/s$  sludge processed. The dewatered sludge is conveyed to the Northern sludge handling plant, as shown on Figure 63. This operation is performed on a 24-hour basis.

**Figure 62: Sludge Flow to Dewatering Presses**

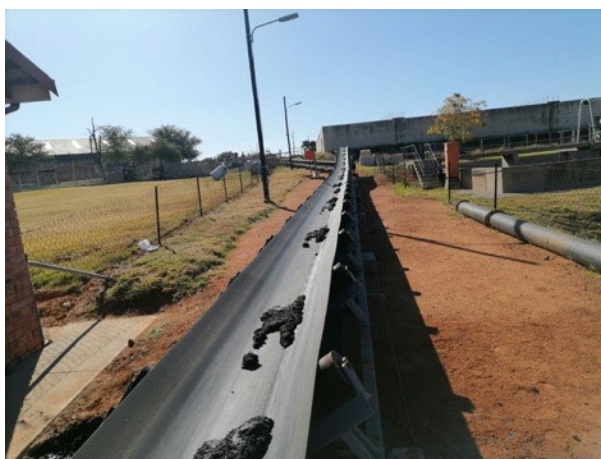
**Figure 63: Dewatered sludge Conveyed to the Concrete Slap North of Rooiwal WWTW**

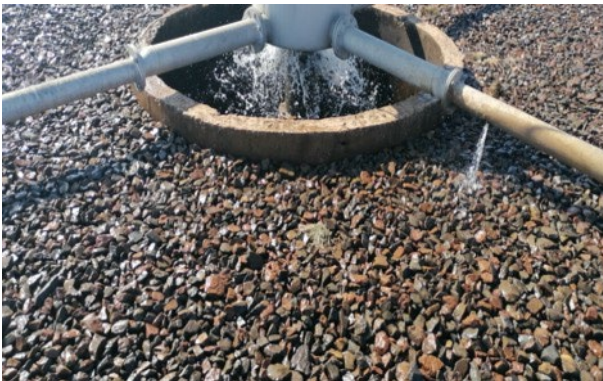
**Figure 71: Problems on the centre column**

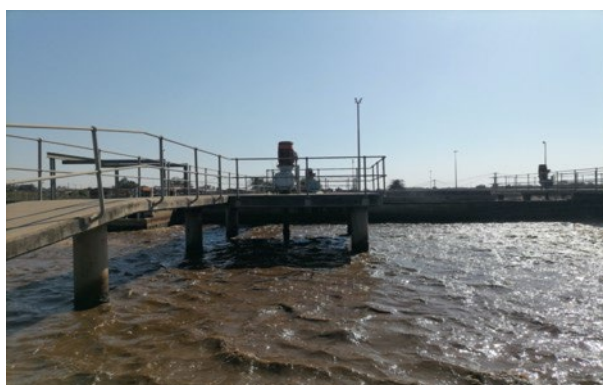
**Figure 75: Aerator not working**

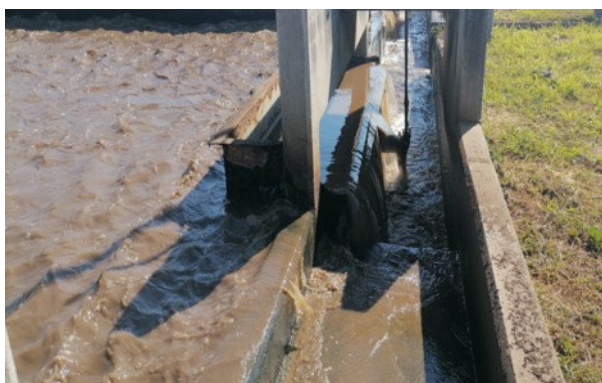
**Figure 76: Good visuals of mixed liquor at the reactor effluent**

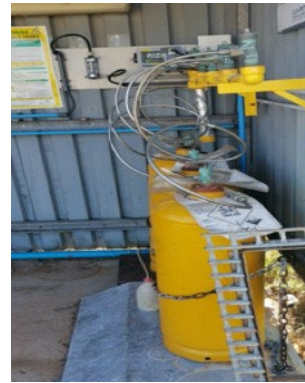
**Figure 80: Dosing equipment without standby**

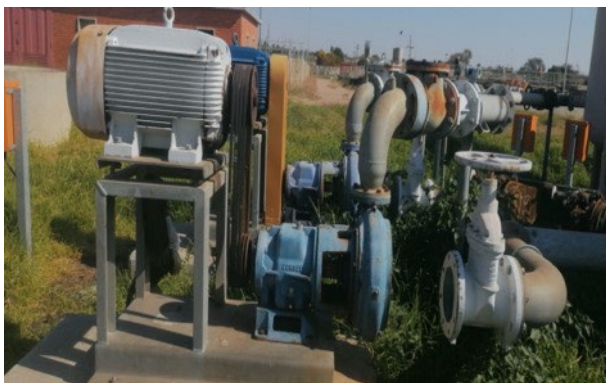
**Figure 81: One of the DAF pumps not working**

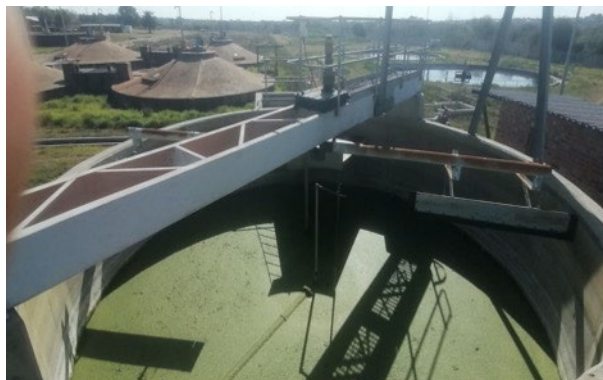
**Figure 84: Presence of duckweed in the DAF unit suggests long standing time**
