# **A Manual on Mine Water Treatment and Management Practices in South Africa**

## **APPENDIX Volume 2 Coal Mine Site Visit Reports**

**WRC Report No 527/2/96**

### Coal Mine Site Visit Reports

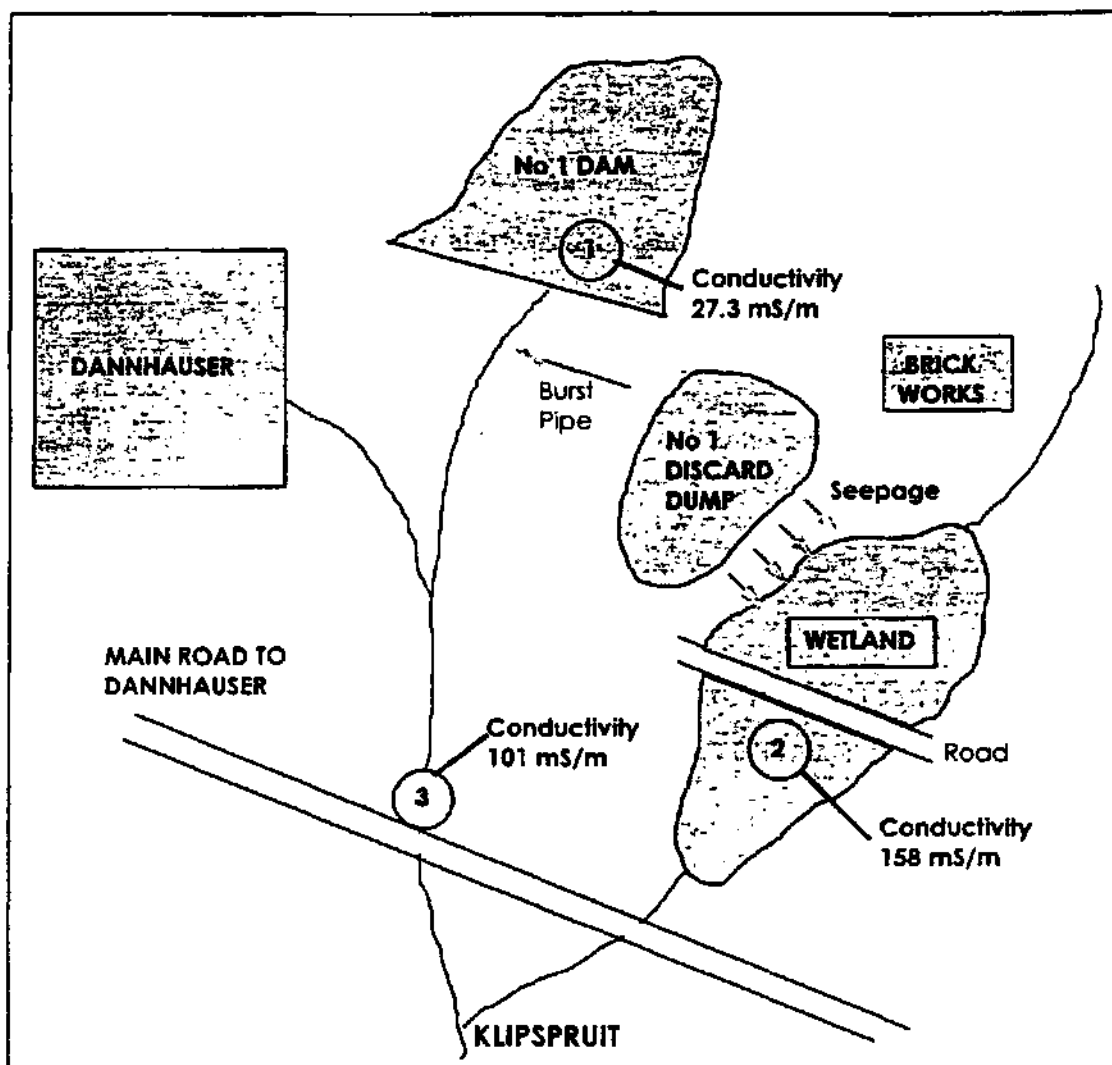
**Figure 4 : Sampling Programme Around No 1 Discard Dump**

The No 1 discard dump is essentially burned out and consists largely of ash. Although the ash has a lower pollution potential than fresh discard, the conductivity readings taken in the wetland below the No 1 ash dump clearly indicate that this dump is still contributing polluted effluent to the surface water systems.

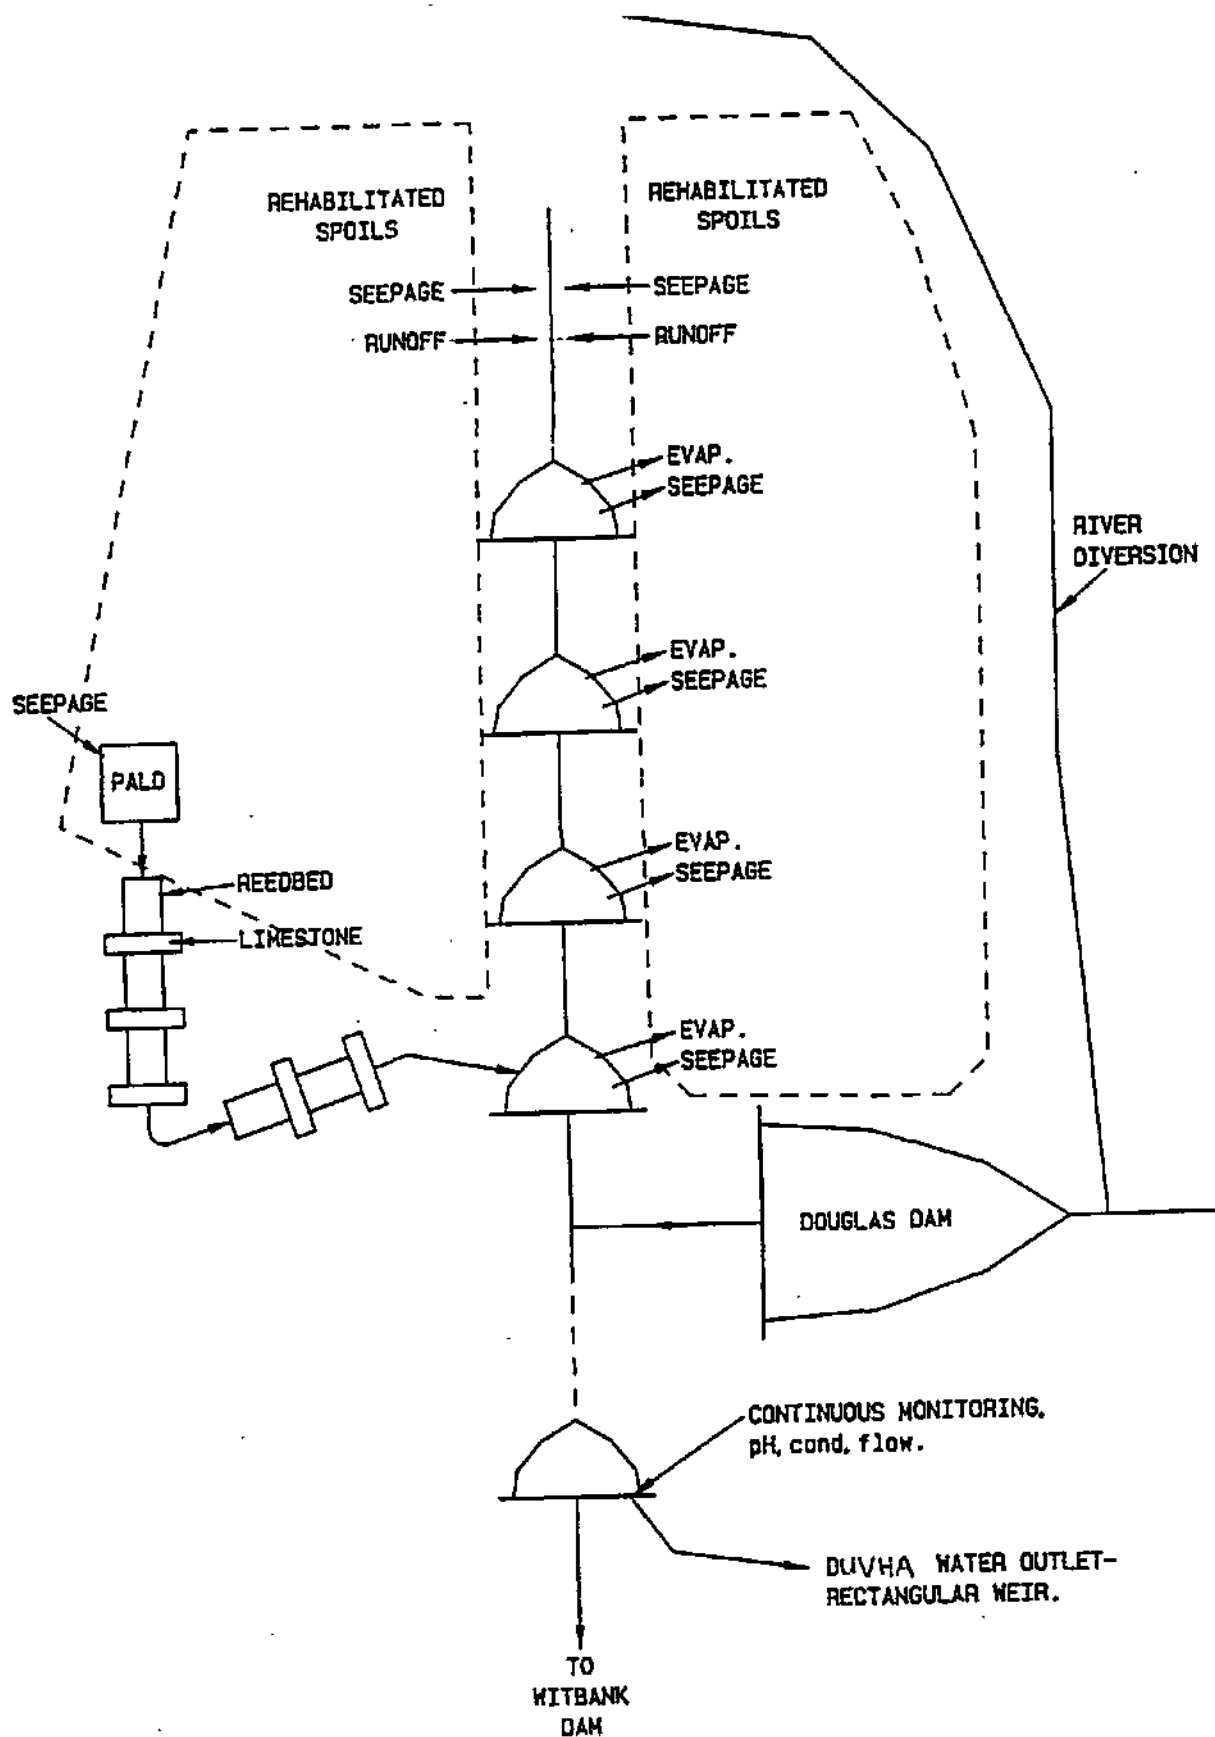
Figure 1 : Main components of the Duvha surface water system

Figure 1 is an overview of the main components of the surface and groundwater systems of the mine. No information was obtained with regard to surface runoff and infiltration rates. Some of the more important features such as the reedbeds and continuous monitoring station, are also indicated.
