# Lessons learned: Smallholder Irrigation Schemes

***South Africa has made significant investments into small-scale irrigation schemes over the last 20 years. Despite these investments a large number of these schemes remain underutilised and underperforming. A project funded by the Water Research Commission (WRC) investigated factors influencing the under-utilisation of smallholder irrigation schemes in Limpopo and opportunities for improvement. The final report makes a number of recommendations for the improvement of these schemes.***

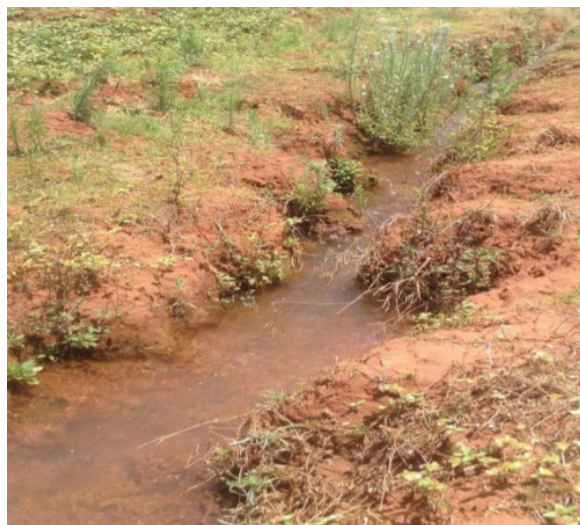
*Soil erosion challenges at the scheme due to flood irrigation.*

- Easy and affordable irrigation scheduling methods must be introduced to assist smallholder irrigation farmers, and training provided.
- The sustainability of 'floppy' irrigation systems in terms of operational costs, design and profitability should be investigated, and there should be a gradual conversion of existing large-scale sprinkler irrigation schemes to drip-irrigation farming.

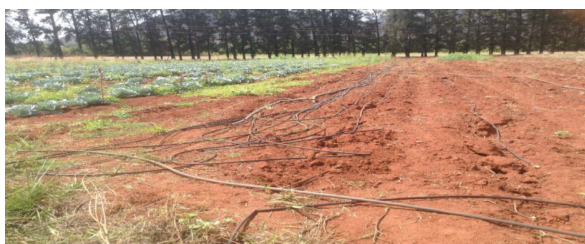
*Vandalised drip irrigation lines at one of the schemes investigated.*

**Vandalism and theft.** Three of the schemes had experienced serious problems related to vandalism and theft of irrigation assets. This can be attributed to overall management problems and lack of accountability in leadership.

- Vandalism experienced in some of the irrigation schemes needs to be addressed by the owners to ensure the sustainability of these and future irrigation schemes.
