**Would you  
swim here?**

**In March this year, Hartbeespoort Dam experienced one of the worst algae blooms in its history. Some three hectares of water close to the dam wall were covered with a 30cm-thick sludge of rotting toxic algae, releasing smelly gases and necessitating an emergency clean-up operation. It was just another episode in the ongoing controversy surrounding what has become one of South Africa's most popular recreational dams and elite country settlements.**

**By Sophia Dower**

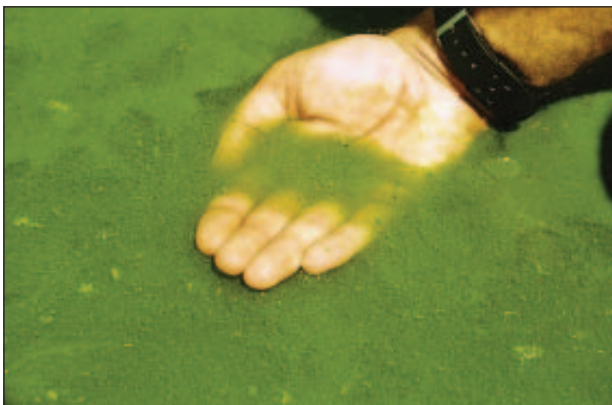
*A typical cyanobacterial bloom initially looks like pea-green soup. Once it reaches the surface it is blown by wind into smaller inlets, where it accumulates and dies off.*

Petrus Venter, Deputy Regional Director: Water Resource Management of the North West Province, explains that a typical cyanobacterial bloom initially has the appearance of green pea soup. "Cyanobacteria on the surface is blown by wind into smaller inlets where it accumulates and dies off," he says.

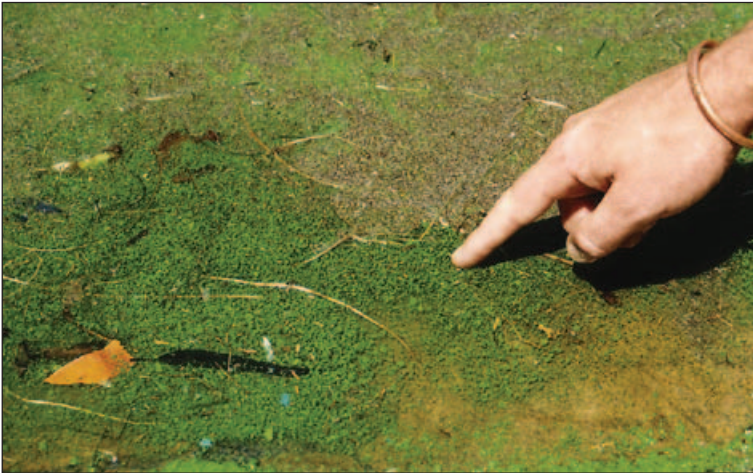
(Top) When excess nutrients are released into the water, they boost algae growth. This forms dense accumulations and floats to the surface.

"Much of the nutrients are trapped in the sediments at the bottom of the dam and remain inactive for extended periods," explains van Ginkel. "In summer, however, different thermal layers form in the water column. The deeper layer becomes anaerobic (oxygen depleted). Under these conditions phosphorus is released from the sediments. This process is known as internal loading. When mixed into the upper layers of the

water, these nutrients boost algal growth. The cyanobacteria are able to regulate their position in the water column for optimal growth. During a cyanobacterial bloom of *Microcystis* the cyanobacteria form dense accumulations, which then floats to the surface. Once exposed to sunlight, it starts to decompose, and toxins that are normally bound inside the algae, are released."

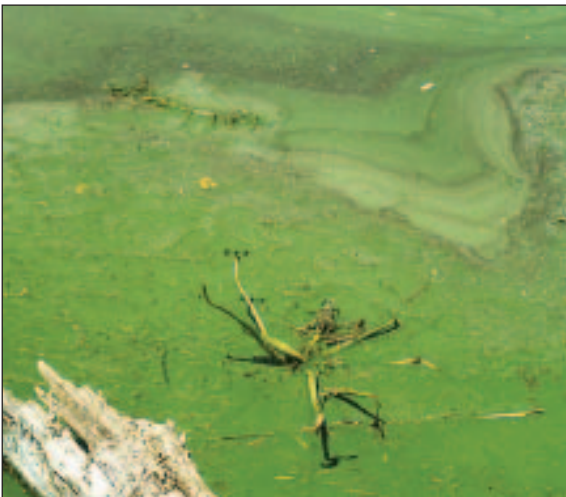
(Left) While cyanobacteria is not unique to Hartbeespoort, nowhere else do these "hyperscums" produce so rapidly or in such vast quantities.

Van Ginkel adds that the problem is not unique to Hartbeespoort, and occurs in about 20% of South Africa's monitored reservoirs. But for unknown reasons, nowhere else do these "hyperscums" produce so

rapidly or in such vast quantities.
